Post Drilling/Annual Well Site Inspection Form

Section 1: General Information	
Operation Data	Inspection Data
Operator Name Snake River Oil & Gas, LLC	Inspector Name James Thum
Well Name Tracy Trust #3-2, USWN 11-075-20011	Area Office Boise / Director's office
Authorized Contact Dan Johaneck (208) 707-7867	Inspection Date 8/26/2021 1:00 PM
County Payette	Report Date 8/30/2021
Inspector's Signature: /signed/ James Thum	Inspection Summary:
Date of Signature: 8/30/2021	<input type="checkbox"/> Operation appeared to be in compliance at the time of the inspection. <input checked="" type="checkbox"/> Issues of concern identified at the time of the inspection.
Location Description: 1.5 miles east of New Plymouth, Payette Co. Idaho. Due east of the intersection of Idaho Street and Blaine Road. Google map location Latitude 43.973024, Longitude -116789054. Weather sunny, slightly smoky haze 80° F, winds calm.	
Scope of Inspection (check all that apply and, or, were verified during the inspection): <input checked="" type="checkbox"/> Well site <input type="checkbox"/> Tank Battery <input checked="" type="checkbox"/> Wellhead <input type="checkbox"/> Meters <input type="checkbox"/> Other:

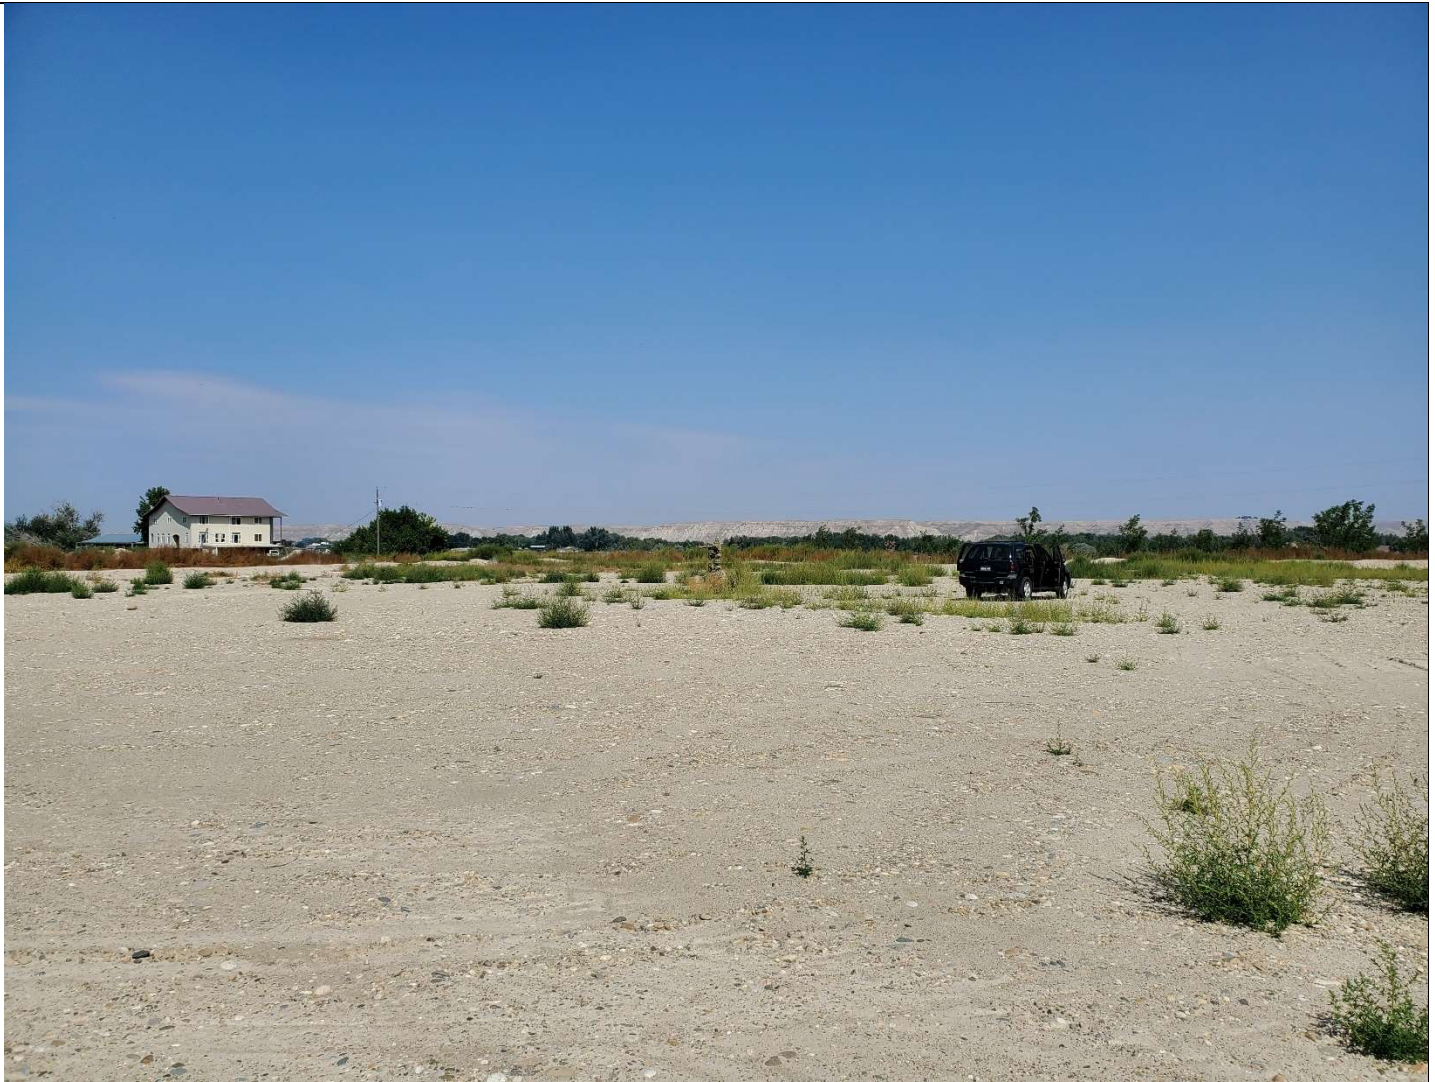
Well is currently partially plugged as of November 2019 with the top of cement in the surface-production casing annulus at approximately 733’. Operator anticipates completing P&A operations before the end of 2021. Well Pad has had little maintenance and is showing signs of erosion and deterioration, particularly on the NW perimeter adjacent to the irrigation ditch on this perimeter. Vegetation control is not evident with between 5 and 10% of the pad having weed growth. No sign was visible, nor located anywhere on the well pad. Concrete Jersey barriers are no longer positioned around the well head, and no locked cage is in place.

Photo 1: Tracy Trust 3-2 well pad looking NNW, well head in middle center, left of IDL state vehicle.

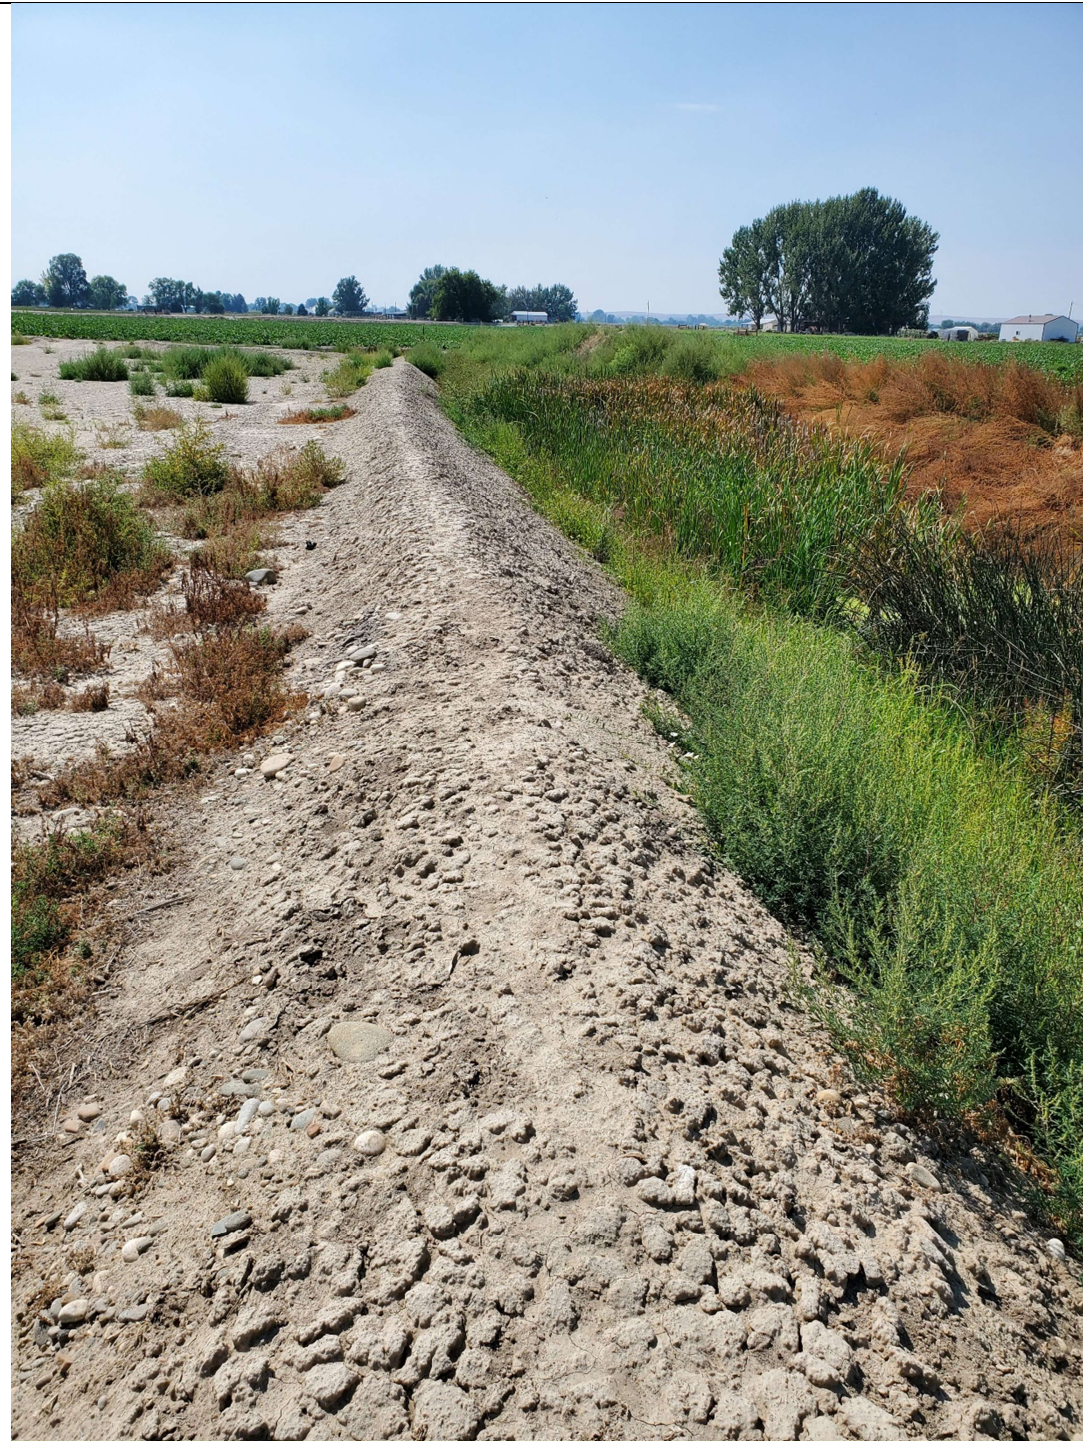
Photo 2: NW perimeter of Tracy Trust well pad, looking SSW. Dike (approximately 18 inches high) in center of photo separates well pad on left from irrigation ditch on right.

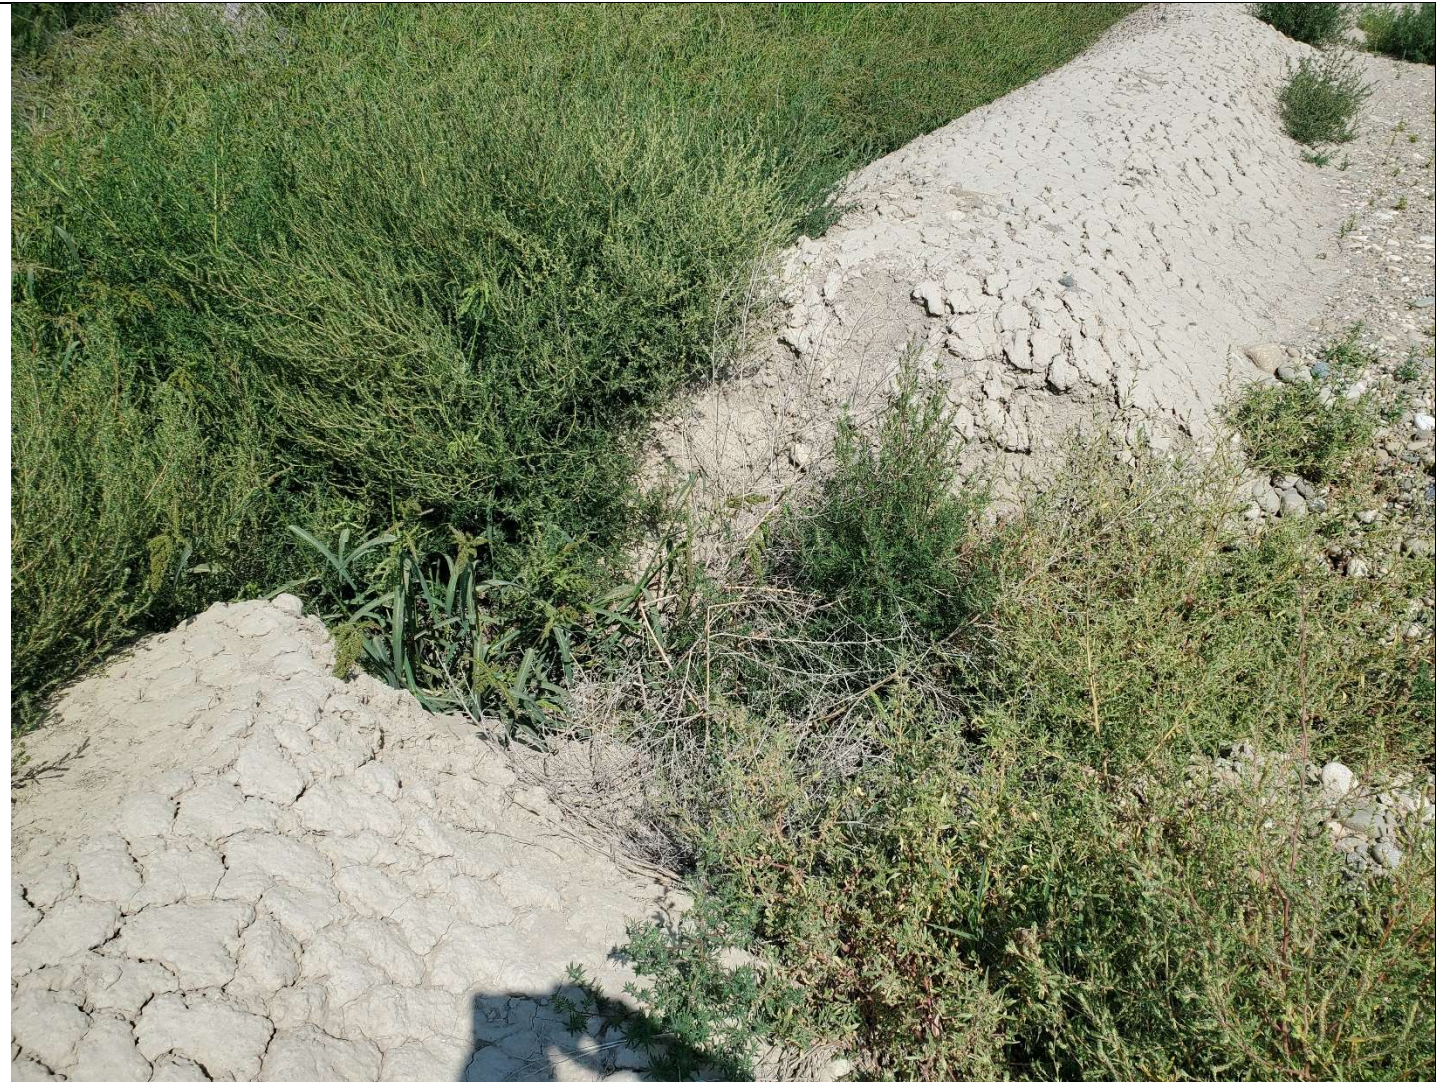
Photo 3: Dike breach on NNW perimeter of well pad. Irrigation ditch is thickly vegetated area in upper left of photo.

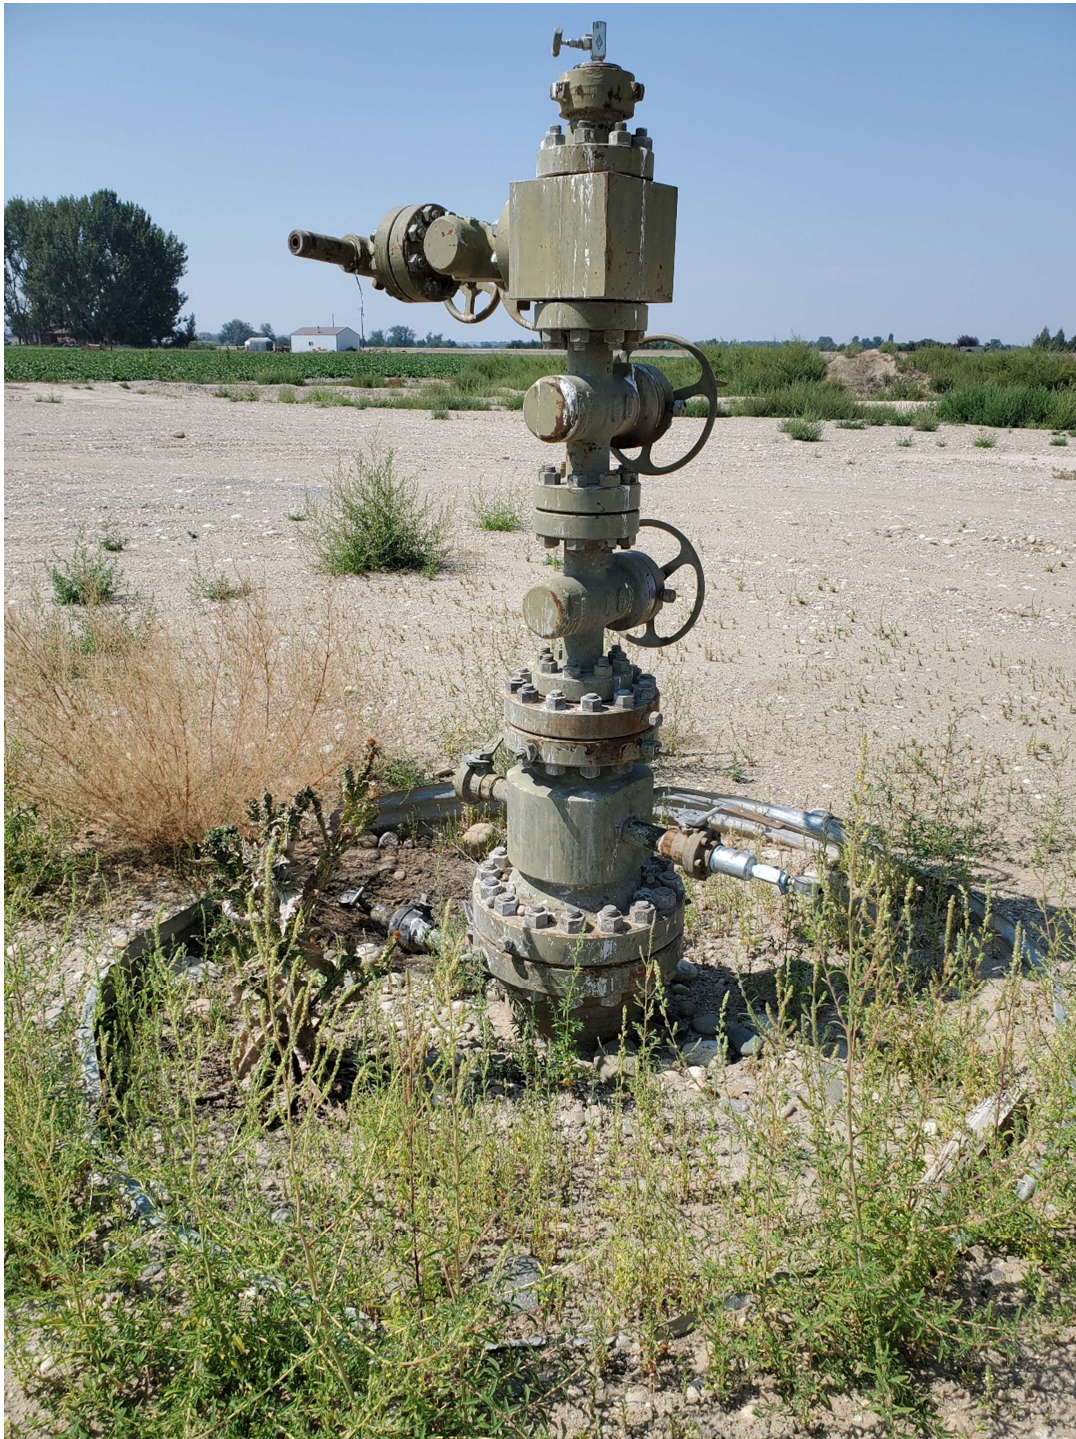
Photo 4: Tracy Trust 3-2 well head looking SW. 5 1/2" pressure gauge valve stem visible on lower right; 9 5/8" pressure gauge valve stem partially visible on lower left.

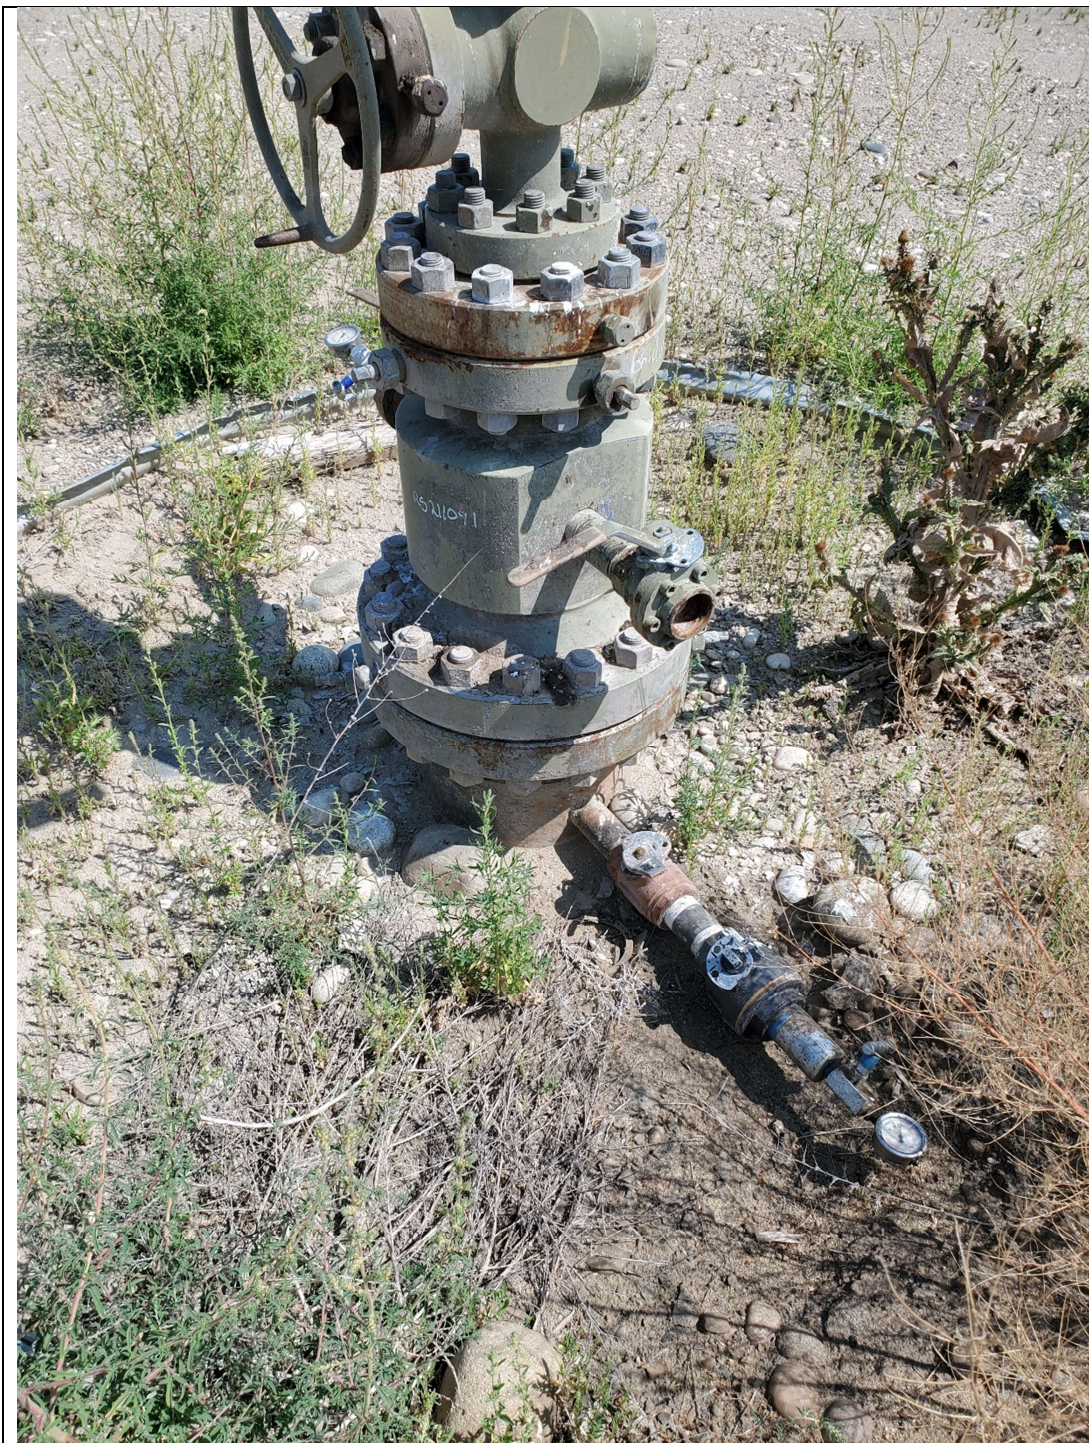
Photo 5: Tracy Trust 3-2 well head, 9 5/8" pressure gauge valve stem visible on lower right.

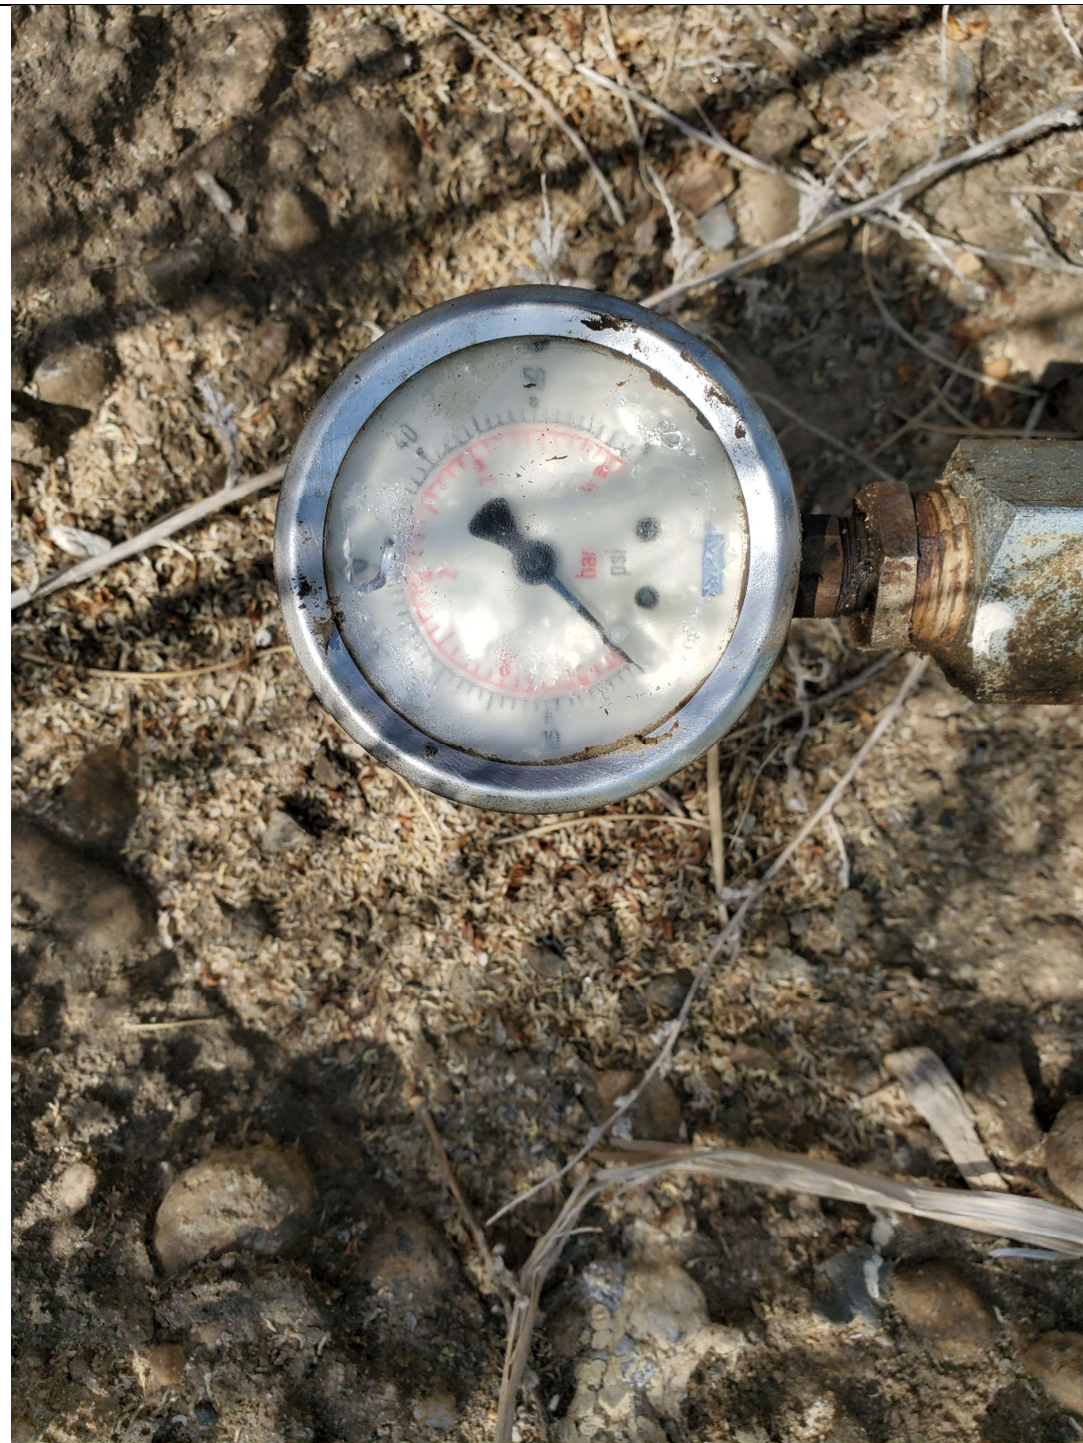
Gauges are still installed on both the 9 5/8” and 5 1/2” casing. Both read 0 psi. The 5 1/2” valve was turned to the “on” position and increased to 3.5 psi after 15 seconds. The pressure did not increase nor drop after 30 minutes, at which time the valve was returned to the “Closed” position. The 9 5/8” valve required a wrench and was not turned on. The pressure remained at 0 psi.

Photo 6: Tracy Trust 3-2 9 5/8" pressure gauge.

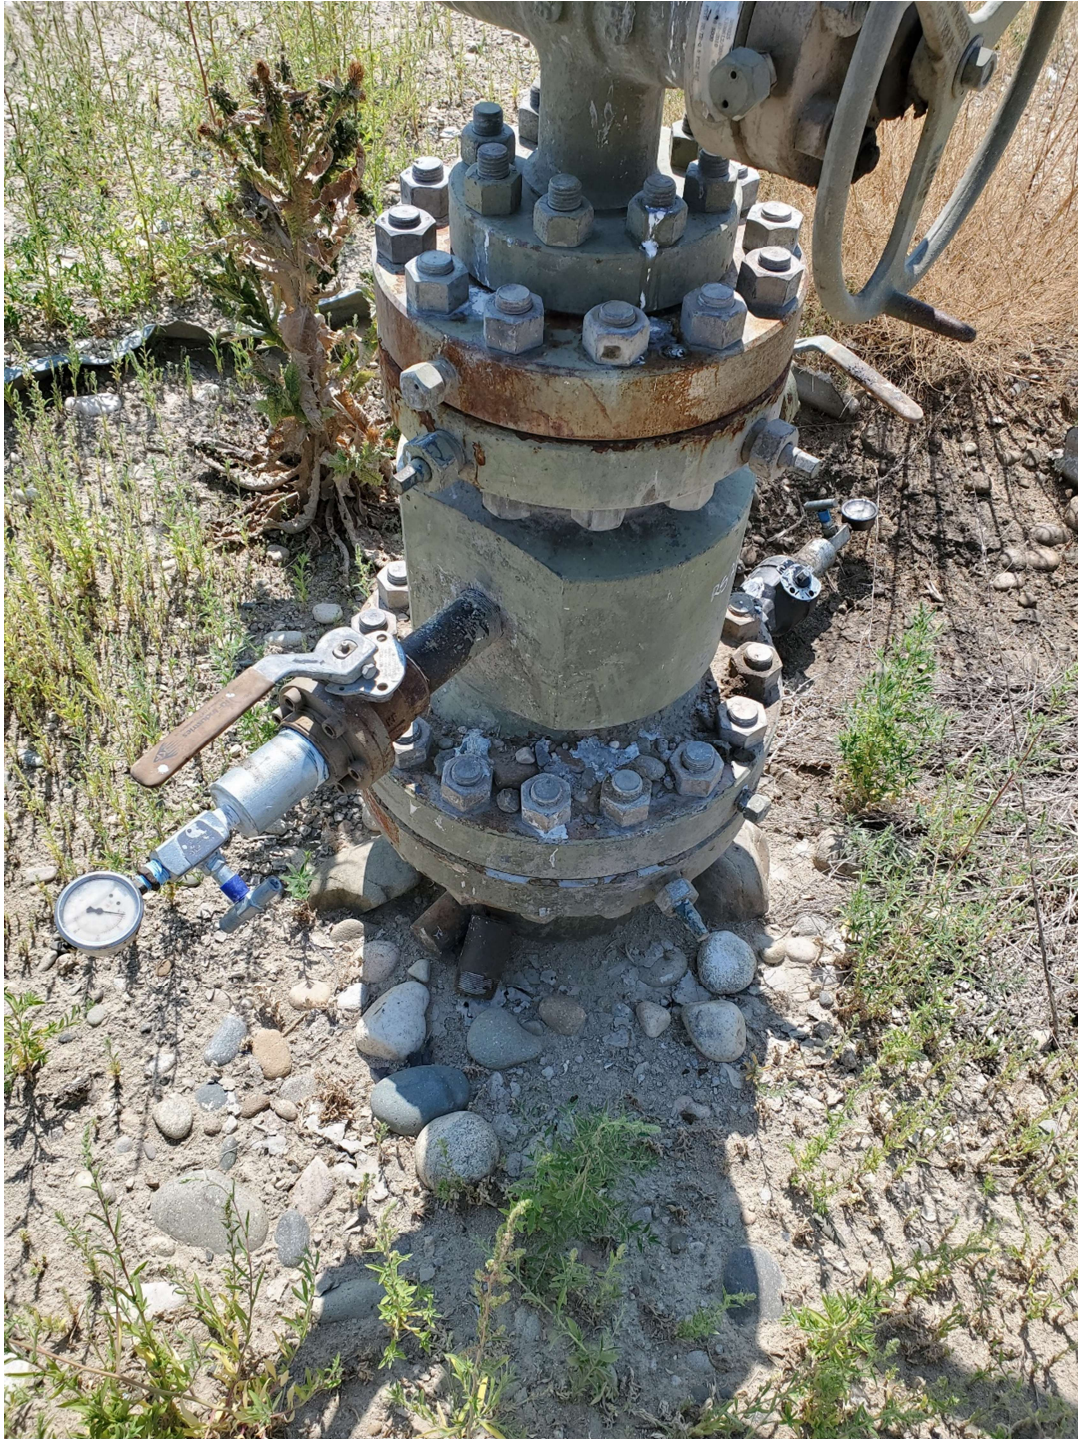
Photo 7: Tracy Trust 3-2 well head, 5 1/2" pressure gauge and valve stem visible on lower left. Valve is in the "Open" position.

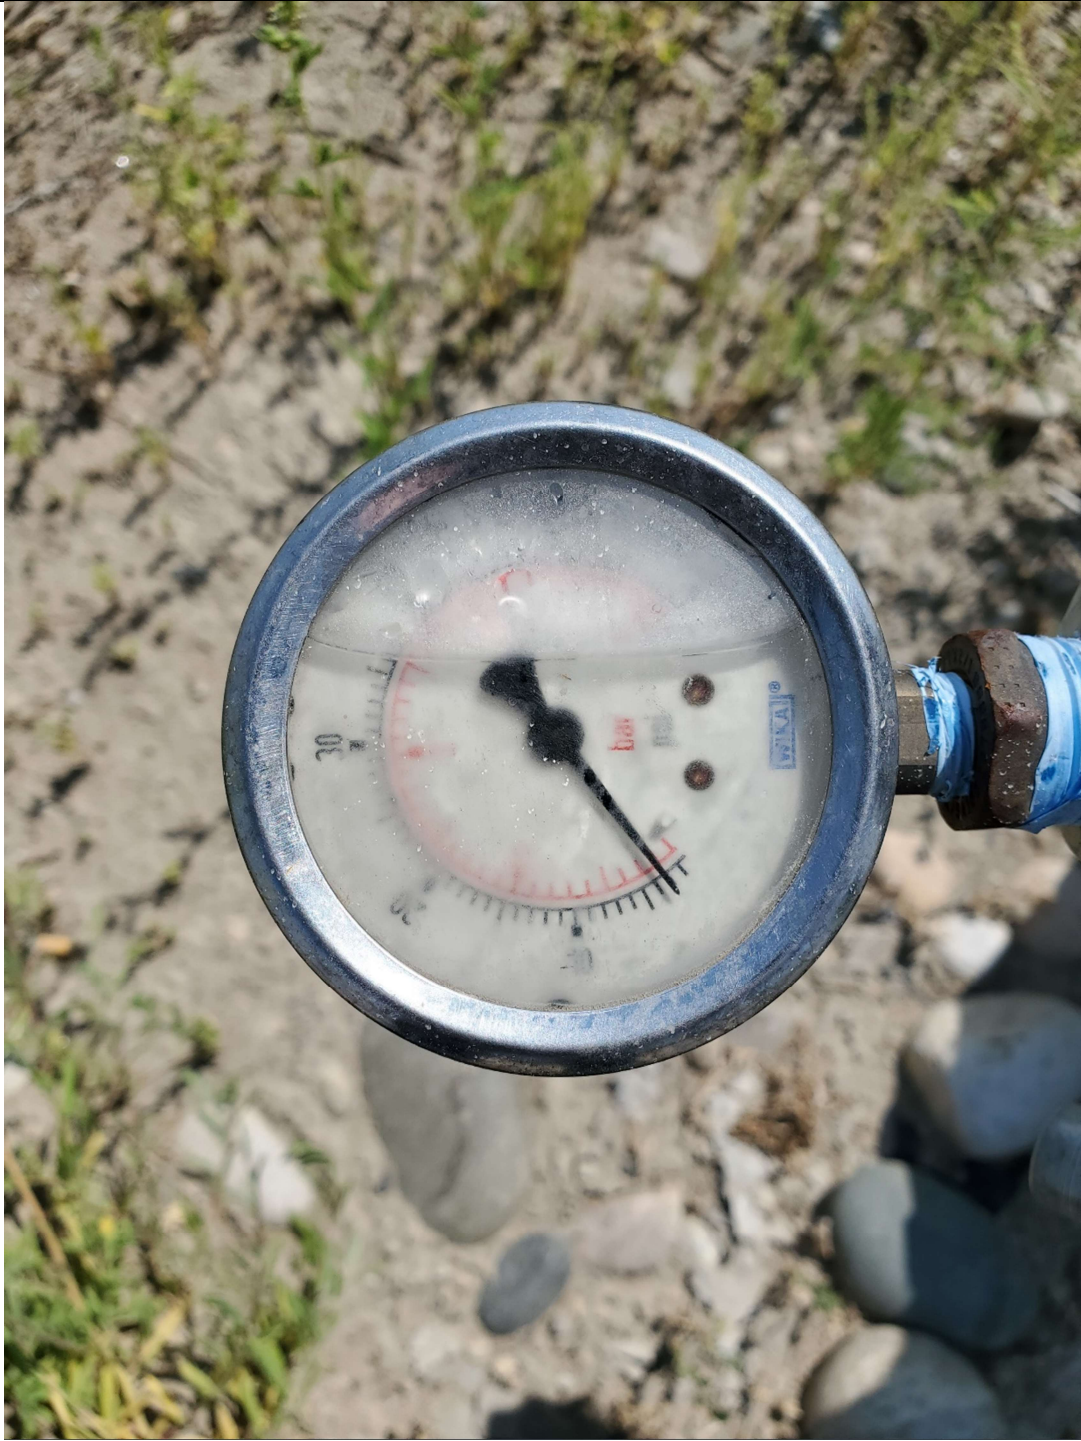
Photo 8: Tracy Trust 3-2 5 1/2" pressure gauge reading with valve in the "Open" position for 30 minutes.
