Active Drilling Inspection Form

Section 1: General Information		
Operation Data	Inspection Data	
Operator Name	Inspector Name	
Snake River Oil + Gas LLC	James Thum	
Well Name	Area Office	
Fallon #1-11, USWN 11-075-20037 Authorized Contact(s)	Boise / Director's Office Inspection Date	
Nate Caldwell-Operations Manager (870) 904-7305	11/3/2021 In: 6:00 AM Out: 10:00 AM	
Clint Harmon-Company Man (713) 822-3167	11/3/2021 III. 0.0071111 Out. 10.007111	
County	Report Date	
Payette	11/4/2021	
Inspector's Signature: /signed/ James Thum	Inspection Summary:	
	Operation appeared to be in compliance at the	
	time of the inspection.	
	Issues of concern identified at the time of the	
Date of Signature: 11/5/2021	inspection.	
Location Description:	F	
Location Description.		
1 mile NE of Fruitland, north side of Killebrew Road across from	Payette Rocks Gravel Quarry. Location is just off the	
road, in irrigated farmland / pasture. Approximate coordinates fro

Fallon #1-11, 9-5/8" Surface Casing

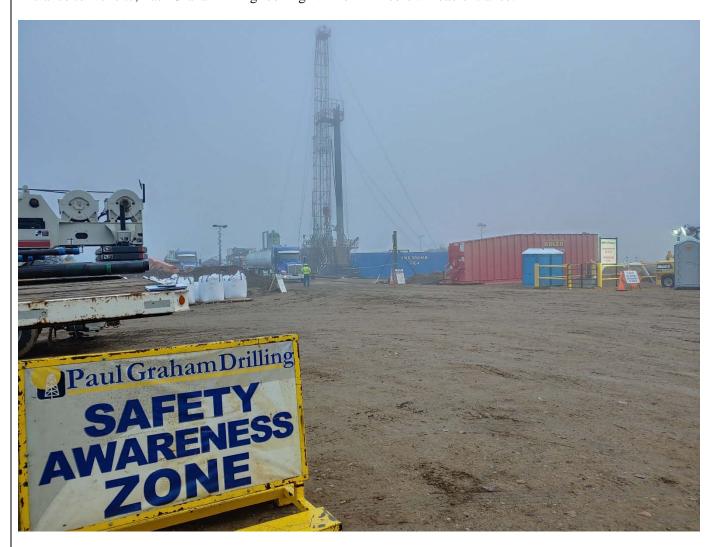
Entrance to wellsite, Paul Graham #4 rig looking NE from Killebrew Road entrance.

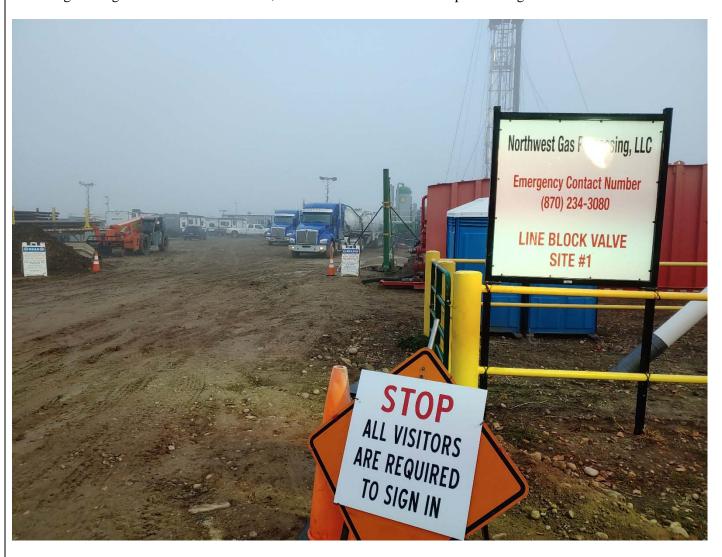
Harmon gathering line riser and block valve, entrance to Fallon #1-11 well pad looking N. from Killebrew Rd.

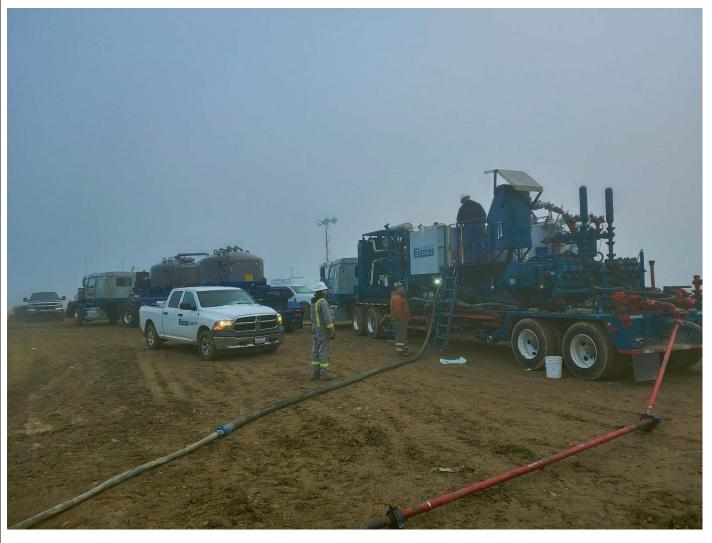
Resource Cementing equipment and crews set up for surface casing cement.

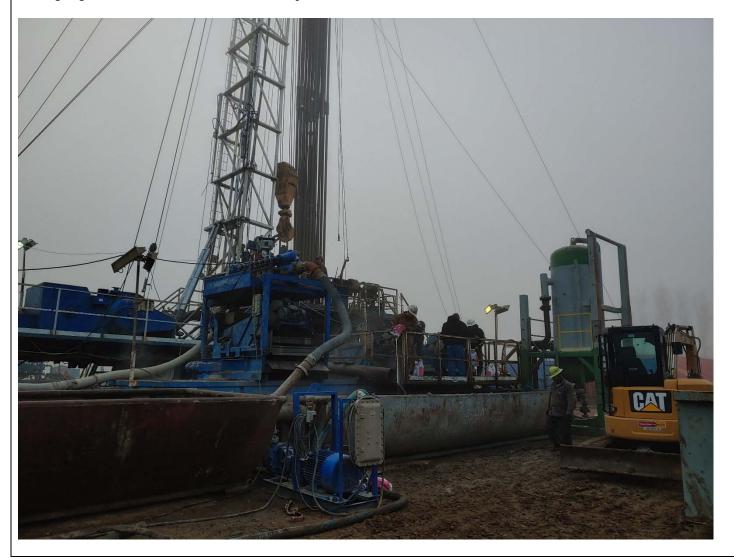
Adding sugar to cement returns in mud tank to prevent solidification.
