Gas Processing Facility Inspection Form

Operation Data	Inspection Data
Operator Name: NW Gas Processing LLC / SROG	Inspector Name: James Thum
Location Name: Highway 30 Gas Processing Facility	Area Office: Boise / Director's office
Authorized Contact: Dan Johaneck (208) 412-5475 Tyler Hartung (208) 412-5475	Inspection Date: 11/30/2021 9:15 AM
County: Payette	Report Date: 1/10/2022
Inspector's Signature: /signed/ James Thum Date of Signature: 1/10/2022	Inspection Summary: <input checked="" type="checkbox"/> Operation appeared to be in compliance at the time of the inspection. <input type="checkbox"/> Issues of concern identified at the time of the inspection.

Location Description: 4201 US 30, New Plymouth ID 83655. West side of Highway 30, 3/4 mile north of I-84 Exit 9. Facility is no longer manned 24 hours. SROG has re-located the field office to a store front located at 112 N. Plymouth Ave, New Plymouth ID 83655. Weather- foggy, calm winds (inversion), temperature 30-35°F.

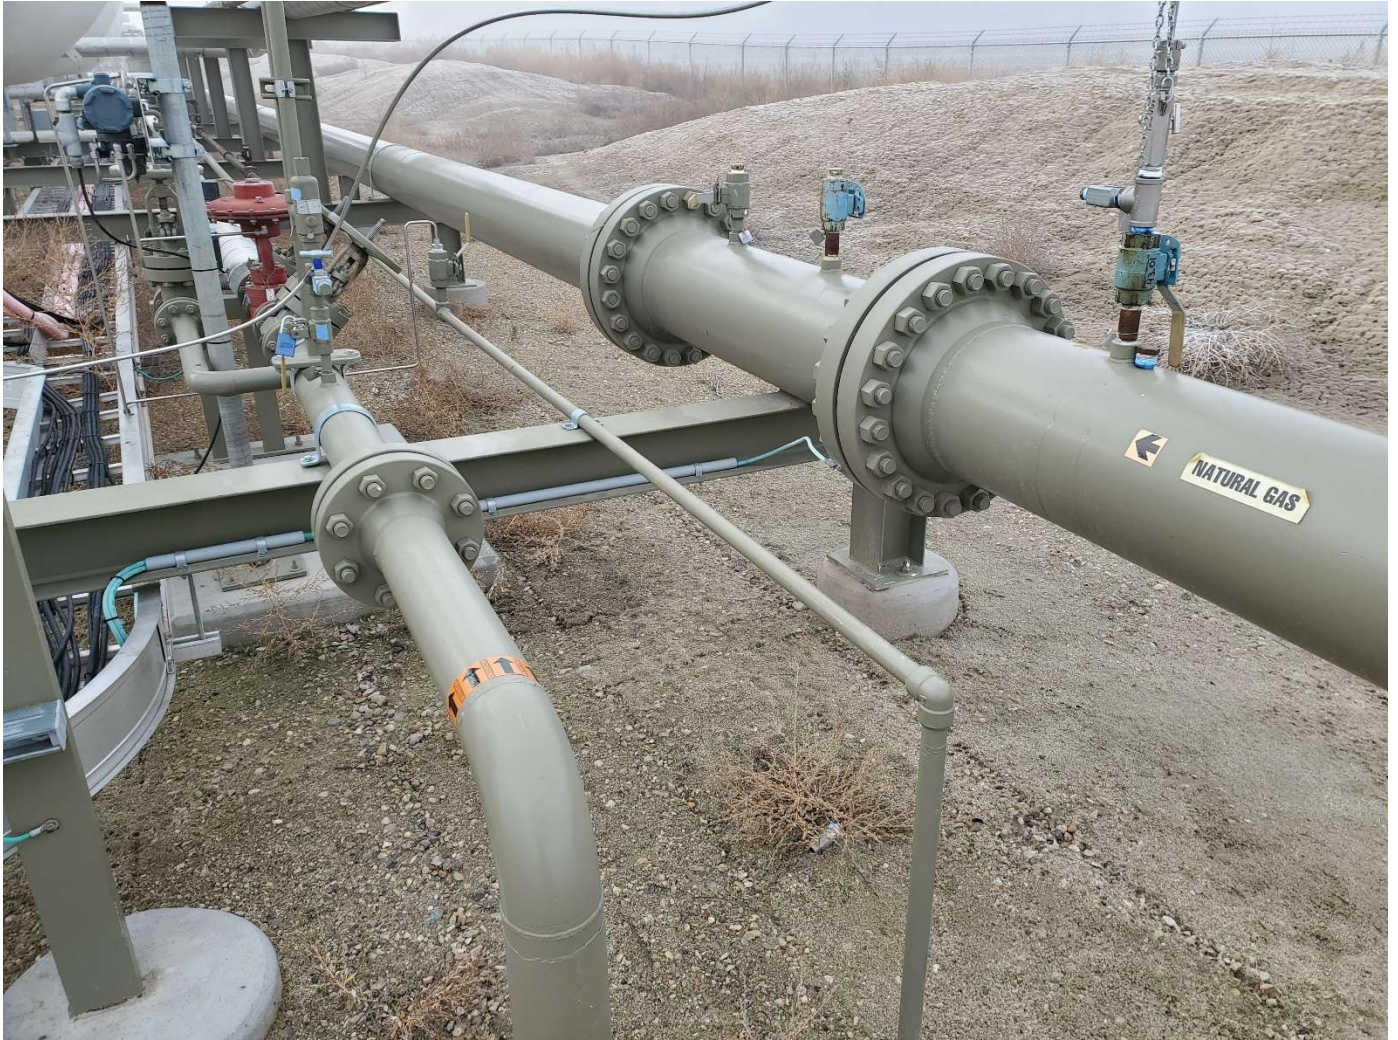
Intake pipeline, west side of Highway 30 facility looking SW. Some vegetation present.

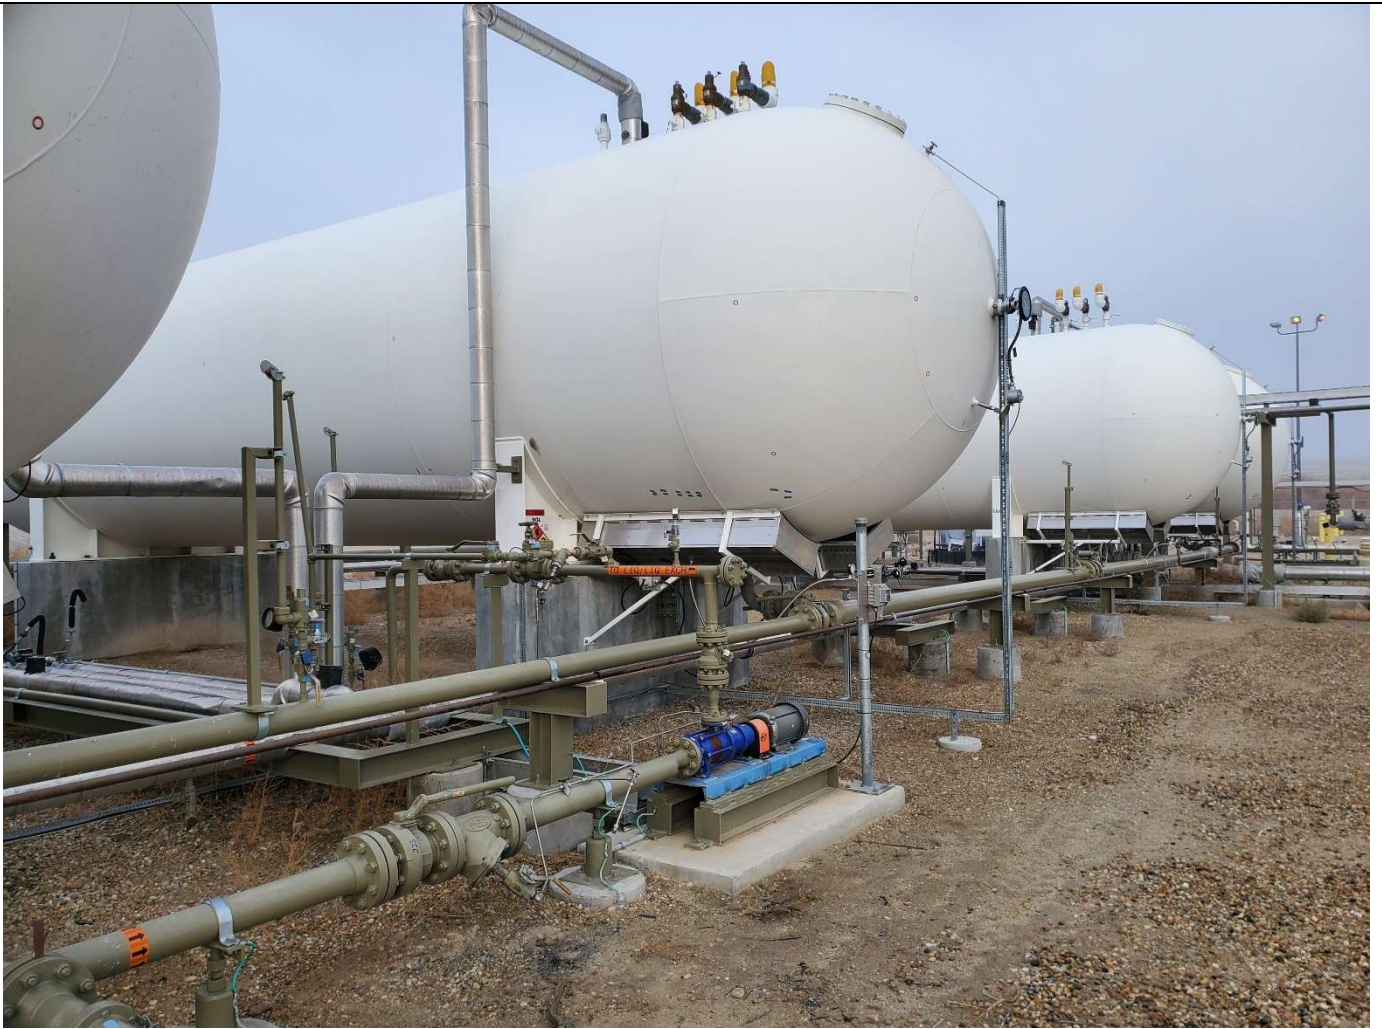
NGL storage tanks, looking NW. Some vegetation abatement needed. Otherwise everything is in good shape.

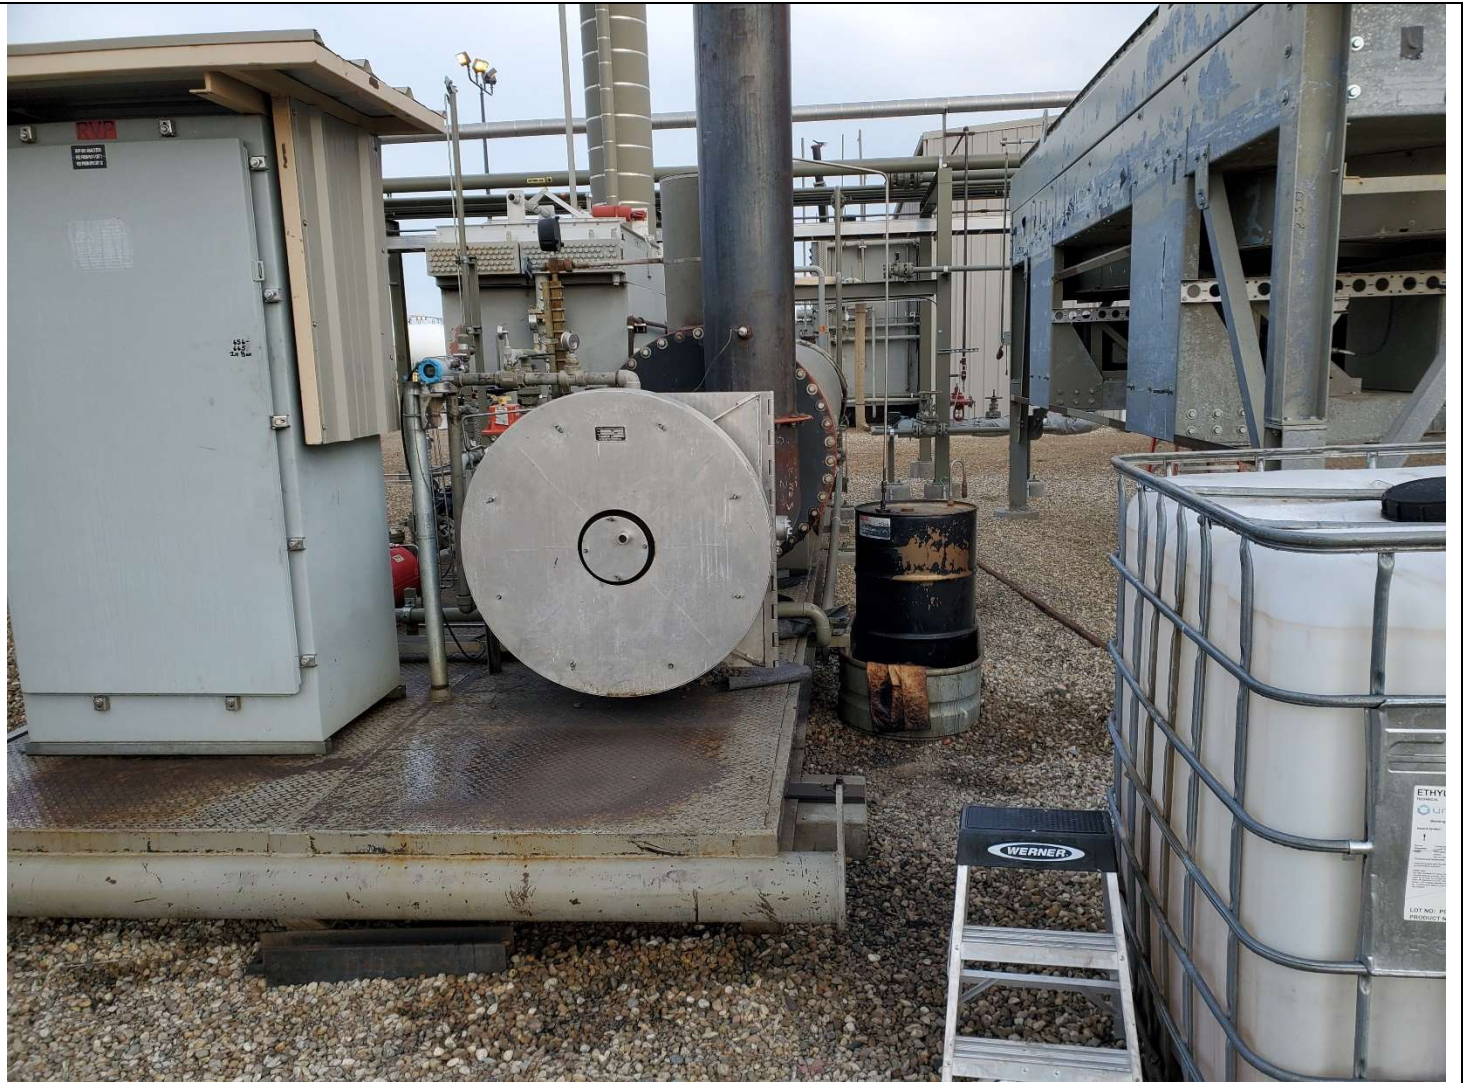
Condenser Unit, looking North. Apparent gravel staining from maintenance operations. No leaks visible at time of inspection. Minor clean-up needed.

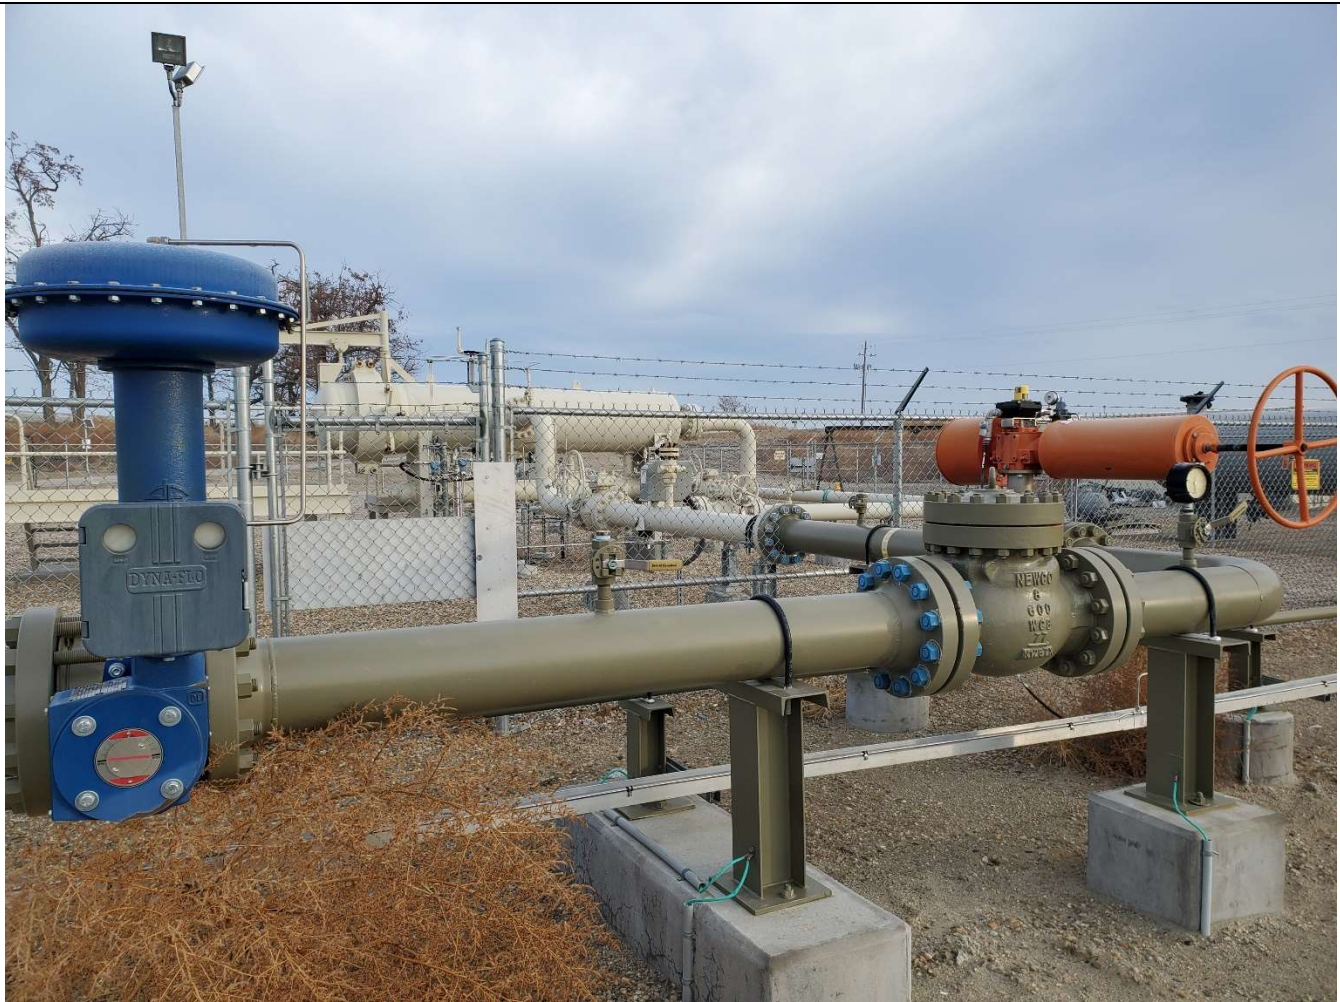
Highway 30 to Williams Pipeline tailgate looking NNE. Additional vegetation remediation needed. Equipment all in good shape at time of inspection.
