## **Post Drilling/Annual Well Site Inspection Form**

Section 1: General Information	
Operation Data	Inspection Data
Operator Name	Inspector Name
Snake River Oil + Gas, LLC	James Thum
Well Name / USWN DJS Properties #1-15, USWN 11-075-20020	Area Office Boise / Director's
<b>Authorized Contact</b> Dan Johanek (208)707-7867	Inspection Date
112 N. Plymouth Ave, New Plymouth ID 83655	11/29/2021 11:50 AM
County	Report Date
Payette	12/1/2021
Inspector's Signature: /signed/ James Thum	Inspection Summary:
	Operation appeared to be in compliance at the time of the inspection.
	Issues of concern identified at the time of the
Date of Signature: 12/1/2021	inspection.
<b>Location Description:</b> 1.09 miles SSE from Little Willow C	Gathering Facility, 4649 Little Willow Road, Access road
due south of LW. Google Maps location Latitude 44.034893	
appears to be within the cut zone, but cannot verify. Well cu	rrently producing.
Weather- cold, 40°F, fog/inversion, wind calm.

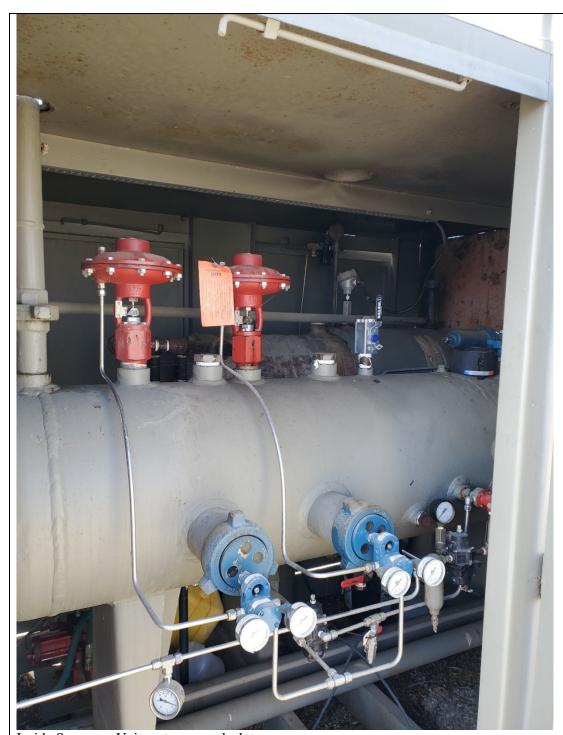
Inside Separator Unit, note orange leak tag.

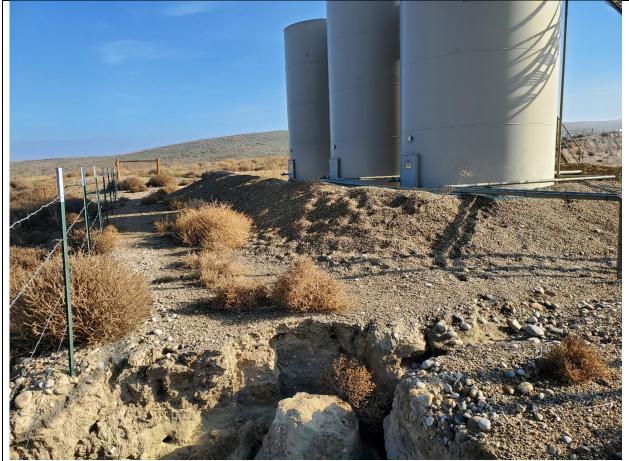
**Comments and Issues of Concern:** Pad erosion is occurring on the NNW side of the well pad near the NW corner of the tank dike (see photos). Recommend remedial fill work with possible mesh and gravel to prevent further erosion. The cellar has been filled with gravel since the last visit by this inspector. Vegetation control, especially in the vicinity of the wellhead, tank battery and separator should be conducted.

Tank battery and tank dike, North perimeter looking NE. Note pad erosion in lower foreground.

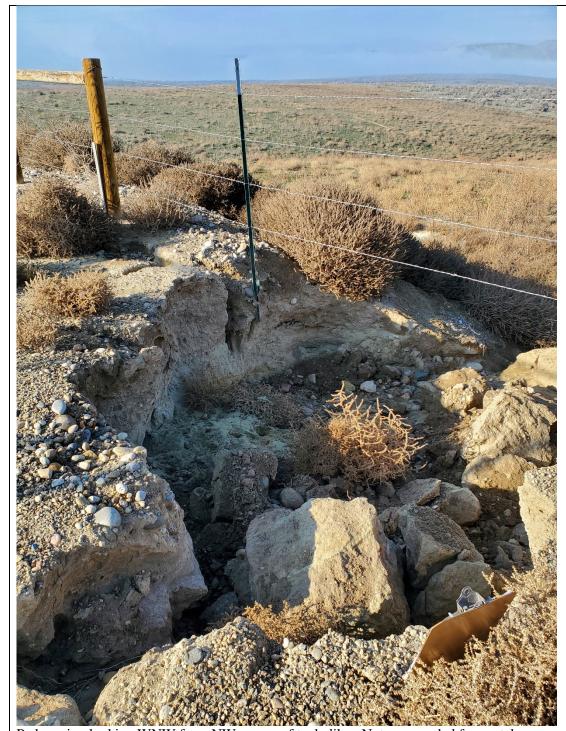
Pad erosion looking WNW from NW corner of tank dike. Note suspended fence stake.

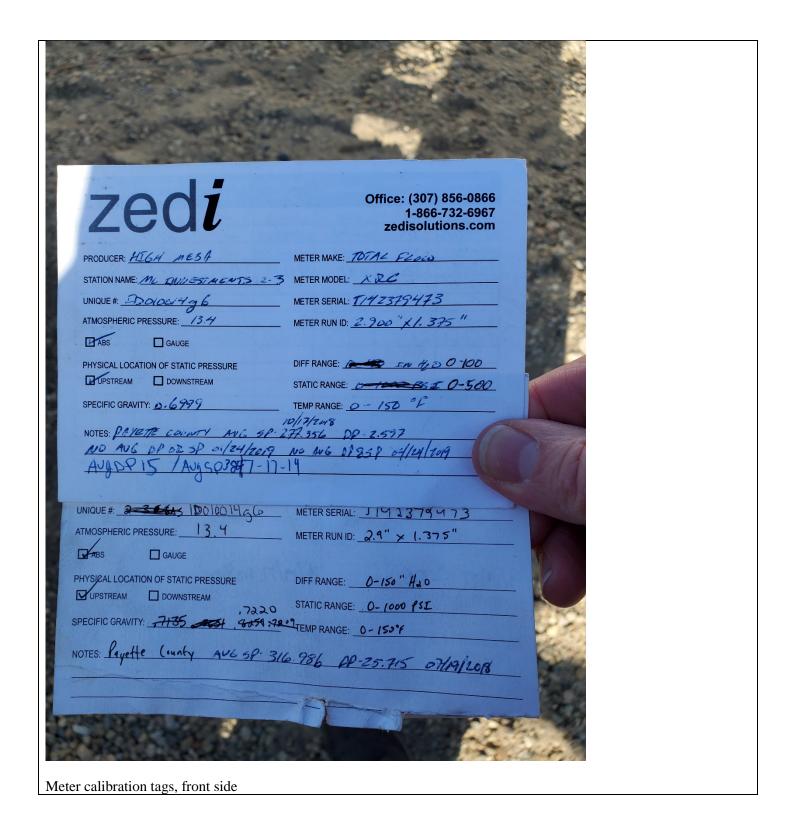
Photos include meter calibration tags.

•		5/21/16	.8259	PA-AM PA-AM	
7/19/16	1.375"		7/19/16	7/19/16 8/23/16	,7029	PA-G=	
01/12/2017	1.375 Frozen/s	hutin	10-12-16	10-12-/6 - 2/14/17	.7066	PA-KI Zeroz-BB	
4/19/17	1.375		7/19/2017	No Flow		26Di - 88	
10/25/2017		0.474	1925/2017	68/15/2017	0.7270	zea-Jy	
1/24/18	3×1,375 30×1375		1/24/17	1/24/17	.71/2	BB ZECK SM	
07/19/2018	3.0X1375 N-LABS.COM. DU	0.474	07/19/2018			N-2001	
		1		196	26		
		1	34				
eter calibrati	on tags, back	side.
