# Post Drilling/Annual Well Site Inspection Form

| Section 1: General Information | |
|---|---|
| <b>Operator Name</b><br>Snake River Oil + Gas, LLC | <b>Inspector Name</b><br>James Thum |
| <b>Well Name / USWN</b><br>ML Investments #2-10, USWN 11-075-20022 | <b>Area Office</b><br>Boise / Director's |
| <b>Authorized Contact</b> Dan Johaneck (208)707-7867<br>112 N. Plymouth Ave, New Plymouth ID 83655 | <b>Inspection Date</b><br>11/29/2021 11:45 AM |

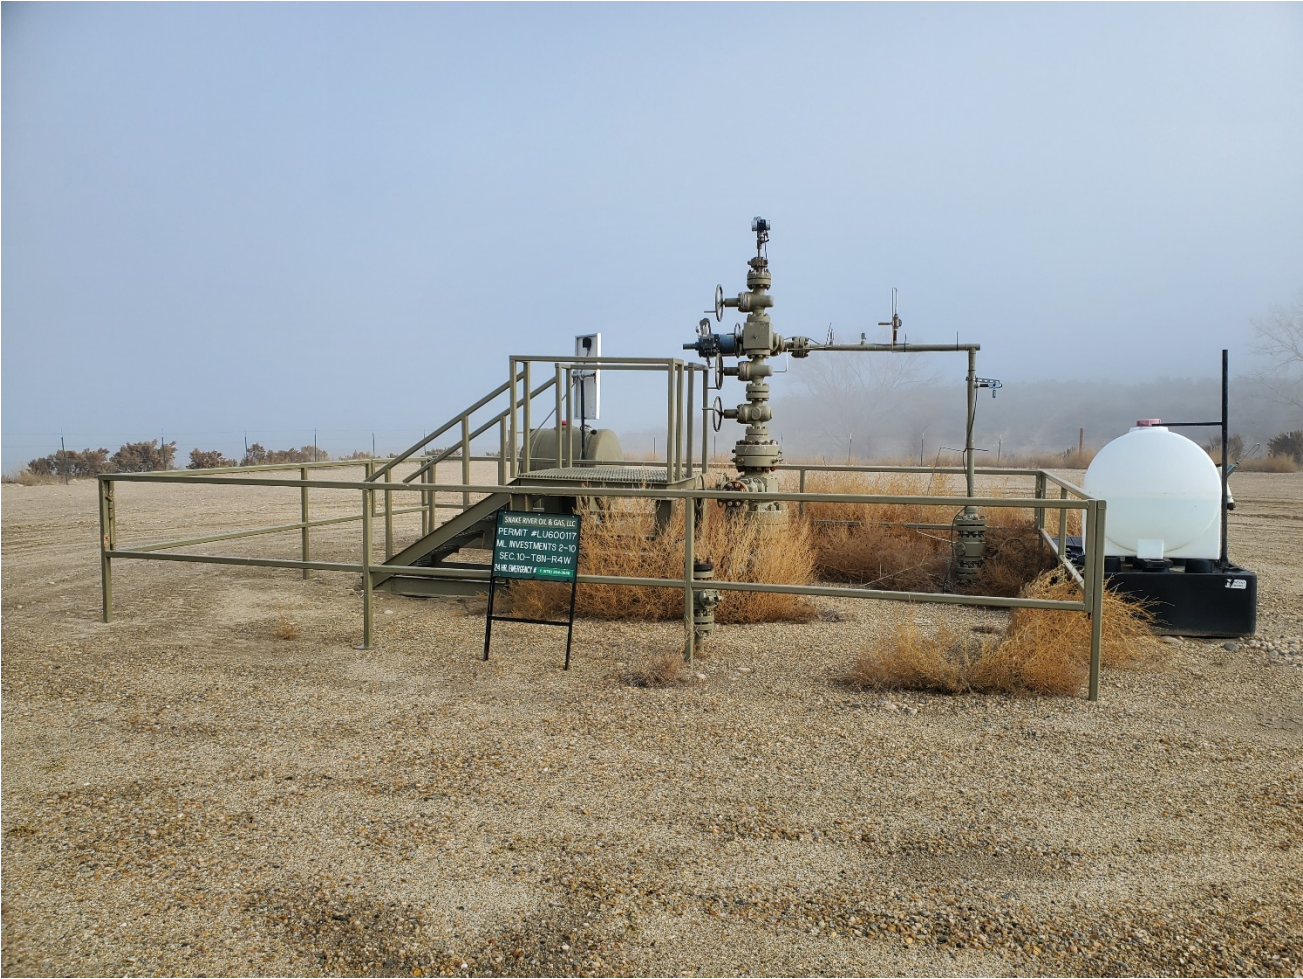
1. Inner wellhead fencing looking ENE with chemical storage tank on right.

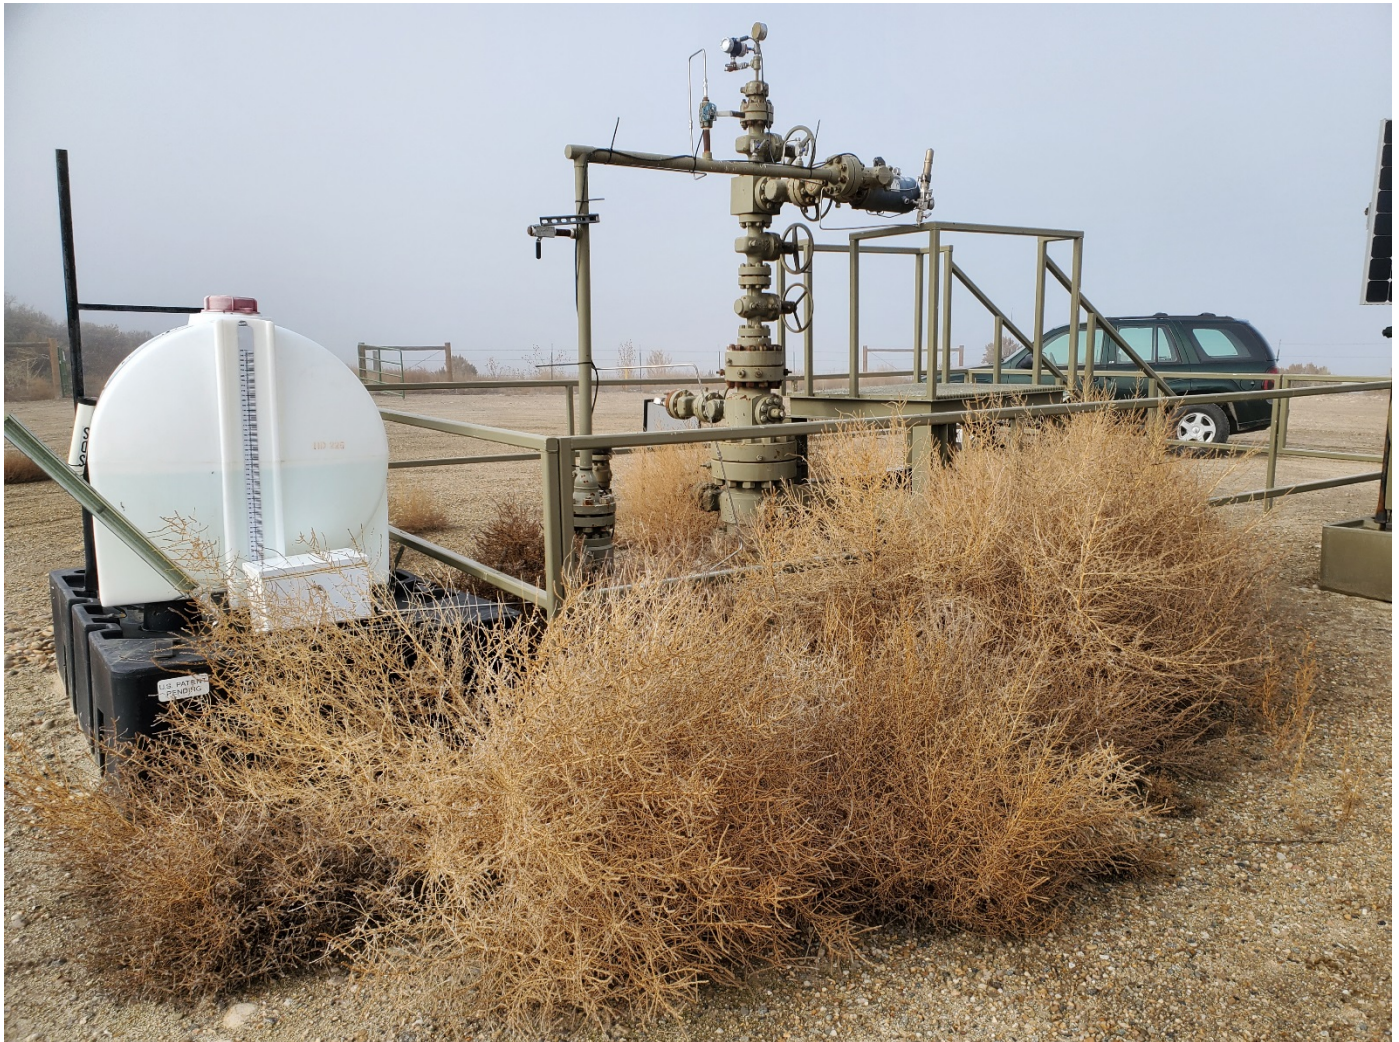
**Section 4 Comments:** Vegetation <5% on well pad except within and around the wellhead protective fencing where it is closer to 25%. This includes rooted vegetation and trapped tumbleweeds. No weed abatement measures are apparent within this fencing. Old completion rig that was located in the SE corner of the pad has been removed. An unutilized/decommissioned gas separator and flare stack are located in the SW corner of the well pad. Cellar has been filled with gravel.

2. Inner wellhead fencing looking W showing vegetation.

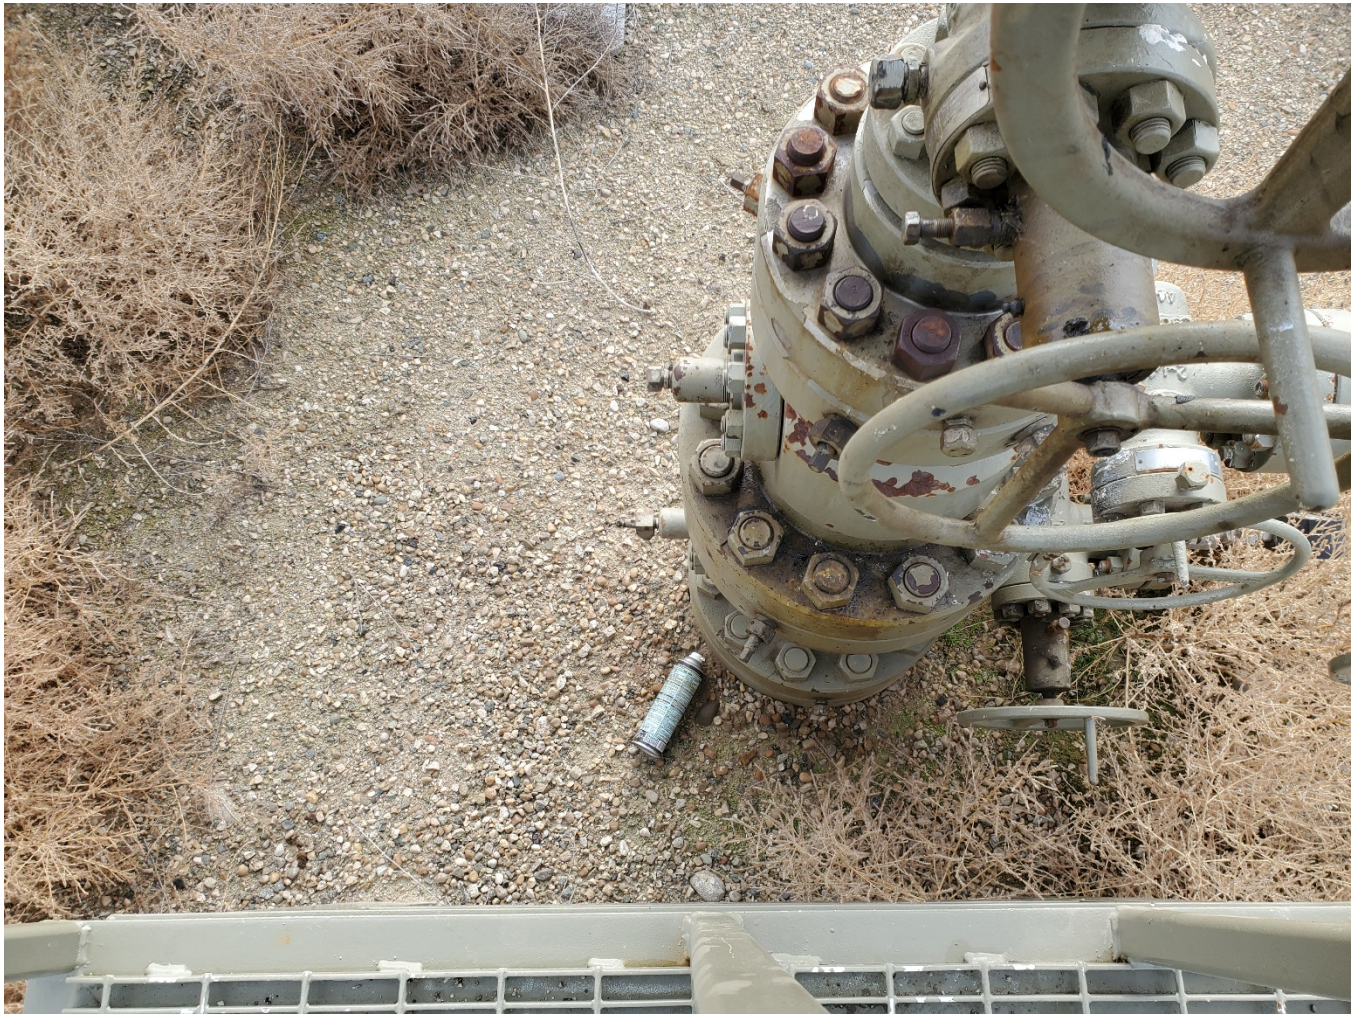
3. Looking down at gravel-filled cellar, vegetation around wellhead.

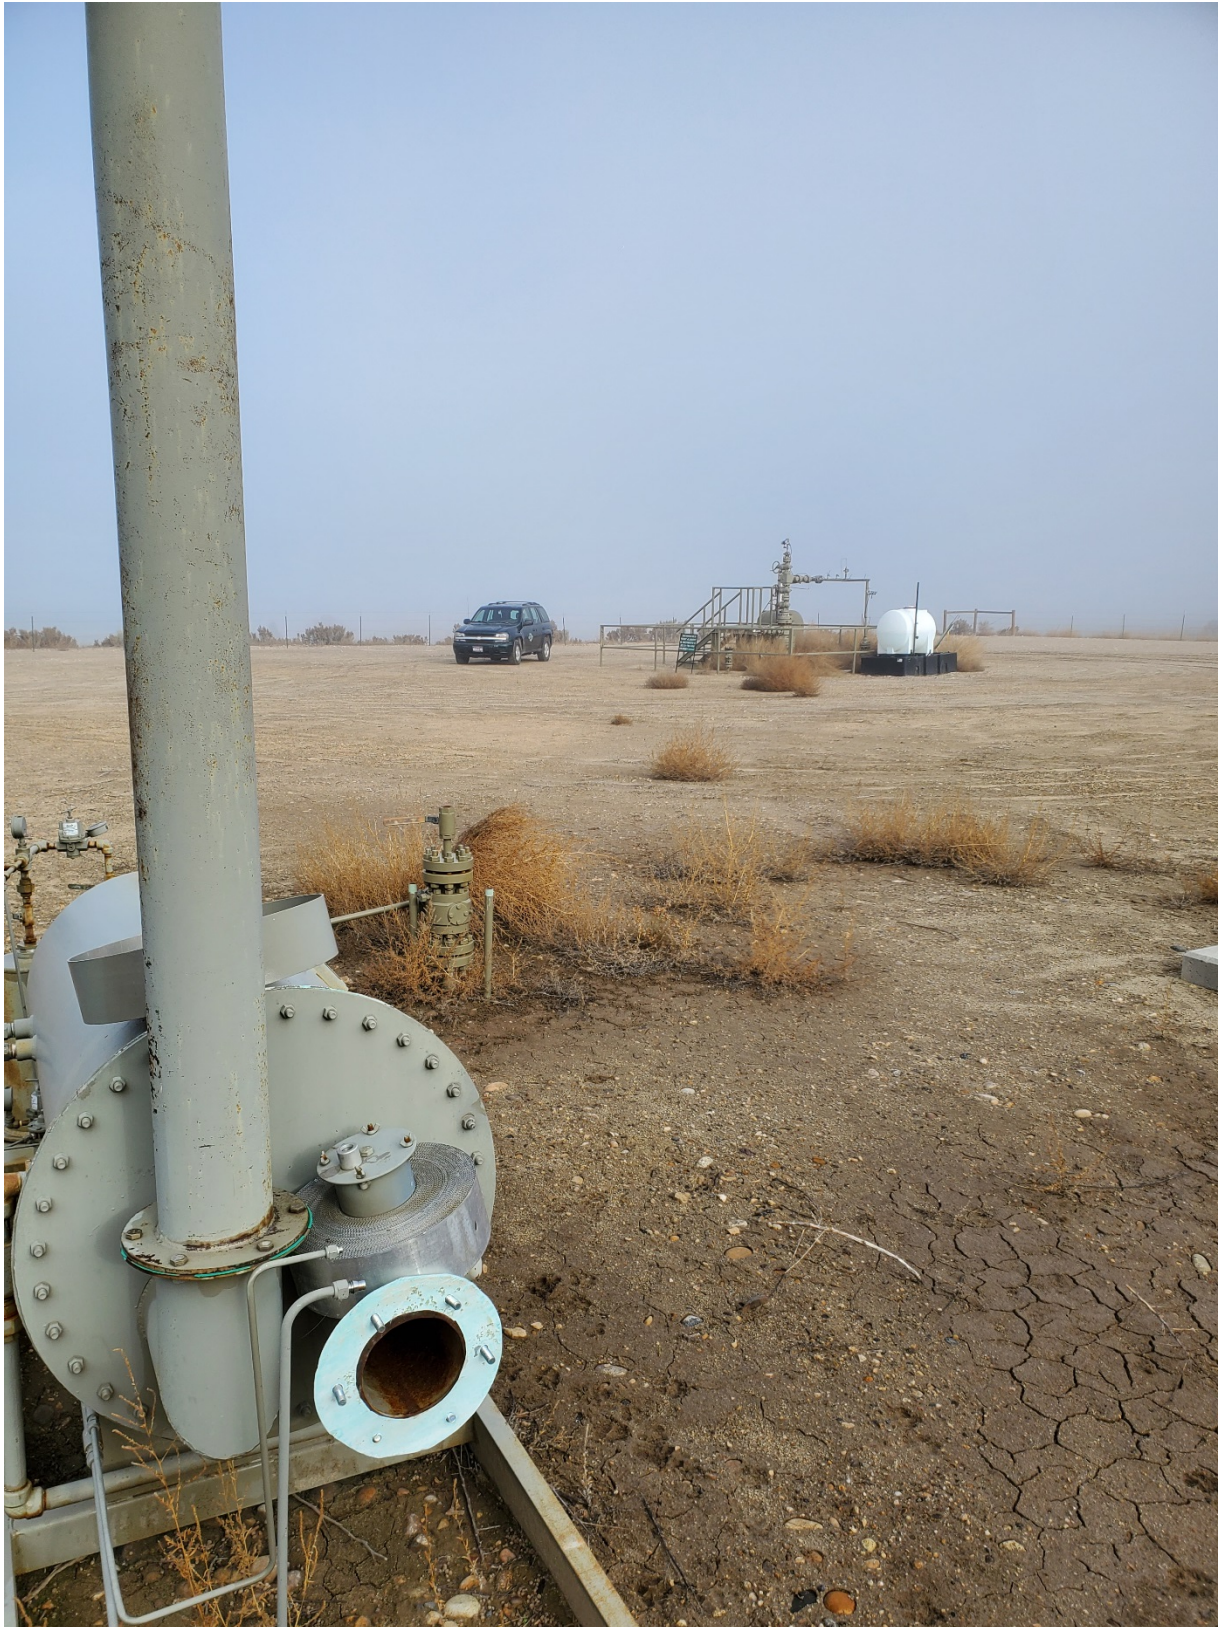
4. Looking ENE towards wellhead, decommissioned separator in foreground.
