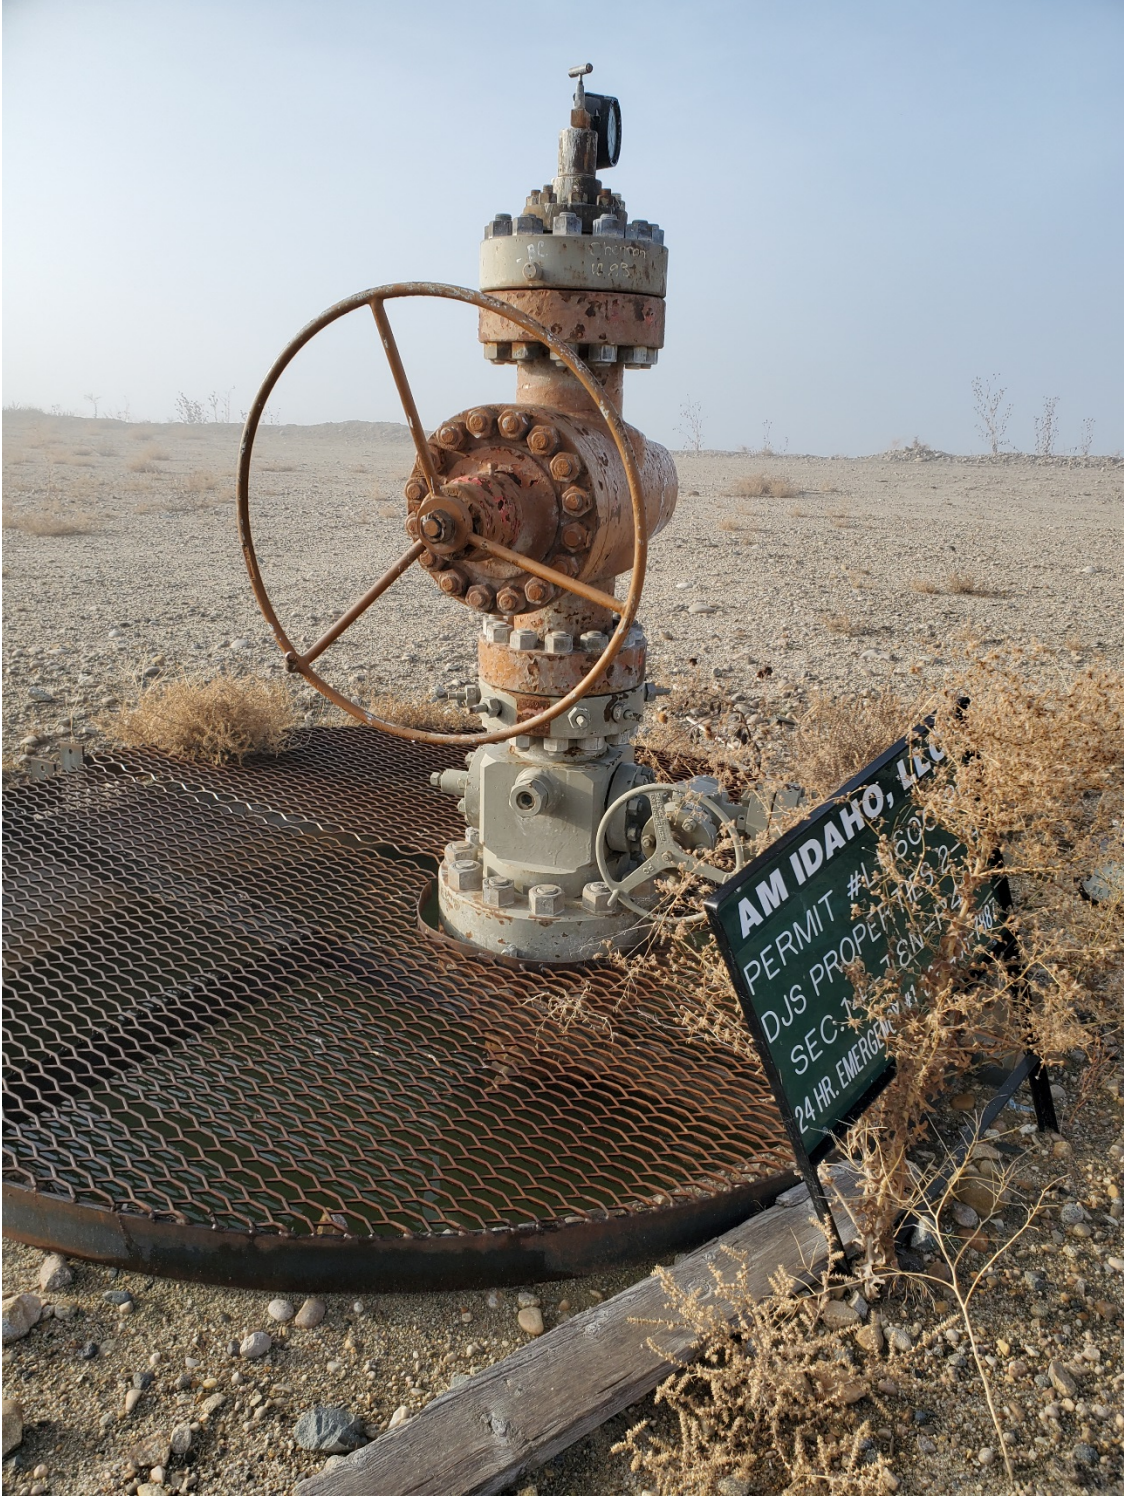
Comments and Issues of Concern: Section 3- Signs are out of date; indicates AM Idaho LLC as operator with incorrect 24-hour emergency number.

1. Wellhead and cellar, view SSE with incorrect identification sign.

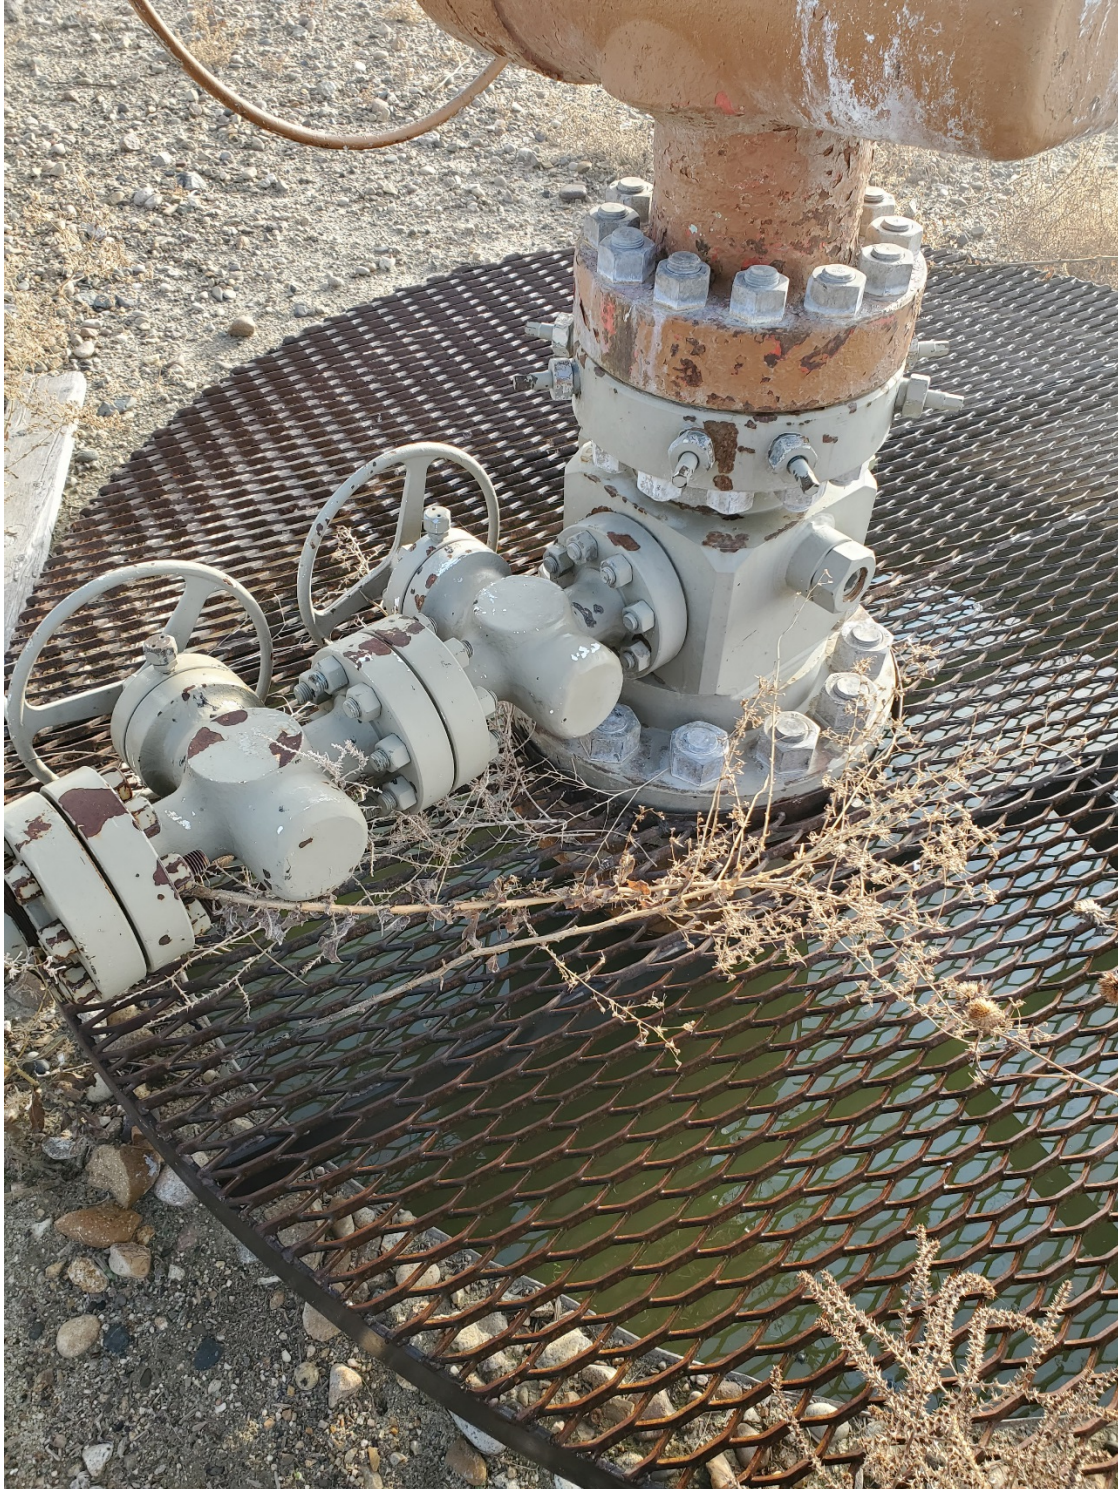
Other- water in cellar is within 1 foot of the top of the conductor casing. No gas bubbling was observed (daily solar heating had not yet occurred). 2 pressure gauges installed (one surface, one production casing) read 0 PSI; surface casing pressure gauge needle appears to be broken. Slight erosion on NW side of pad; observed on initial inspection in 2017.

2. Detail view of wellhead and cellar; note water level.

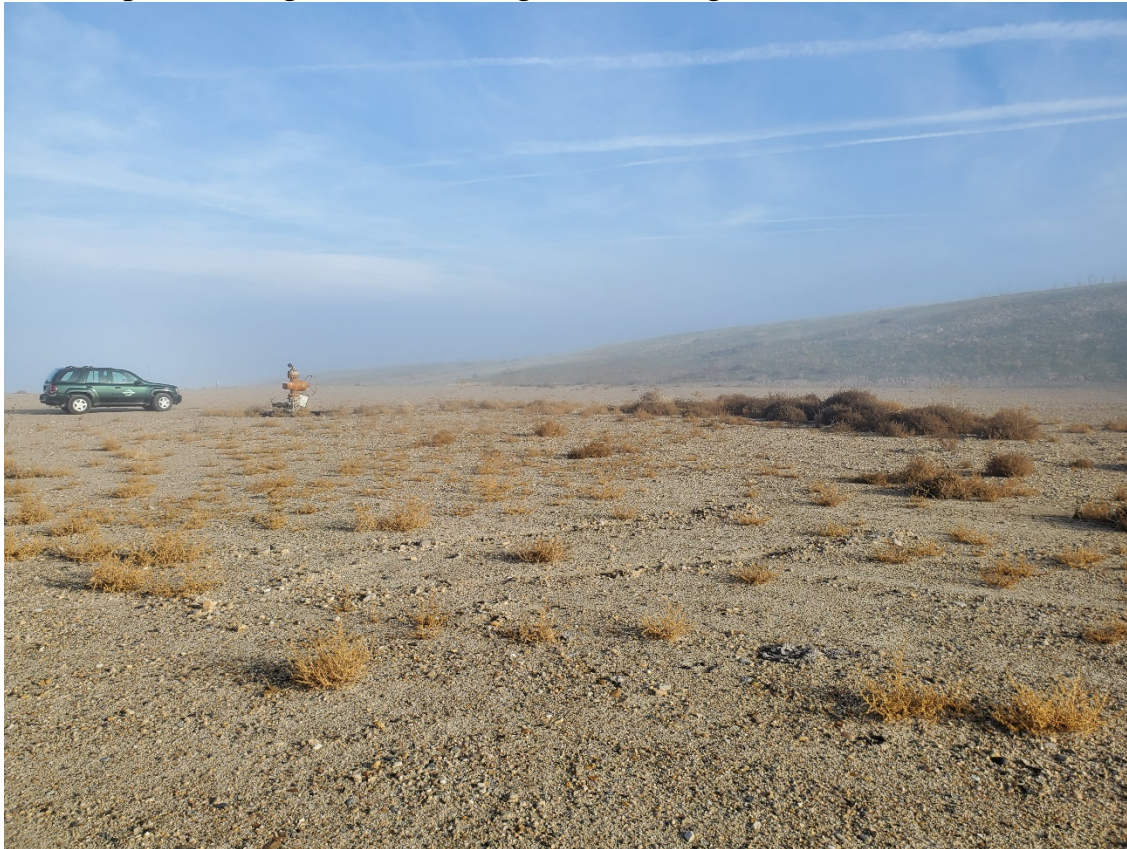
Section 4- Racked 2-1/2-inch production tubing stored at SE corner of the well pad. Vegetation on well pad >5% but <10%; no recent eradication appears to have been done.

3. Well pad looking NNW showing areas of vegetation.

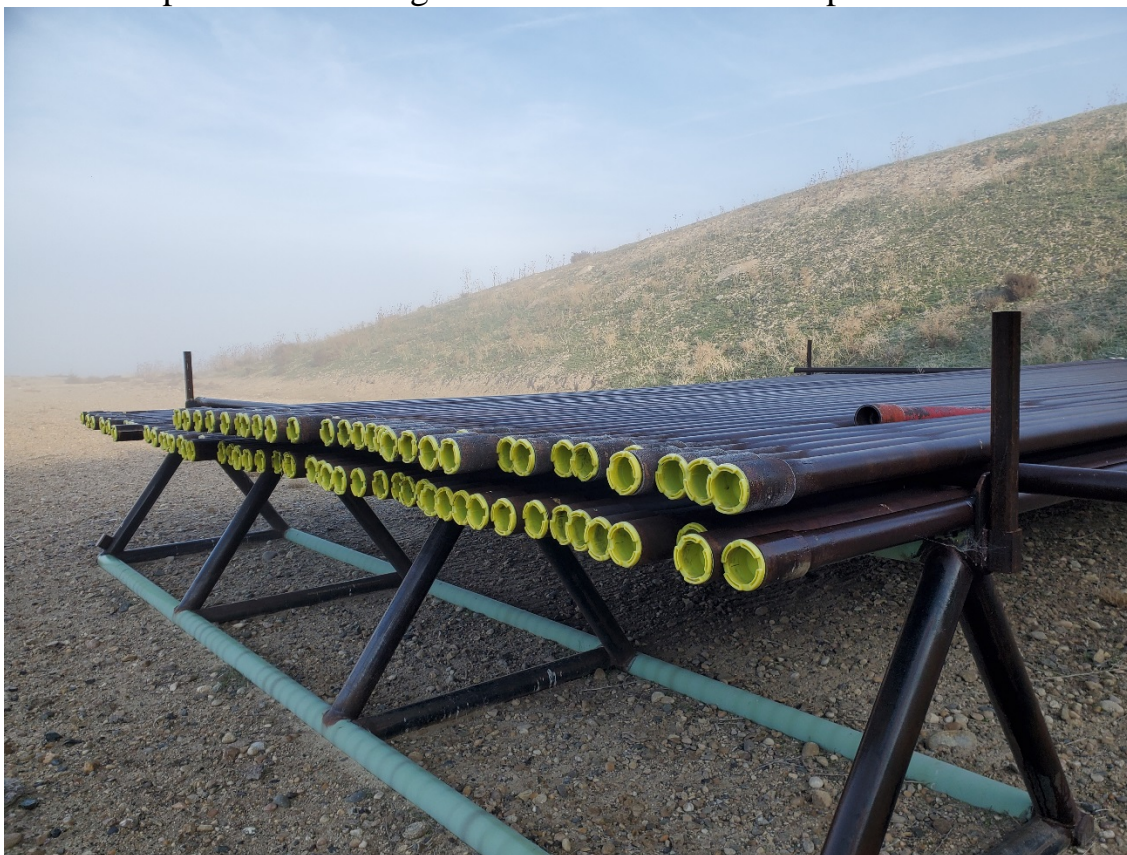
4. Racked production tubing stored at E corner of well pad

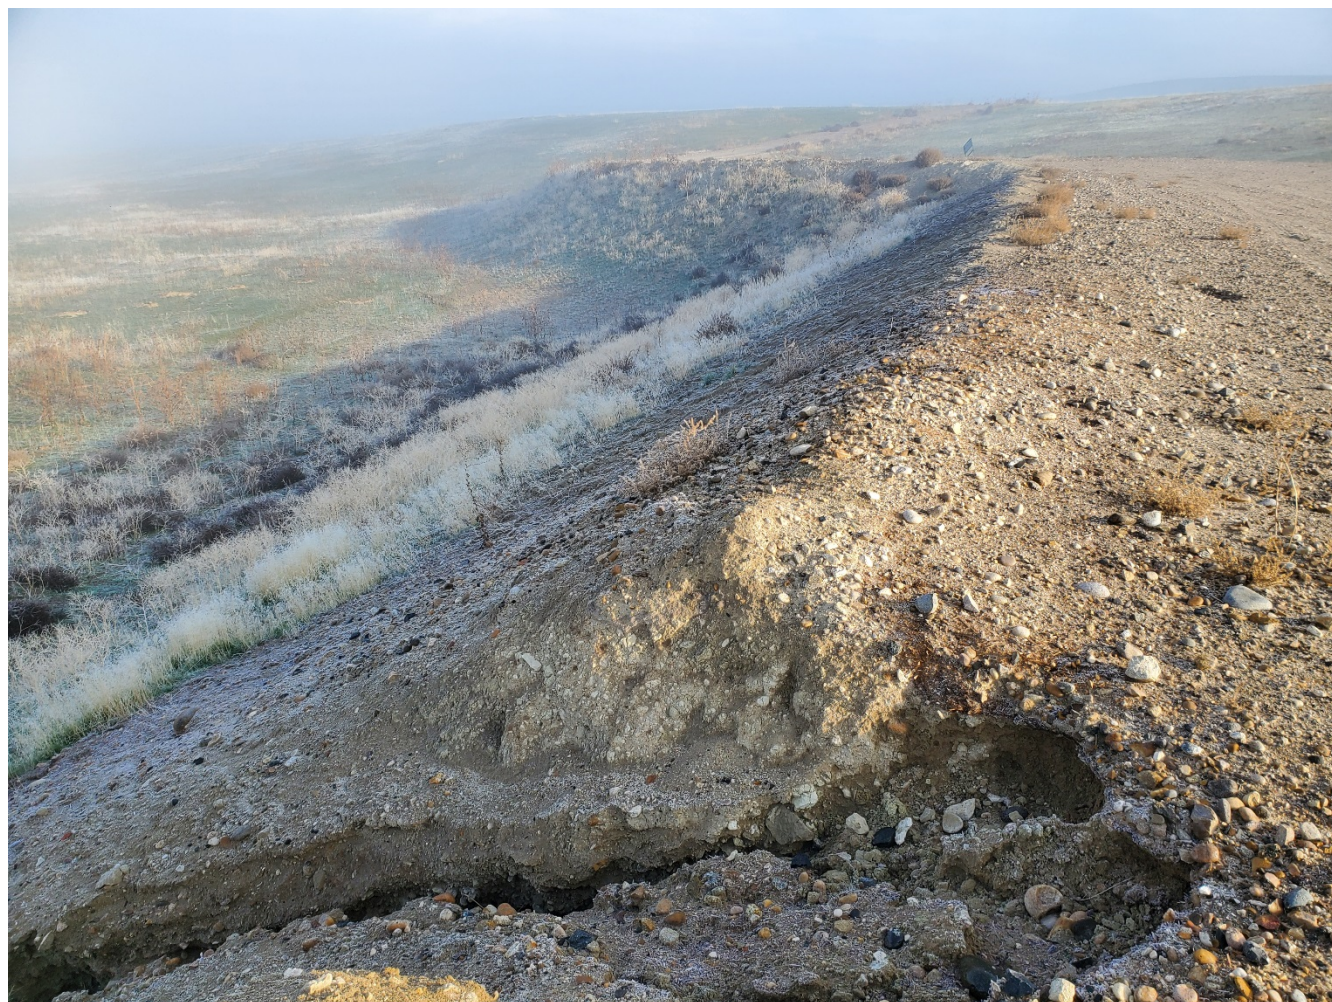
5. Pad erosion on NW side.
