Post Drilling/Annual Well Site Inspection Form

Section 1: General Information	
Operation Data	Inspection Data
Operator Name	Inspector Name
Snake River Oil + Gas, LLC Well Name	James Thum Area Office
Kauffman #1-34, USWN 11-075-20024	Boise / Director's
Authorized Contact Dan Johanek (208)707-7867	Inspection Date
112 N. Plymouth, New Plymouth ID	11/29/2021
County	Report Date
Payette	1/3/2022
Inspector's Signature: /signed/ James Thum	Inspection Summary:
	Operation appeared to be in compliance at the time of the inspection.
	Issues of concern identified at the time of the
Date of Signature: 1/3/2022	inspection.
Location Description: 2.0 miles NNW from Little Willow location Latitude 44.079257, Longitude -116.810886. Well head appears to be located within the fill area of the pad. Su elevation 2482.5'. Well is currently S/I, last produced Febru Weather: sunny, 45°F, variable light wind <5 MPH	pad is cut and fill, excavated from the east side slope. Well urvey indicates GL on pad as 2484.3', former ground

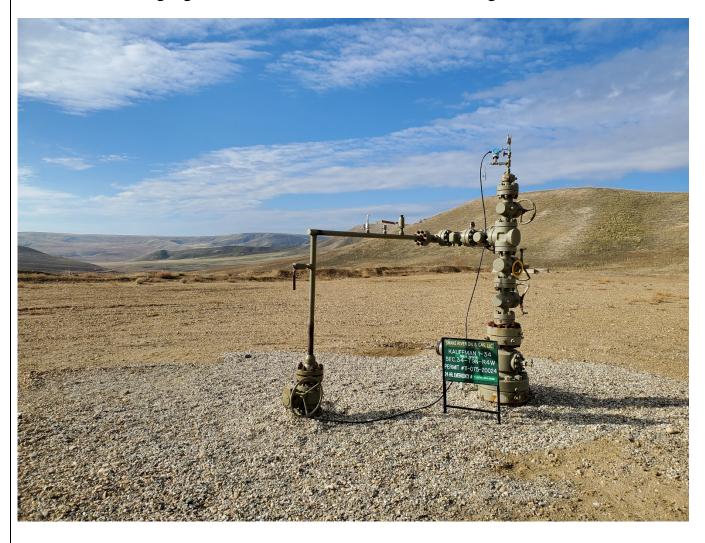
2. Wellhead and signage, view WNW. Note that cellar is now gravel-filled.

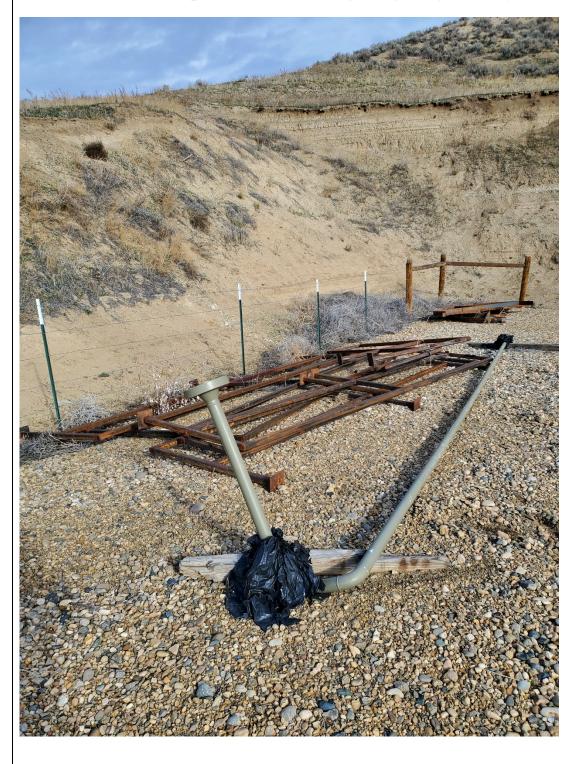
3. North corner of wellpad, view N. Fencing and grating formerly around wellhead.

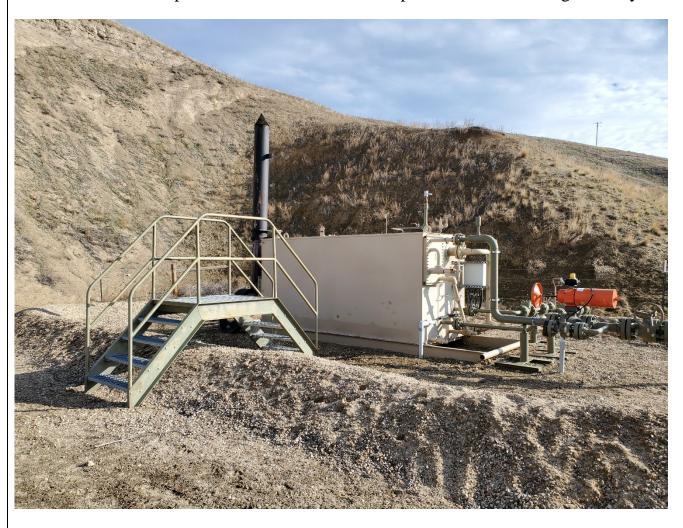
4. East corner of wellpad, view ESE. Flare stack, separator unit containing meter system.

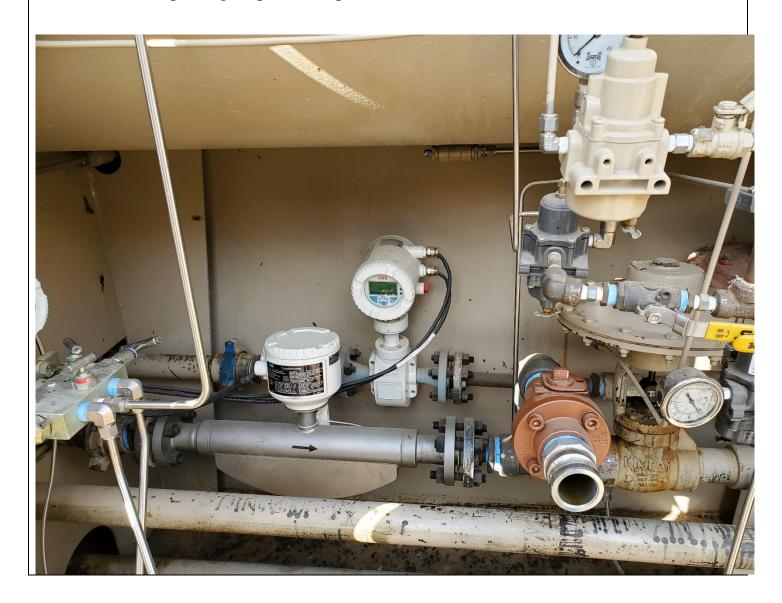
5. Coriolis meter, proving loop inside separator unit.
