Post Drilling/Annual Well Site Inspection Form

| Section 1: General Information | |
|---|---|
| Operator Name Snake River Oil + Gas, LLC | Inspector Name James Thum |
| Well Name ML Investments #1-11, USWN 11-075-20025 | Area Office Boise / Director's |
| Authorized Contact Dan Johaneck (208)707-7867 112 N. Plymouth, New Plymouth ID | Inspection Date 11/29/2021 |

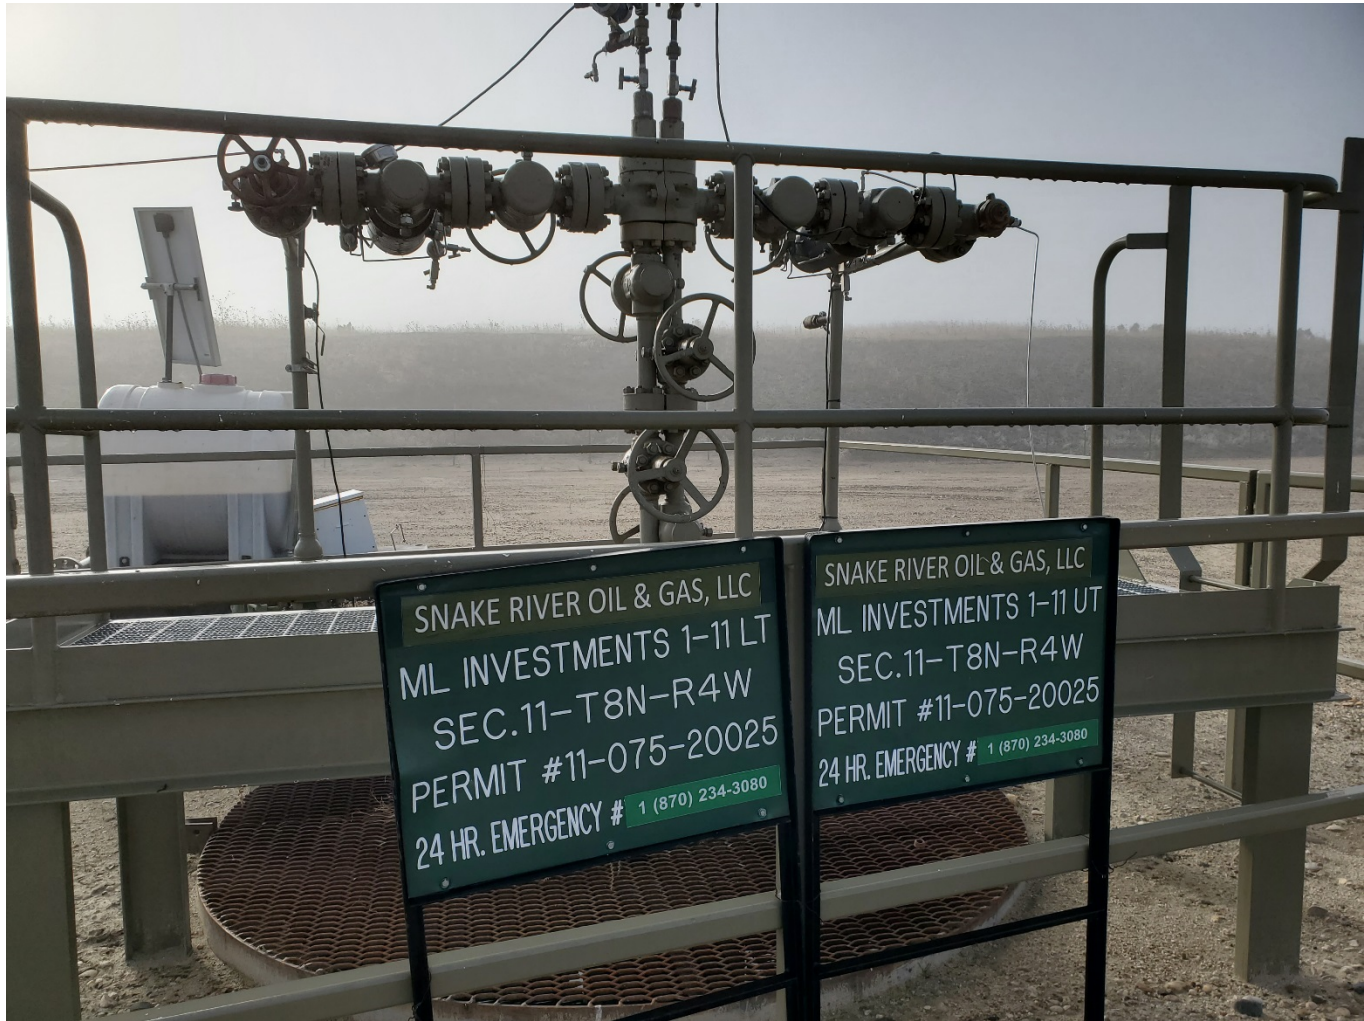
1. Wellhead looking S with dual completion configuration.

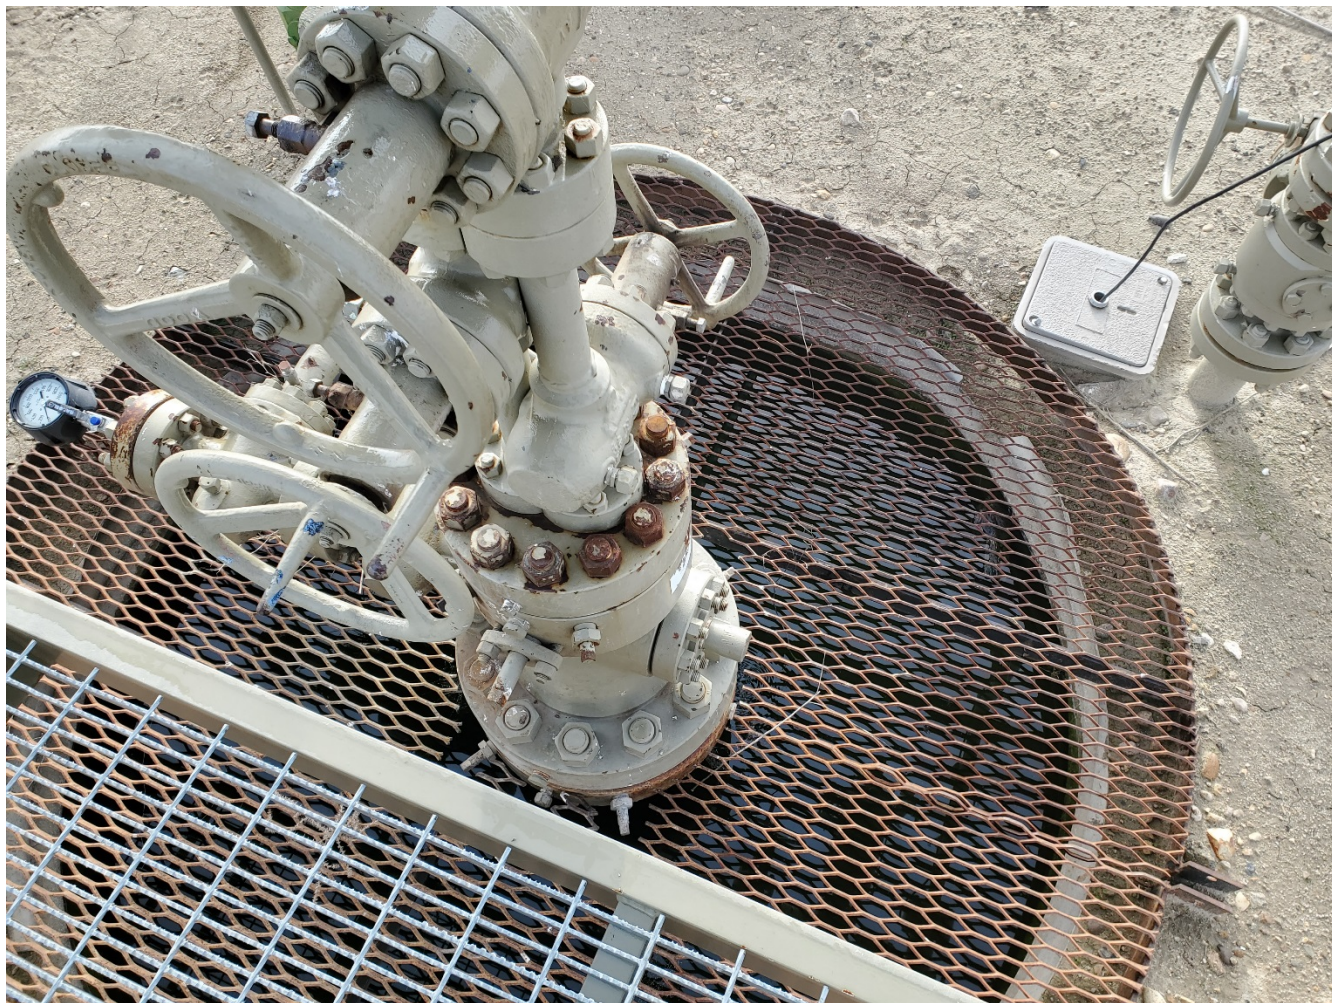
Comments and Issues of Concern: Entrance gate to well pad was chained but not locked. One warning sign was detached from the fence. Water in the cellar was within 1 foot of the top of the conductor, but no bubbling was observed in the water (air temps very cold, no solar heating had occurred). One SDS tube for ethylene glycol, methanol was in tank, submerged; documents were water soaked. Second SDS tube for gas treater GT-236, sulfide scavenger by Nalco Co.

2. Standing water in cellar of wellhead.

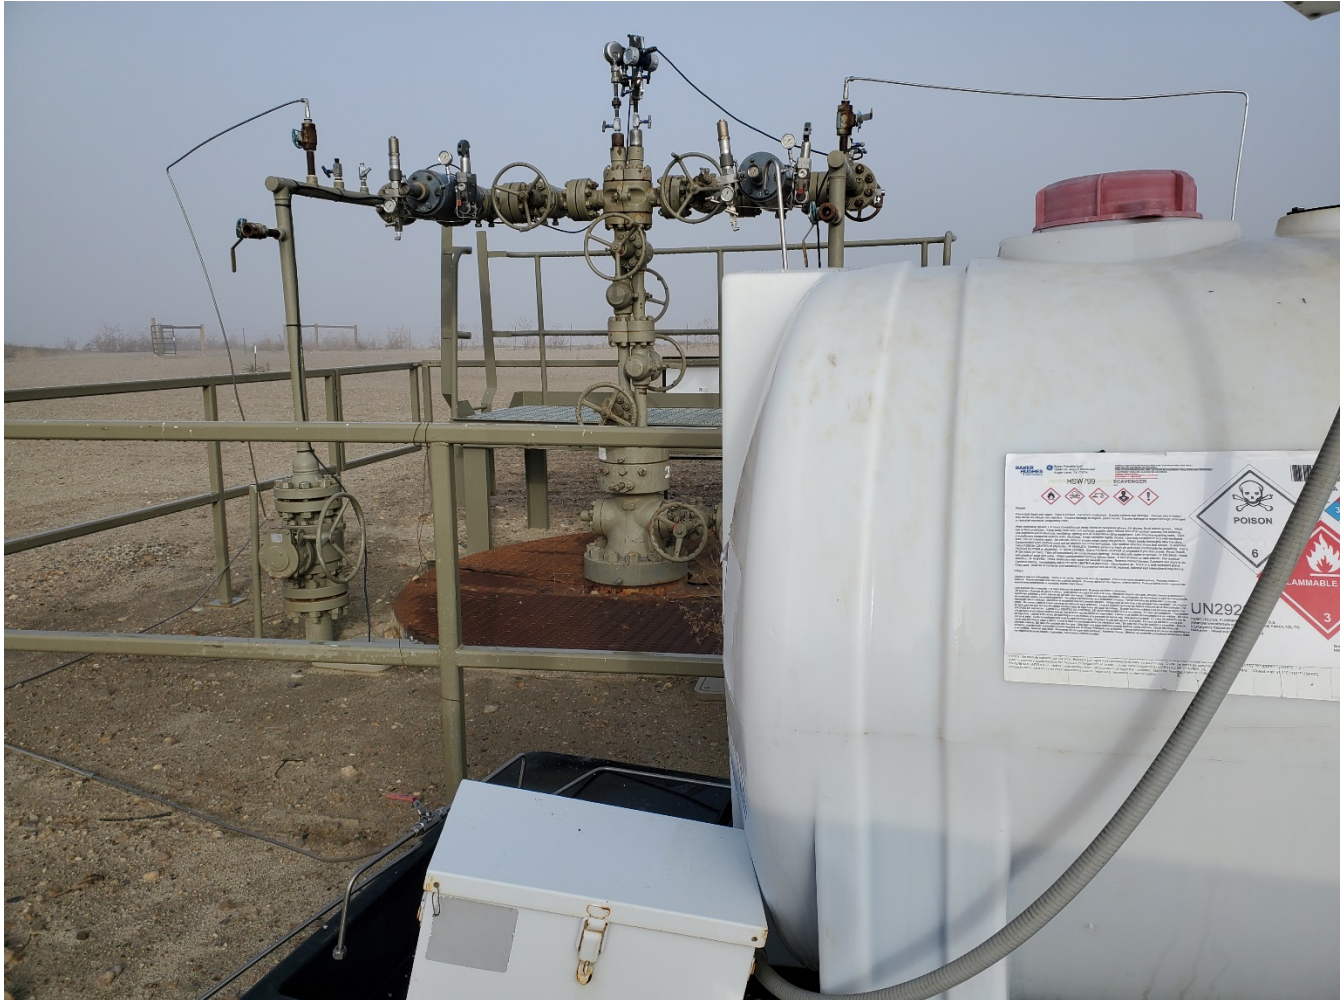
3. Gas treatment chemical tank and wellhead, looking N.

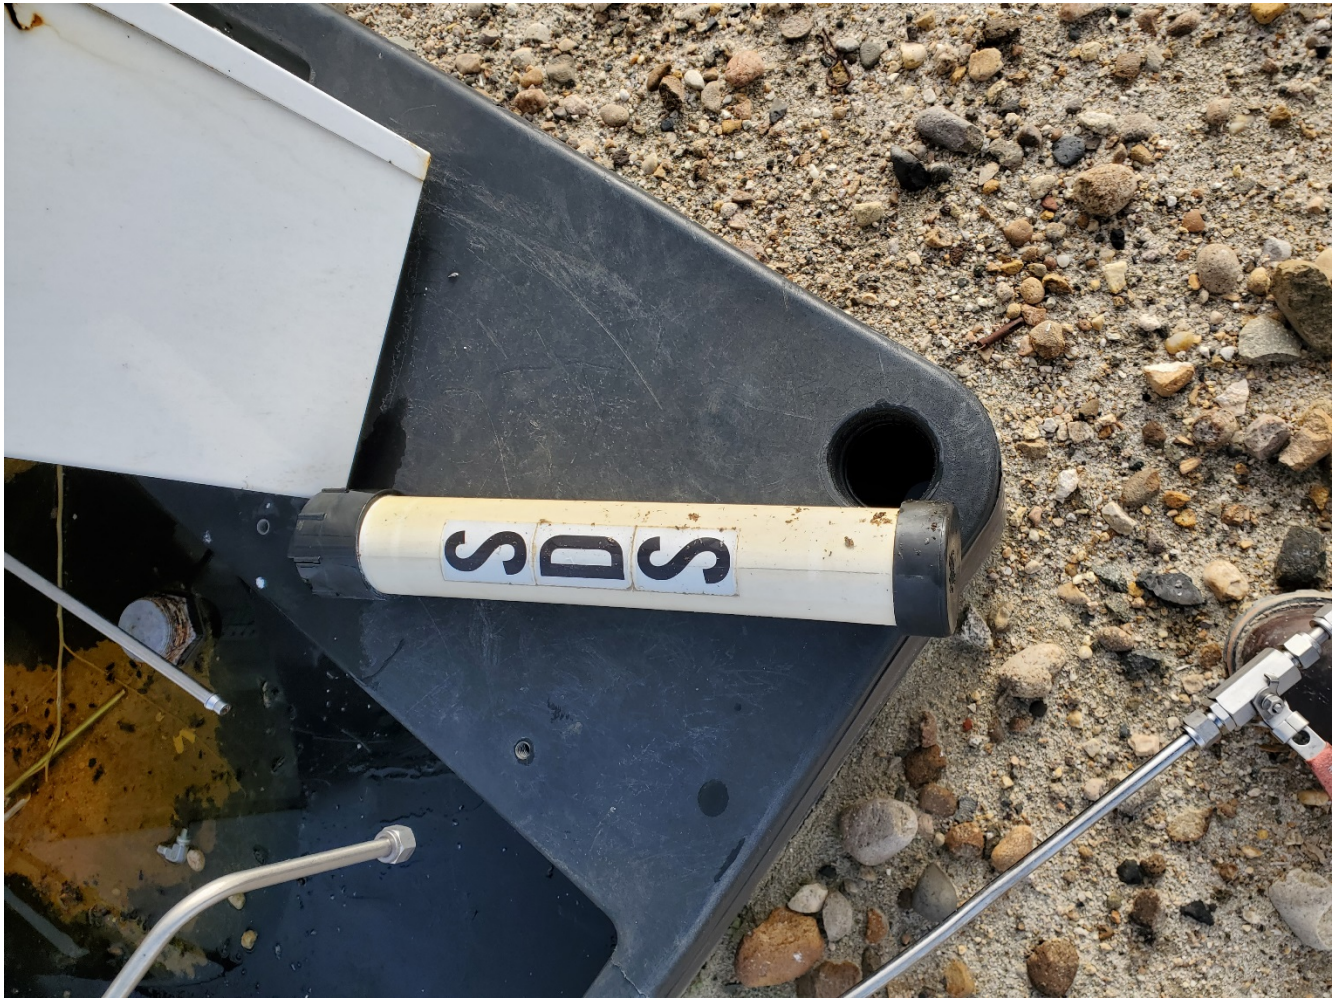
4. SDS tube (retrieved from standing water below chemical storage tank).

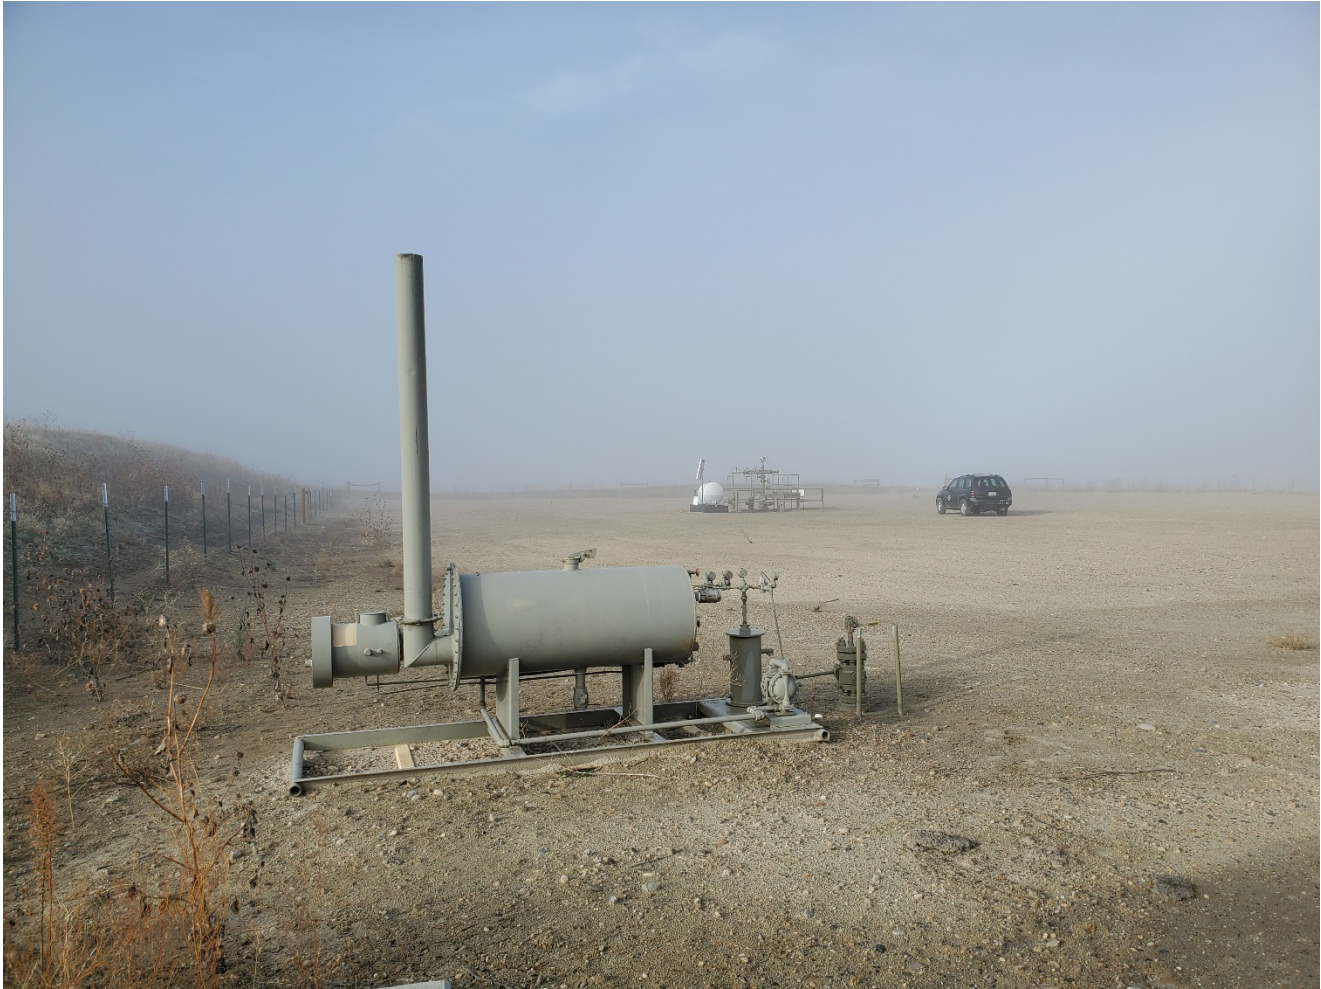
Unutilized/decommissioned small separator/stack at SE corner of well pad.

5. Decommissioned gas separator at SE corner of well pad, looking WNW to wellhead.
