Post Drilling/Annual Well Site Inspection Form

Section 1: General Information	
Operation Data	Inspection Data
Operator Name Snake River Oil + Gas, LLC	Inspector Name James Thum
Well Name Kauffman #1-9, USWN 11-075-20027	Area Office Boise / Director's
Authorized Contact Dan Johaneck (208)707-7867 112 N. Plymouth, New Plymouth ID	Inspection Date 11/29/2021, 3:30 PM
County Payette	Report Date 1/6/2022
Inspector's Signature: /signed/ James Thum	Inspection Summary: <input type="checkbox"/> Operation appeared to be in compliance at the time of the inspection. <input checked="" type="checkbox"/> Issues of concern identified at the time of the inspection.
Date of Signature: 1/6/2022	
Location Description: 3726 feet WNW from Little Willow Gathering Facility, 4649 Little Willow Road. Google Maps location Latitude 44.053214, Longitude -116.817247. Well is a dual completion; both zones currently S/I. Weather: partly cloudy, 50°F, variable light wind <5 MPH

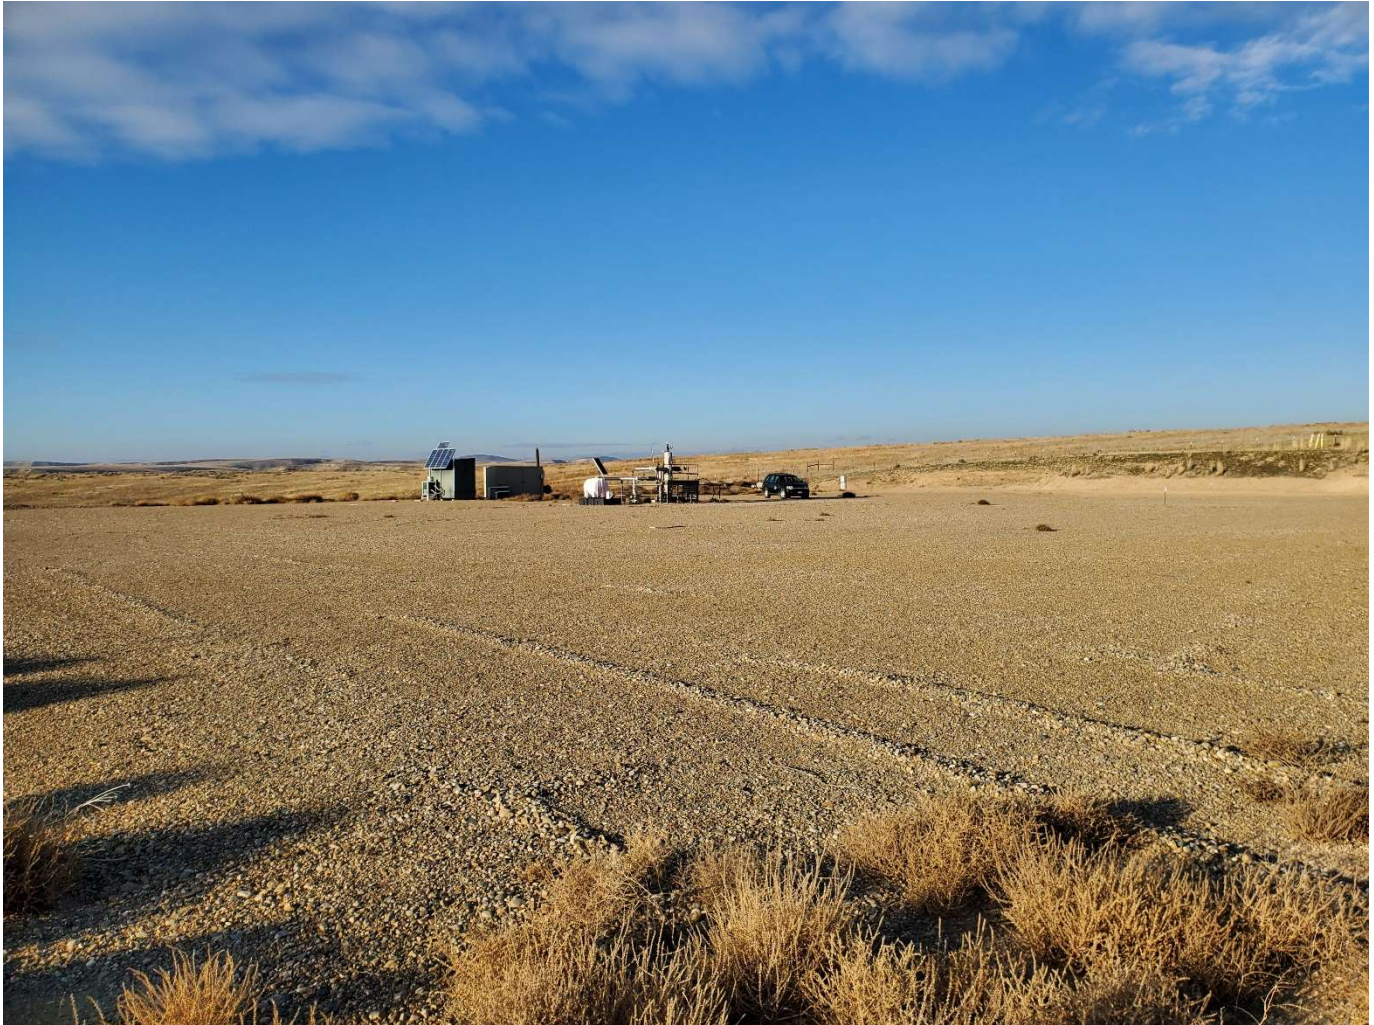
1. Well pad from S corner, view N. Wellhead center, chemical tank and separator unit to left.

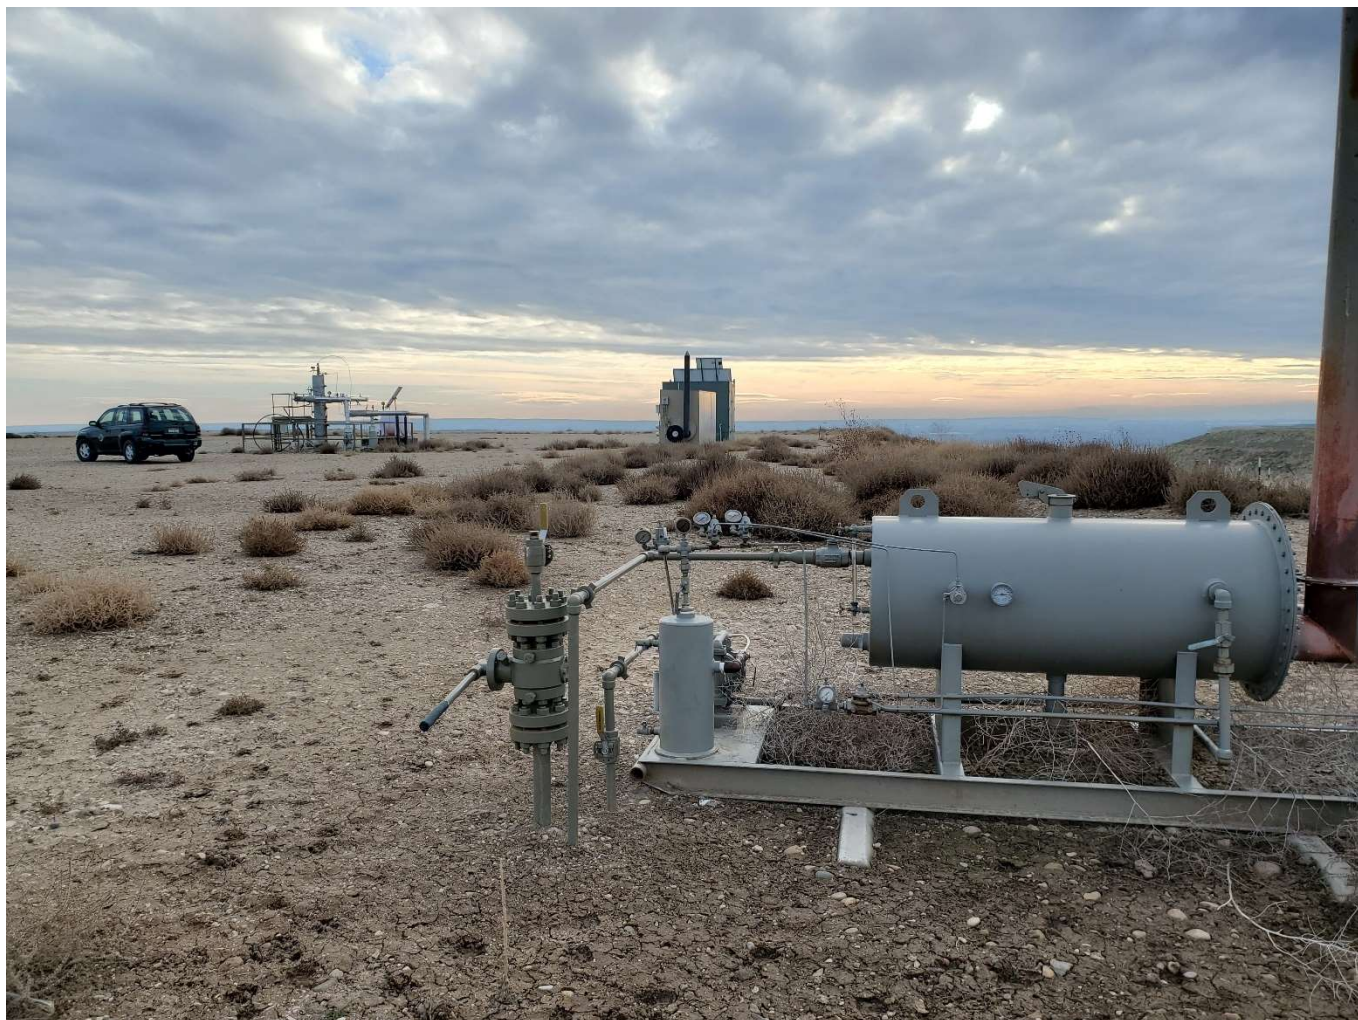
Section 4 comments: Wellsite is fenced with approximately 18-inch high berm around the inside fence perimeter. Vegetation coverage <5% except in the vicinity of the wellhead steel fence and separator enclosure, and along the top and sides of the berm. No weed mitigation measures were apparent.

2. Well pad from N corner, view SSW. Decommissioned separator in foreground right, separator unit center rear, wellhead left rear. Note vegetation.

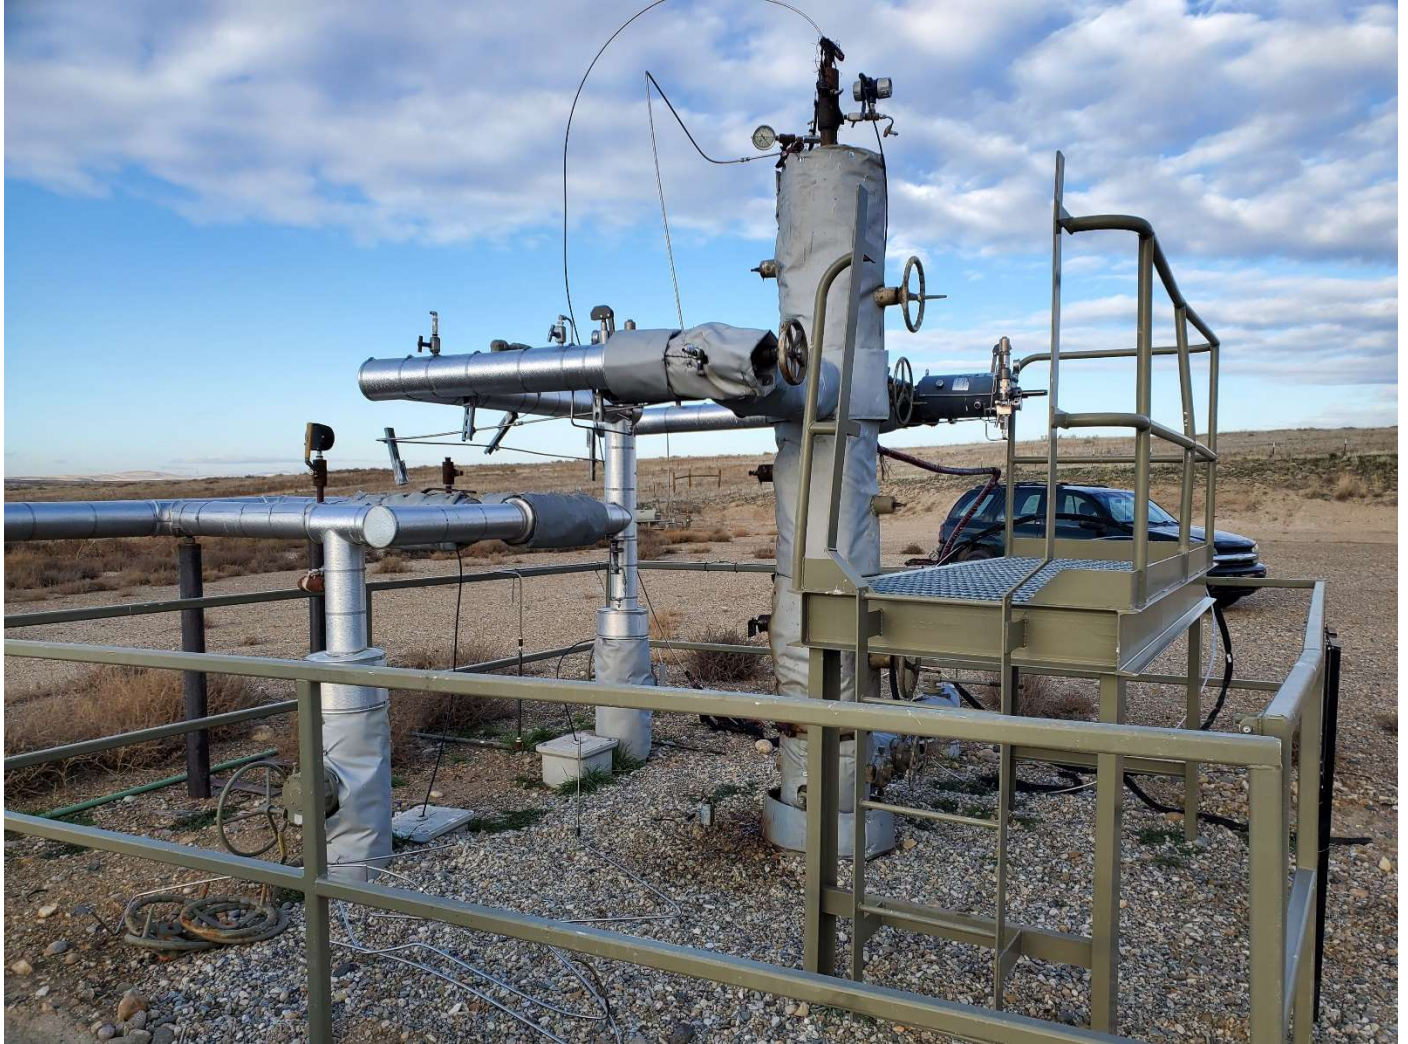
Item of concern: Due to the paraffin inhibitor treatment tube inserted into the LT tubing string, the valves cannot be completely shut. As a result, the LT tubing string is slowly leaking oil. The insulation encasing the wellhead is stained and soaked, and the oil has leaked sufficiently to stain the gravel that has been used to fill in the cellar. Recommend removing the treatment tubing, contaminated gravel and the wellhead insulation material.

3. Wellhead and inner fencing, view N. Cellar has been gravel-filled. Note vegetation, oil stained gravel left side, base of wellhead.

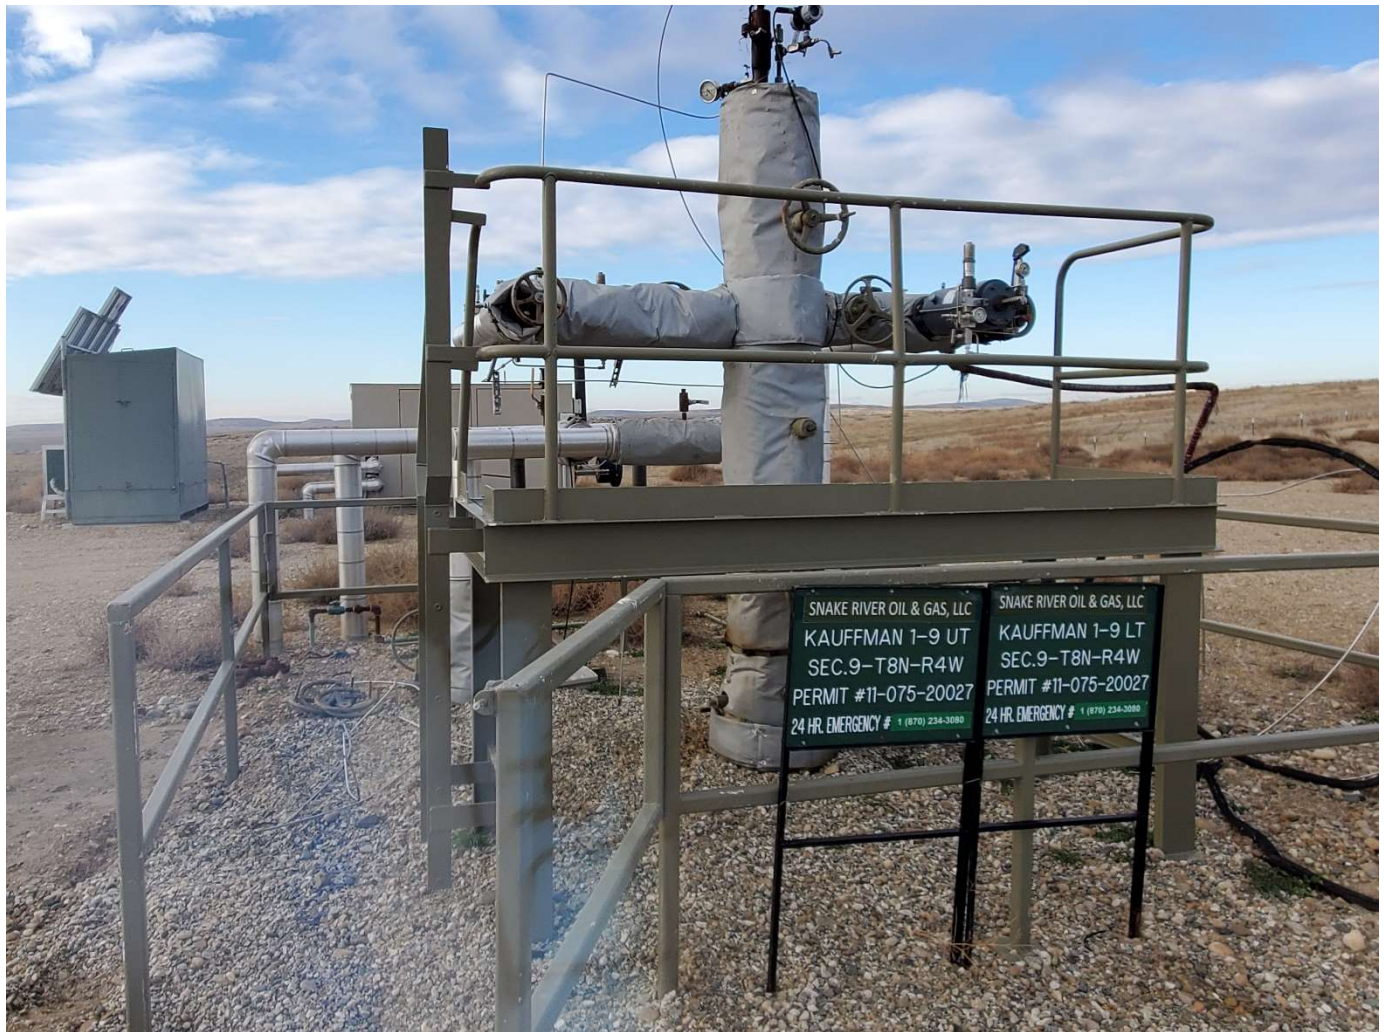
4. Wellhead and inner fencing, view NW. Cellar has been gravel-filled. Note vegetation, oil stained gravel left side, base of wellhead.

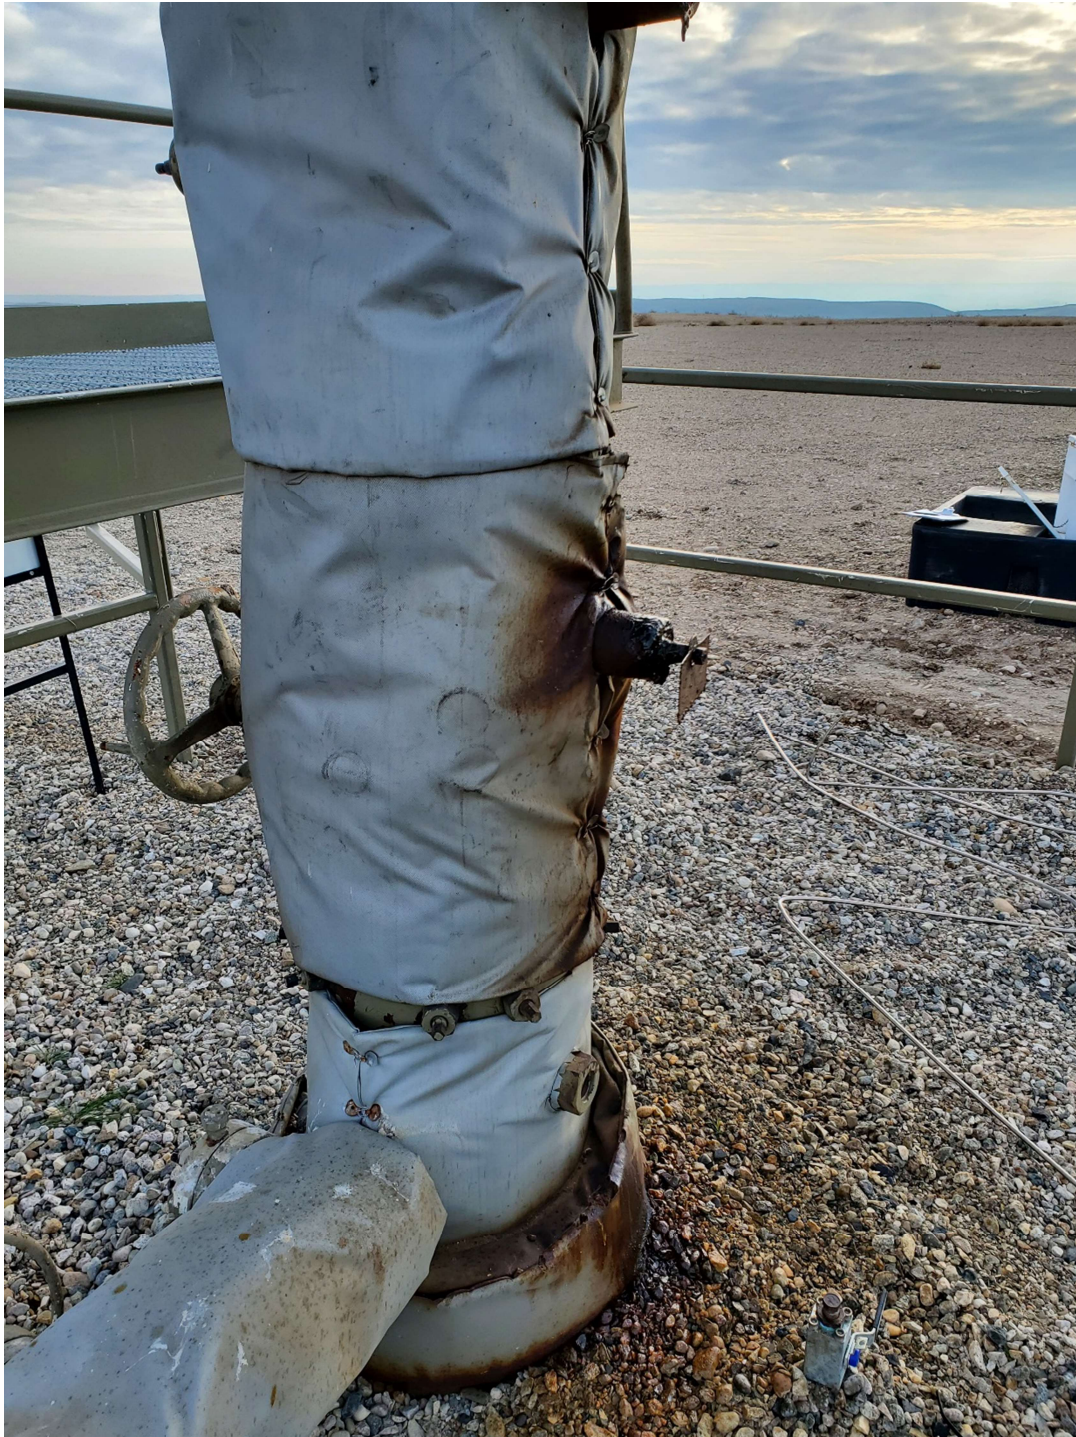
5. Detail of lower wellhead and insulation, view S. Note oil stained gravel, insulation and valve stems.

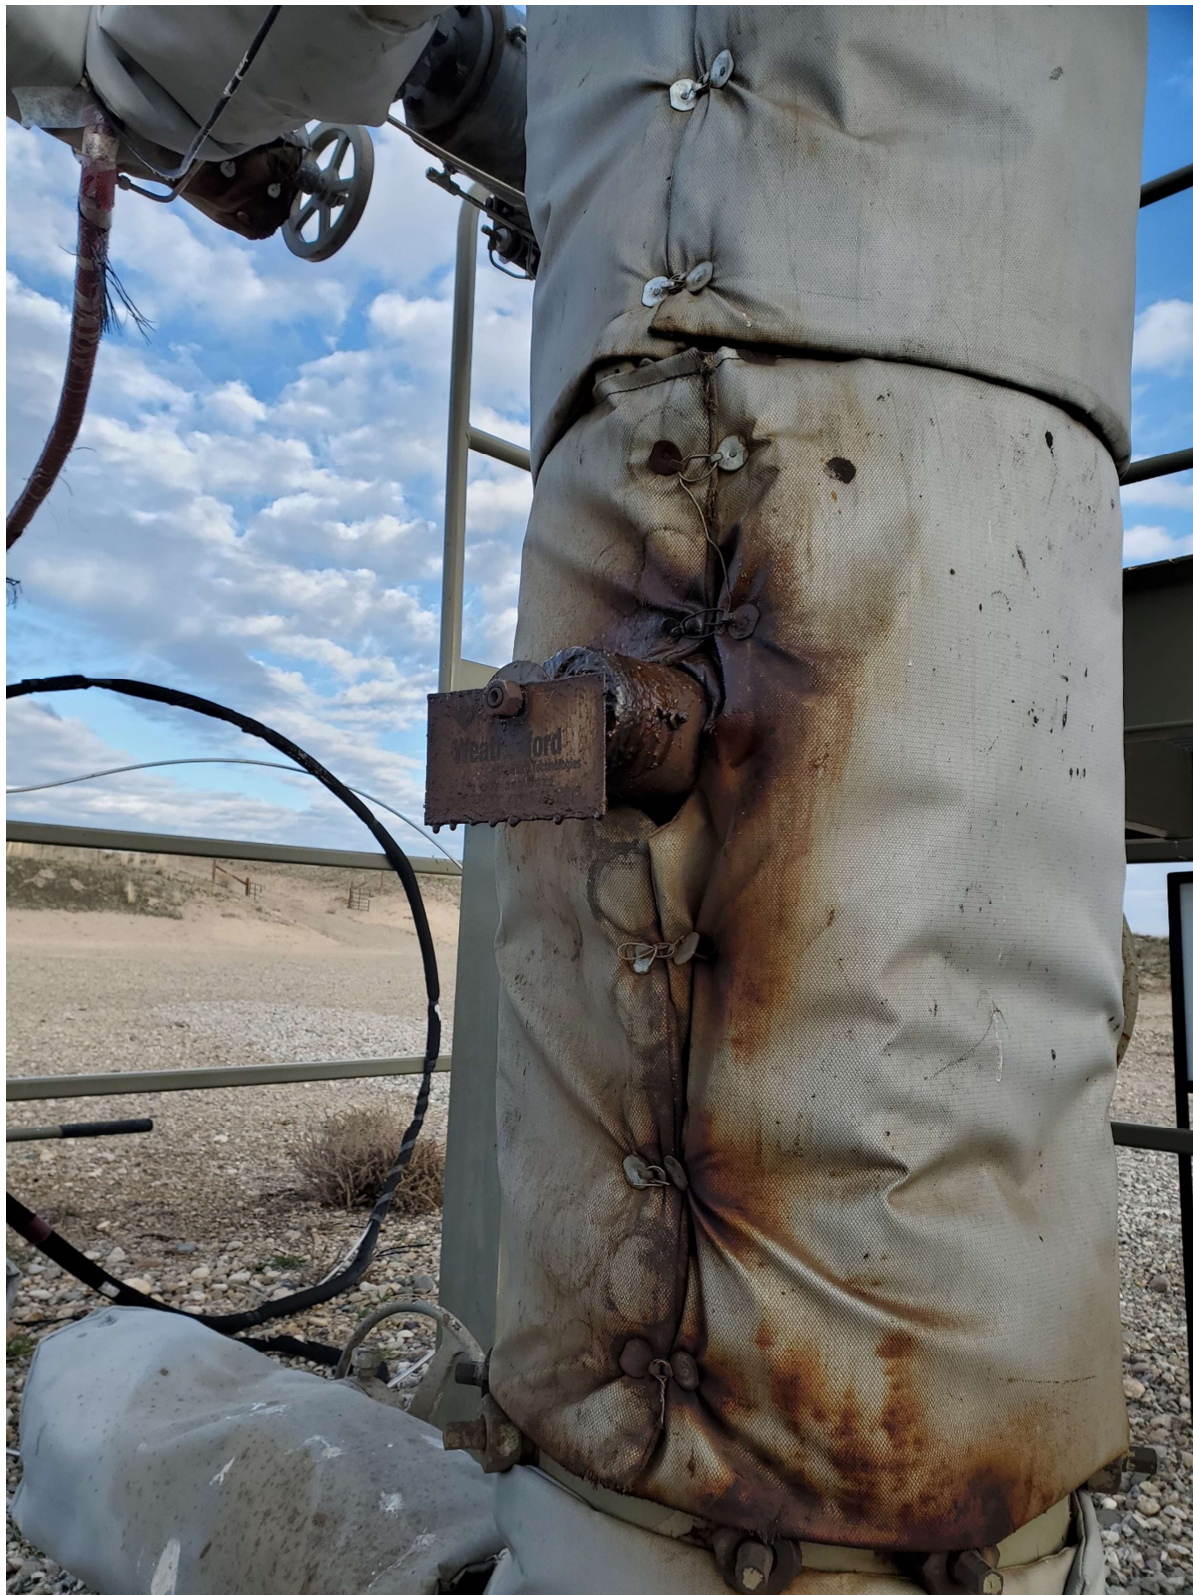
6. Detail of lower wellhead and insulation, view E. Note oil stained insulation and valve stems.

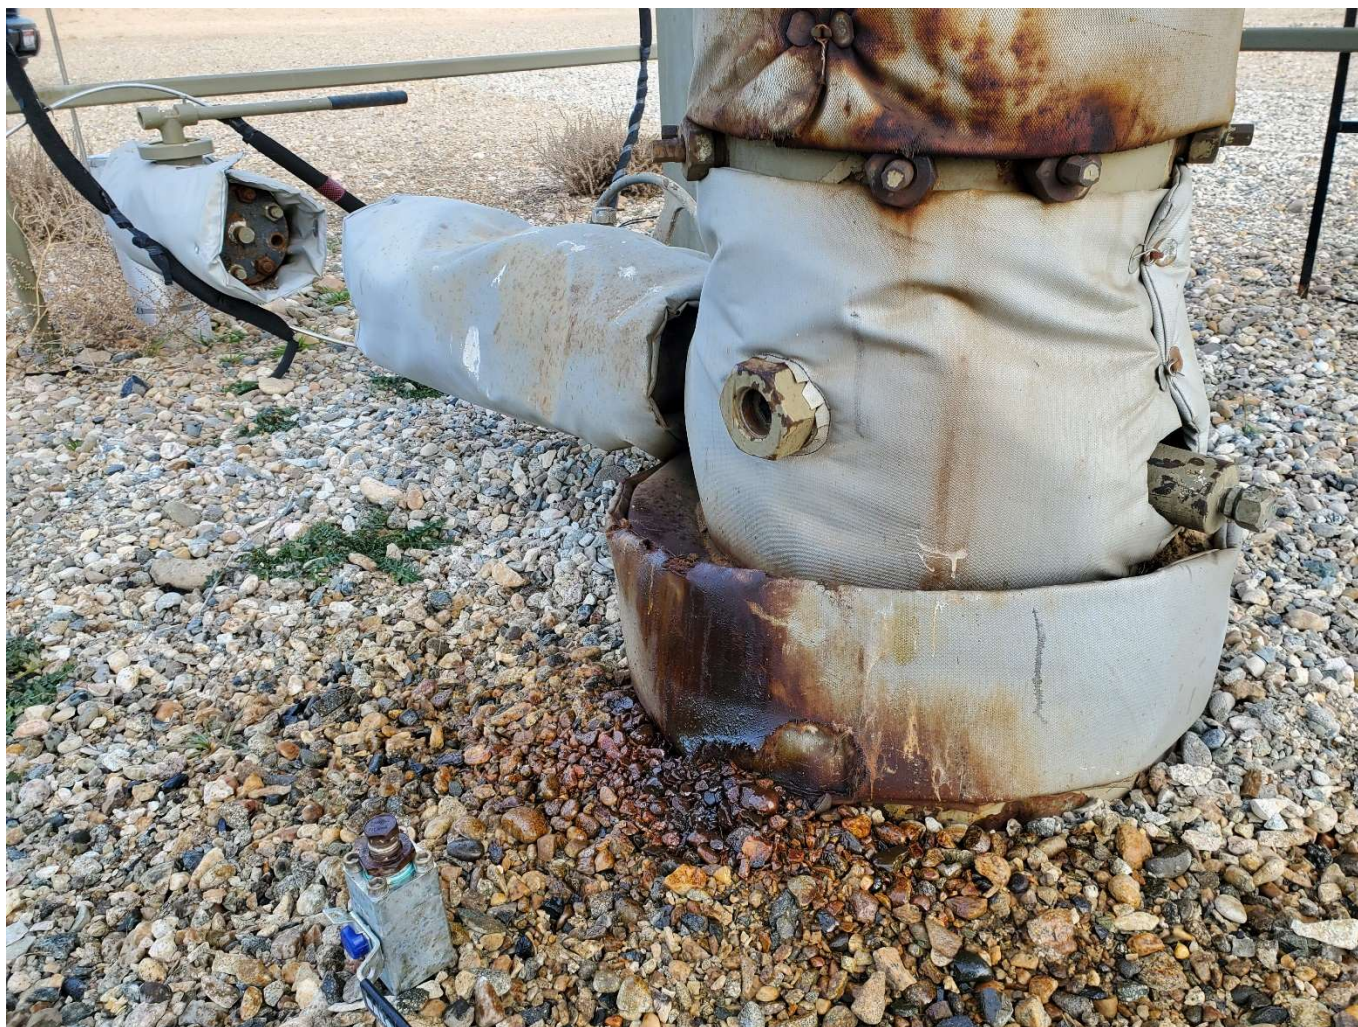
7. Detail of lower wellhead and insulation, view E. Note oil stained insulation and gravel around base of wellhead.
