Post Drilling/Annual Well Site Inspection Form

2021.11.23 Post Drilling/Annual Well Inspection Report

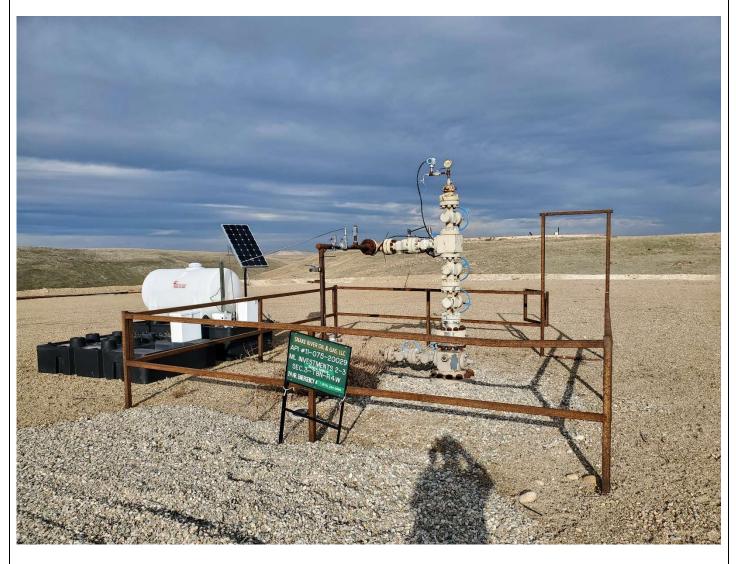
1. Wellhead, fencing and chemical tank looking NE, ML 1-3 wellpad in background. Note cellar is gravel-filled.

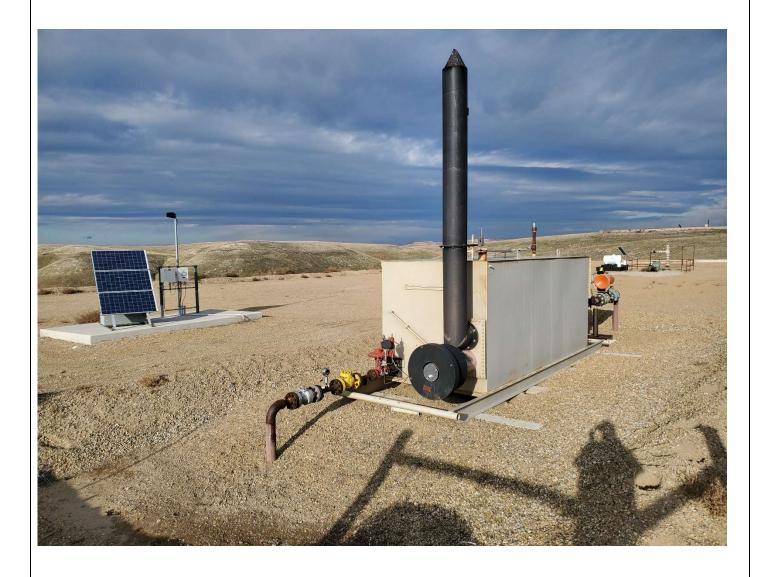
2. View N; SCADA transmitter system and readouts at left, separator, meter housing and flare stack at center, wellhead and chemical tank at right rear of photo.

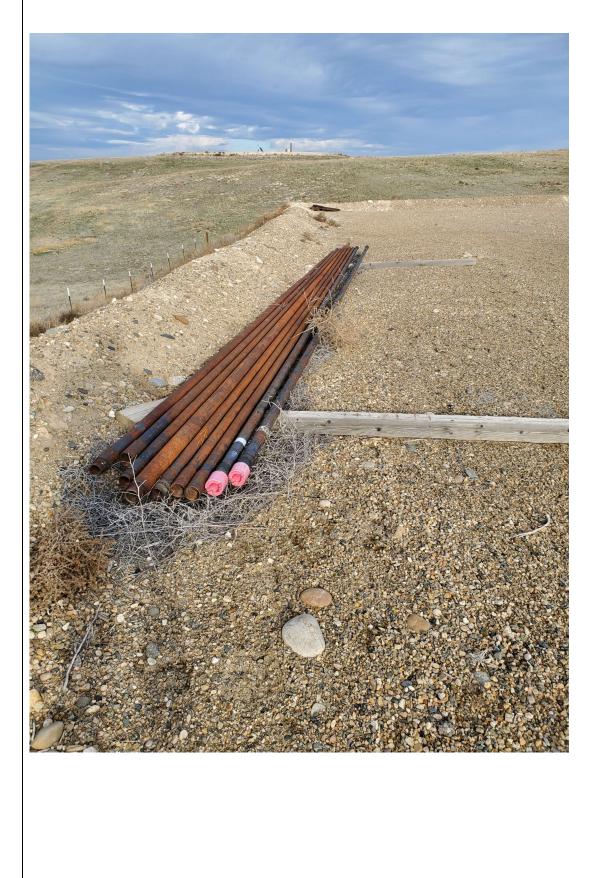
3. Northwest pad perimeter, view NE showing tubing stored on site. ML 1-3 wellpad in center back.

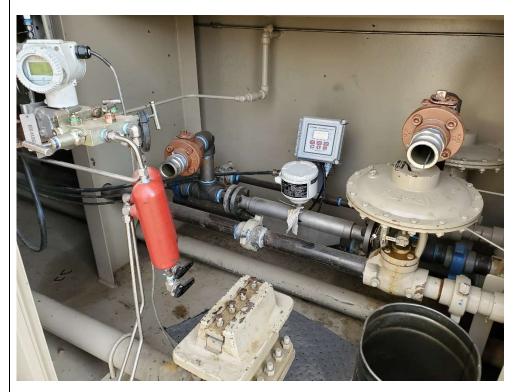
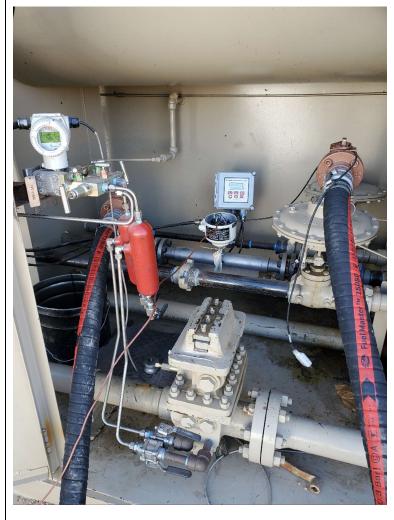
4 & 5. Proving loop set-up for Coriolis meter. Second photo shows SPL testing hoses installed in preparation for 10/19/2021 meter proving.

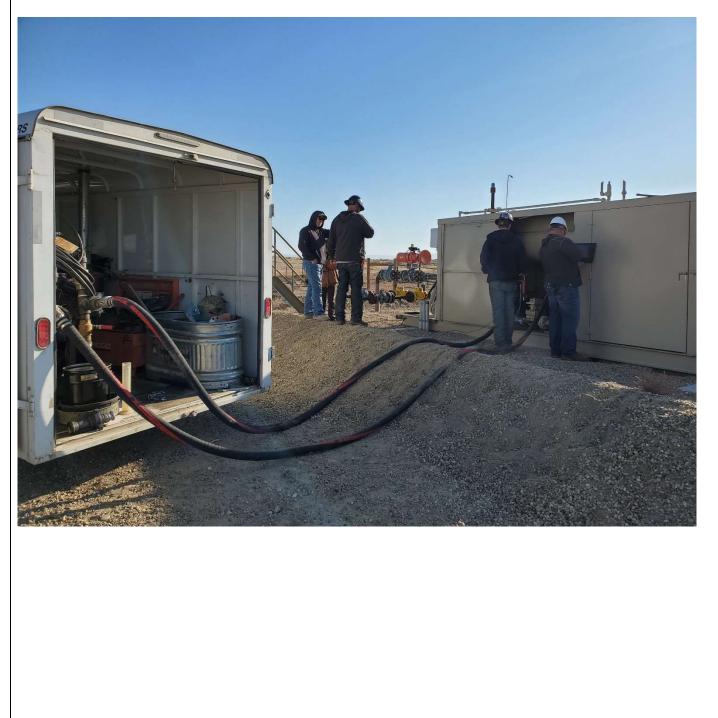
6. SPL meter proving set-up 10/19/2021. Separator/meter housing at right, proving monitors in trailer at left.
