Post Drilling/Annual Well Site Inspection Form

Section 1: General Information	
Operation Data	Inspection Data
Operator Name Snake River Oil + Gas, LLC	Inspector Name James Thum
Well Name ML Investments #3-10, USWN 11-075-20031	Area Office Boise / Director's
Authorized Contact Dan Johaneck (208)707-7867 112 N. Plymouth, New Plymouth ID	Inspection Date 11/29/2021
County Payette	Report Date 1/4/2022
Inspector's Signature: /signed/ James Thum	Inspection Summary: <input checked="" type="checkbox"/> Operation appeared to be in compliance at the time of the inspection. <input type="checkbox"/> Issues of concern identified at the time of the inspection.
Date of Signature: 1/4/2022	
Location Description: 2277 feet SSW from Little Willow Gathering Facility, 4649 Little Willow Road. Google Maps location Latitude 44.045220, Longitude -116.807109. Well is currently producing (Willow Field). Weather: sunny, 45°F, variable light wind <5 MPH	
Scope of Inspection (check all that apply and, or, were verified during the inspection): <input checked="" type="checkbox"/> Well site <input type="checkbox"/> Tank Battery <input checked="" type="checkbox"/> Wellhead <input type="checkbox"/> Meters <input t

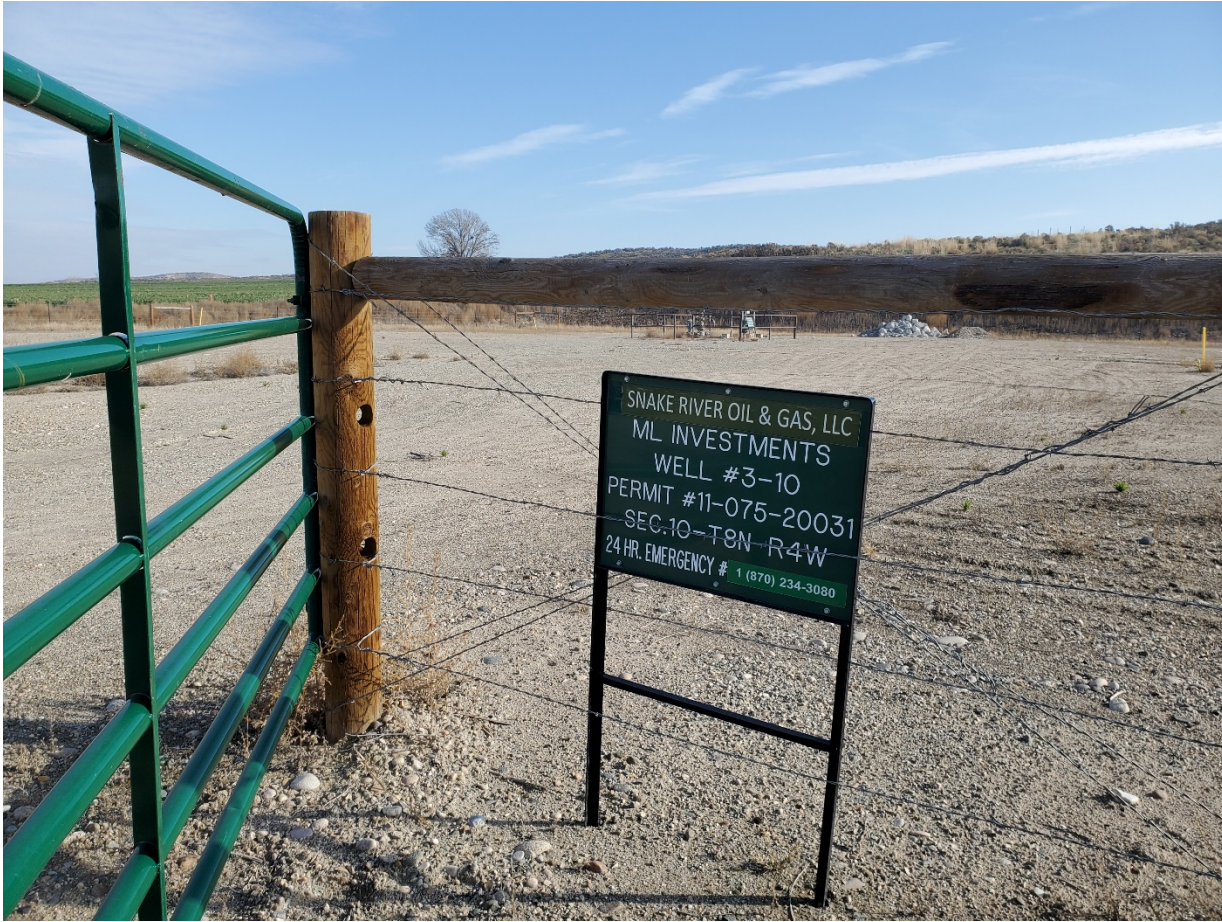
1. Entrance gate looking ESE; signage, wellhead in center background.

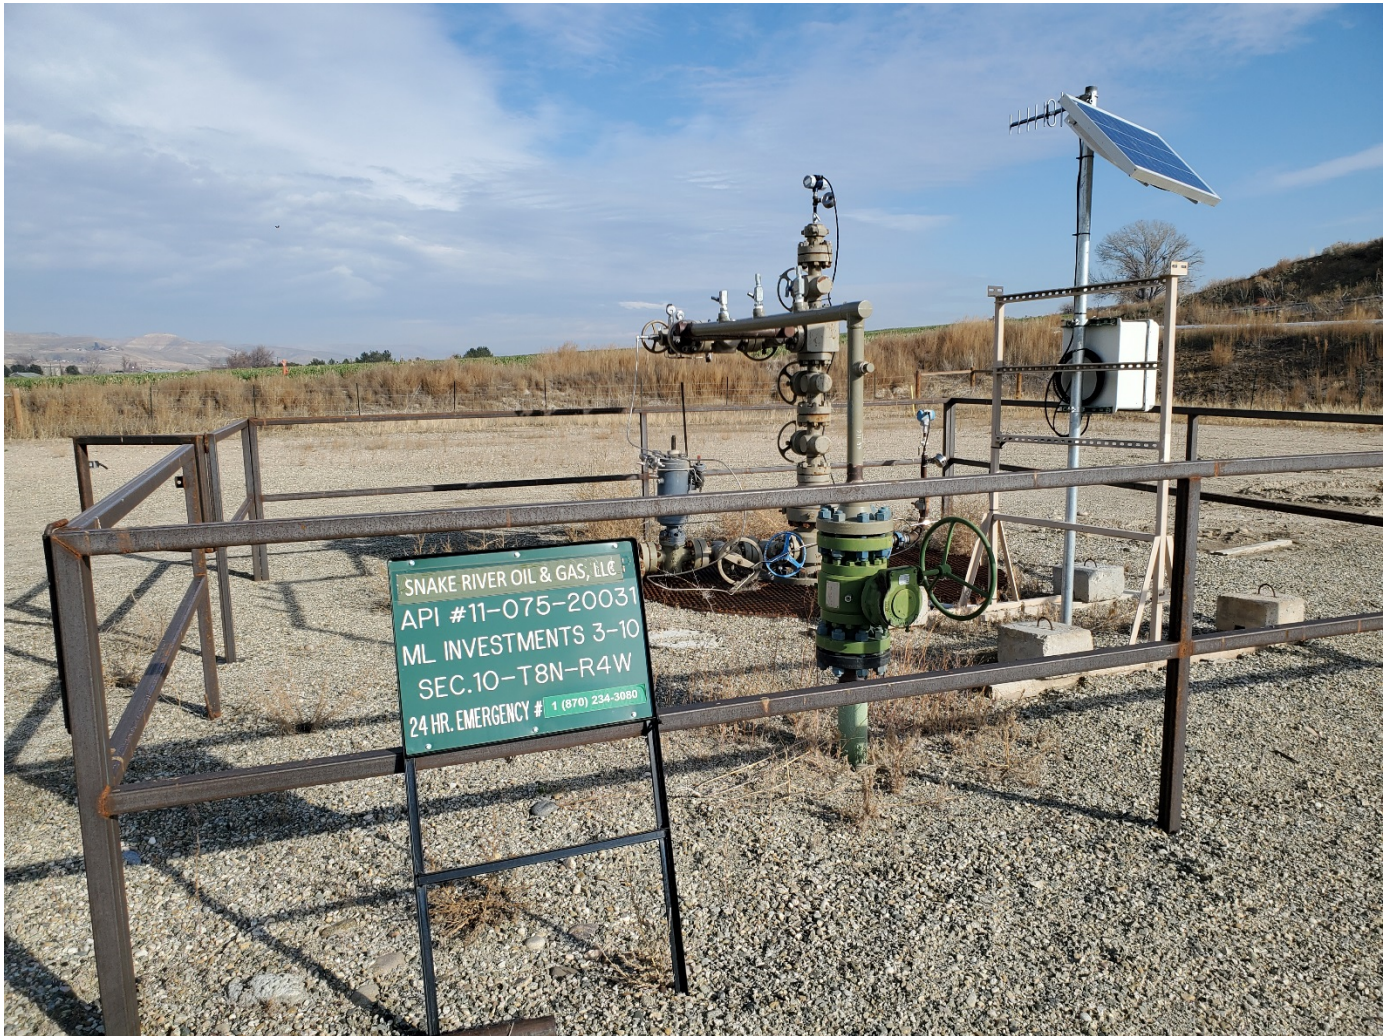
2. Wellhead fencing, wellhead and riser looking E.

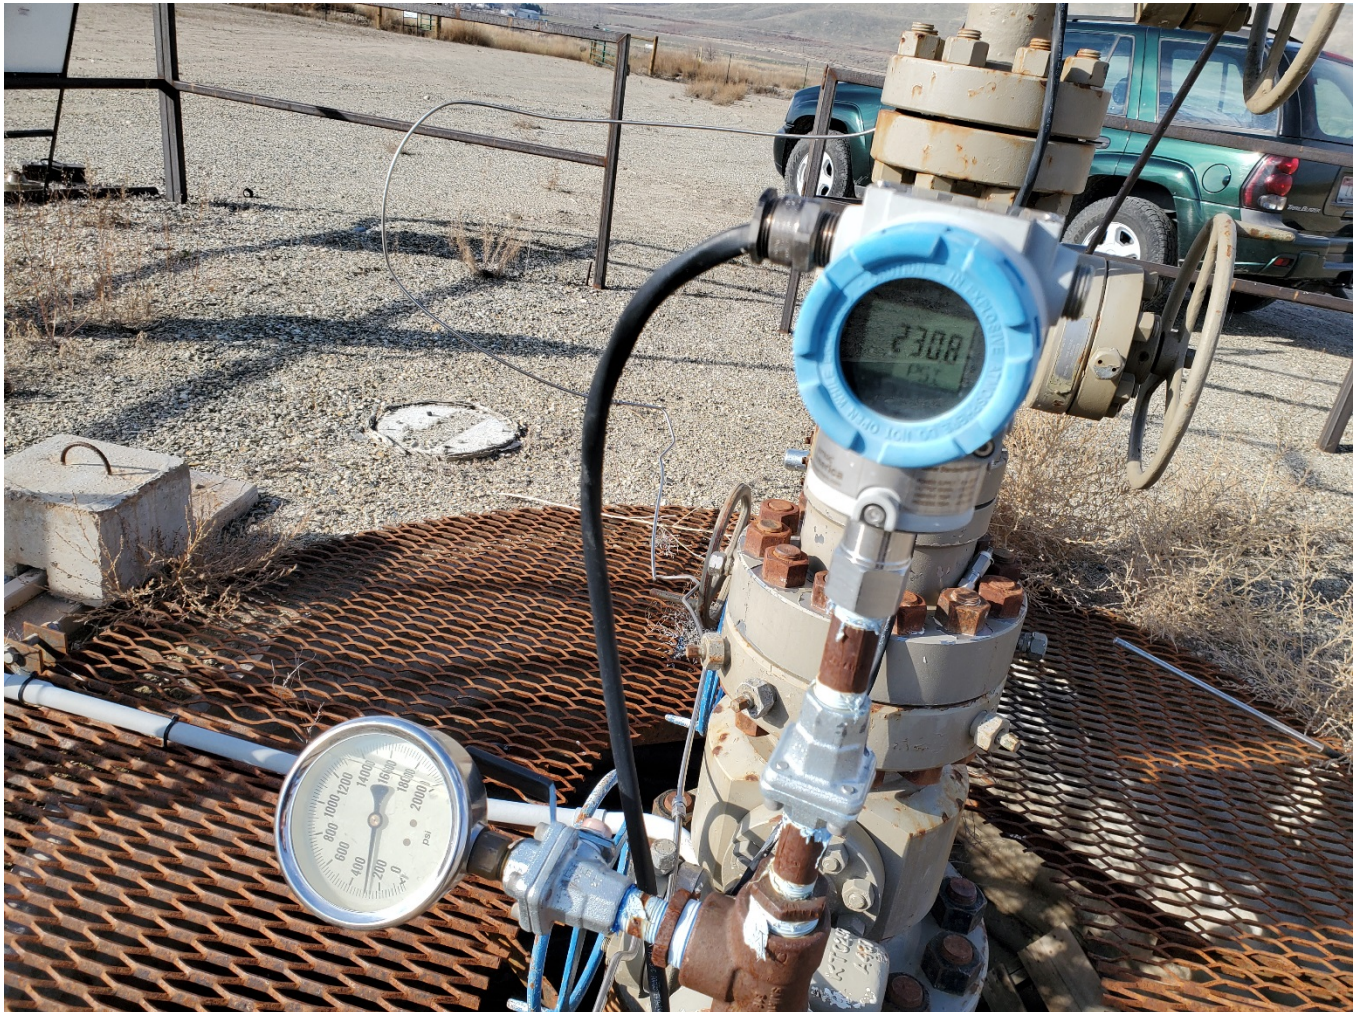
Production casing: 230.4 PSI (193 PSI reported 11/1/2021)

Tubing string: 110.4 PSI (263 PSI reported 11/1/2021)

Additional comments: well cellar not gravel-filled. Cellar is grated and contained no water at the time of inspection.

3. Wellhead showing analog and digital pressure gauges, grated cellar.

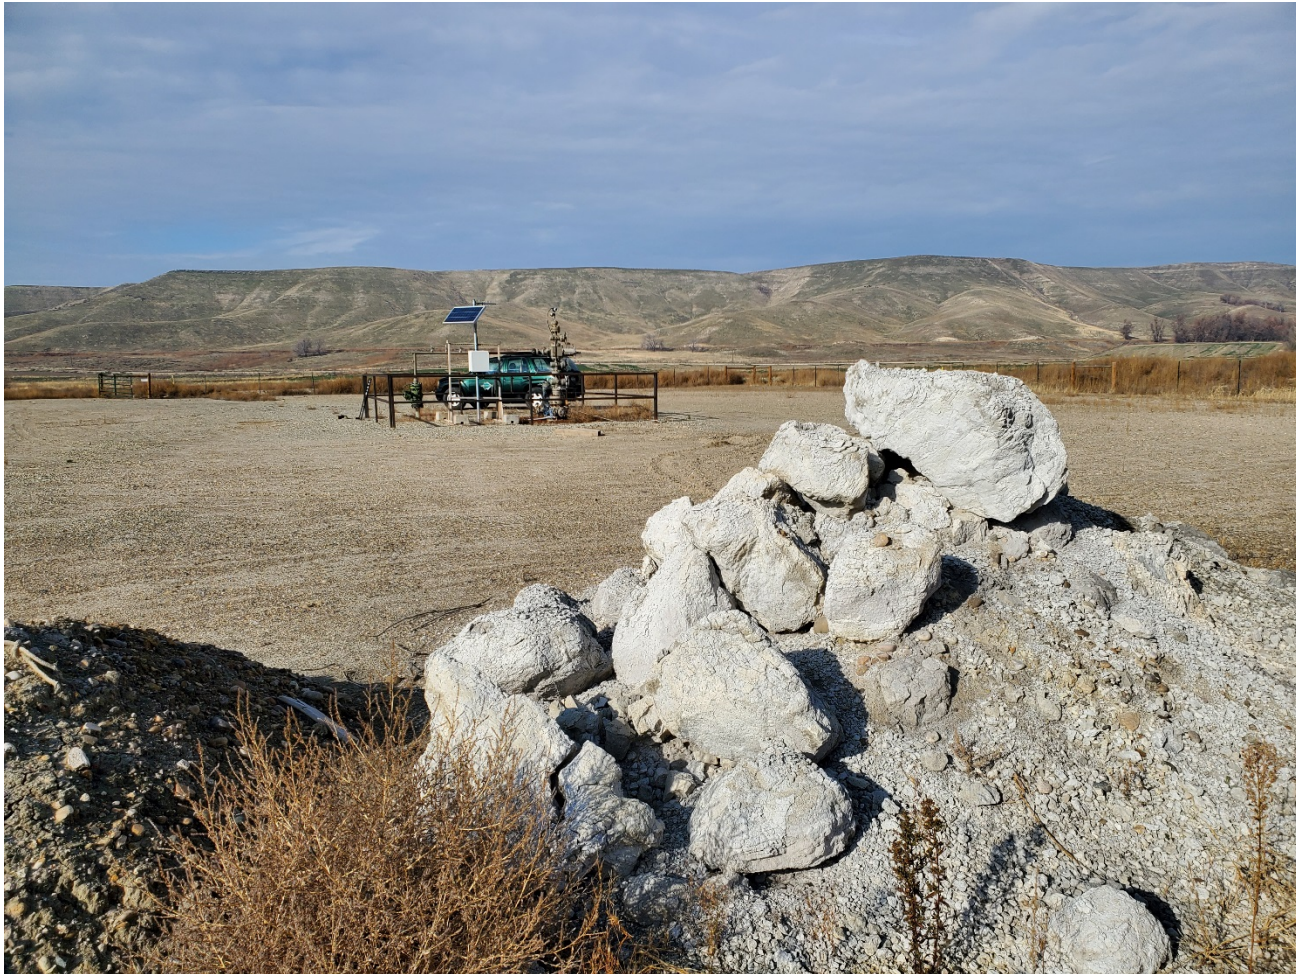
Section 4 comments: Excess concrete returns from surface casing cementing remain on site on SE side of well pad.

4. Wellpad overview looking NW. Concrete returns in foreground, wellhead in center background.
