# Post Drilling/Annual Well Site Inspection Form

| Section 1: General Information | |
|---|---|
| <b>Operator Name</b><br>Snake River Oil + Gas, LLC | <b>Inspector Name</b><br>James Thum |
| <b>Well Name</b><br>Barlow #1-14, USWN 11-075-20033 | <b>Area Office</b><br>Boise / Director's |
| <b>Authorized Contact</b> Dan Johaneck (208)707-7867<br>112 N. Plymouth, New Plymouth ID | <b>Inspection Date</b><br>3/16/2022 3:45 PM |

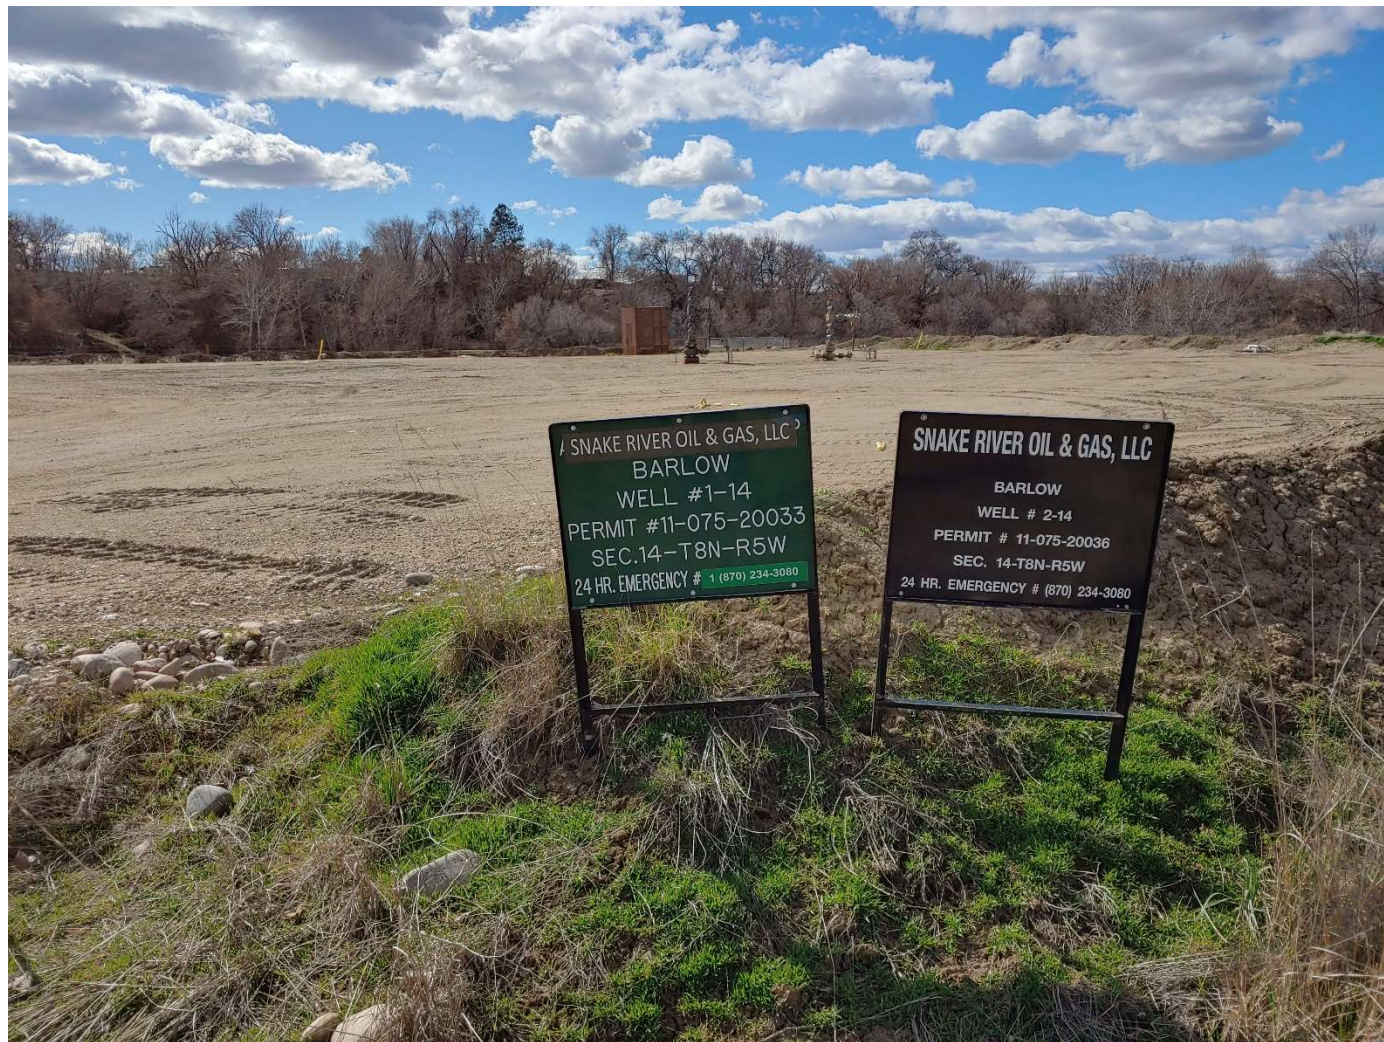
Dual signage at east side entrance to well pad, looking west to well heads.

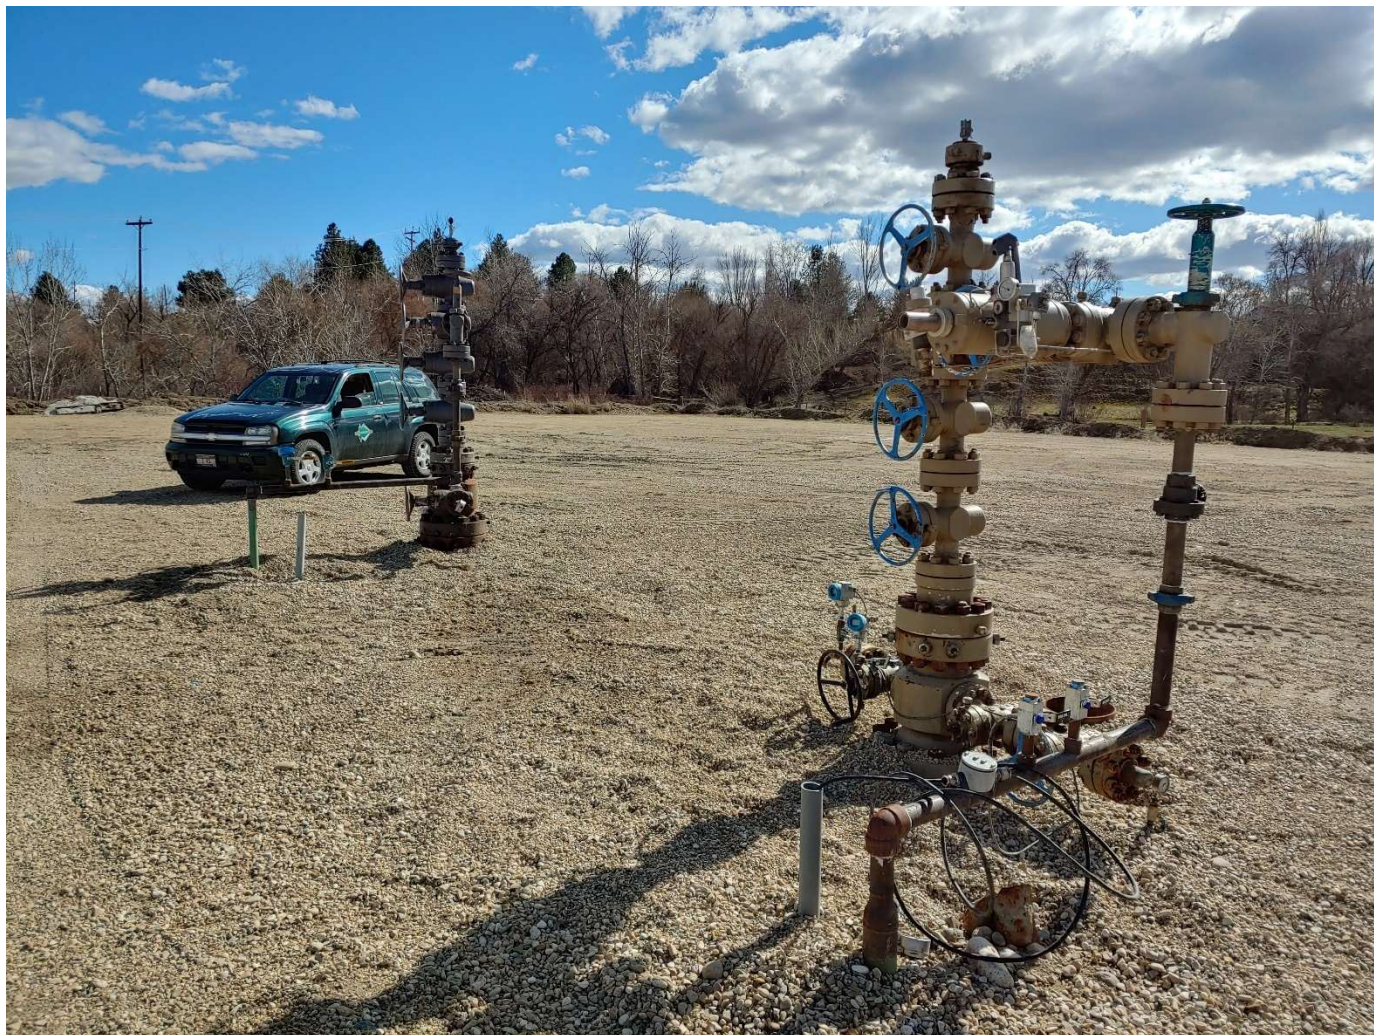
Barlow #2-14 wellhead on left, Barlow #1-14 wellhead on the right. View south.

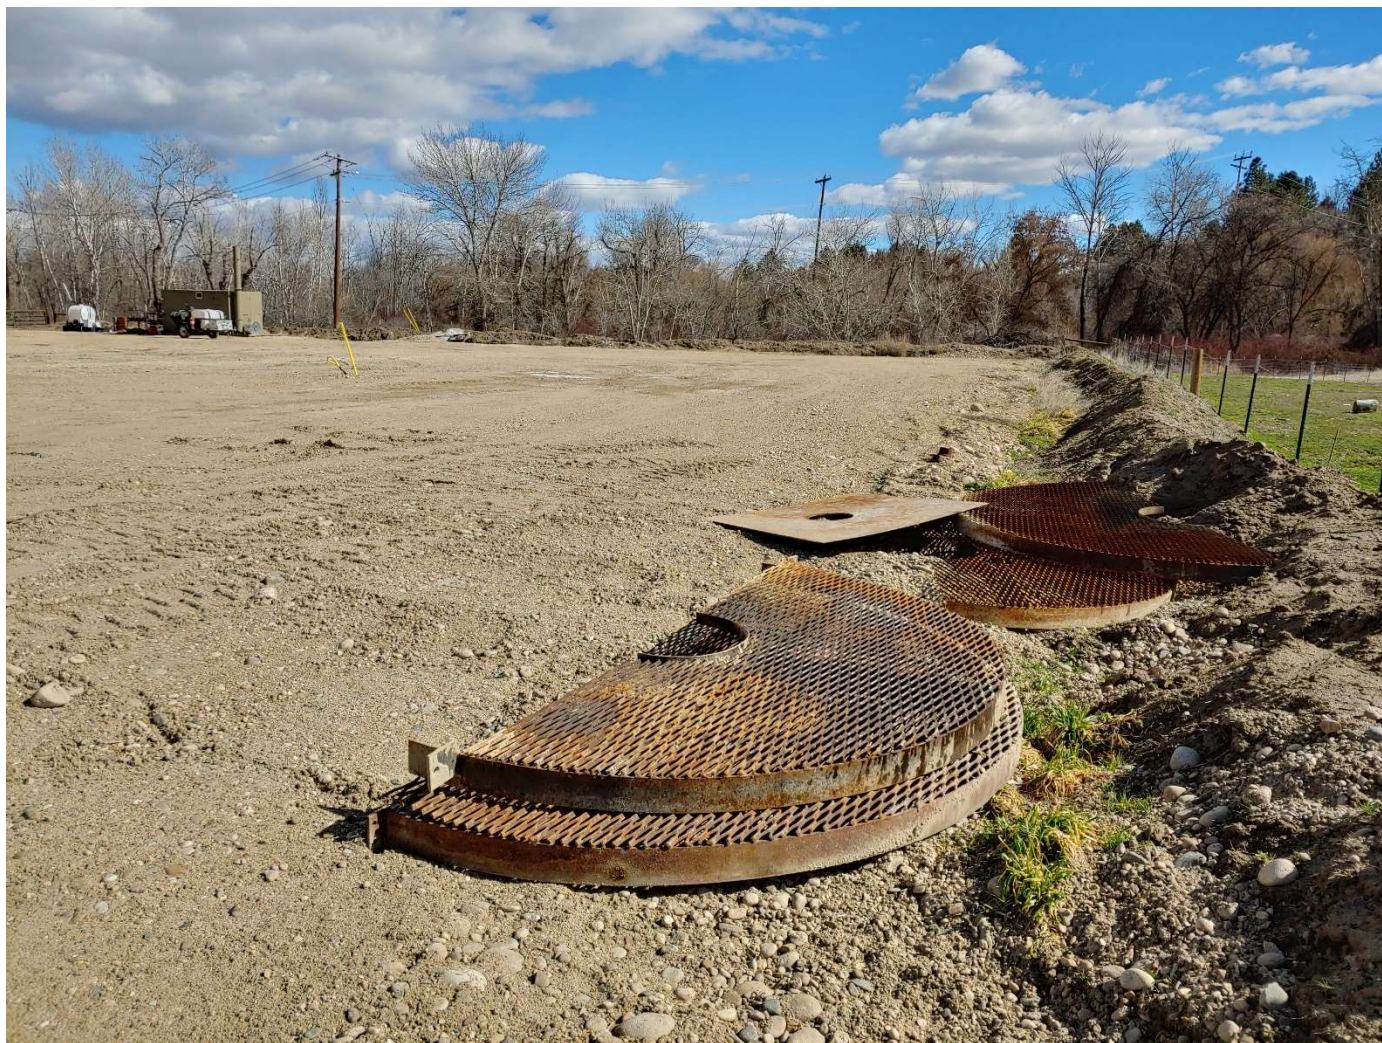
**Comments and Issues of Concern:** Cellar filled with gravel and protective grating removed.

Still minor amounts of debris/trash on site from drilling ops, some equipment on site due to ongoing work and maintenance.

Southwest side of well pad, looking SE. Old cellar grate from Barlow 1-14. Cellar now gravel-filled. Dual separator unit in left background with miscellaneous equipment trailer and scavenger unit.

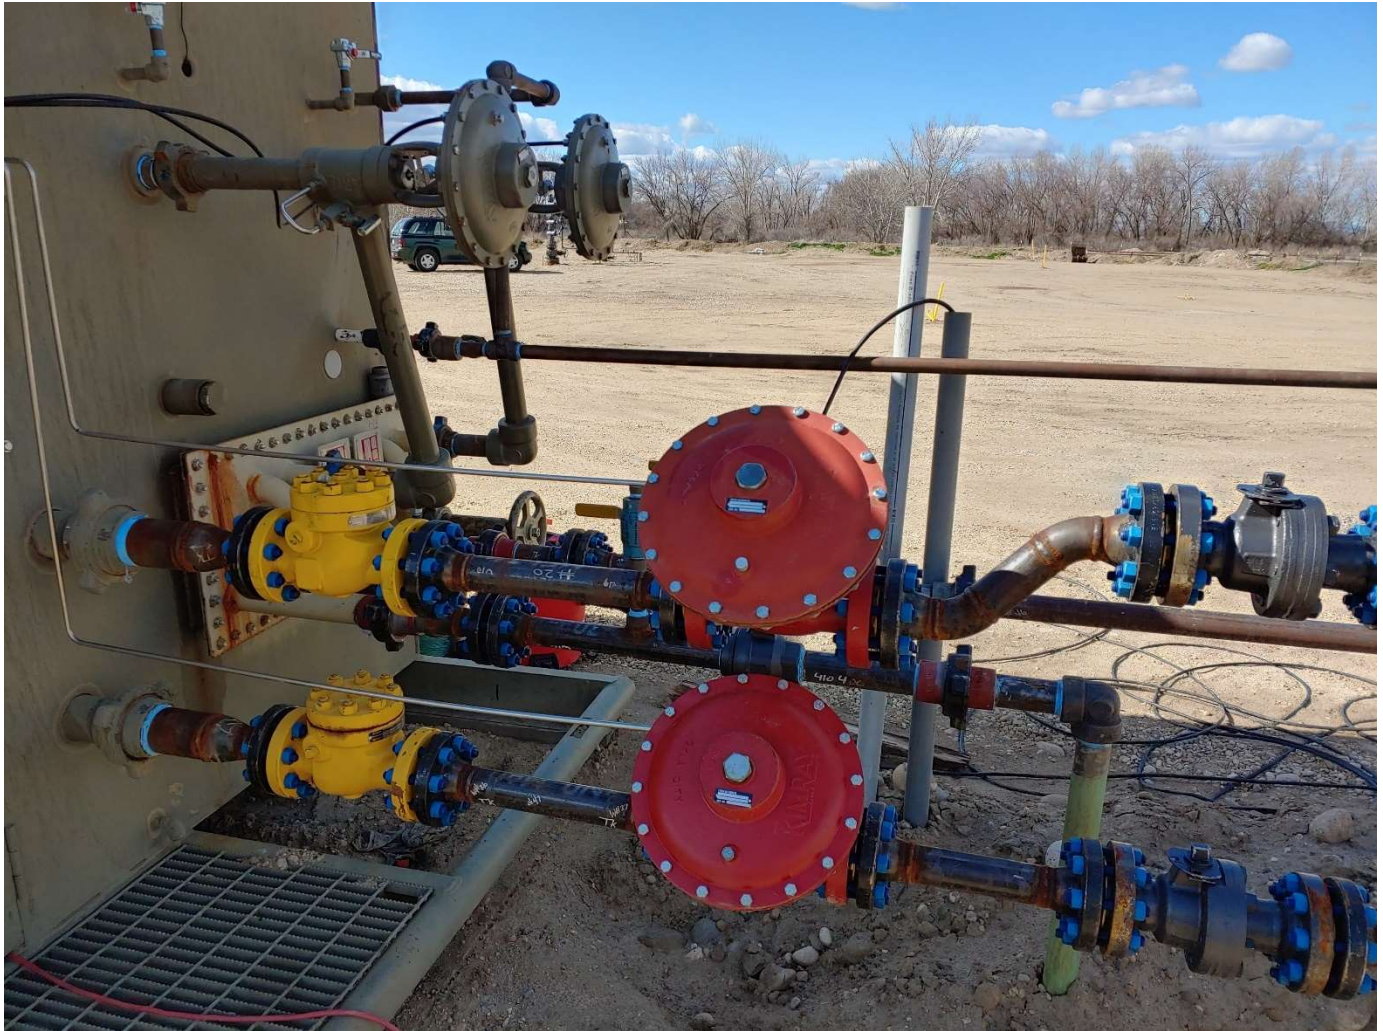
NE side of separator unit looking NNW towards well heads.

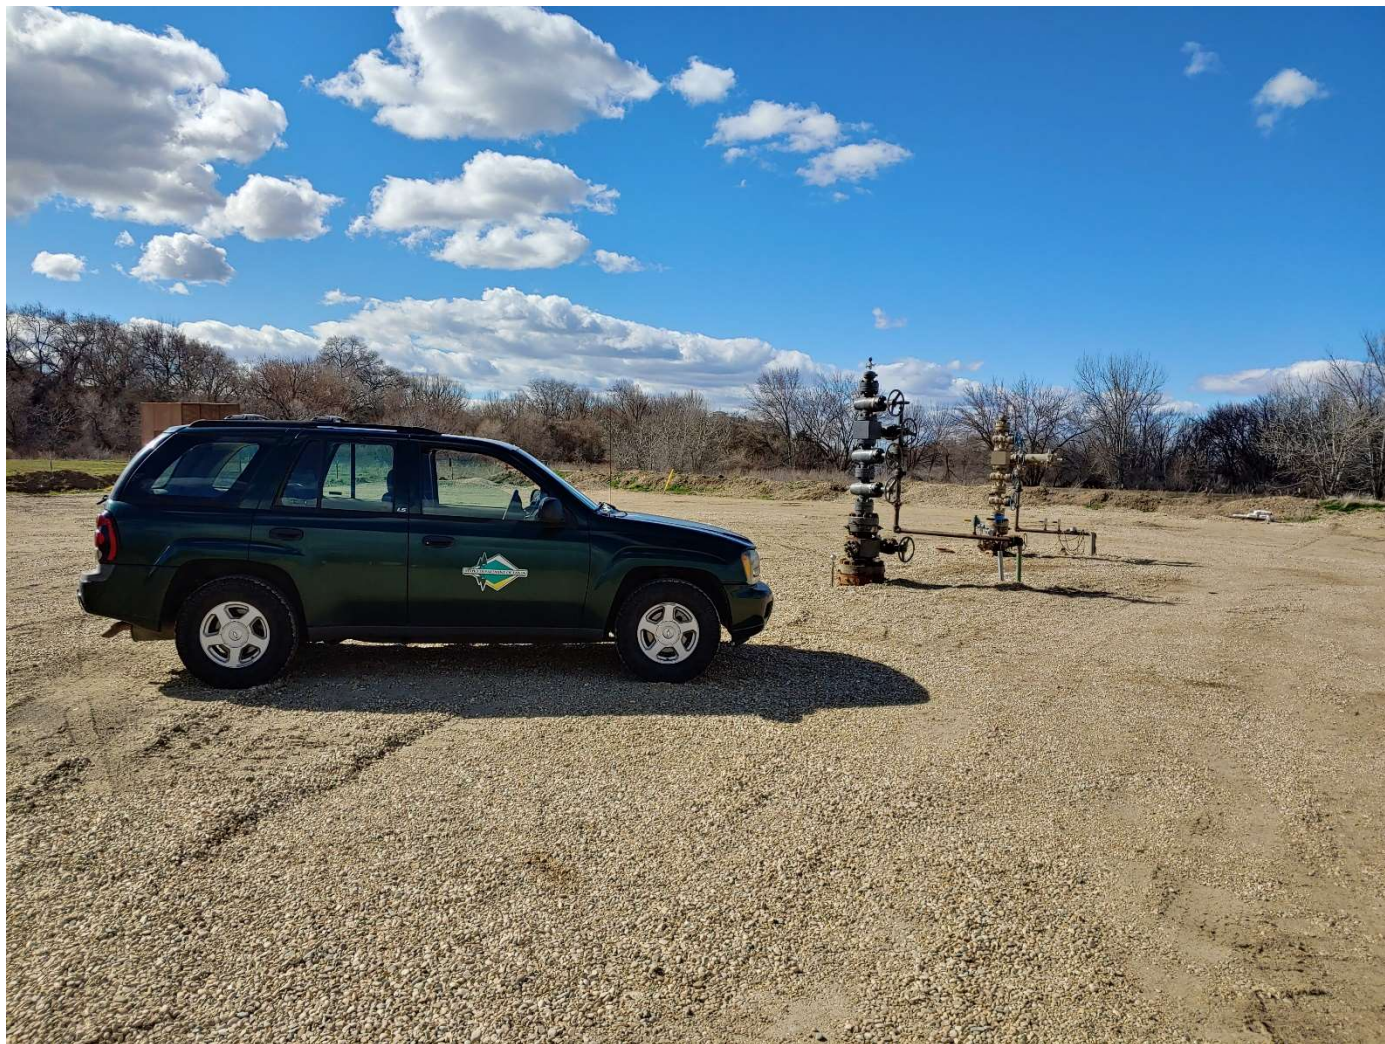
Barlow #2-14 wellhead on the left, Barlow #1-14 wellhead on the right. View NW.
