# Post Drilling/Annual Well Site Inspection Form

Section 1: General Information	
<b>Operation Data</b>	<b>Inspection Data</b>
<b>Operator Name</b> Snake River Oil + Gas, LLC	<b>Inspector Name</b> James Thum
<b>Well Name</b> Fallon #1-10, USWN 11-075-20032	<b>Area Office</b> Boise / Director's
<b>Authorized Contact</b> Dan Johaneck (208)707-7867 112 N. Plymouth, New Plymouth ID	<b>Inspection Date</b> 3/16/2022 2:30 PM
<b>County</b> Payette	<b>Report Date</b> 3/17/2022
<b>Inspector's Signature:</b> /signed/ James Thum	<b>Inspection Summary:</b> <input checked="" type="checkbox"/> Operation appeared to be in compliance at the time of the inspection. <input checked="" type="checkbox"/> Issues of concern identified at the time of the inspection.
<b>Date of Signature:</b> 3/17/2022	
<b>Location Description:</b> 1.40 miles NNW from Hwy 30 and Hwy 95 intersection in Fruitland, ID, west side of Hwy 95 north of the Payette River. Google Maps location Latitude 44.045495, Longitude -116.927641. Well production commenced 2/8/2022 per Sundry Notice. Weather- partly cloudy, 60° F, NW wind 10-15 MPH.

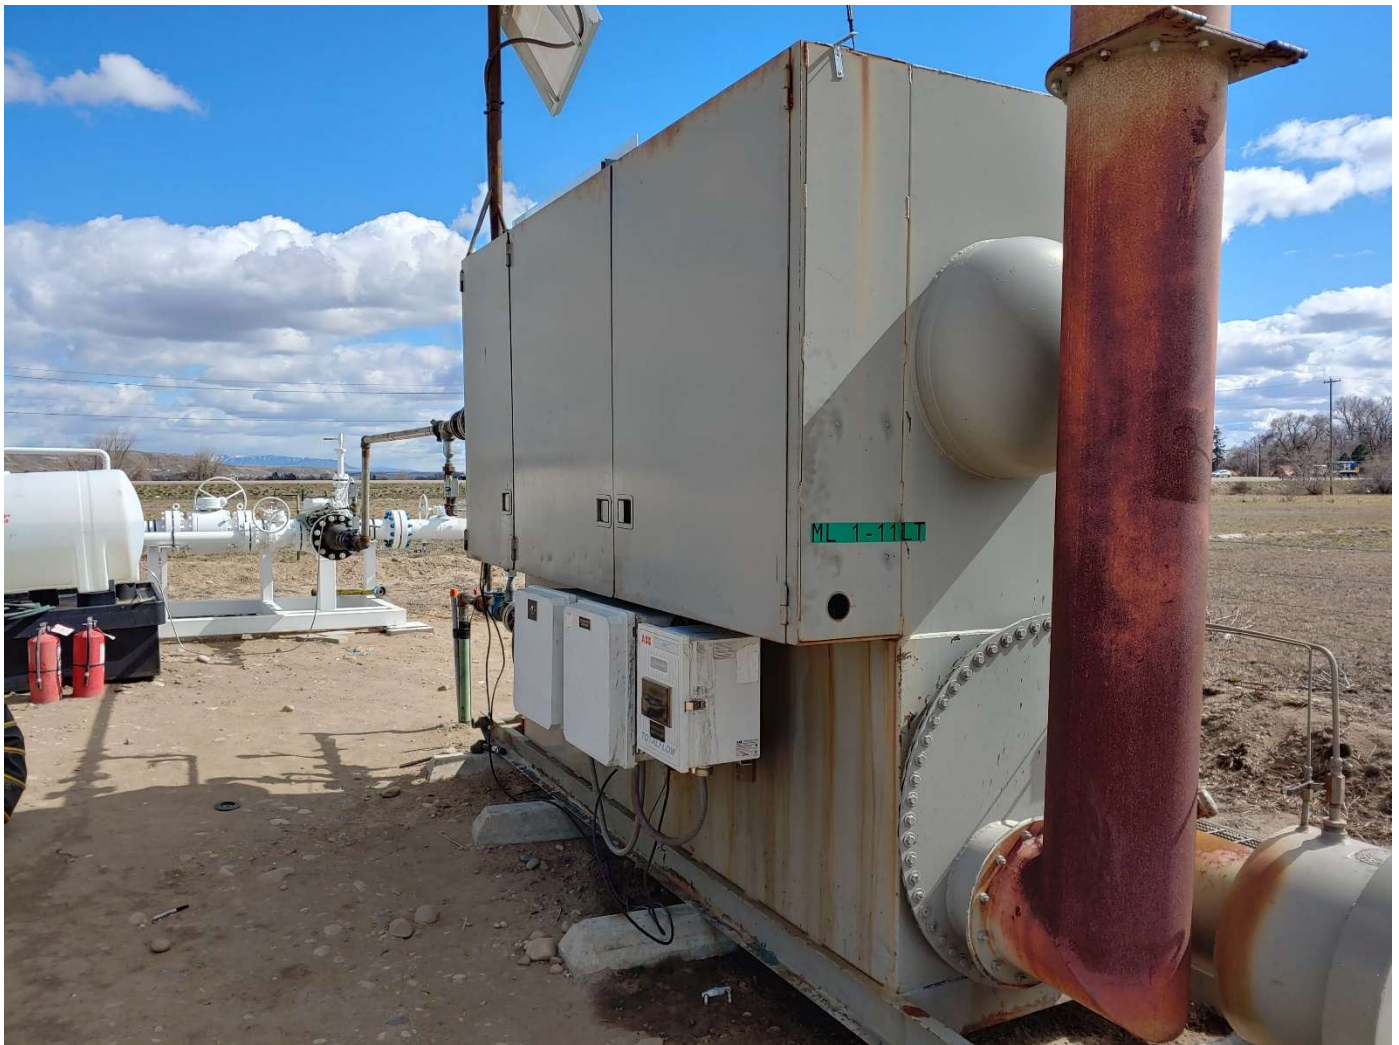
Re-purposed separator unit (mis-labeled as “ML 1-11 LT”) and flare stack, looking East.

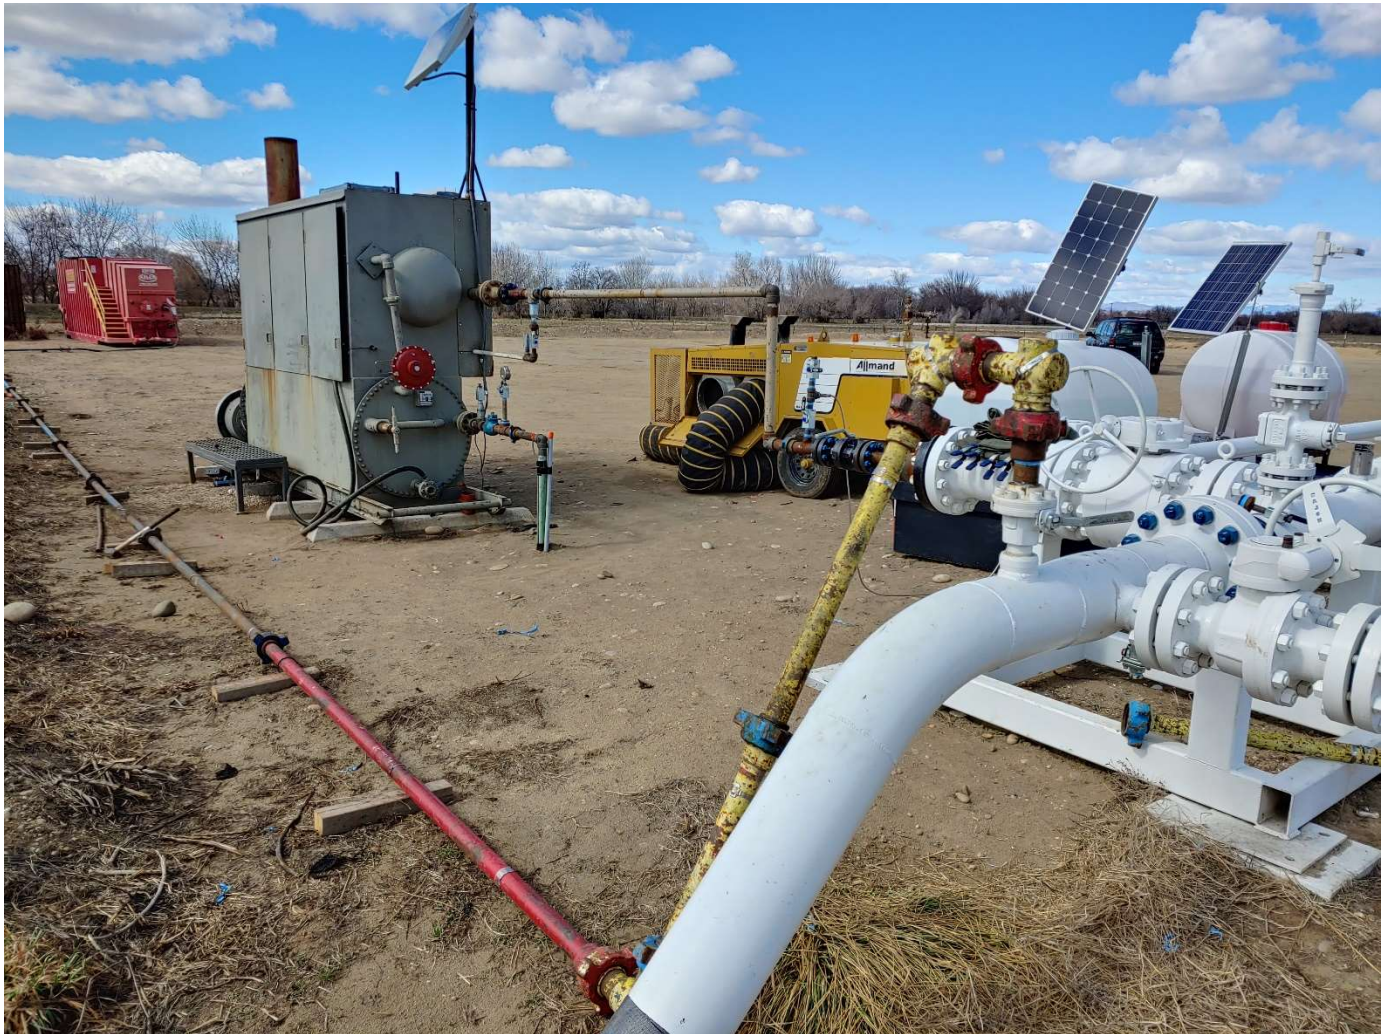
It is unclear whether the operator intends to install a more permanent tank battery to replace the temporary H2O tank in the SW corner of the pad. The temporary tank is undiked, so spill containment will have to rely on the well pad berm which is low and eroded near the tank.

Fallon 1-10 well pad from SE corner, looking NW. Left to right: red temporary H2O tank, gray well separator unit, yellow temporary / portable heating unit, white pipeline riser. Yellow & red surface flow line connected to temporary H2O unit along southern pad dike.

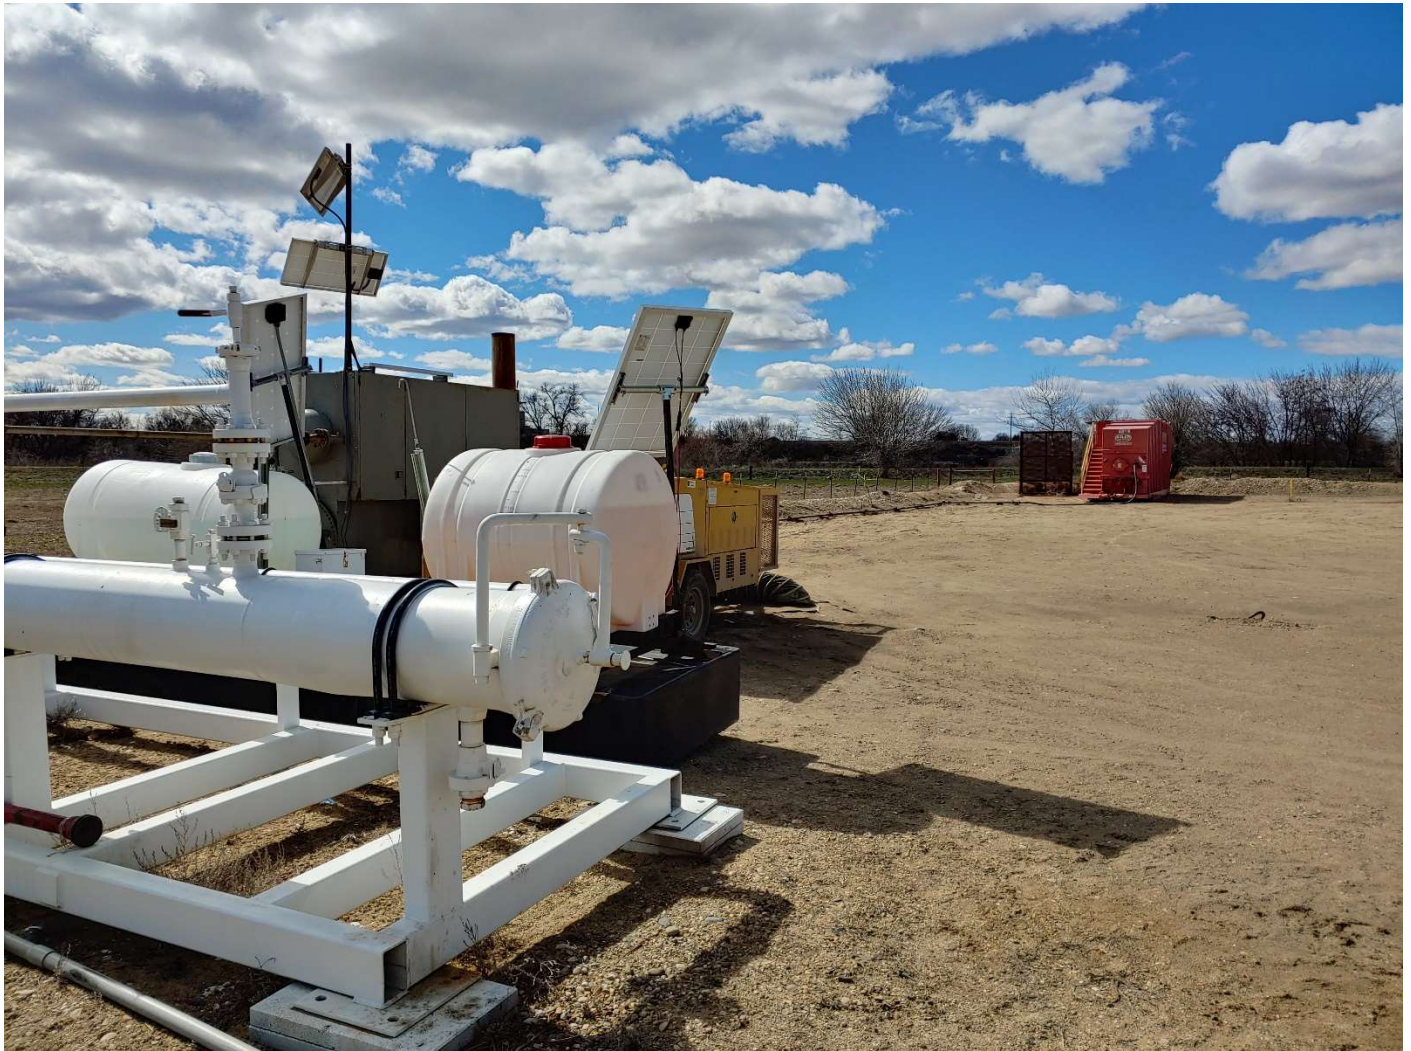
Pig launcher in pipeline riser, separator unit and portable heating unit in background, temporary water tank at right-rear of photo. Phot taken from east side of well pad looking WSW toards SW corner.

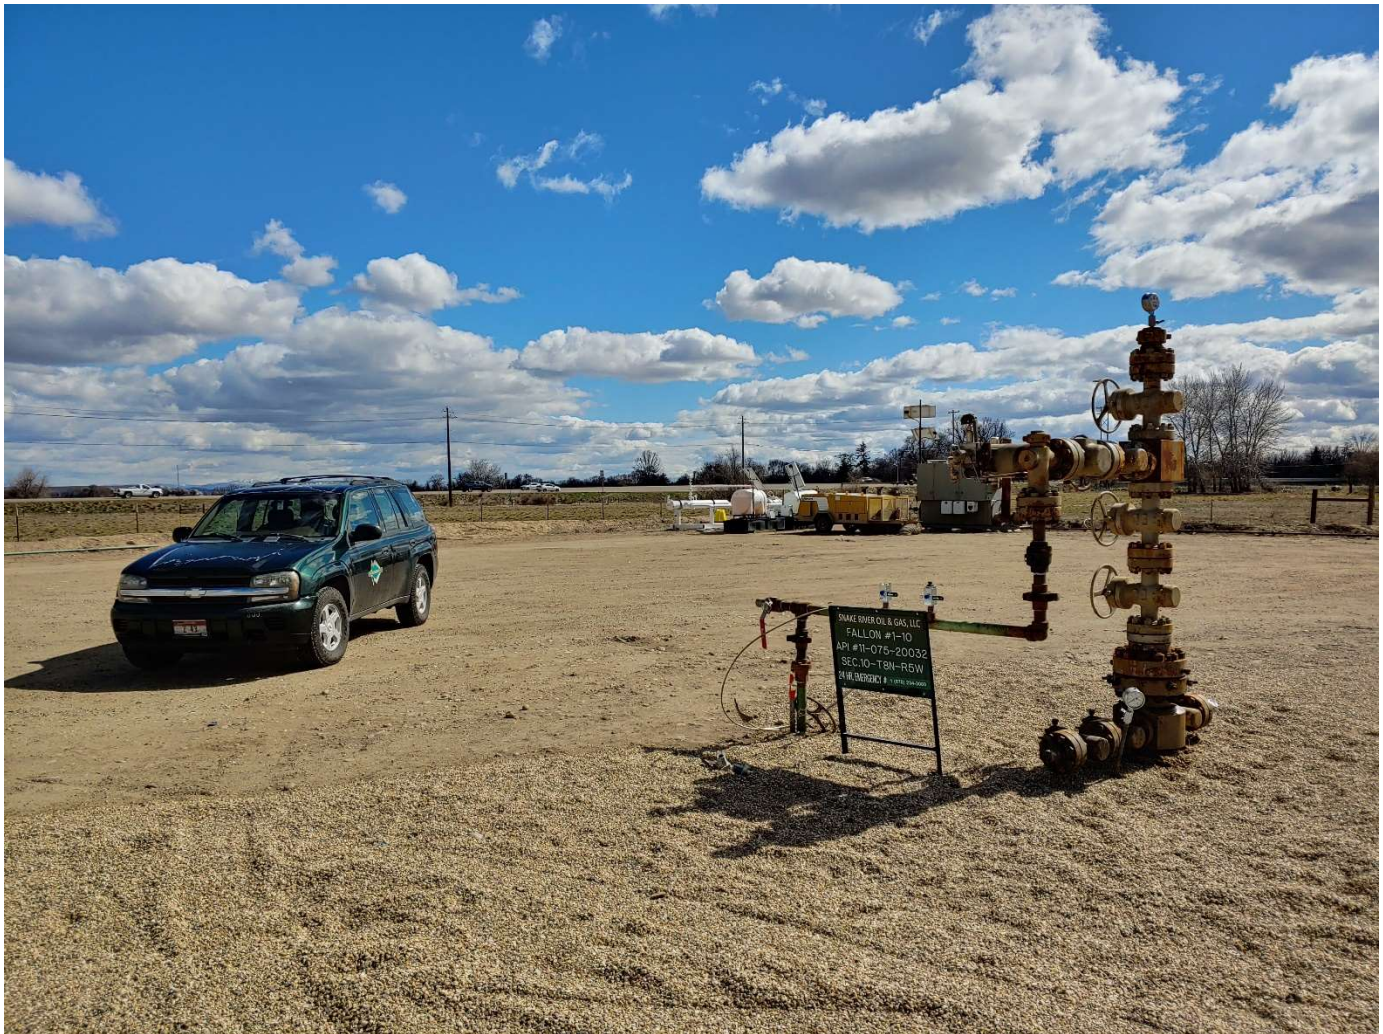
Fallon 1-10 wellhead and sign. Pipeline riser / pig launcher, separator unit and temporary heating unit in background. View SE to US 95.
