# Post Drilling/Annual Well Site Inspection Form

Section 1: General Information	
<b>Operation Data</b>	<b>Inspection Data</b>
Operator Name Snake River Oil + Gas, LLC	Inspector Name James Thum
Well Name DJS Properties #1-15, USWN 11-075-20020	Area Office Boise / Director's
Authorized Contact: Dan Johaneck (208)707-7867 112 N. Plymouth, New Plymouth ID, Tyler Hartung (208) 412-5475	Inspection Date 9/29/2022 2:30 PM
County Payette	Report Date 10/4/2022
<b>Inspector's Signature:</b> /signed/ James Thum	<b>Inspection Summary:</b>
<b>Date of Signature:</b> 10/17/2022	<input type="checkbox"/> Operation appeared to be in compliance at the time of the inspection. <input checked="" type="checkbox"/> Issues of concern identified at the time of the inspection.
<b>Location Description:</b> 1.09 miles SSE from Little Willow Gathering Facility, 4649 Little Willow Road. Google Maps location Latitude 44.034893, Longitude -116.800803. Mike Shafer, LW contact through T. Hartung. Well currently S/I  Weather: Sunny to PC, 71° F no wind

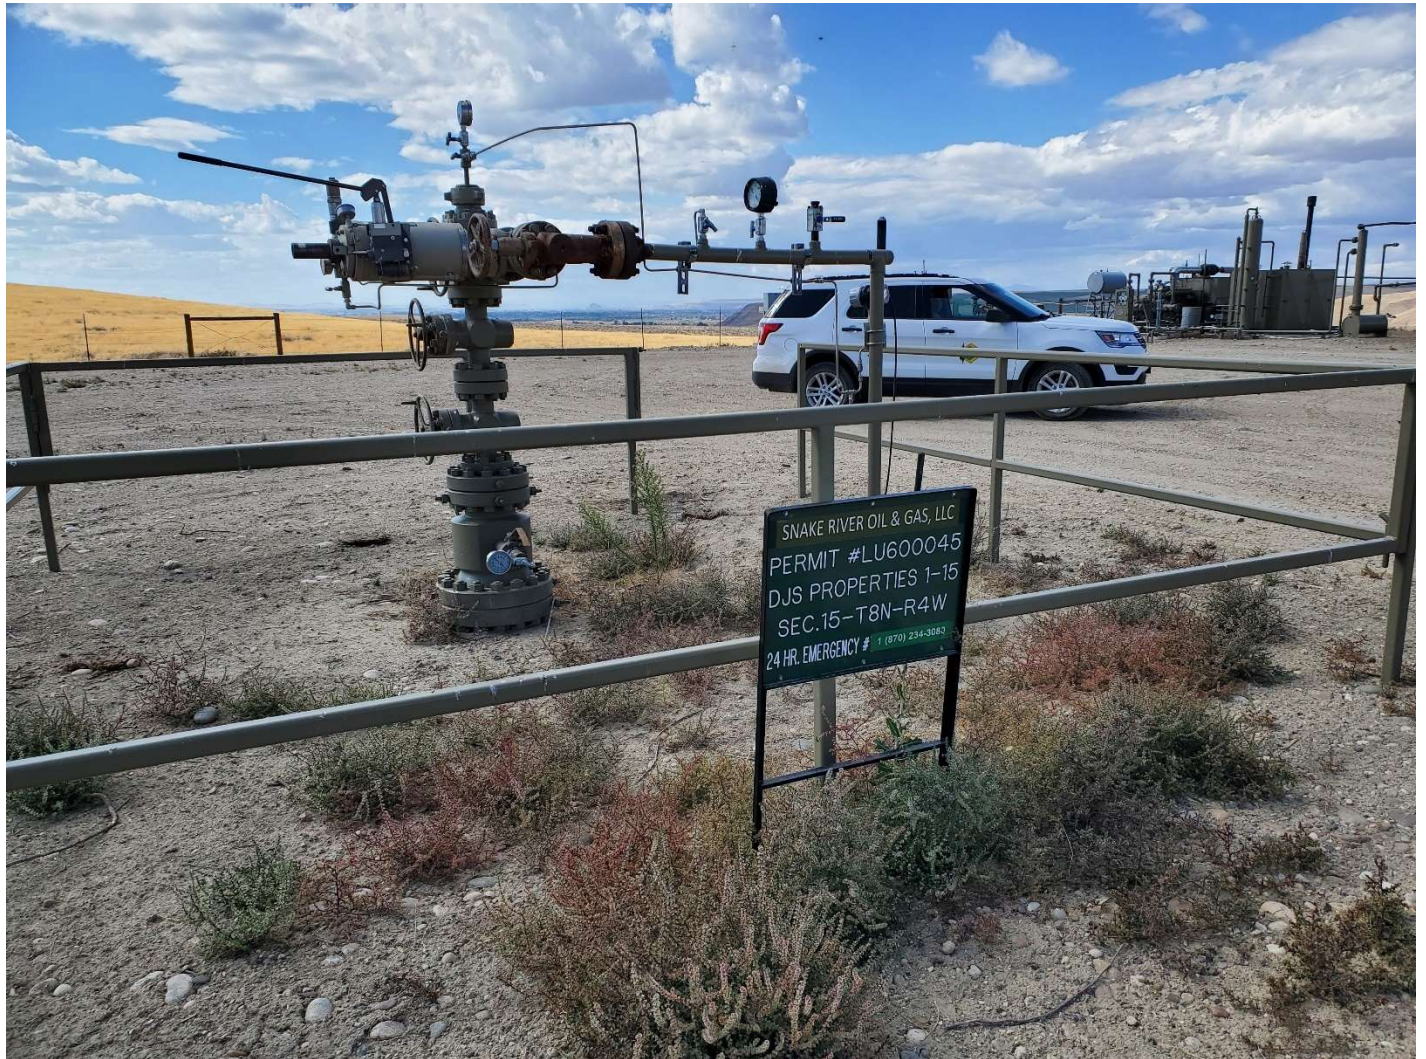
Well head with inner steel fence, view WNW with separator installation in background right. Note weed growth.

In general the pad needs basic maintenance and weed remediation.

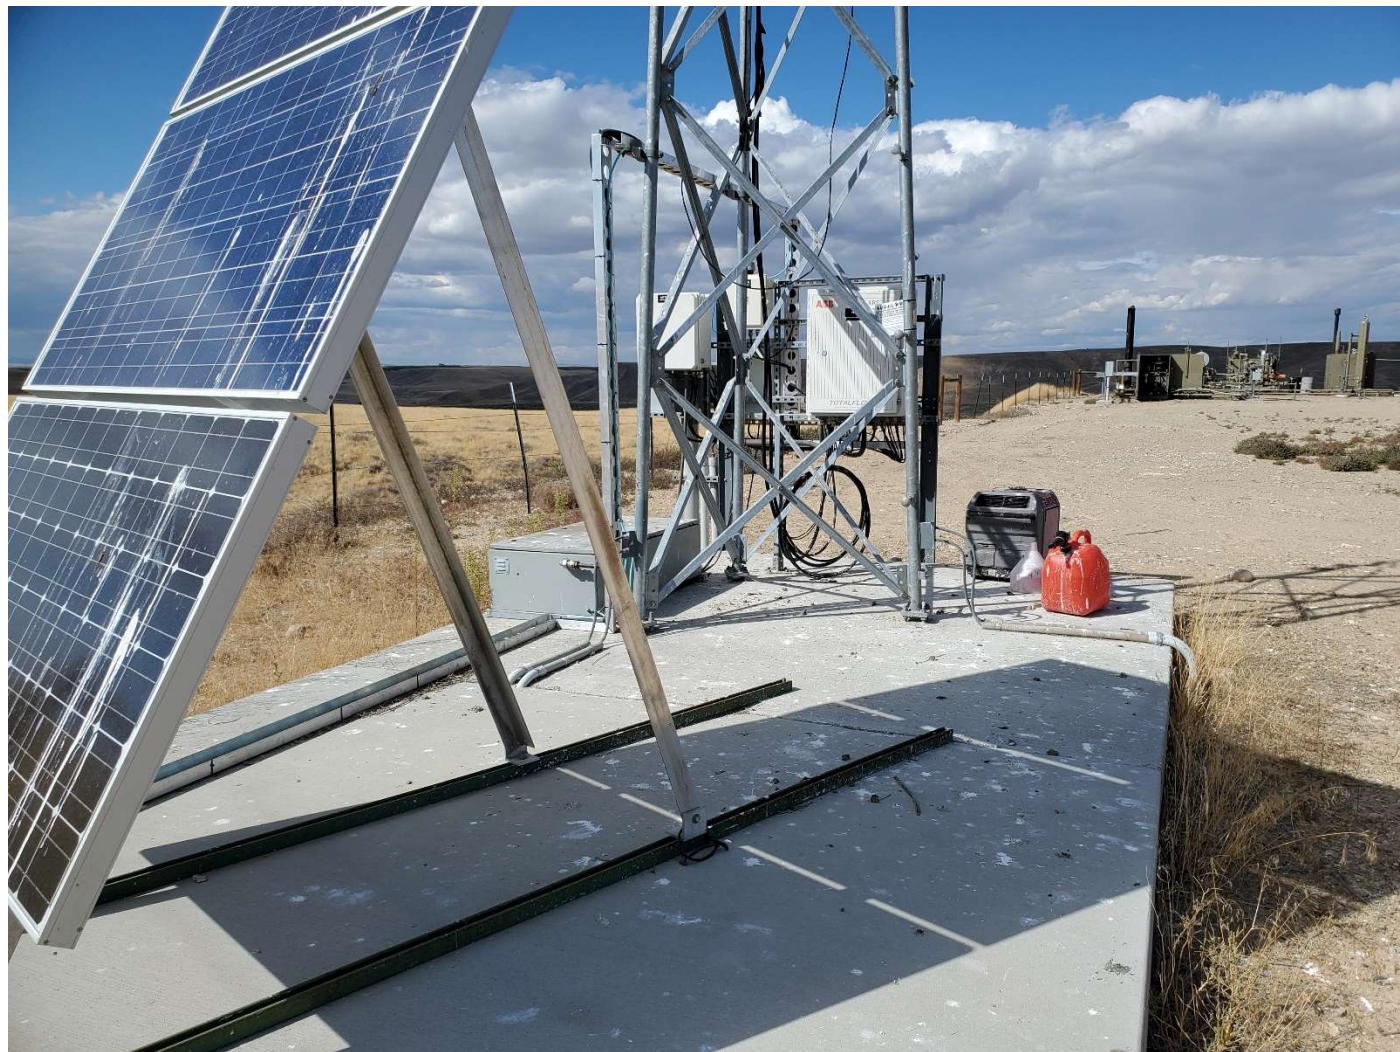
Pad for communications tower, south corner of well pad, view NW. Separator Unit in background right. Generator and gas can sitting on tower pad.

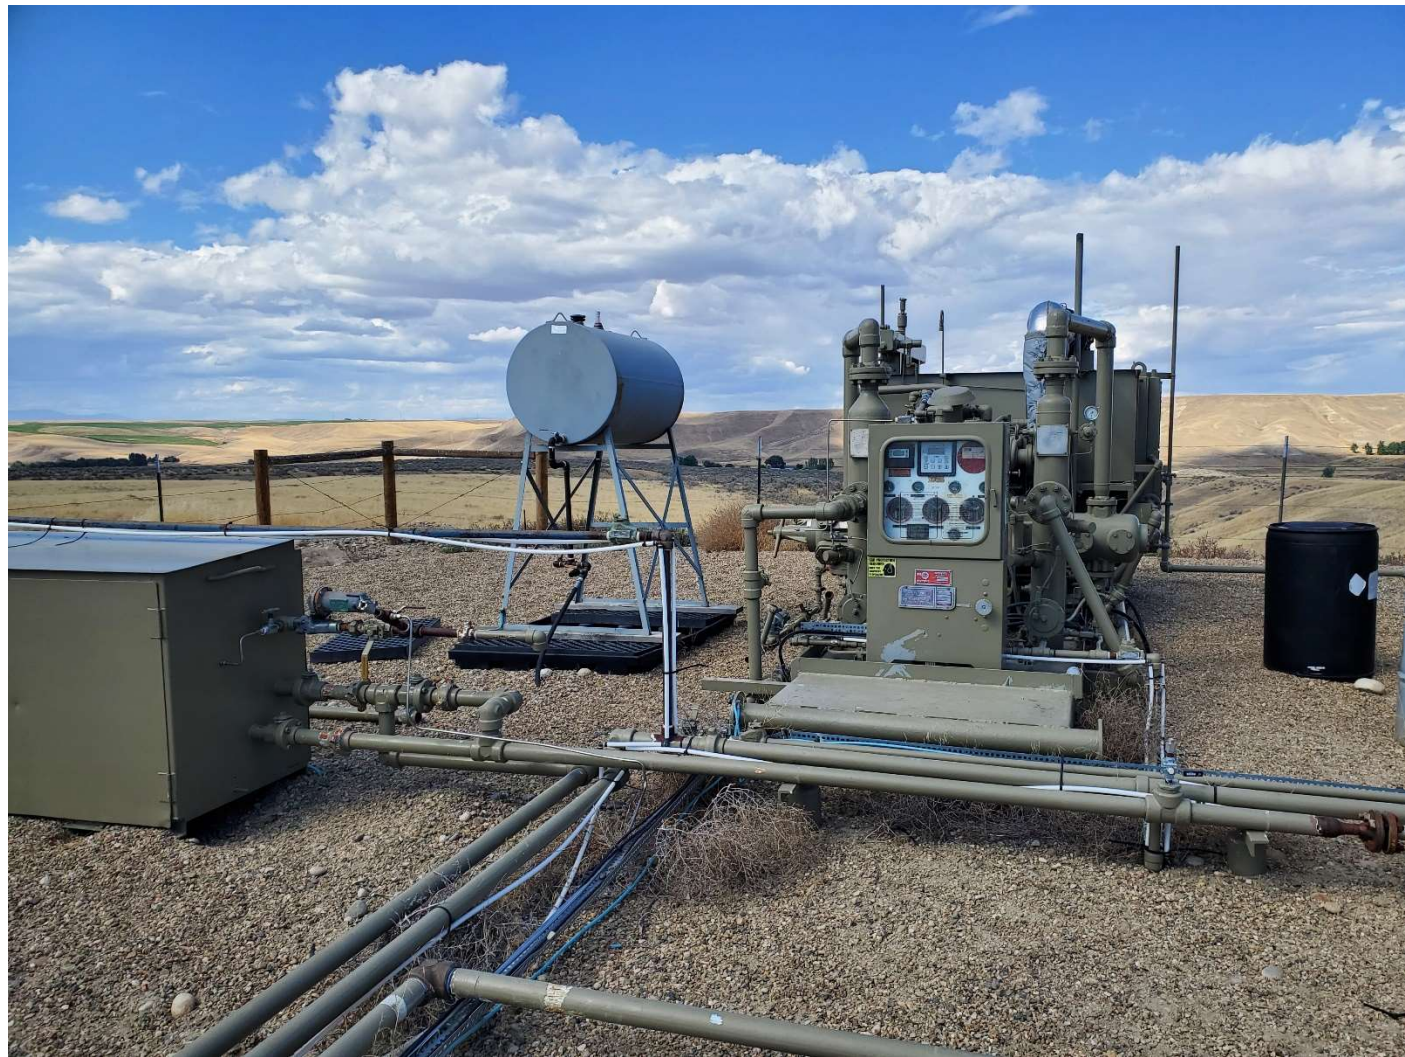
Separator unit in west corner of well pad, view west.

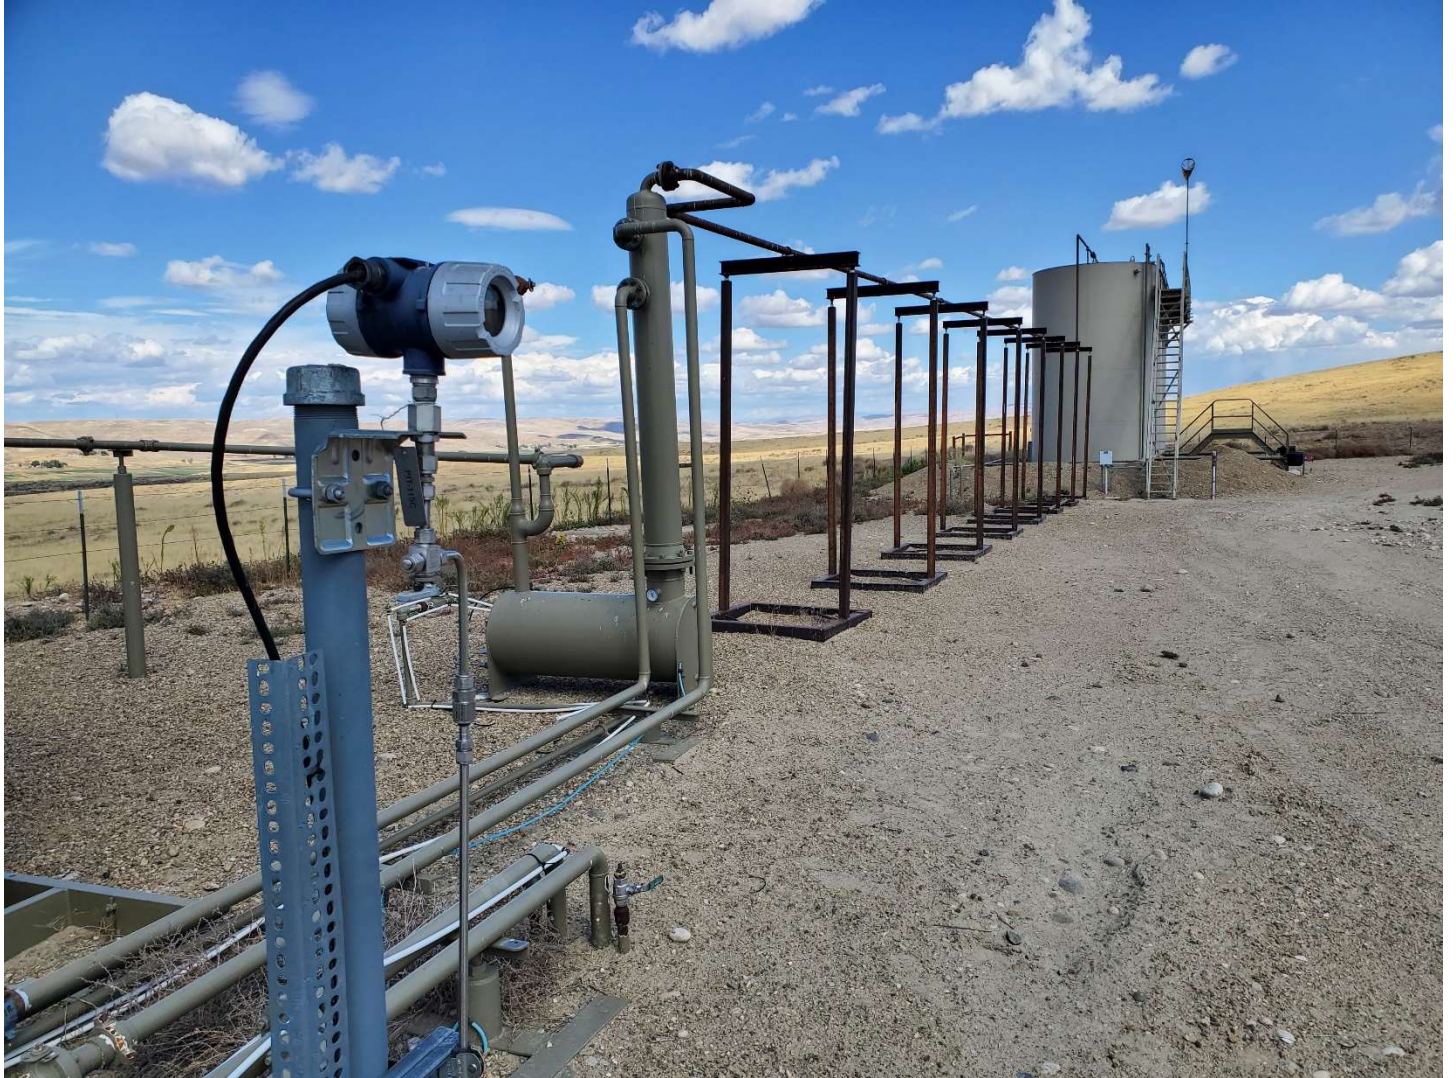
Northwest perimeter of well pad, produced water tank batter in background, view NE. Note weed encroachment along fence and tank battery dike perimeters.

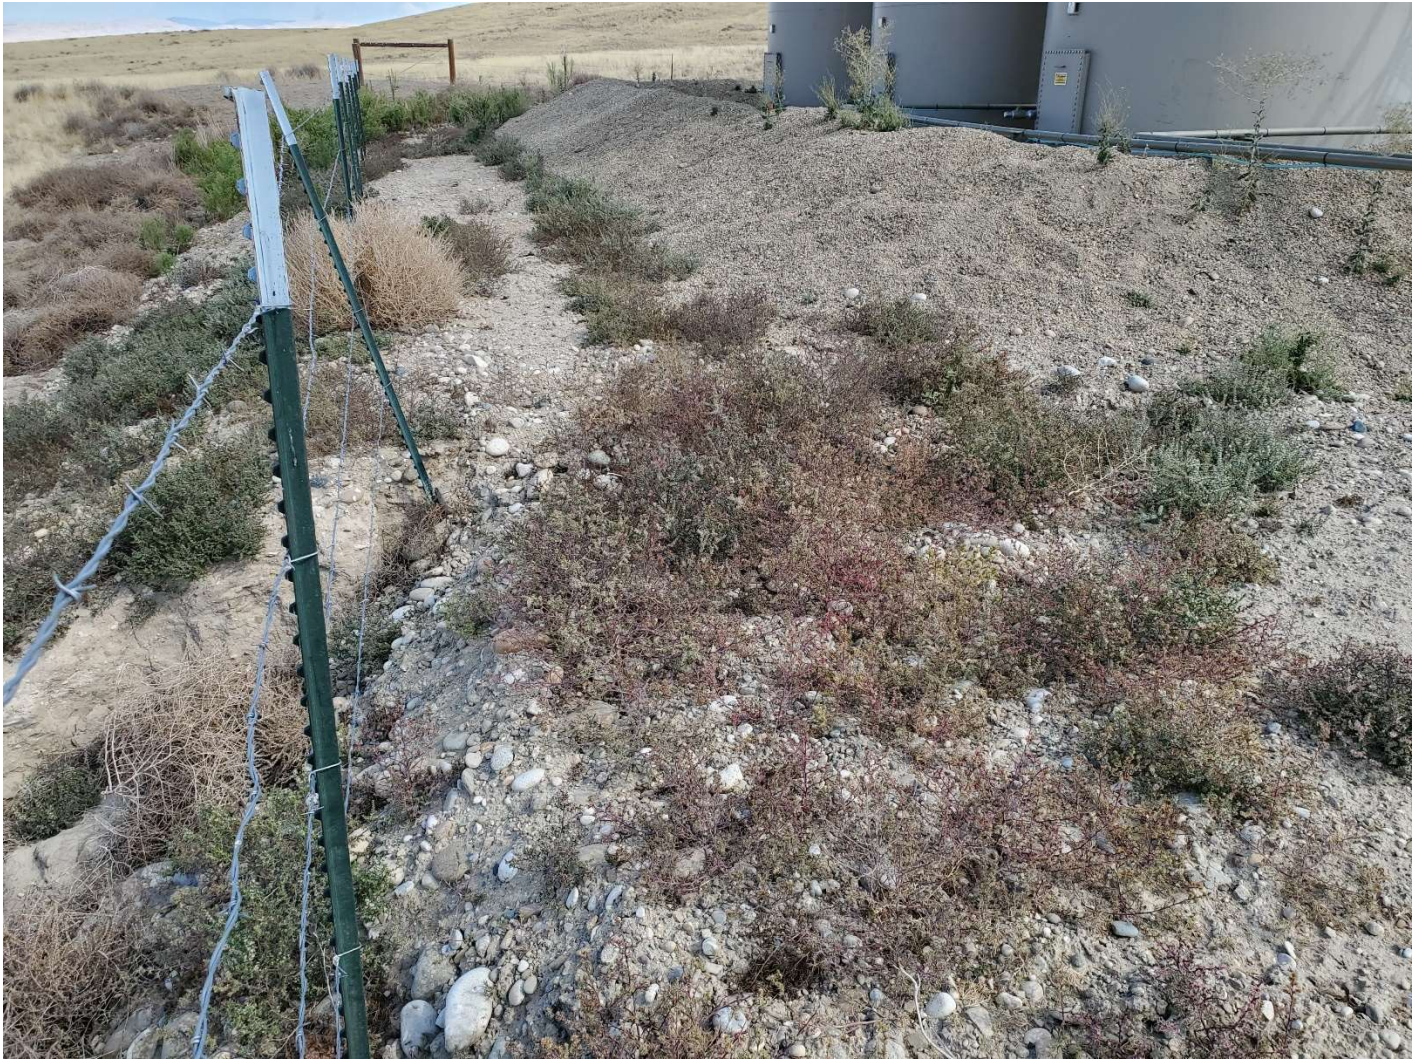
Gate was open with clear signs of livestock having been present on the well pad, on and within the tank dike. Pad contained 5-10% vegetation cover in the area of the well head and tank dike, especially on the NNW side of the pad.

NW pad perimeter in area of 2022 erosion repair, view NE. Note weed encroachment on and around tank dike, livestock disturbance over dike berm.

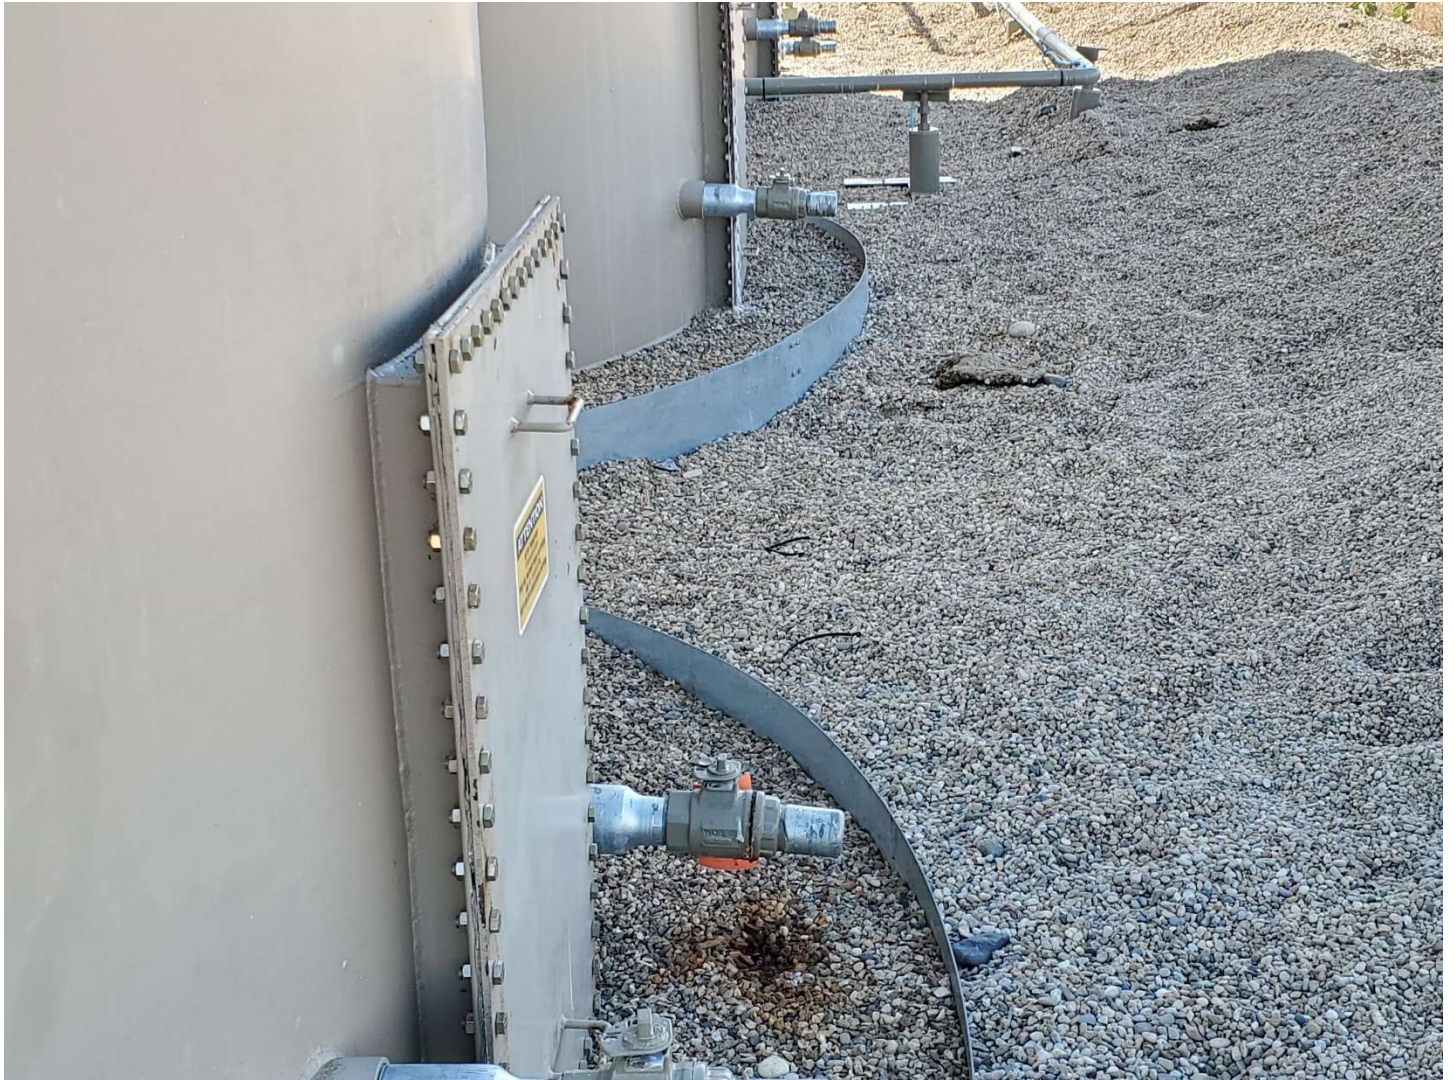
Several leak tags dated 9/22/2022 were posted on the middle and northern produced water tanks at both the top and base of the tanks.

NW perimeter of tank dike, view SW. Note evidence of livestock disturbance on and within tank dike. Orange leak detection hangtag in lower center at base of northern-most produced water tank.

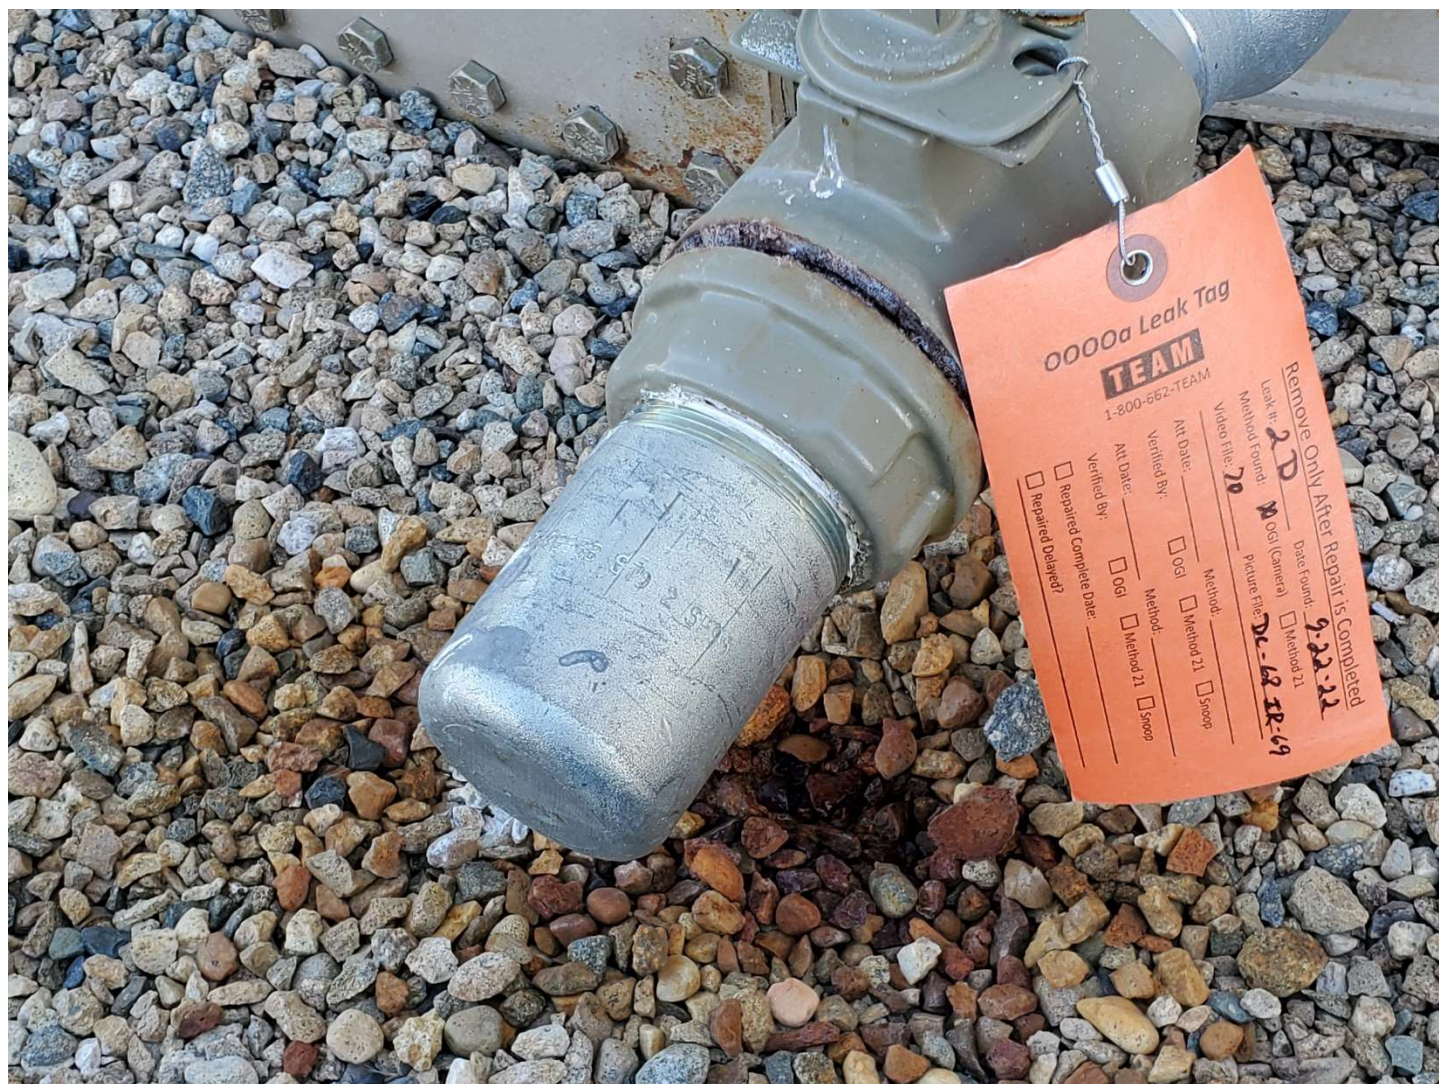
Close-up of leak, hangtag and gravel stain on northern-most produced water tank.

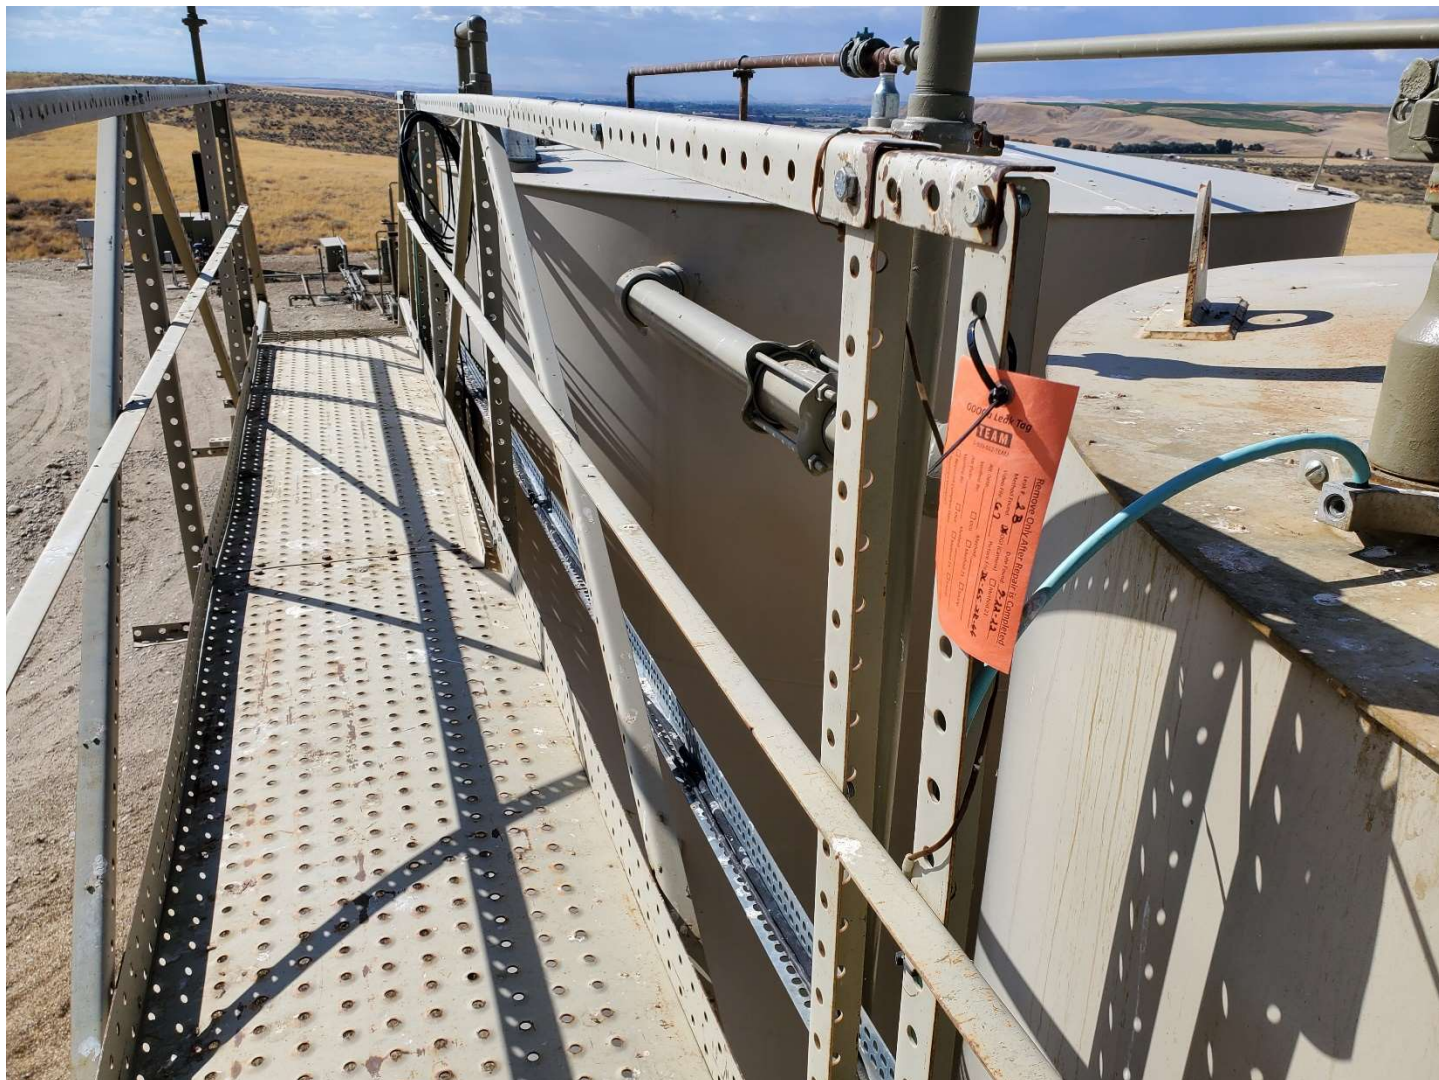
View SW of tank battery from the top, leak detection hang tag for middle produced water tank.

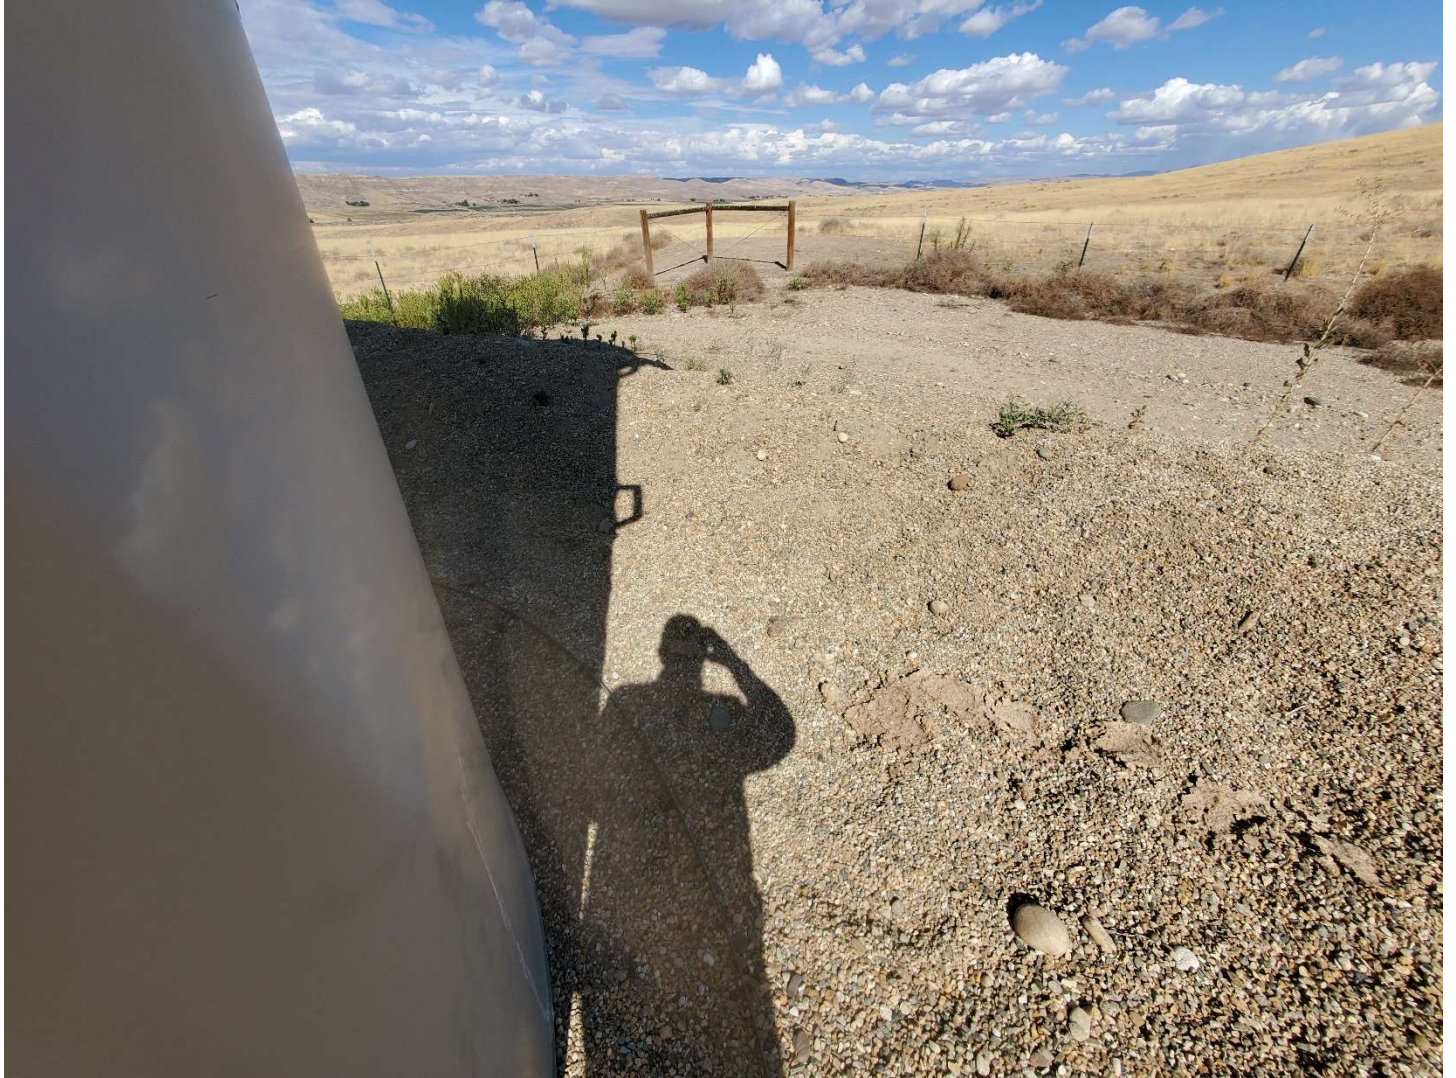
NW corner of containment dike, view N. Note livestock disturbance on and within tank dike.

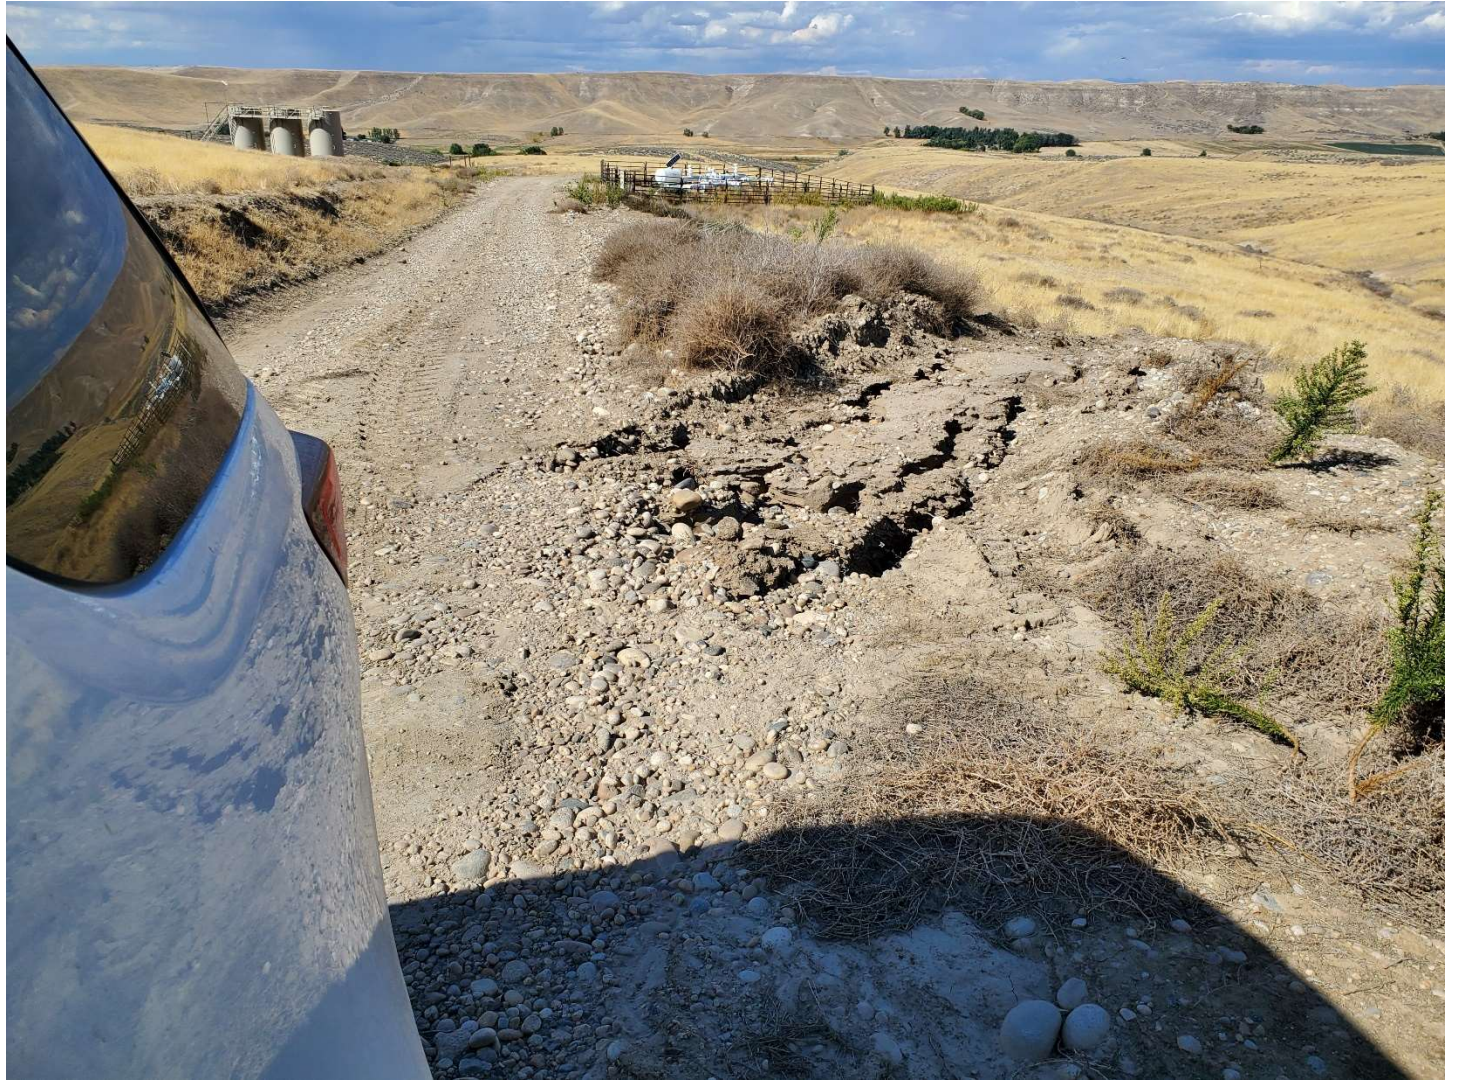
The SE access road just south of the gathering line riser shows signs of extensive erosion to the NE into the gully north of the well pad. This area requires immediate grading and possible gravel along the NE side to prevent the access road from washing out completely.

Well pad access road, view NW. Produced water tank battery visible on left, Little Willow to Highway 30 pipeline riser in center rear. Large area of erosion not present during May 2022 inspection.
