## **Post Drilling/Annual Well SiteInspection Form**

Section 1: General Information				
Operation Data	Inspection Data			
Operator Name	Inspector Name			
Snake River Oil + Gas, LLC	James Thum			
Well Name	Area Office			
ML Investments #2-10, USWN 11-075-20022 Authorized Contact: Dan Johanek (208)707-7867	Boise / Director's			
112 N. Plymouth, New Plymouth ID; Tyler Hartung (208)	Inspection Date 9/29/2022 1:45 PM			
412-5475	<i>JEJI2022</i> 1.43 1 WI			
County	Report Date			
Payette	10/4/2022			
Inspector's Signature:/signed/ James Thum	Inspection Summary:			
	Operation appeared to be in compliance at the time of the inspection.			
	Issues of concern identified at the time of	of the		
Date of Signature: 10/4/2022	inspection.			
<b>Location Description:</b> 1800 feet ESE from Little Willow Gathering Facility, 4649 Little Willow Road. Google Maps location Latitude 44.049326, Longitude -116.796756. Mike Shafer – Little Willow staff, contact thru Tyler.				
Weather: Sunny / hazy smoke, 70 degrees F. Slight variable wind

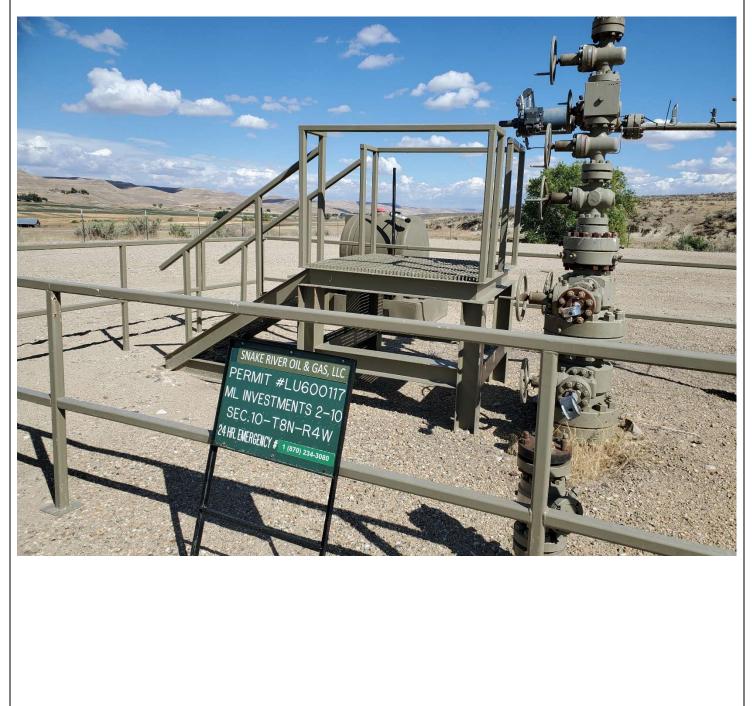
Well head and steel fence, view north-northeast.

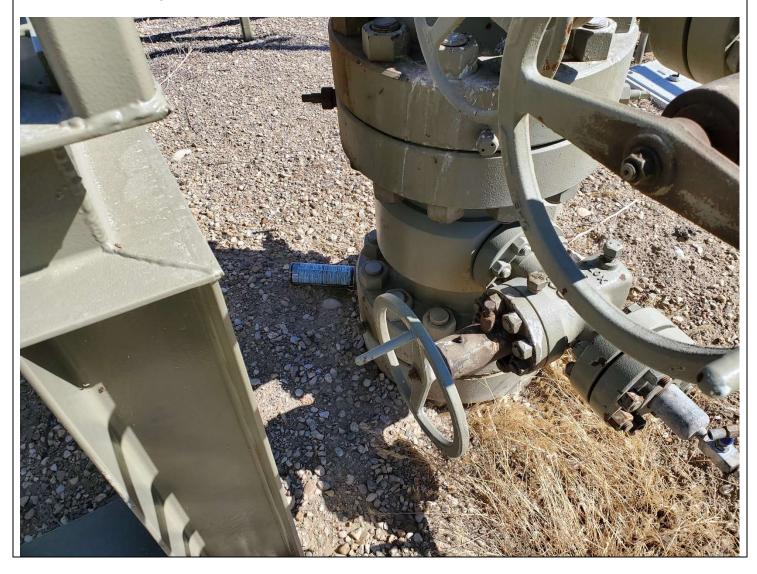
E. Do drain lines	have a valve installed, closed and capped off if not in use?	Yes No		
Section 10: Inspection C	omments			
Comments and Issues of	Concern:			
Two entrance gates- SE gate not signed, closed; SW gate open, signed to the west. Fence keeps animals and livestock out of well area only when gate is closed.				
Cellar is gravel-filled, no v	vegetation on pad and well site is clean.			
Scavenger unit does not appear functional. Gauges not working, opaque tank so fill level uncertain. MSDS paper wet / rotted and needs replaced.				
Surface casing: 540 psi (a Production casing: 180 ps Tubing string: 526.2 psi (a	si (analog gauge)			
Pressure noted on all three	e casing strings – check for verification; possible MIT needed.			
9 photos from inspection i	n files.

Base of well head with gravel filled cellar.
