Post Drilling/Annual Well Site Inspection Form

Section 1: General Information	
Operation Data	Inspection Data
Operator Name Snake River Oil + Gas, LLC	Inspector Name James Thum
Well Name DJS Properties #2-14, USWN 11-075-20023	Area Office Boise / Director's
Authorized Contact: Dan Johaneck (208)707-7867 112 N. Plymouth, New Plymouth ID; Tyler Hartung (208) 412-5475	Inspection Date 9/29/2022 12:30 PM
County Payette	Report Date 10/3/2022
Inspector's Signature: /signed/ James Thum	Inspection Summary:
Date of Signature: 10/3/2022	<input type="checkbox"/> Operation appeared to be in compliance at the time of the inspection. <input checked="" type="checkbox"/> Issues of concern identified at the time of the inspection.
Location Description: 1.29 miles SE from Little Willow Gathering Facility, 4649 Little Willow Road. Google Maps location Latitude 44.038699, Longitude -116.783345. Well S/I, never produced. CII well application to EPA Region 10. LW contact- Mike Shafer through Tyler. Weather: Sunny, slight haze/smoke, 70 degrees F, no wind

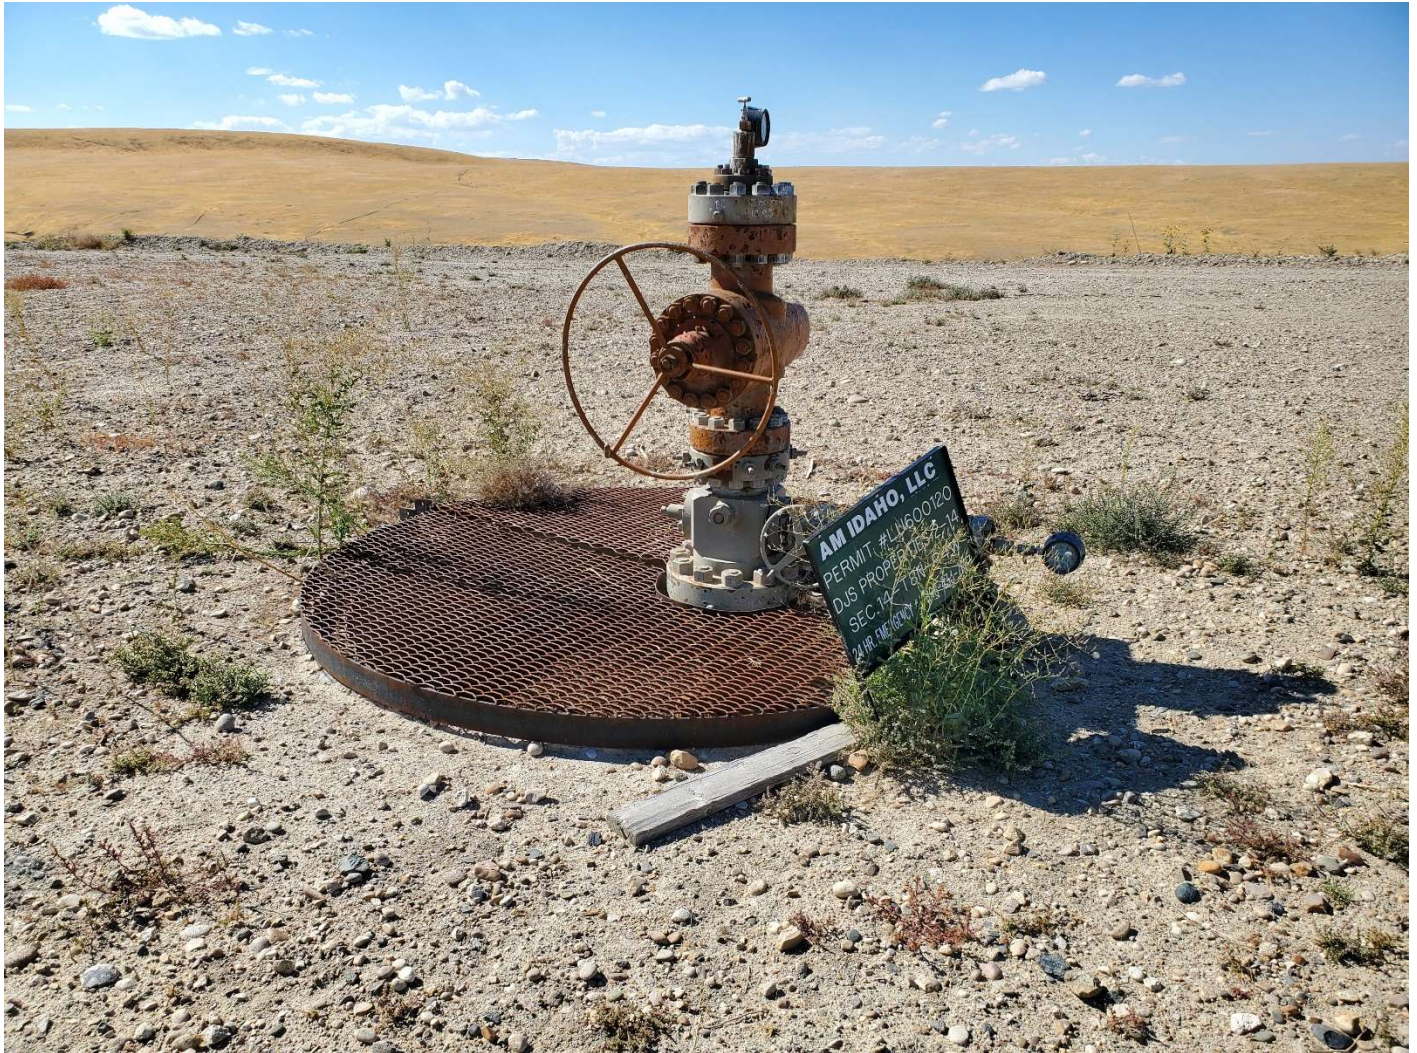
Signs are out of date with name of former operator, wrong emergency contact number.

Well head and cellar, well sign. Minor vegetation and debris around cellar. Production casing, surface casing pressure gauges installed and readable. View is to the south.

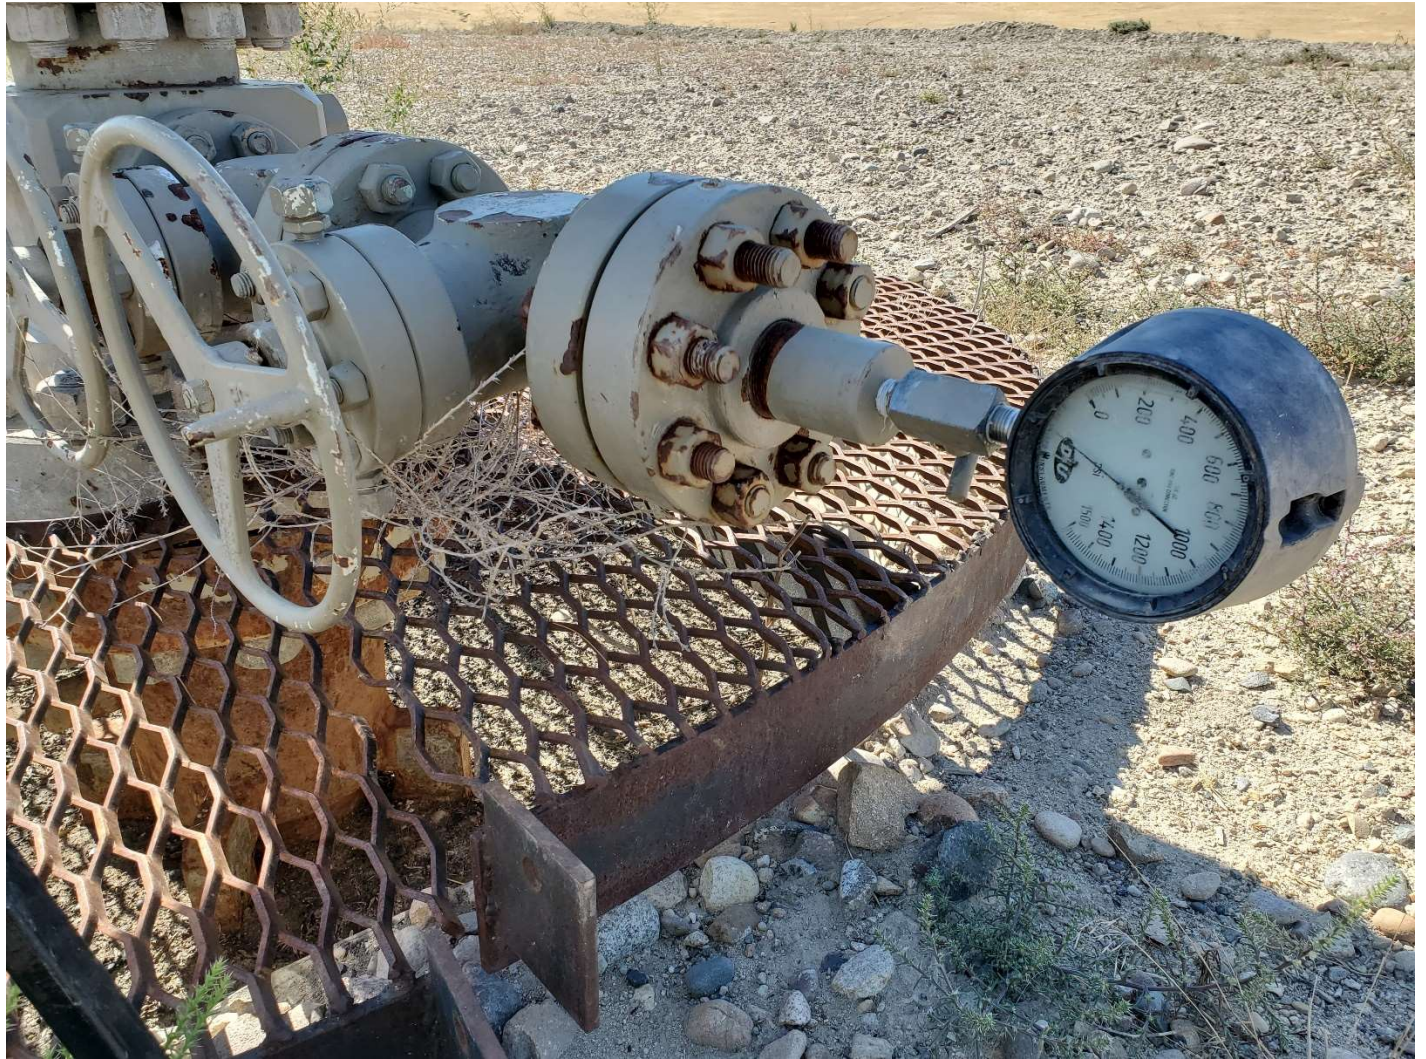
Surface casing: 0 psi (analog)

Production (long string) casing: 0 psi (analog)

Detail of well head, surface casing gauge and cellar (no water nor debris present).

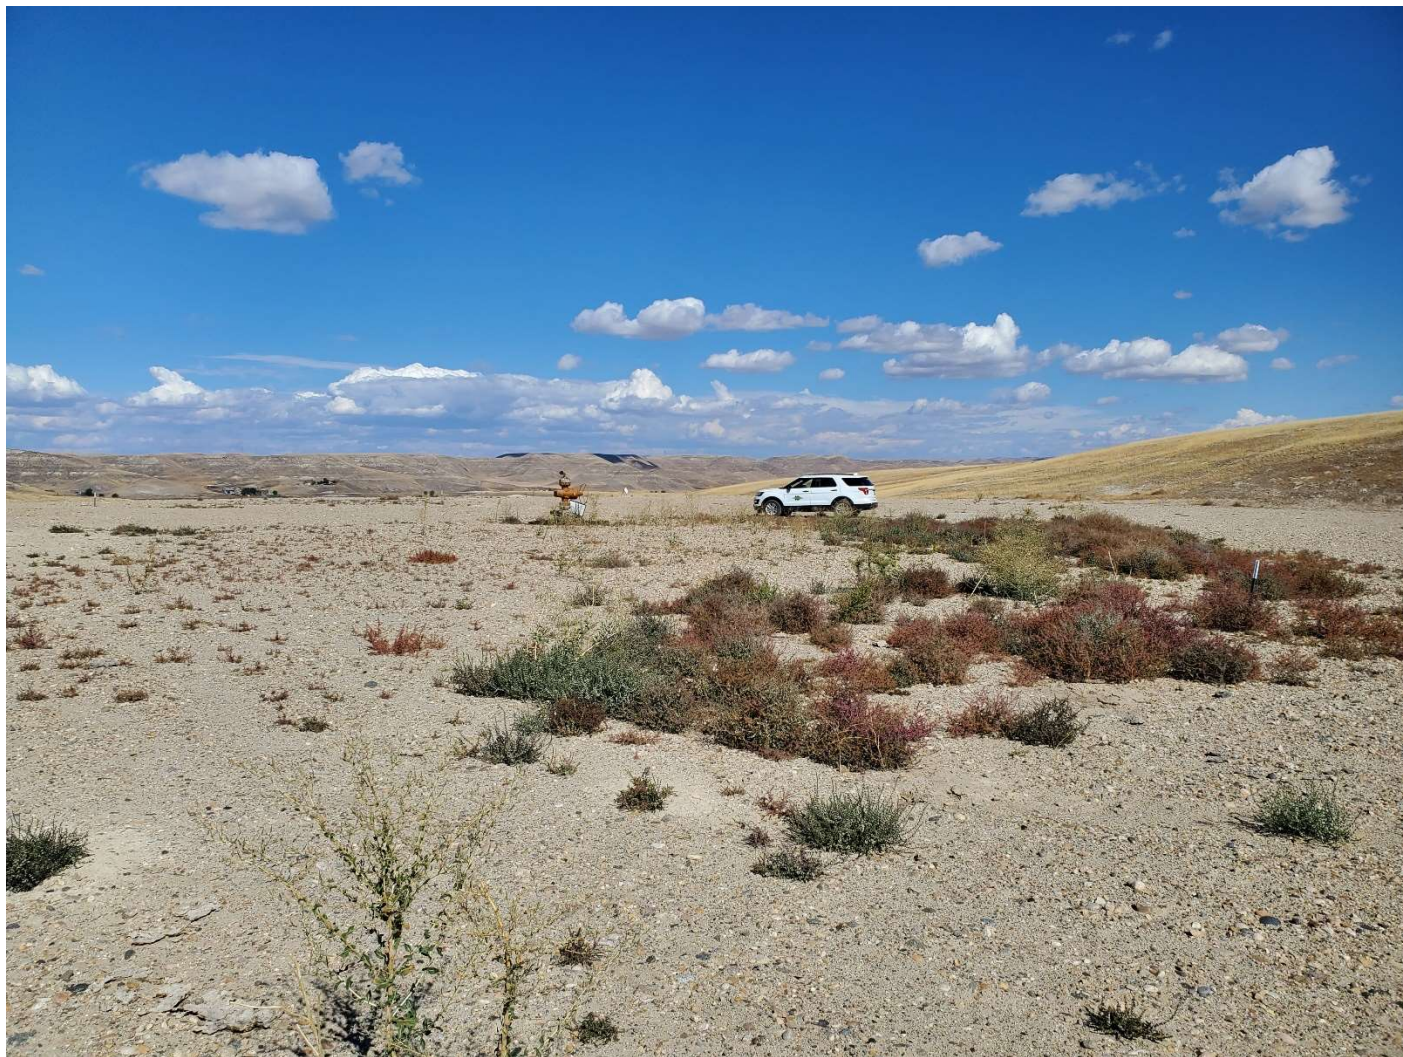
As with other pads, weed abatement needed although it does not appear as severe (estimate 5-8% covered, mainly near the well head.

Well head and area of weed encroachment, looking north to pad entrance, Little Willow Creek.

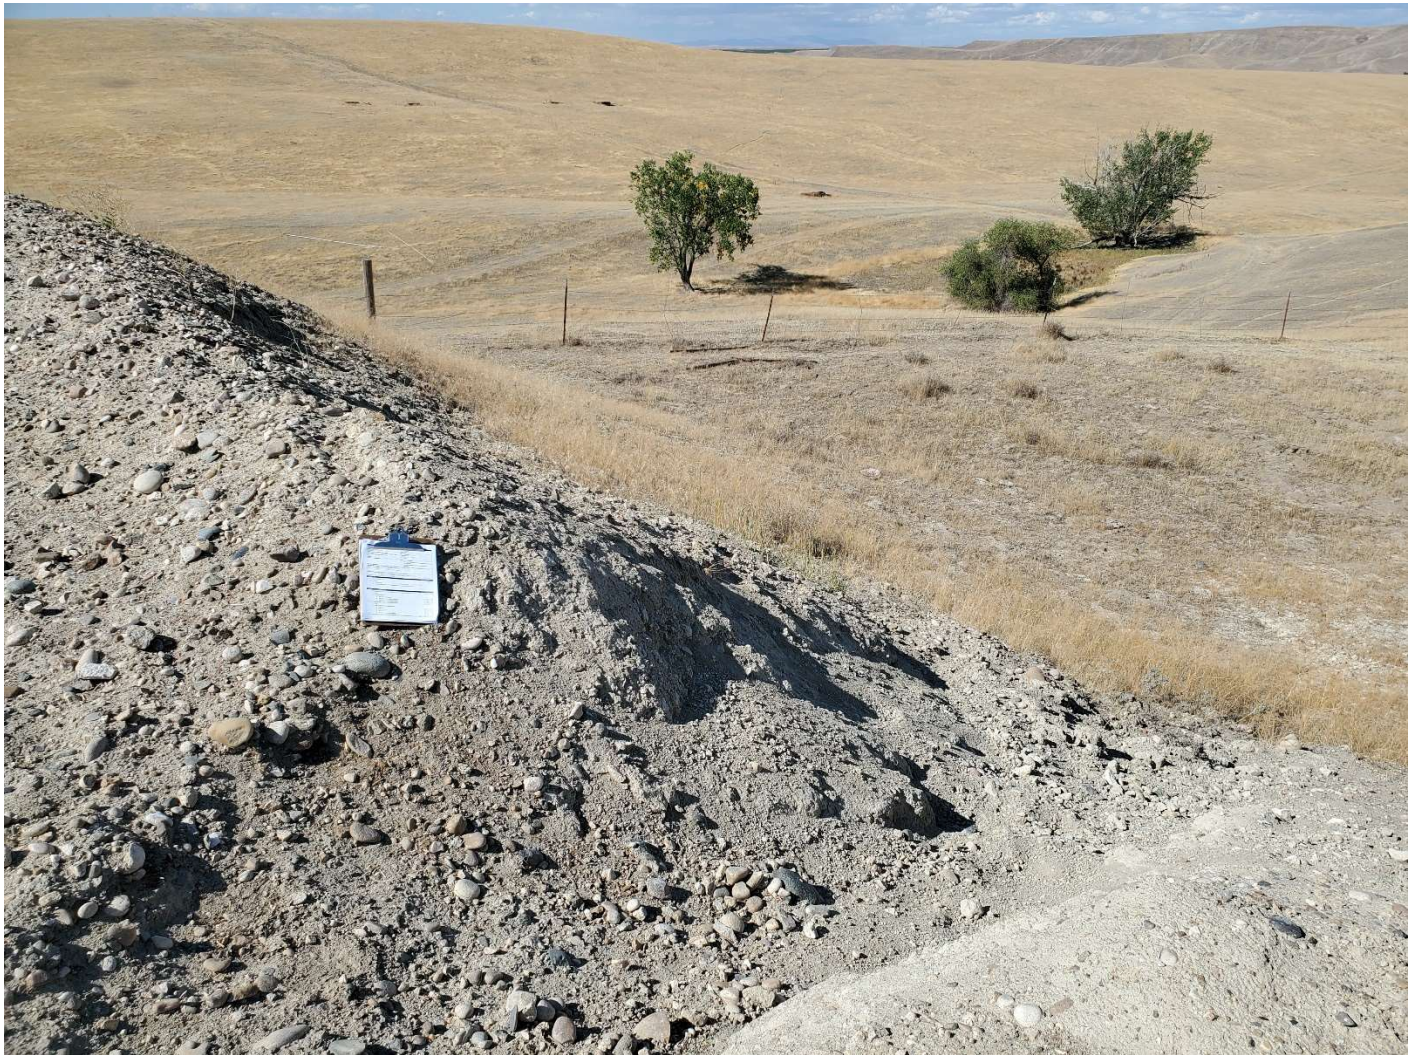
Fencing only on SW, SE perimeters of pad but are not specifically installed for the pad. There is an erosional gully cut into the northwest side of the fill portion of the well pad. This is a long-term issue but has not appeared to have increased in size.

Area of erosional gully on northwest perimeter of well pad, looking due south. Gully is a long-term issue and does not appear to have expanded appreciably.
