Post Drilling/Annual Well Site Inspection Form

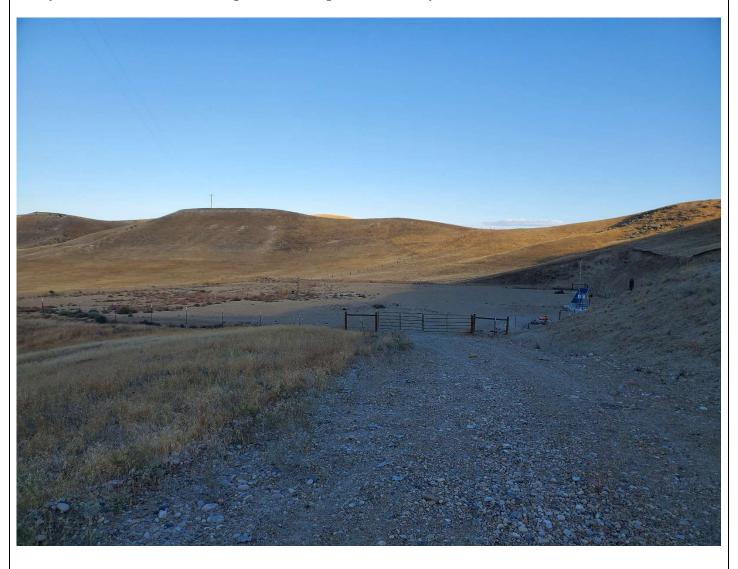
Well pad from lease entrance, looking NW. Note vegetation in vicinity of well head.
