Post Drilling/Annual Well Site Inspection Form

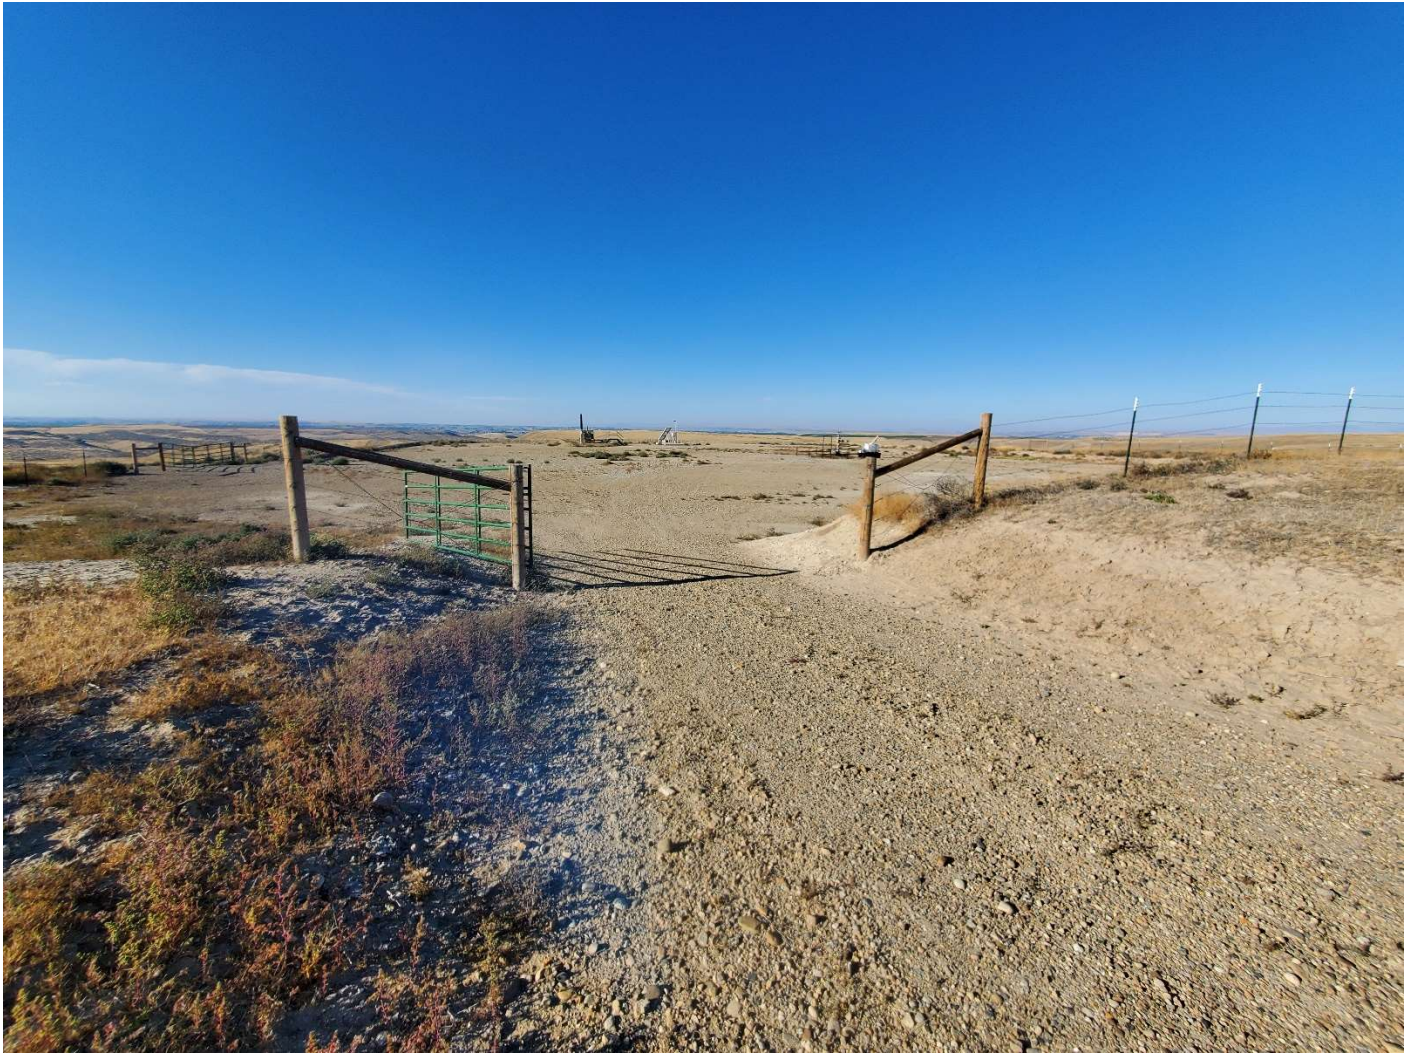
Comments and Issues of Concern: Two gates to access pad, north gate open on arrival. Lease sign located inside east gate. Well pad and separator dike show signs of livestock activity. Gates and fencing are functional but leaving the gate open has allowed livestock access to well pad.

North entrance gate, looking south at well pad. Gate was open on arrival.

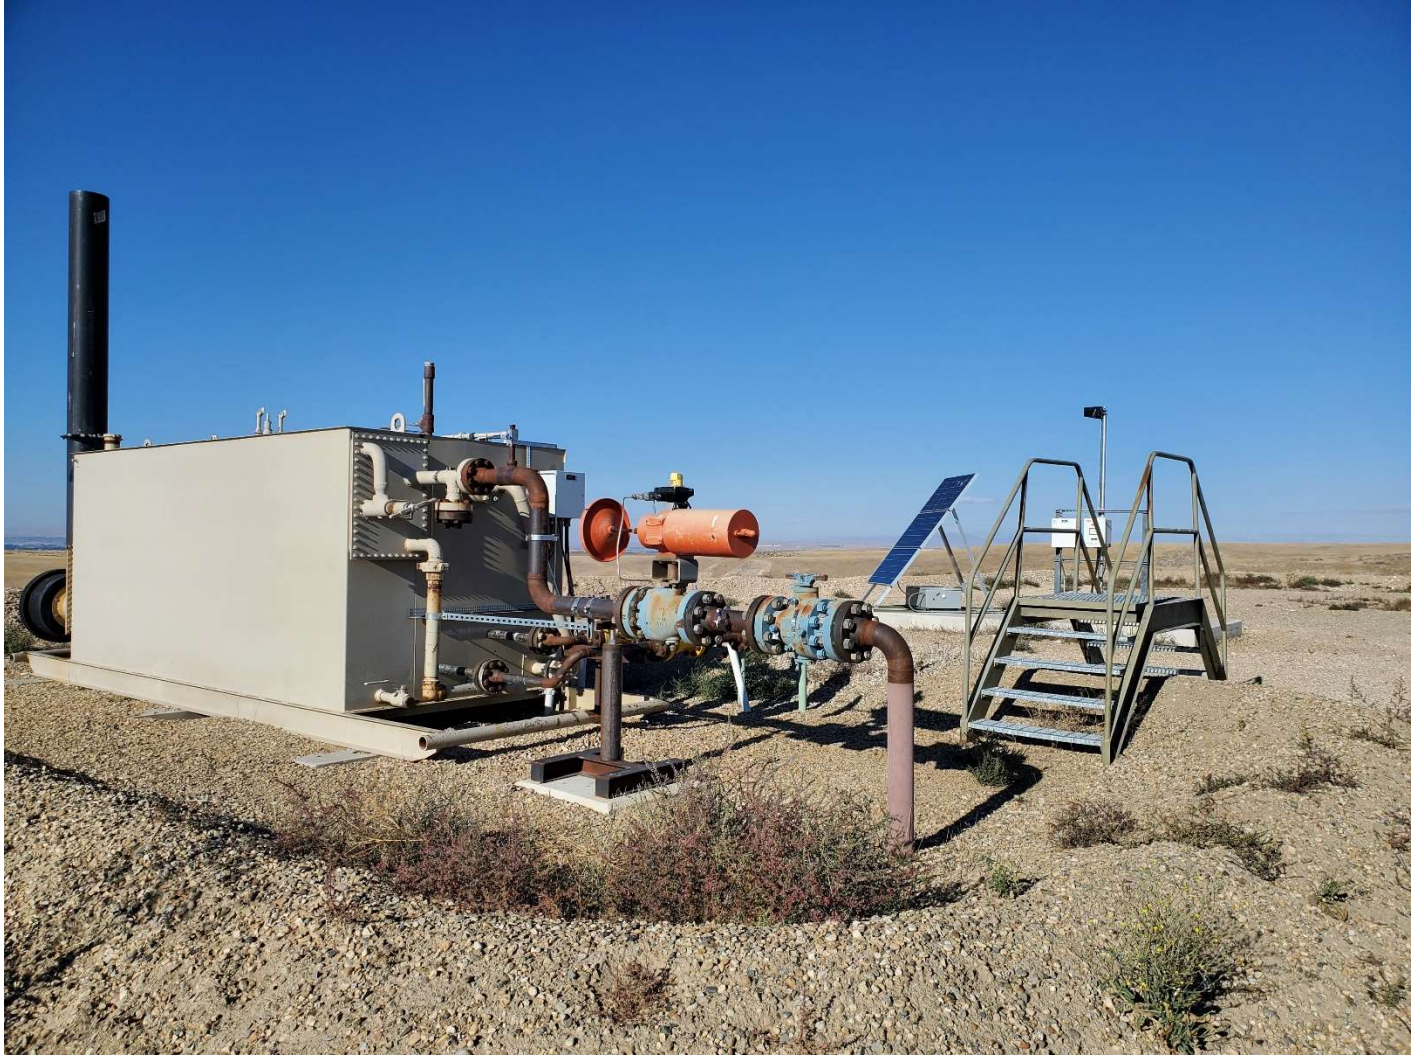
Separator unit and containment dike showing vegetation, missing spark arrestor. SCADA remote system in background.

Weed abatement needed; much more encroachment since 2021 inspection (>10% coverage) most notably near wellhead, separator unit, west side of pad.

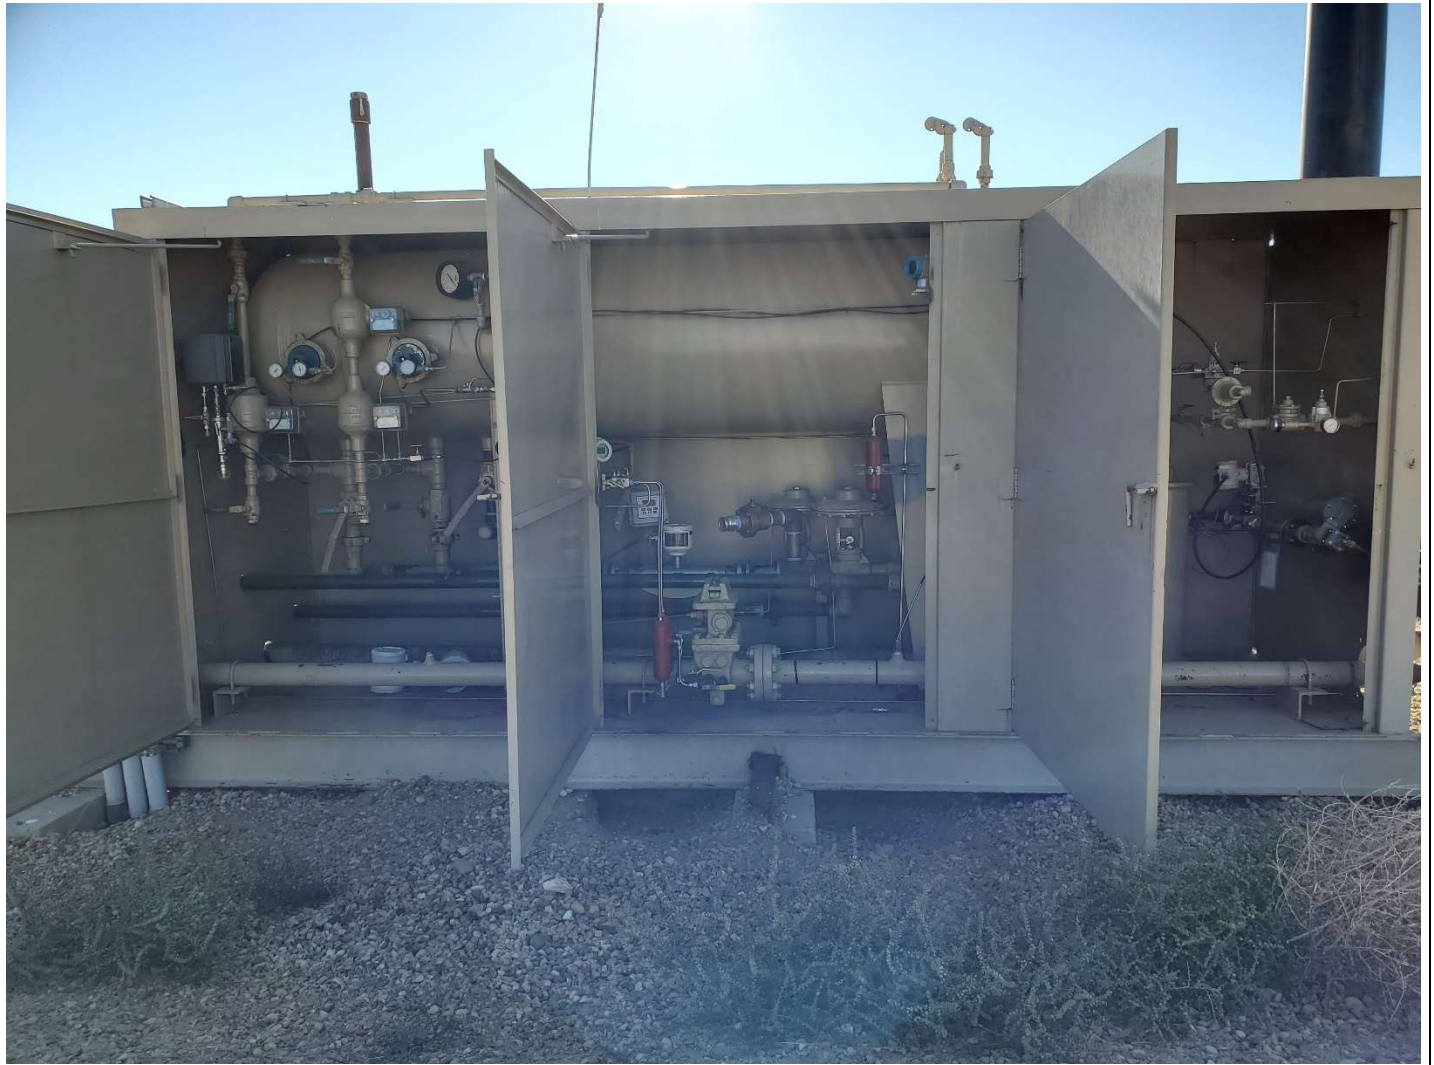
Interior of separator unit. Note weed encroachment in foreground.

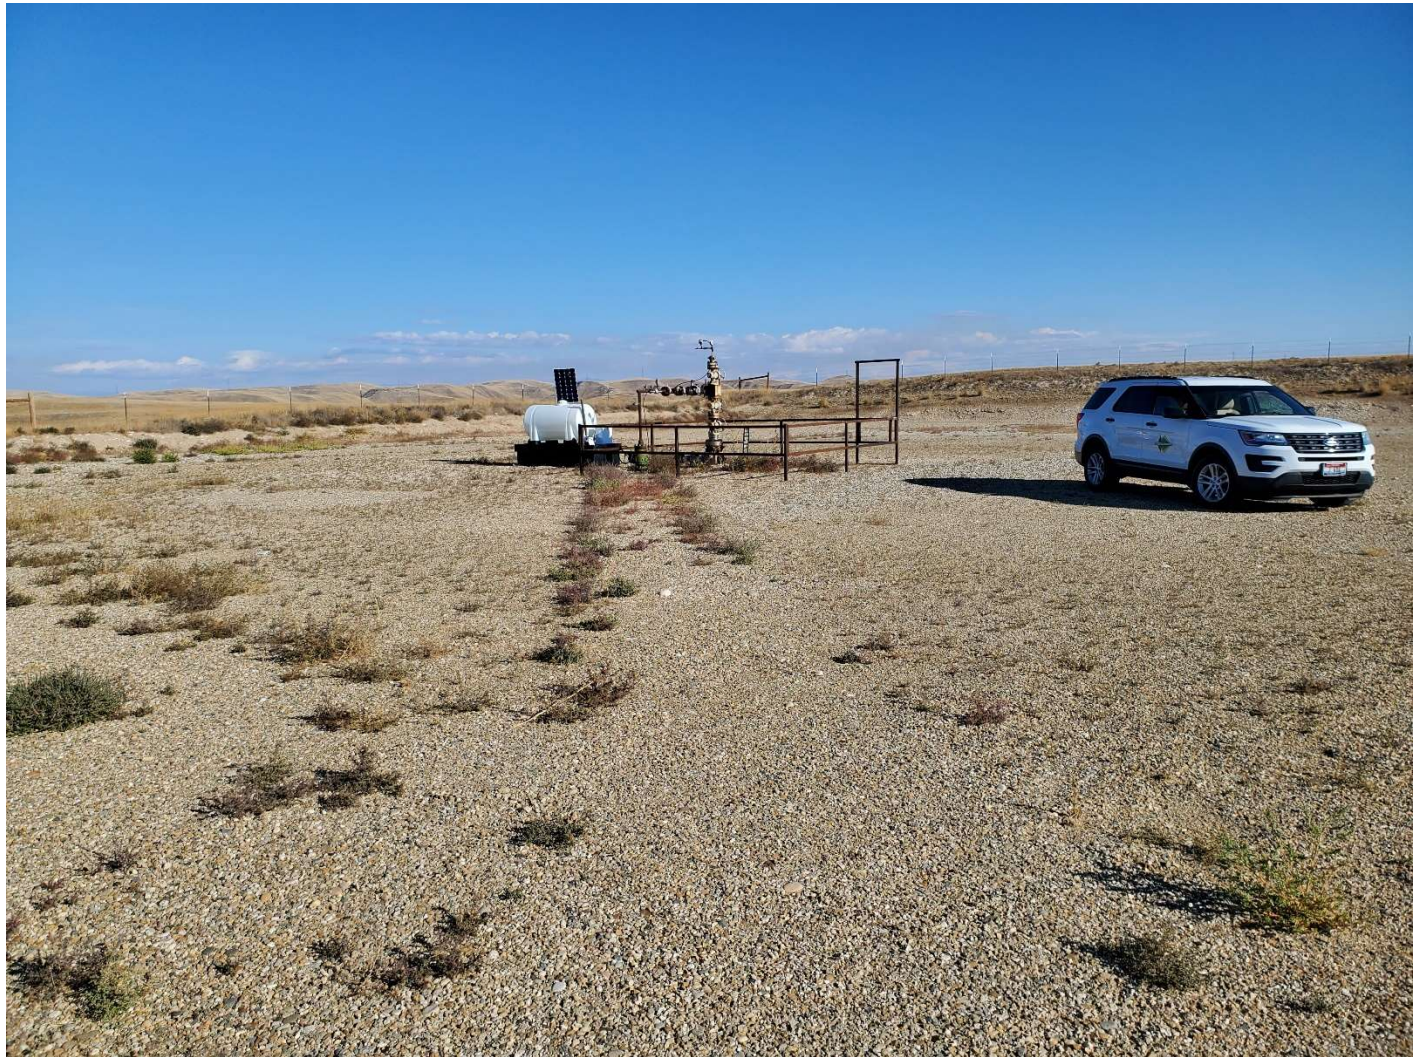
Well head and scavenger unit, looking north showing vegetation encroachment on well pad
