Post Drilling/Annual Well Site Inspection Form

Section 1: General Information	
Operation Data	Inspection Data
Operator Name Snake River Oil + Gas, LLC	Inspector Name James Thum
Well Name Kauffman #1-9, USWN 11-075-20027	Area Office Boise / Director's
Authorized Contact: Dan Johaneck (208)707-7867 112 N. Plymouth, New Plymouth ID; Tyler Hartung (208) 412-5475	Inspection Date 9/29/2022 11:15 AM
County Payette	Report Date 10/3/2022
Inspector's Signature: /signed/ James Thum	Inspection Summary: <input type="checkbox"/> Operation appeared to be in compliance at the time of the inspection. <input checked="" type="checkbox"/> Issues of concern identified at the time of the inspection.
Date of Signature: 10/3/2022	
Location Description: 3726 feet WNW from Little Willow Gathering Facility, 4649 Little Willow Road. Google Maps location Latitude 44.053214, Longitude -116.817247. Additional contact at Little Willow- Mike Shafer. Well S/I, UT completion plugged / inactive

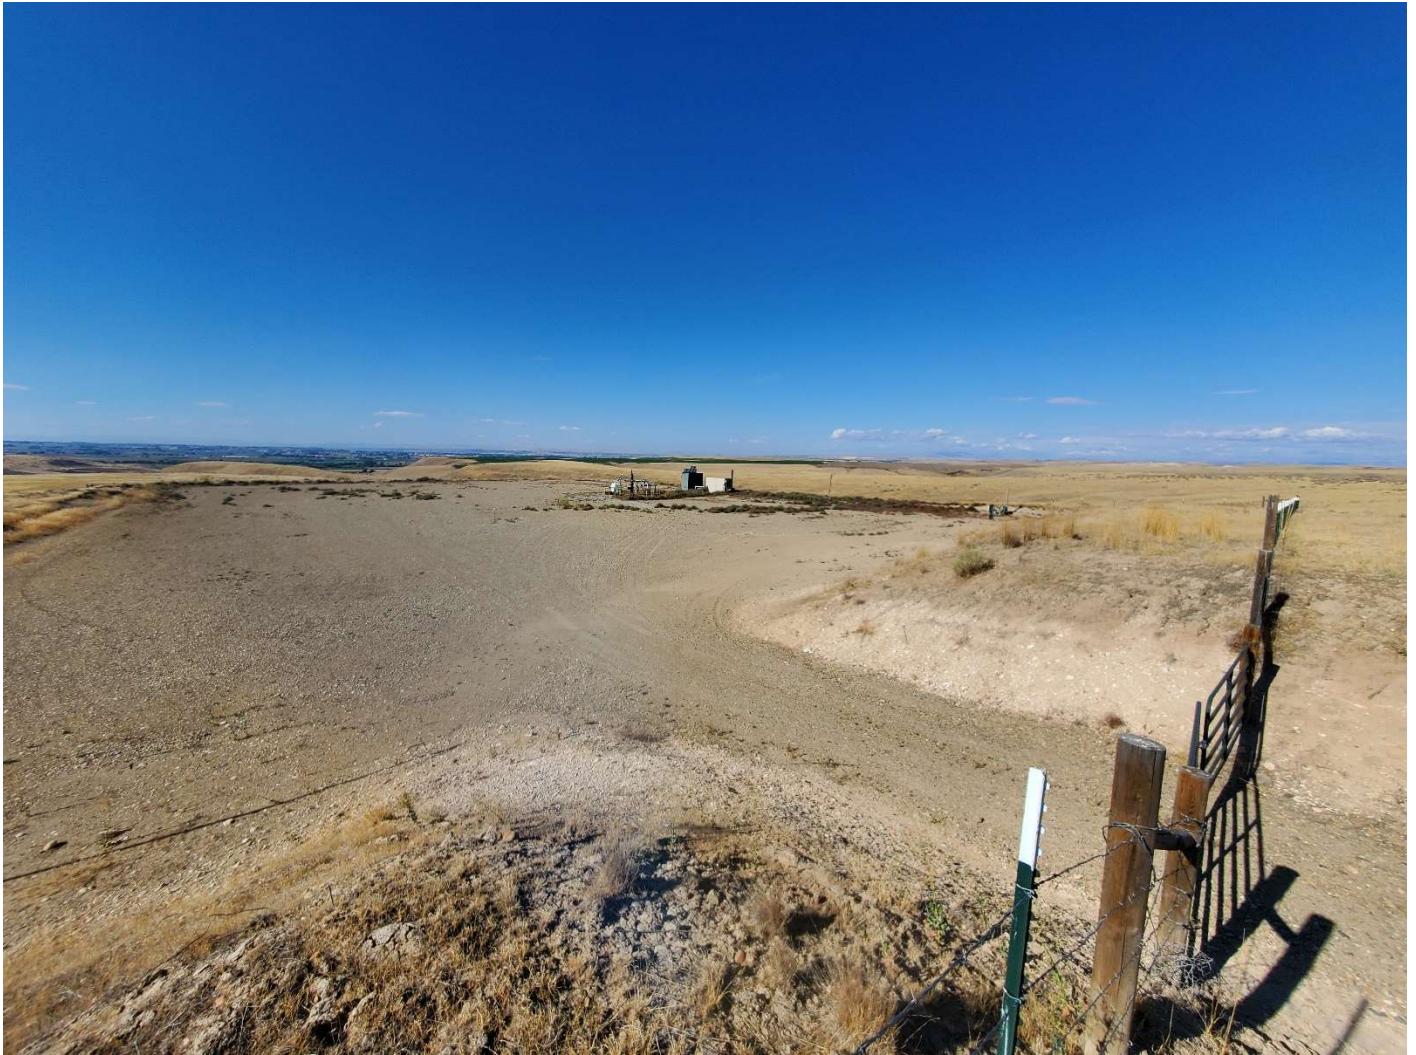
Overview of well pad looking southwest from east side of entrance gate.

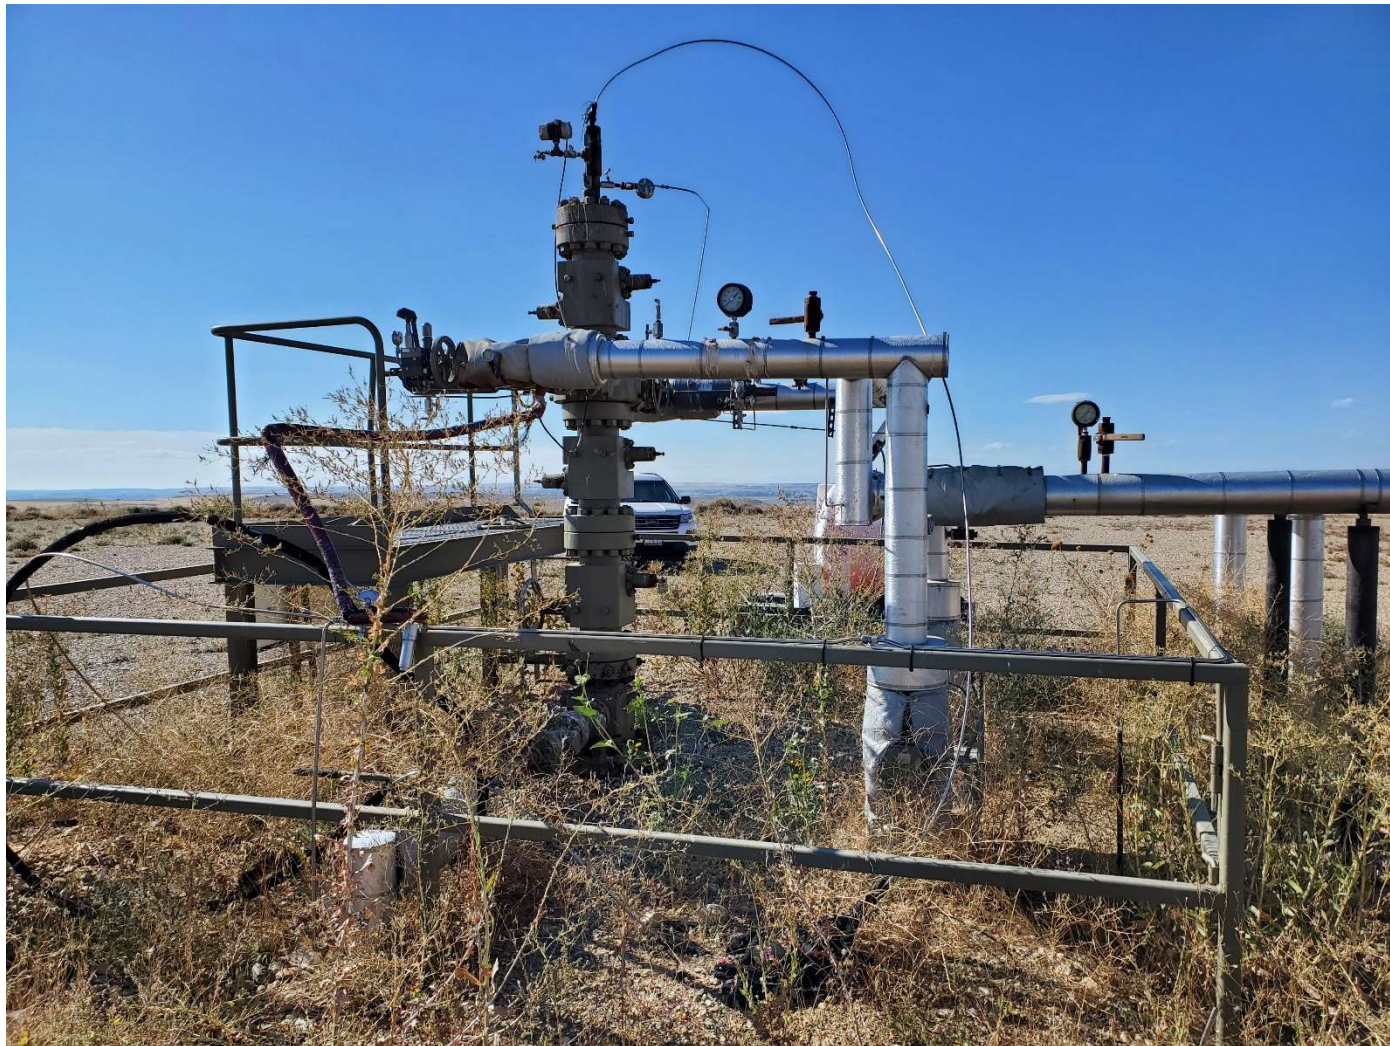
Comments and Issues of Concern: Weed abatement needed. Pad is >10% covered with extremely dense vegetation on west side near fence, separator units and well head.

Well head and steel protection fence showing extensive weed encroachment. View is south.

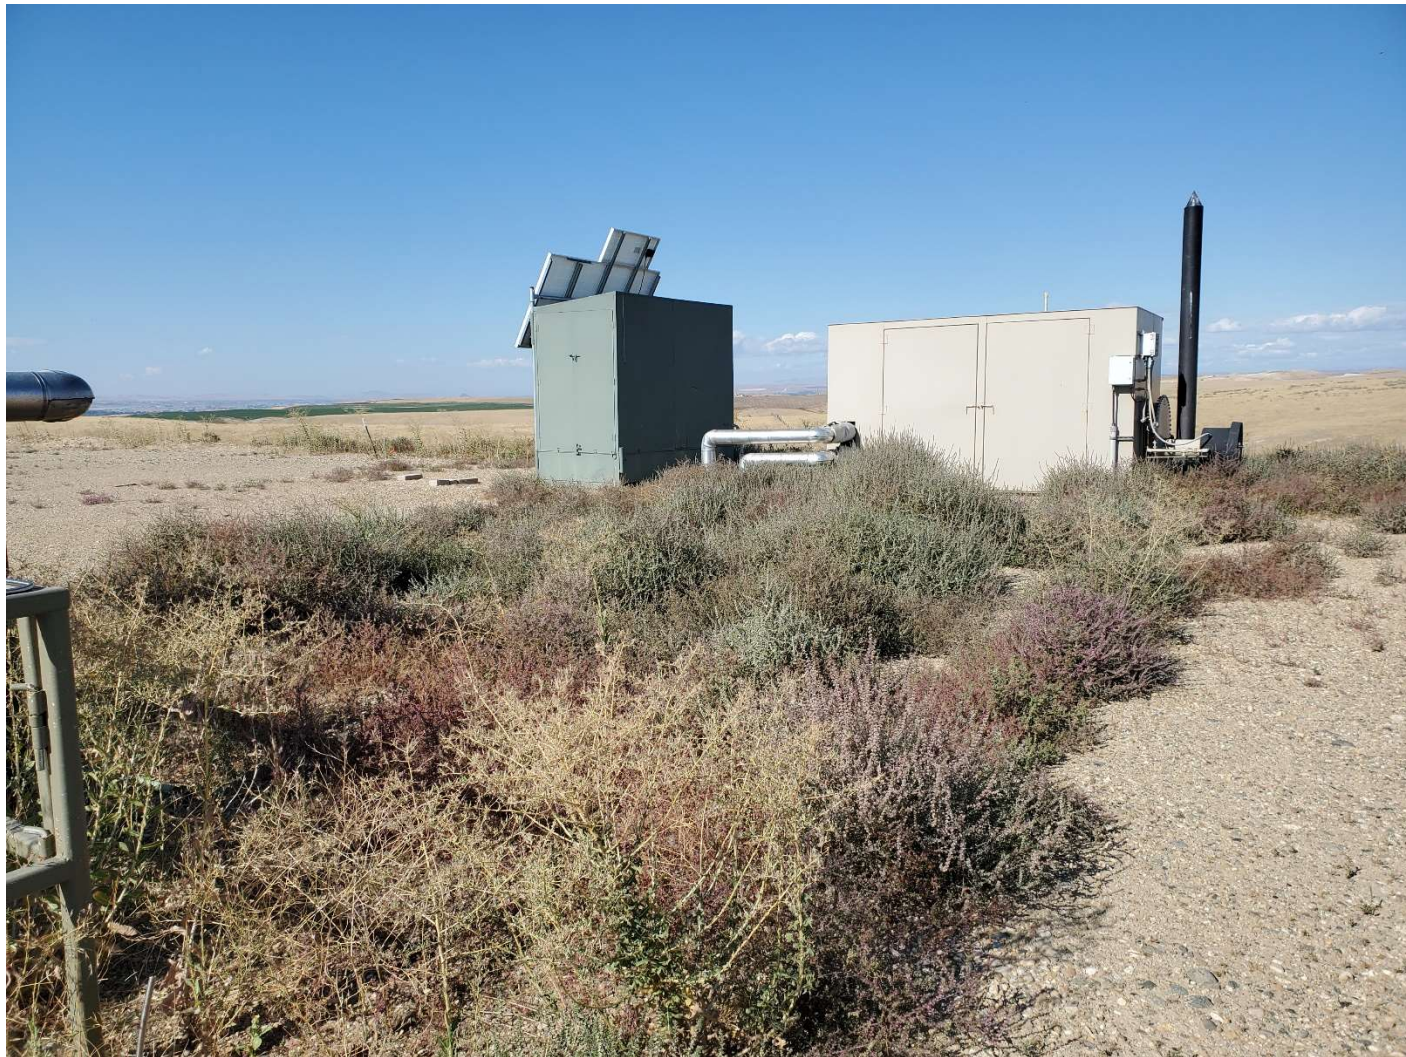
View west from north of steel containment fence towards separator units showing extensive weed encroachment.

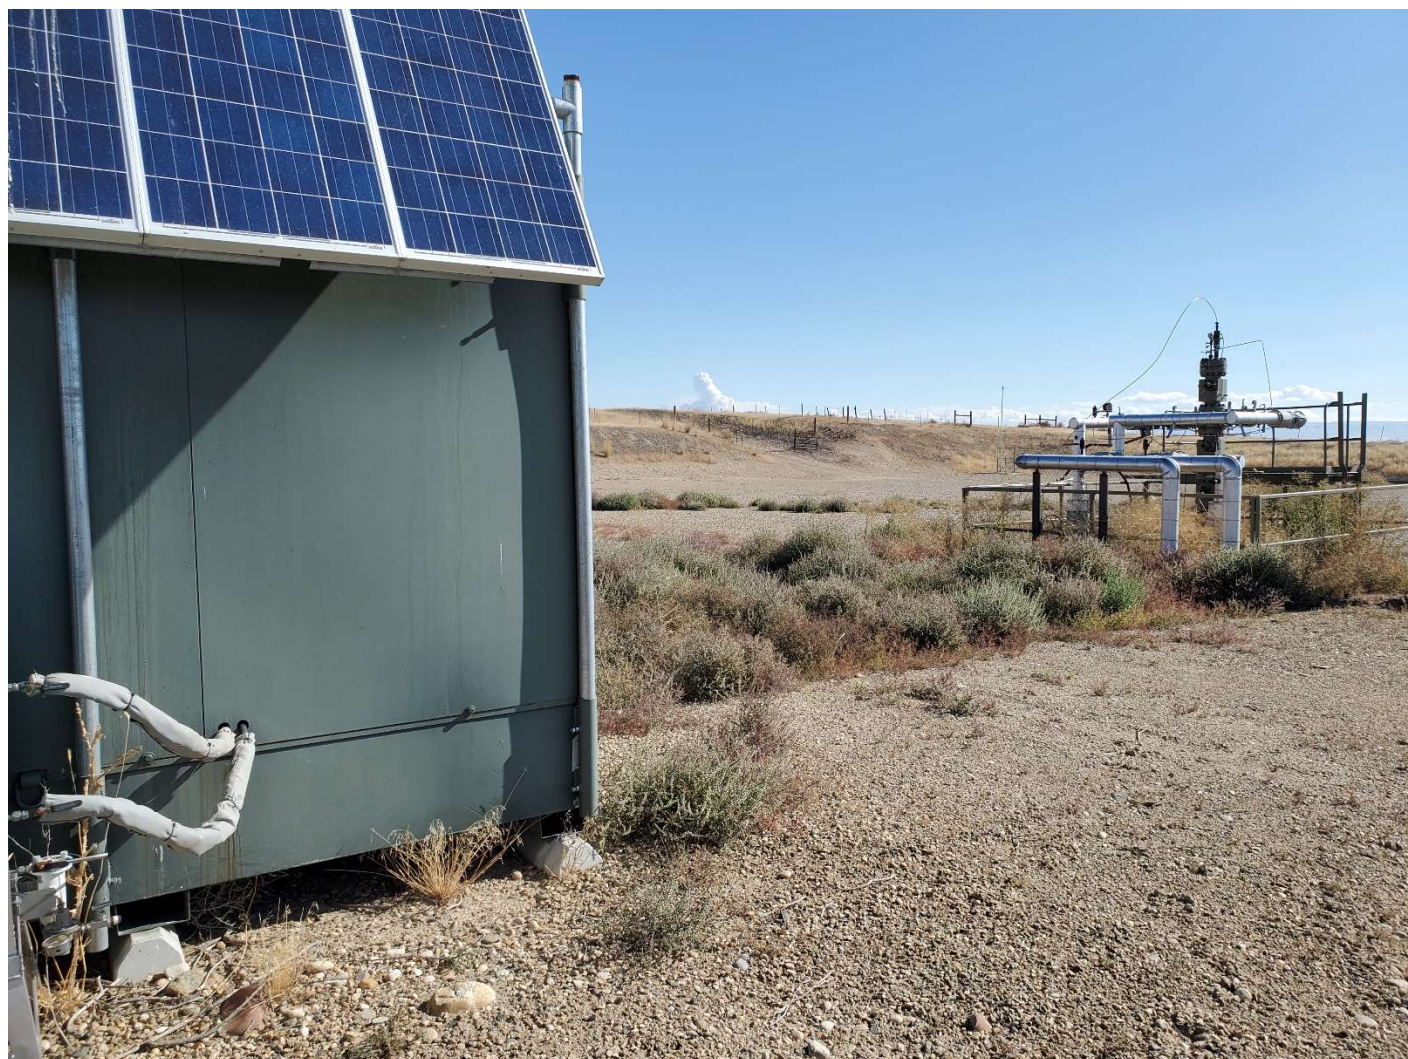
View north from separator. Note extensive weed encroachment between separators and well head,

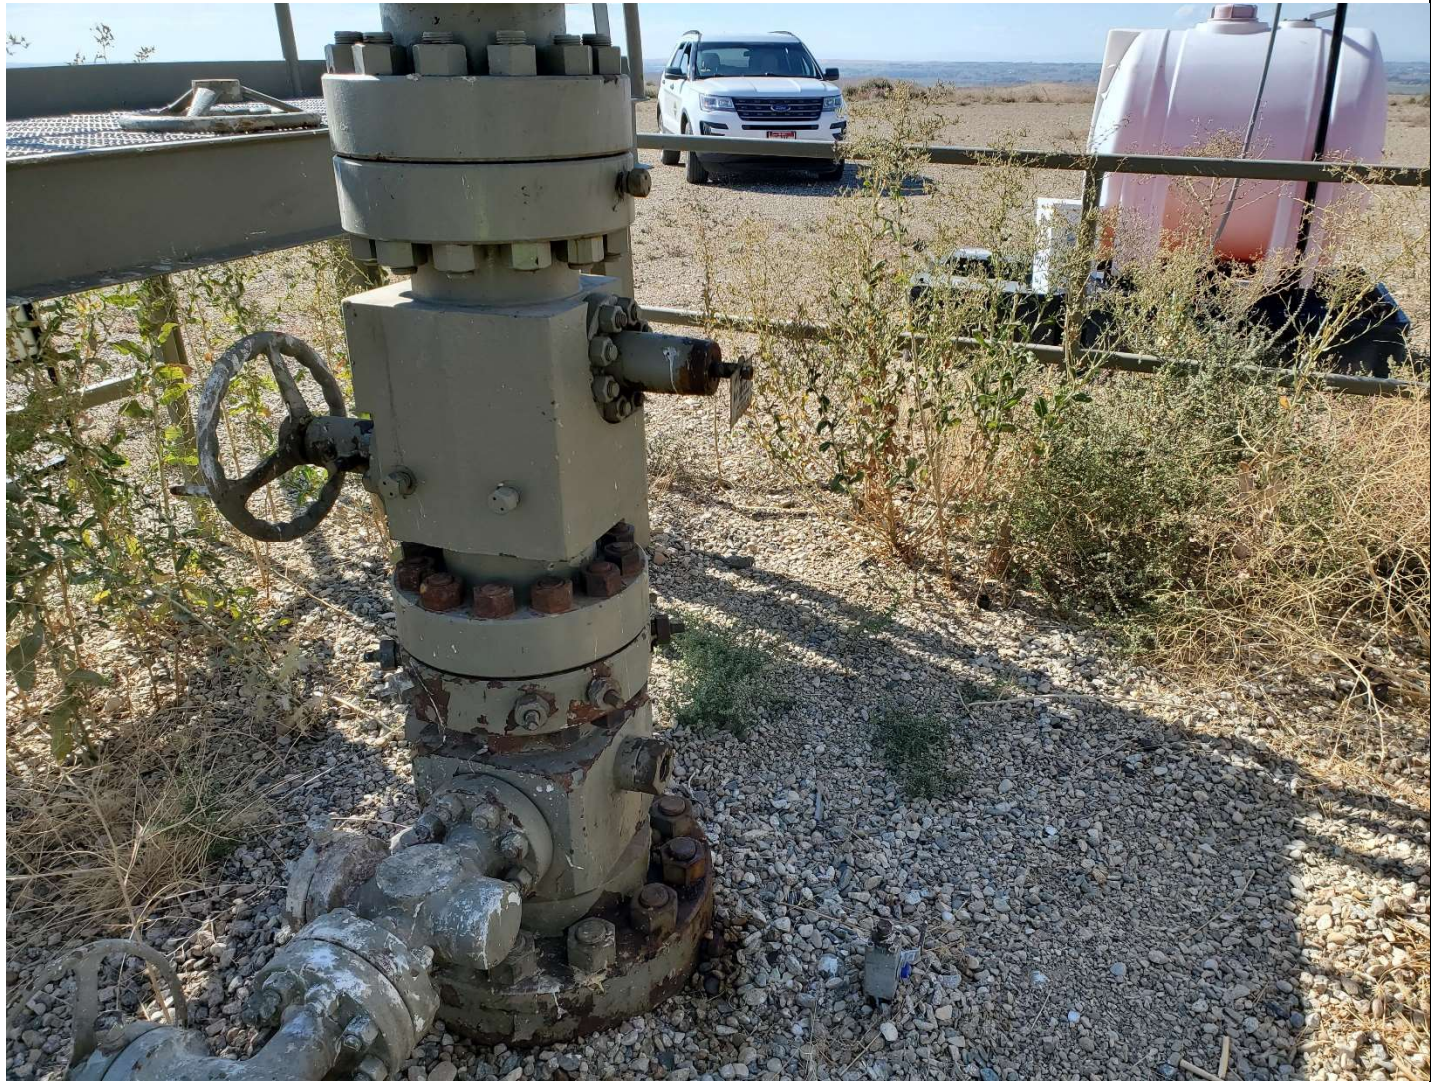
Slight tubing string leak from LT completion with well head and gravel staining at base of well head.

Detailed view of well head and scavenger unit looking south. Note staining from LT tubing leak at base of well head and surrounding gravel in well cellar.
