Post Drilling/Annual Well Site Inspection Form

Section 1: General Information	
Operation Data	Inspection Data
Operator Name Snake River Oil + Gas, LLC	Inspector Name James Thum
Well Name ML Investments #2-3, USWN 11-075-20029	Area Office Boise / Director's
Authorized Contact: Dan Johaneck (208)707-7867 112 N. Plymouth, New Plymouth ID; Tyler Hartung (208) 412-5475	Inspection Date 9/29/2022 10:35 AM
County Payette	Report Date 10/3/2022
Inspector's Signature: /signed/ James Thum	Inspection Summary: <input type="checkbox"/> Operation appeared to be in compliance at the time of the inspection. <input checked="" type="checkbox"/> Issues of concern identified at the time of the inspection.
Date of Signature: 10/3/2022	
Location Description: 3698 feet NNW from Little Willow Gathering Facility, 4649 Little Willow Road. Google Maps location Latitude 44.060772, Longitude -116.807007. Mike Shafer, LW contact through T. Hartung. Well currently S/I	
Weather: Sunny, hazy smoke 65 degrees F. SE wind 5-7 mph

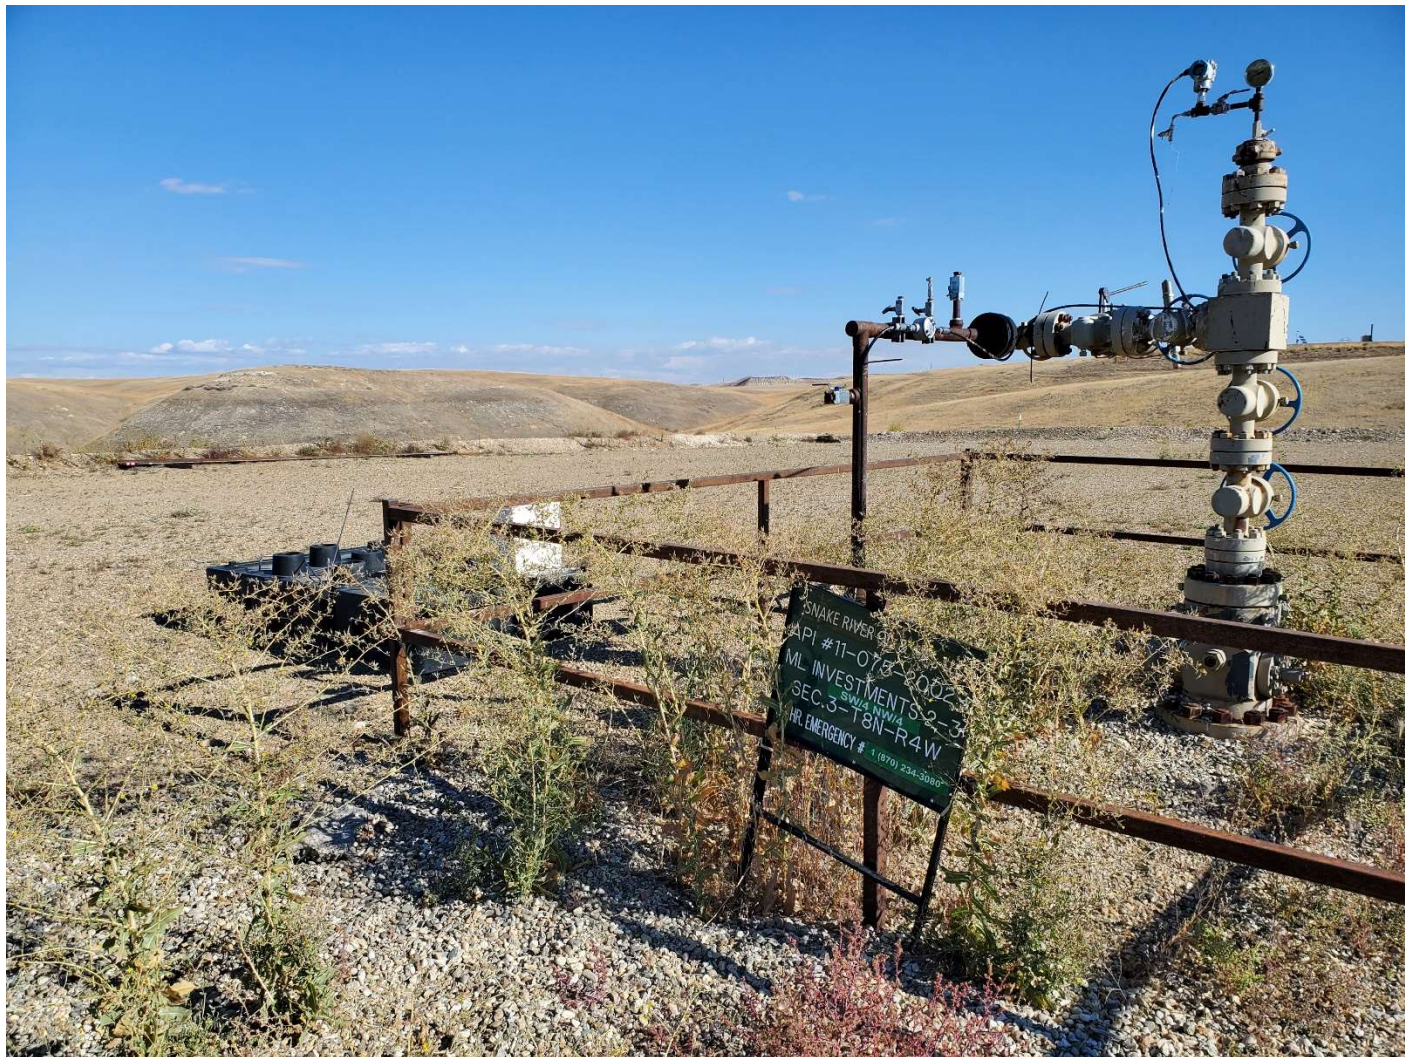
Well head looking NNE, inner safety fence, scavenger unit base. Separator for ML Investments 1-3 background right.

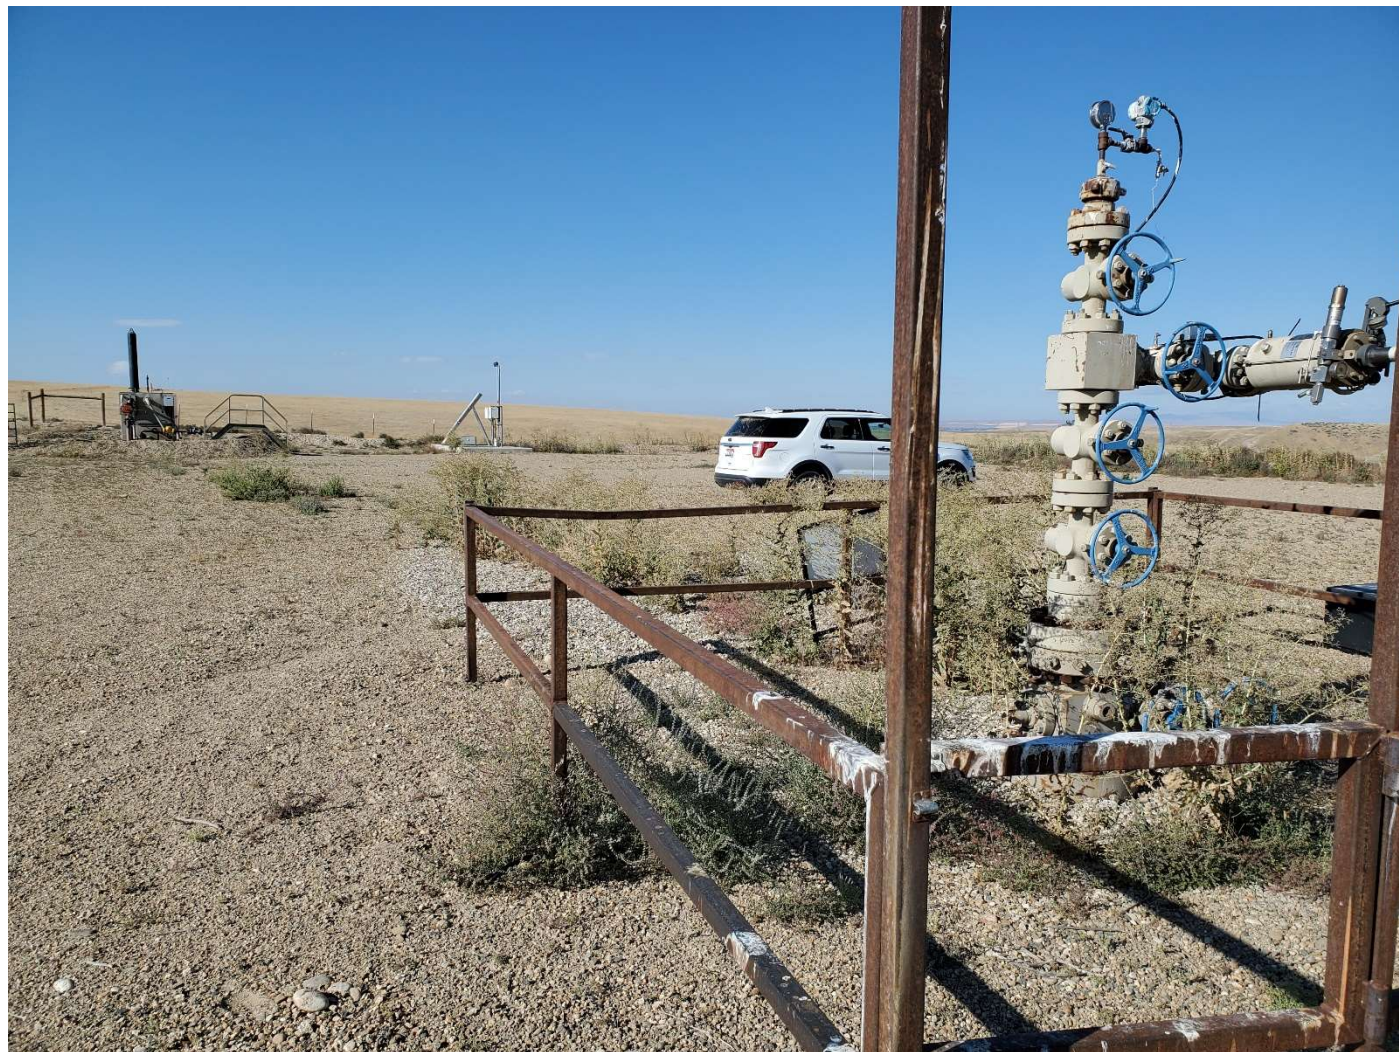
Vegetation on well pad >10%, most prominent in area of well head, path from well head to separator unit, on and within the separator dike containment.

Well head right foreground, separator unit and SCADA transmitter left background

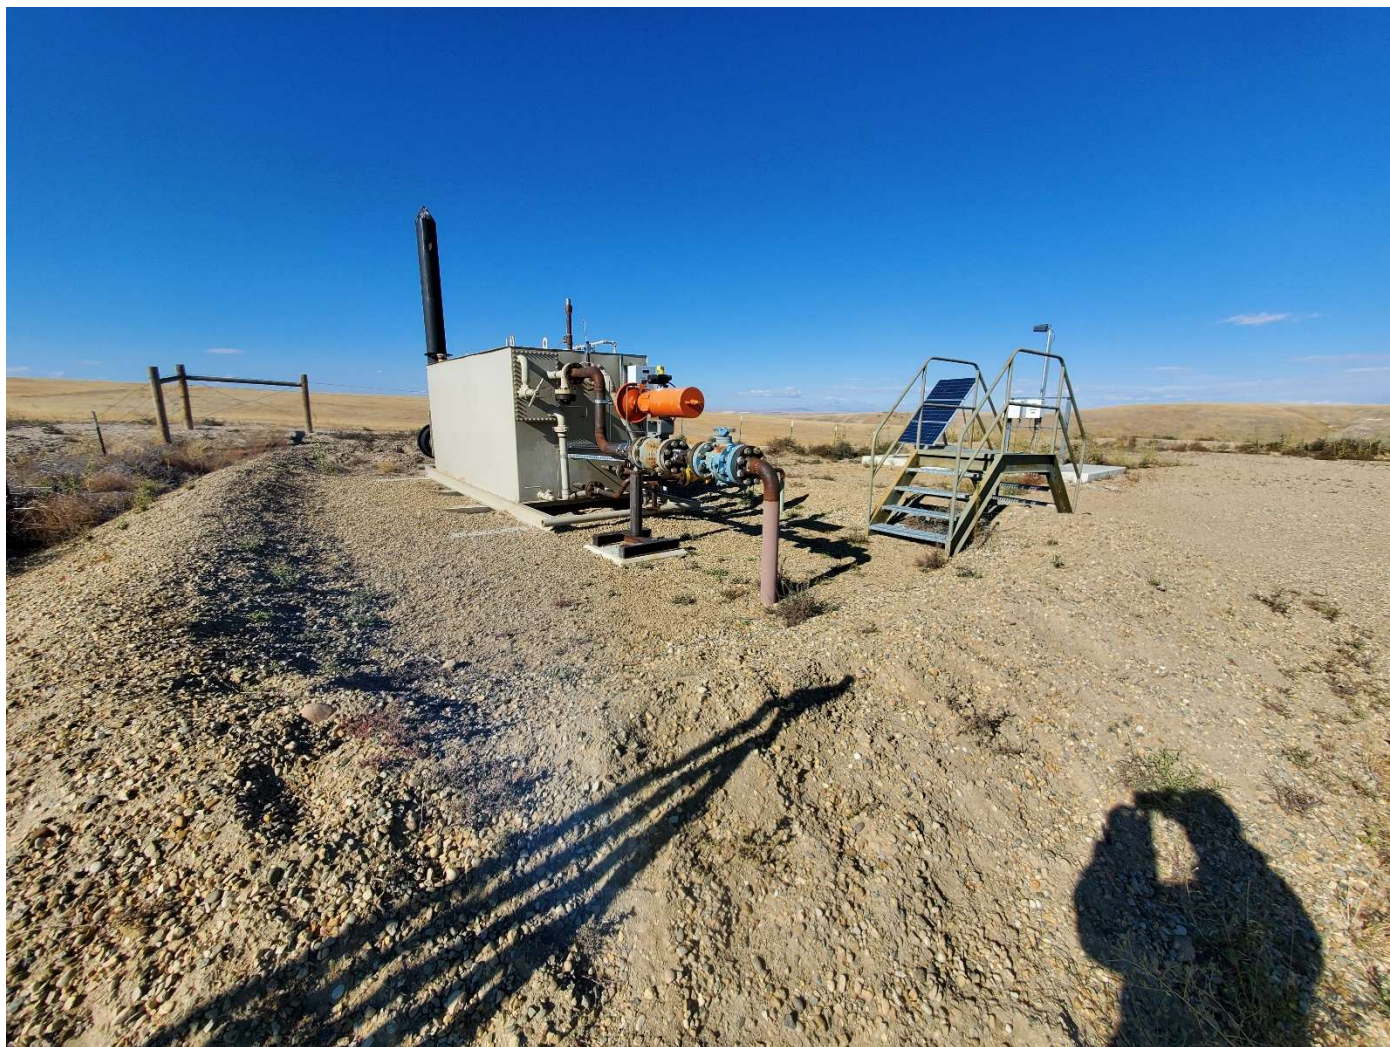
Comments and Issues of Concern: Two entrance gates along southeast pad perimeter; southern gate was open on arrival. Well pad and separator dike show evidence of livestock encroachment; separator dike is disturbed by livestock footprints and numerous locations. Separator unit appears to be excavated at various places by animal burrowing activity.

Separator unit and tank dike looking south. Note footprints of livestock traffic on and within containment dike.

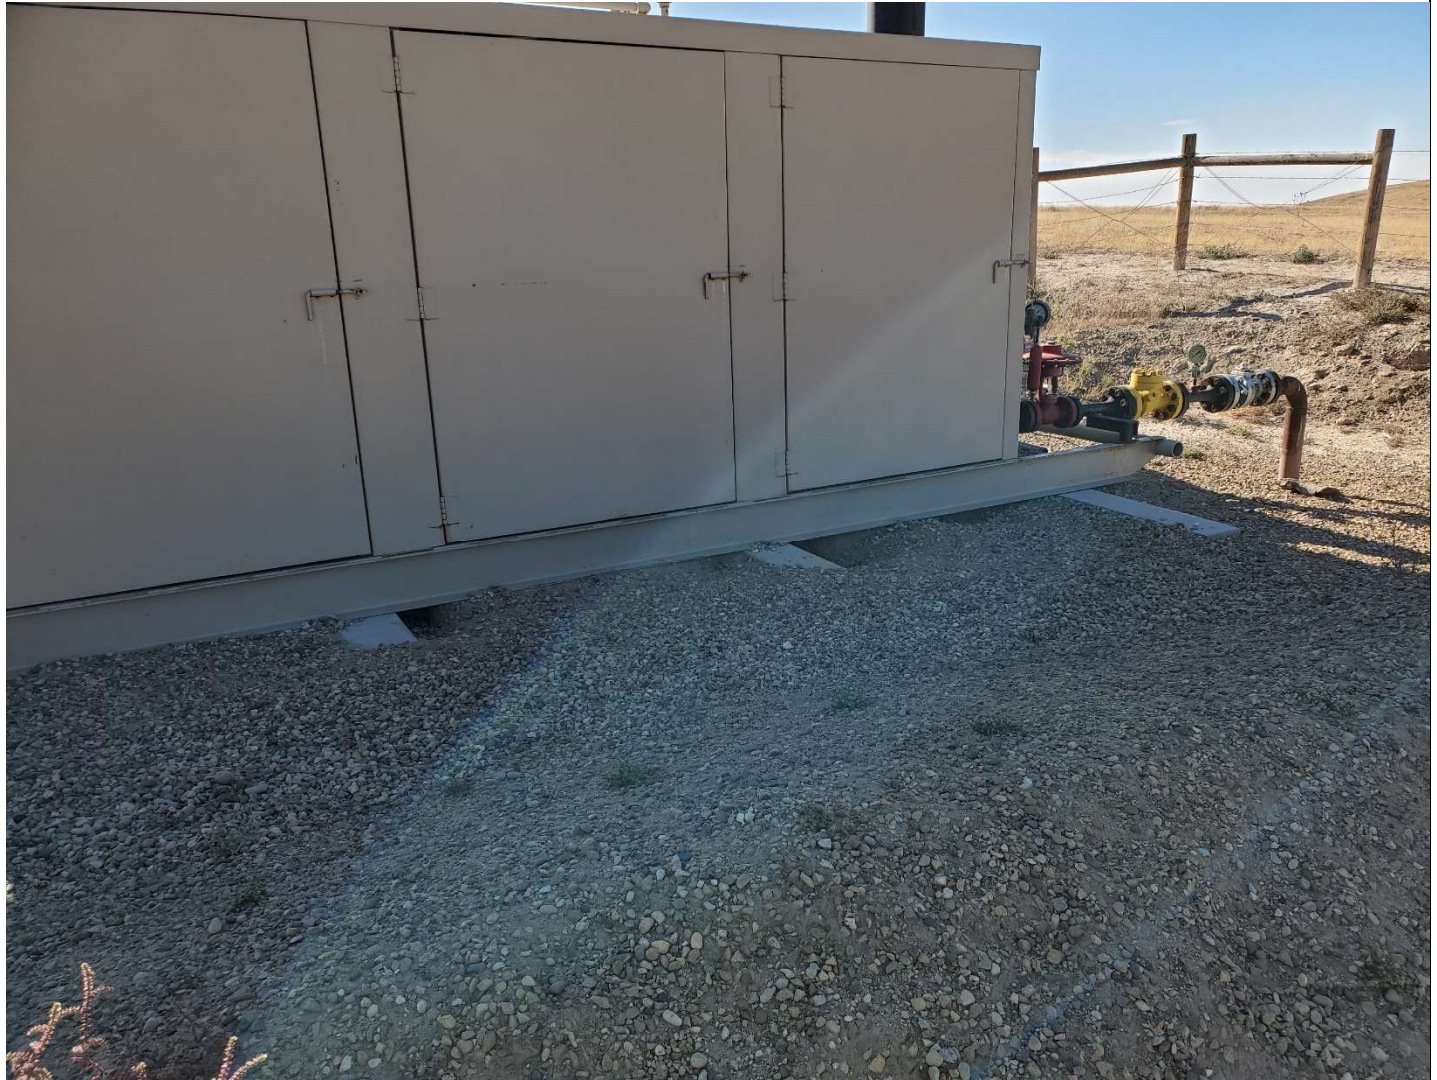
Separator unit showing signs of animal excavation under and around support footings.
