# Post Drilling/Annual Well Site Inspection Form

Section 1: General Information	
<b>Operation Data</b>	<b>Inspection Data</b>
<b>Operator Name</b> Snake River Oil + Gas, LLC	<b>Inspector Name</b> James Thum
<b>Well Name</b> Fallon #1-11, USWN 11-075-20037	<b>Area Office</b> Boise / Director's
<b>Authorized Contact</b> Dan Johaneck (208)707-7867 112 N. Plymouth, New Plymouth ID Tyler Hartung (208) 412-5475	<b>Inspection Date</b> 10/19/2022 1:20 PM    Weather: clear, hazy smoke 63°F, calm winds
<b>County</b> Payette	<b>Report Date</b> 10/19/2022
<b>Inspector's Signature:</b> /signed/ James Thum	<b>Inspection Summary:</b>  <input checked="" type="checkbox"/> Operation appeared to be in compliance at the time of the inspection.  <input type="checkbox"/> Issues of concern identified at the time of the inspection.
<b>Date of Signature:</b> 10/21/2022	
<b>Location Description:</b> 1.0 miles NE from Hwy 30 and Hwy 95 intersection in Fruitland, ID, east of Hwy 95 north side of Killebrew Road, north of the Payette River. Google Maps location Latitude 44.040984, Longitude -116.906820. Well is currently producing as of 2/11/2022. Gathering pipeline riser on site but not part of inspection.

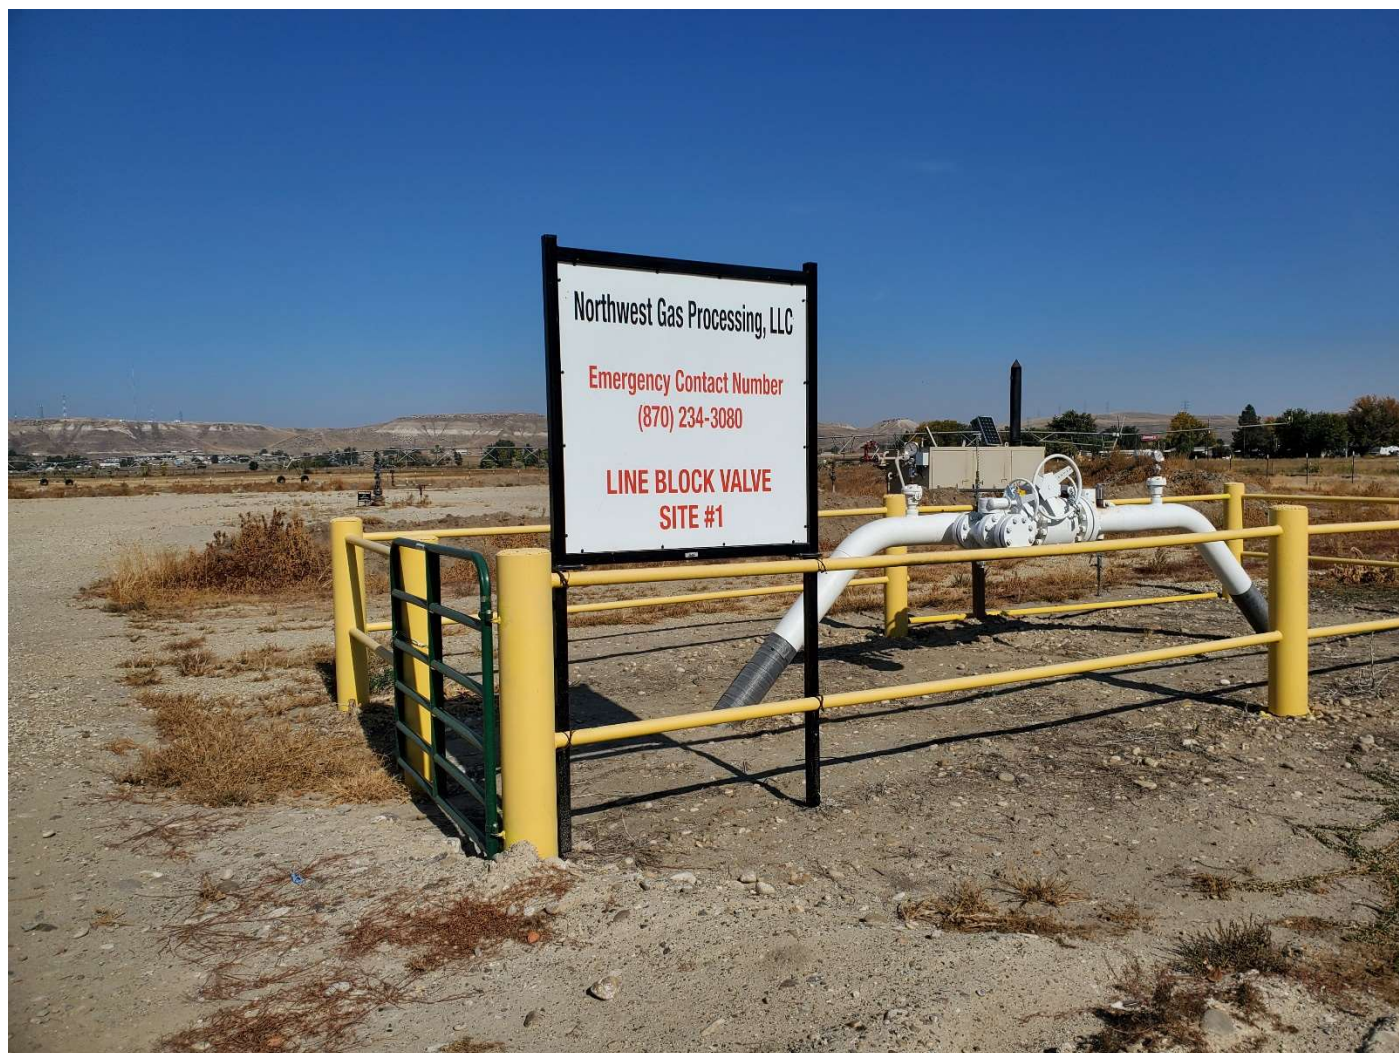
View NE inside perimeter gate. Gathering line riser in foreground, well head at rear left of sign, separator unit at rear right of sign, above gathering line riser.

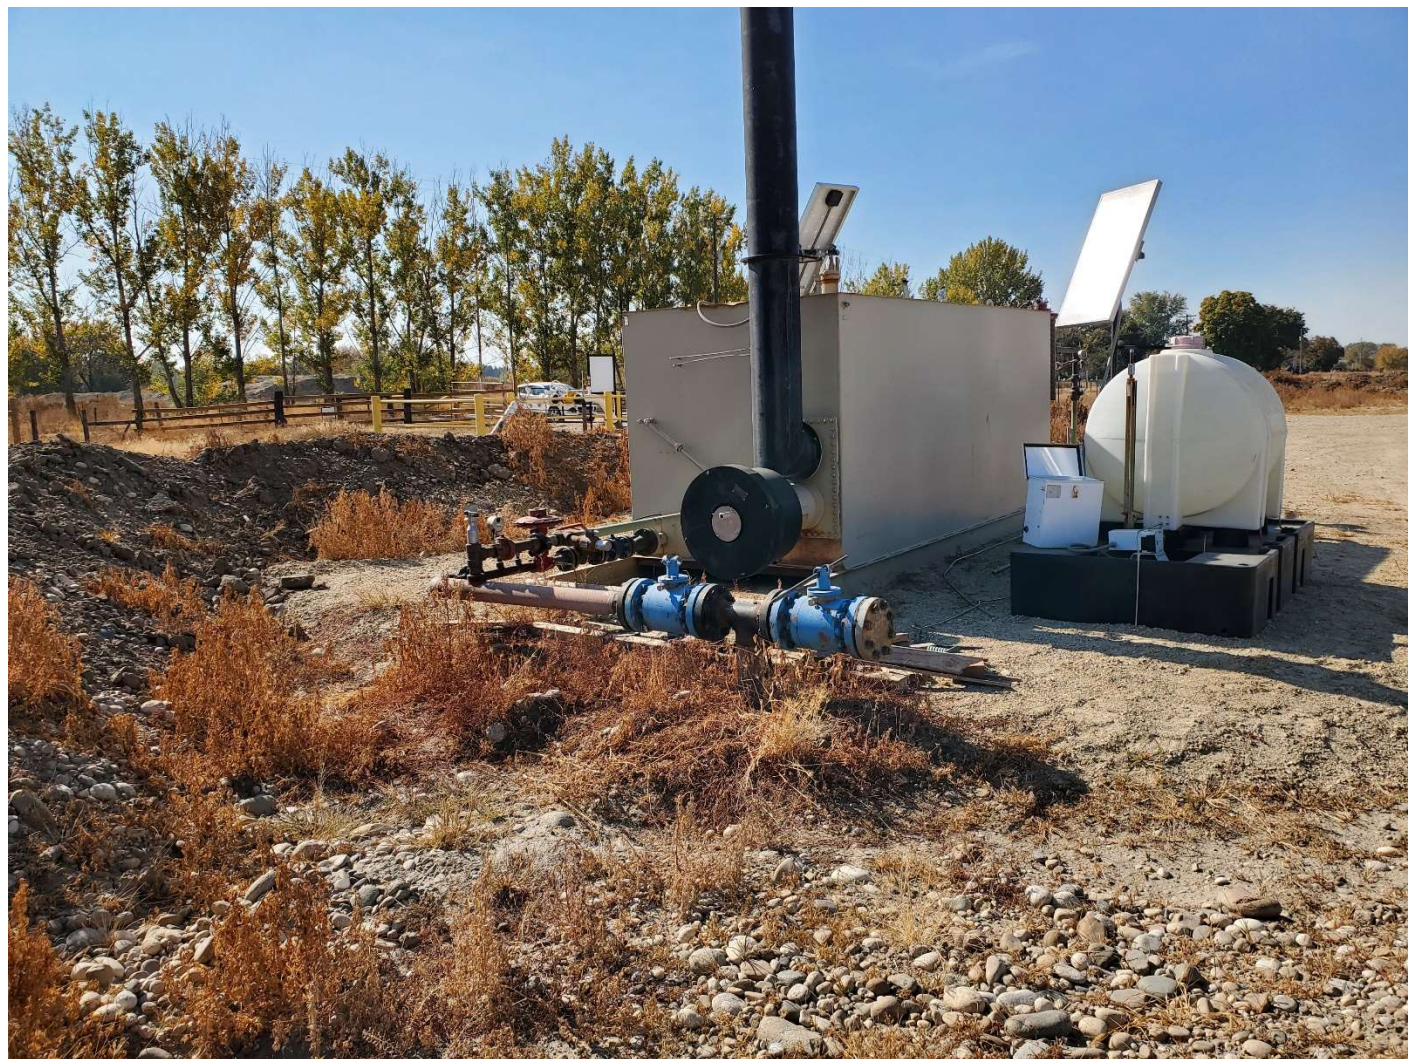
**View SW of Separator and scavenger unit.**

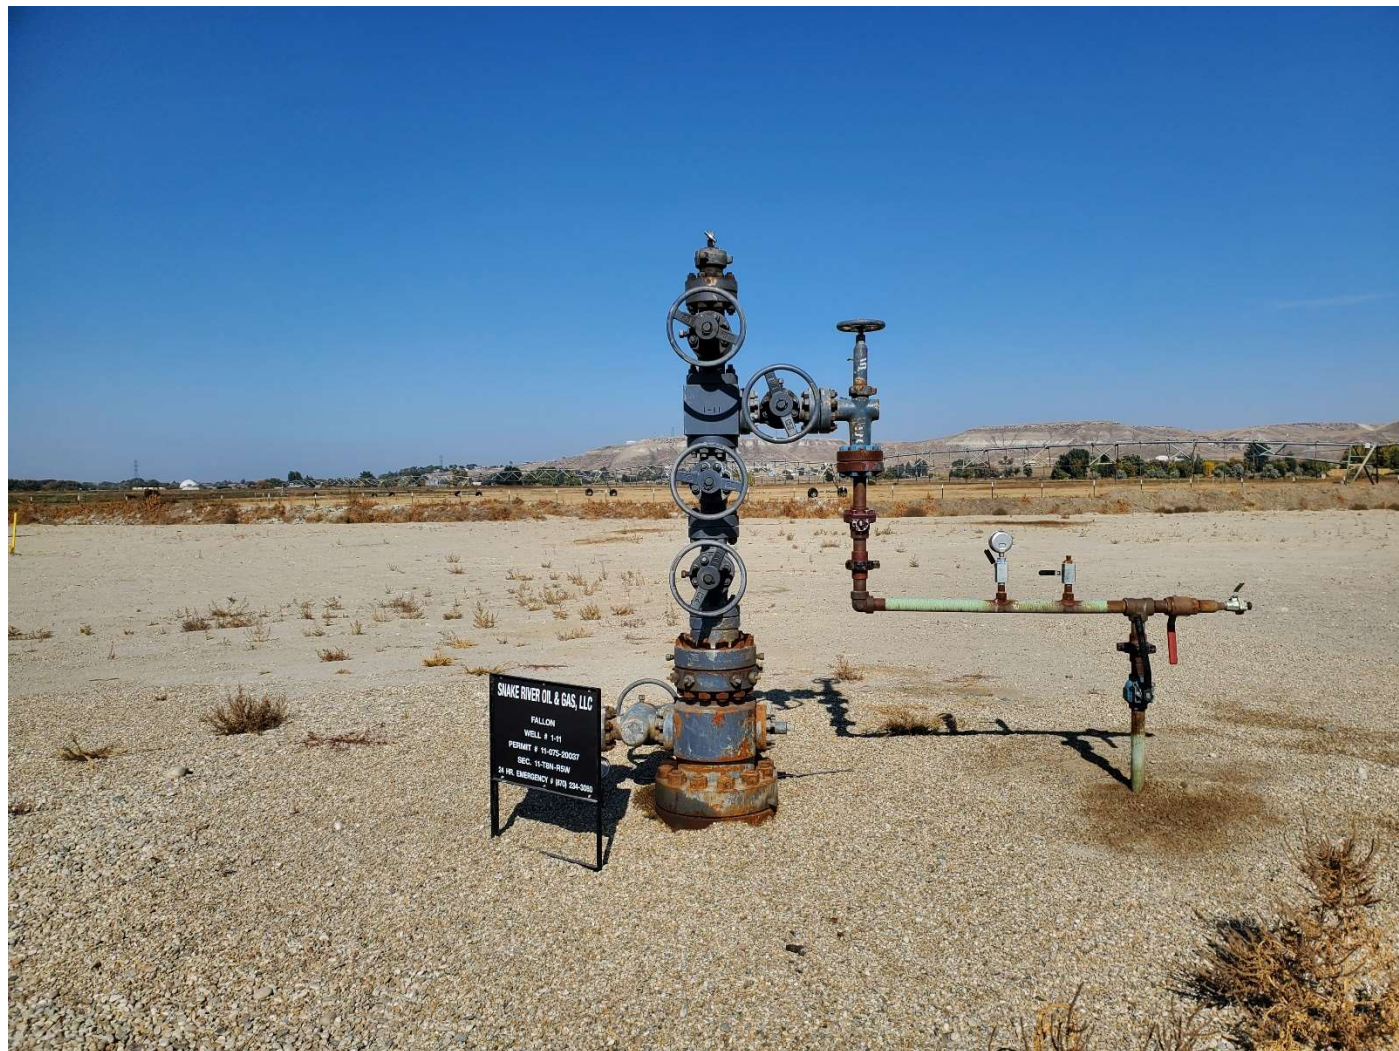
**View North of wellhead, gathering line to separator. All pressure gauges are analog.**
