## Gas Processing Facility Inspection Form

Section 1: General Information							
Operation Data	Inspection Data						
Operator Name:	Inspector Name:						
NW Gas Processing LLC / SROG	James Thum						
Location Name:	Area Office:						
Highway 30 Gas Processing Facility	Boise / Director's office						
Authorized Contact: Dan Johanek (208) 412-5475	Inspection Date:						
Tyler Hartung (208) 412-5475	10/19/2022 9:50 AM						
County:	Report Date:						
Payette Inspector's Signature:	10/20/2020						
/signed/ James Thum	Inspection Summary:						
/signed/ dames main	Operation appeared to be in compliance at the time of the inspection.						
Date of Signature: 10/24/2022	Issues of concern identified at the time of the inspection.						
Location Description: 4201 US 30, New Plymouth ID							
Exit 9. Facility is no longer manned 24 hours. SROG has re-located the field office to a store front located at							
112 N. Plymouth Ave, New Plymouth ID 83655. Key pa	nd entry at main gate; access code available from Dan

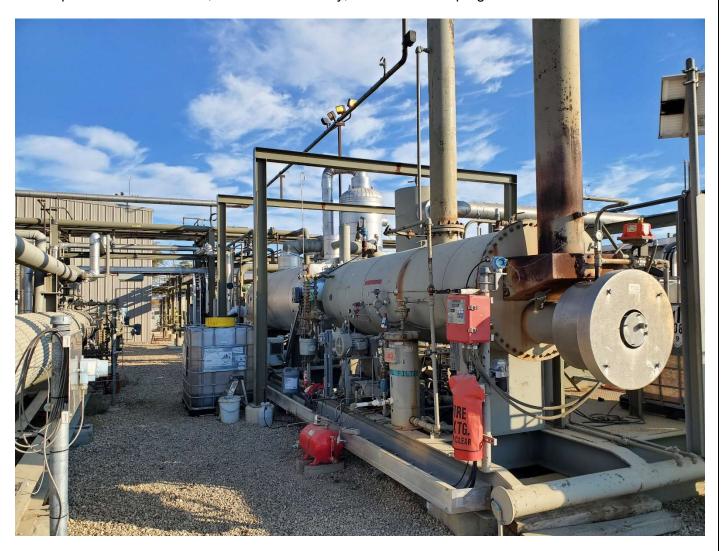
Gas separation/treatment unit, south side of facility, maintenance in progress.

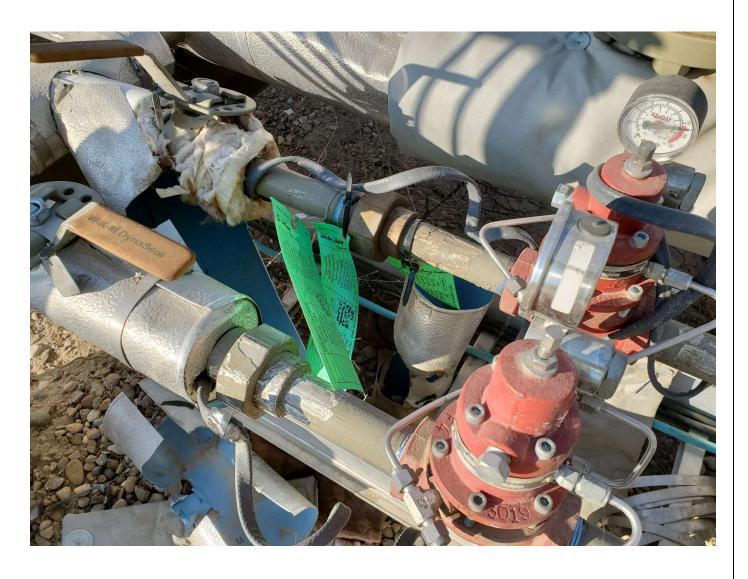
Leak repair tags noted at condensate / NGL outlet lines to storage tanks.

Condensate / NGL flow line repair tags, SW side of facility.

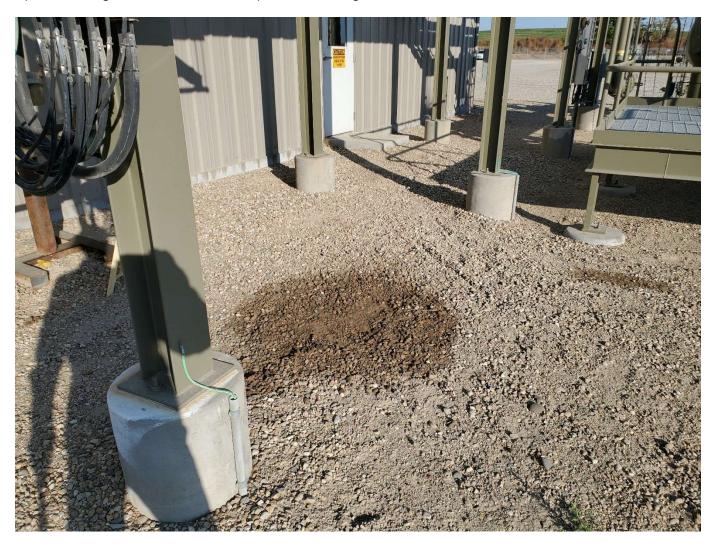
Spill stain on gravel, east side of compressor building.

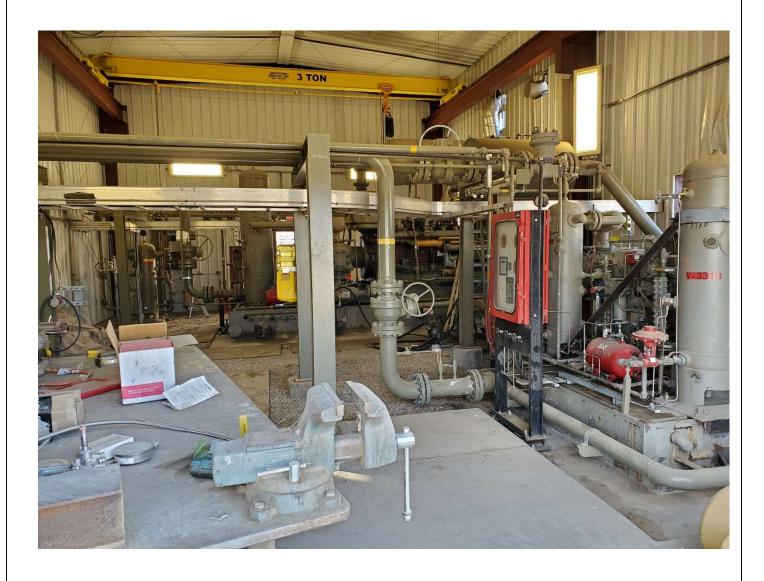
Inside of compressor building, ongoing maintenance.

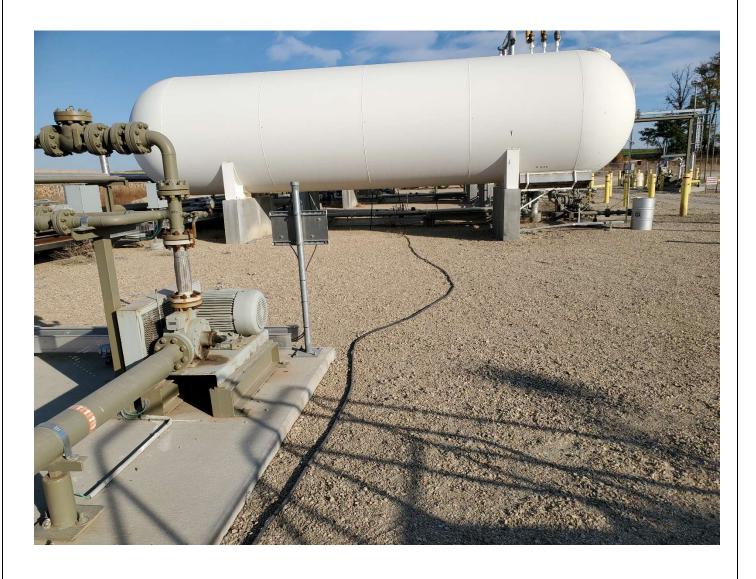
Unknown electrical connection between condensate storage tanks and NGL tanks, view North.

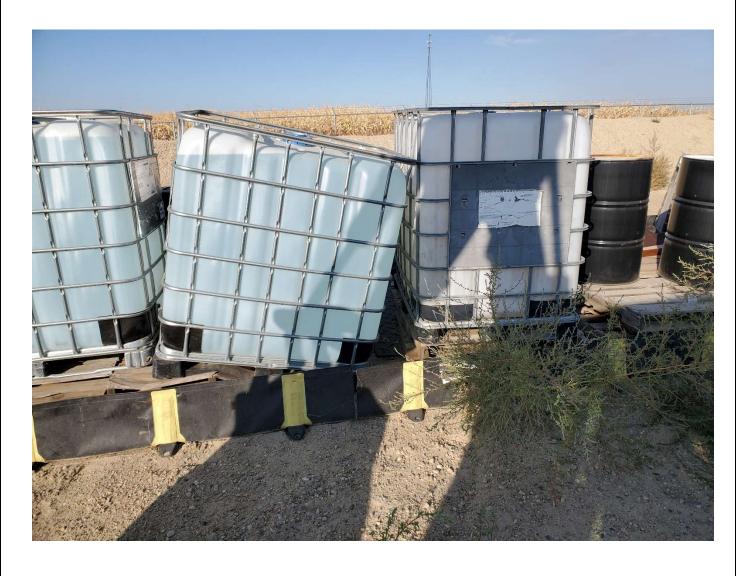
;	5.	Do drain lines have a valve installed, closed and capped off if not in use?	$\boxtimes$	Yes 🗌	No
	Se	ction 8: Inspection Comments			
(	Со	mments and Issues of Concern:			
	NG	D psi noted on gauges into Williams gateway.  SL tanks from south to north: 30%-40%-30%-34% full based on outside gauges spare scavenger unit was stored near the NGL loading station, some recently-denot yet been moved inside the portable storage/spill containment berm. Broke berm.	elivere

Broken pallet holding chemical tanks inside portable spill berm. NW side of faclity, view West.

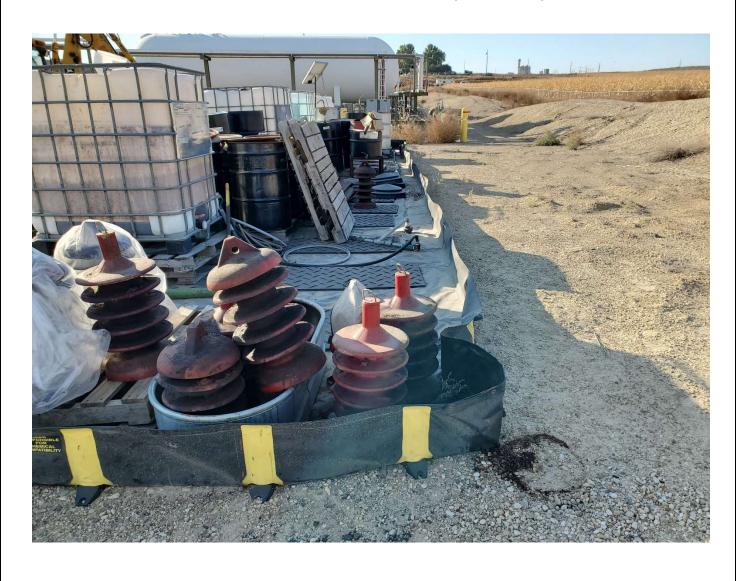
View south of west perimeter of portable spill containment berm, gravel staining.
