Gas Processing Facility Inspection Form

Operation Data	Inspection Data
Operator Name: NW Gas Processing LLC / SROG	Inspector Name: James Thum
Location Name: Little Willow Gas Gathering Facility	Area Office: Boise / Director's office
Authorized Contact: Dan Johaneke (208) 707-7867 Tyler Hartung (208) 412-5475 Mike Shafer via Tyler	Inspection Date: 10/19/2022 12:15 PM
County: Payette	Report Date: 10/20/2022
Inspector's Signature: /signed/ James Thum Date of Signature: 10/20/2022	Inspection Summary: <input type="checkbox"/> Operation appeared to be in compliance at the time of the inspection. <input checked="" type="checkbox"/> Issues of concern identified at the time of the inspection.

Location Description: 4649 Little Willow Road, Payette ID 83661. SE side of Little Willow Road, 2.5 miles NE of the intersection of Idaho SR 52, 6 miles east of Payette ID. Facility now staffed part-time by Mike Shafer since Feb. 2022. Reach him through Tyler. SPL was testing/calibrating fuel use meters when I arrived.

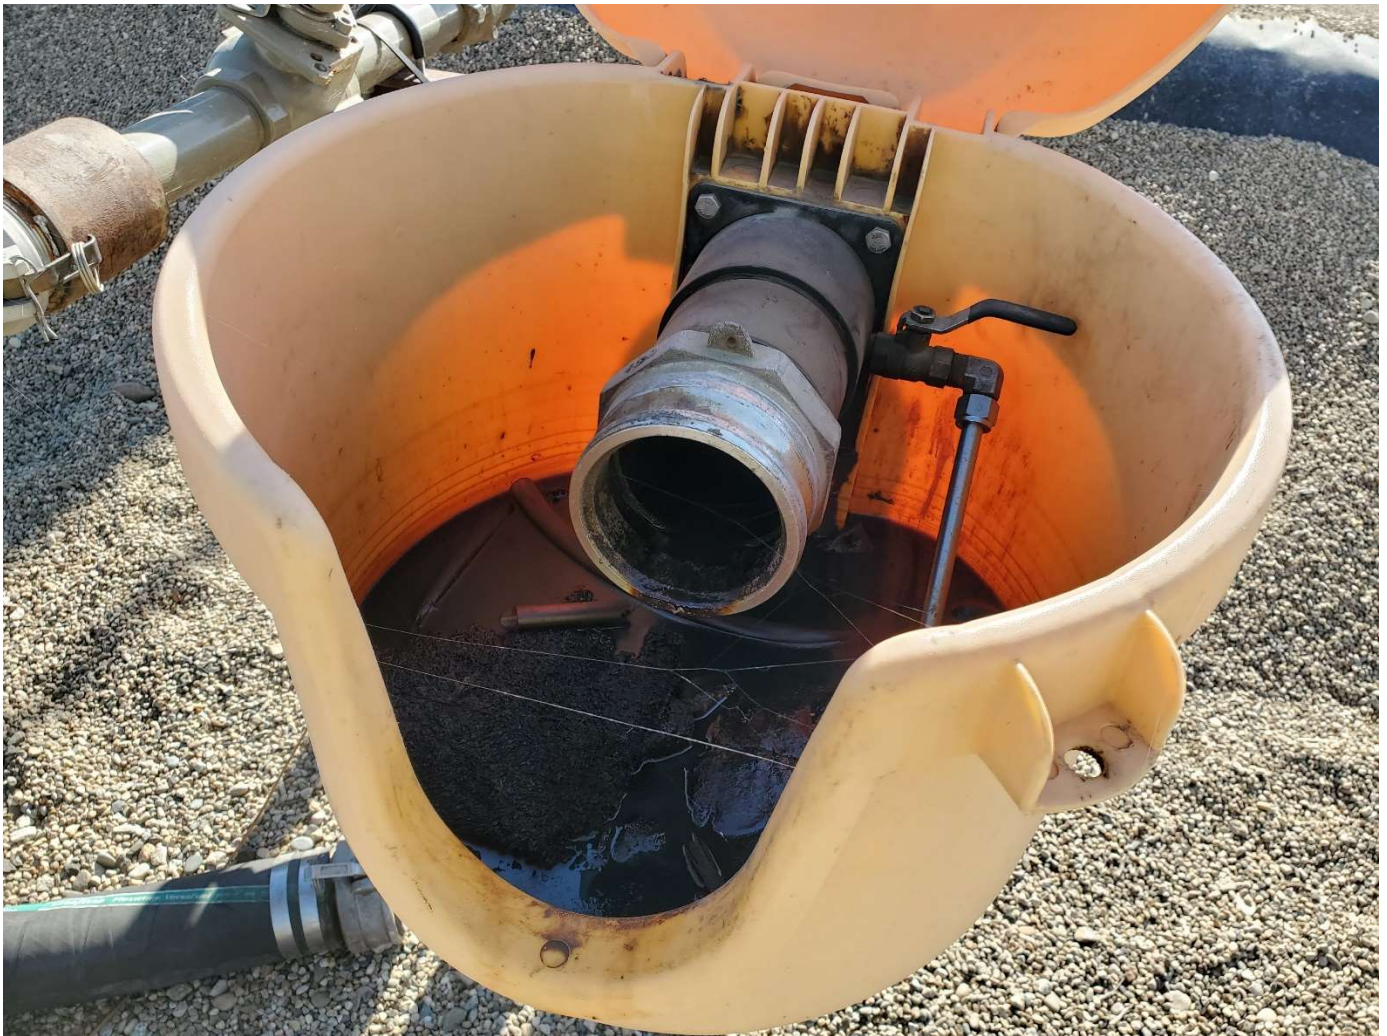
Need better spill containment device around pig launcher, not a metal barrel.
 Leak with noticeable dripping at condensate fill valve – informed Mike of leak after inspection.
 Portable spill containment berm ripped on one side (noted in 2021 inspection).
 Some newly-delivered chemicals not moved within portable spill containment berm.
 Gas detector emitted warning when multi-well separator unit door opened – informed Mike.

Condensate leak at valve within condensate spill control device, north side of containment dike.

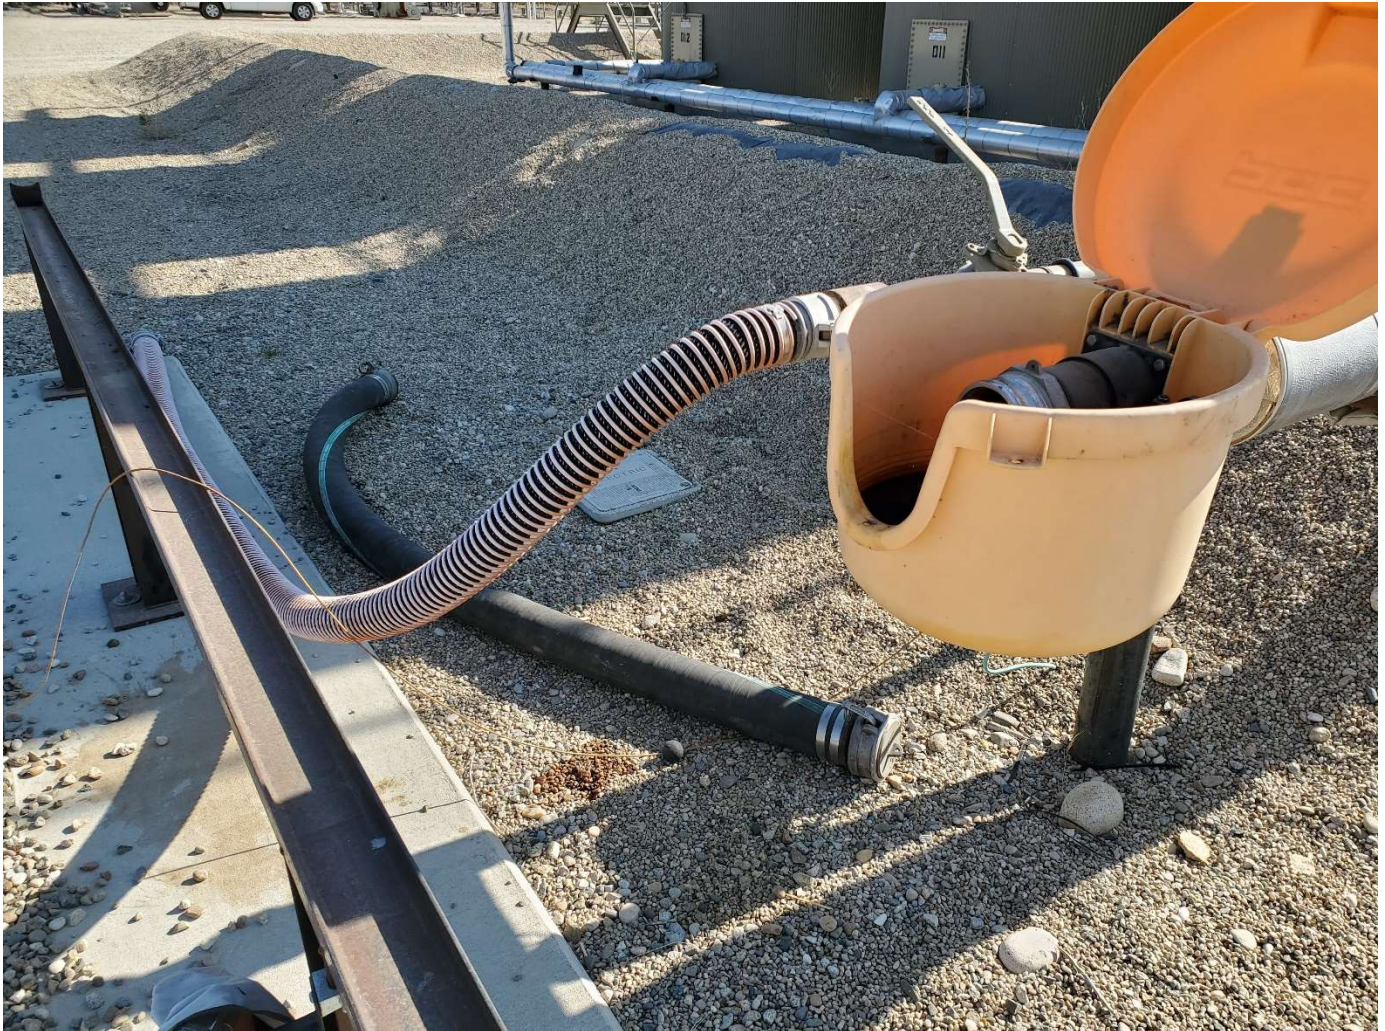
Loading hose rail and hoses at leaking valve, view NE.

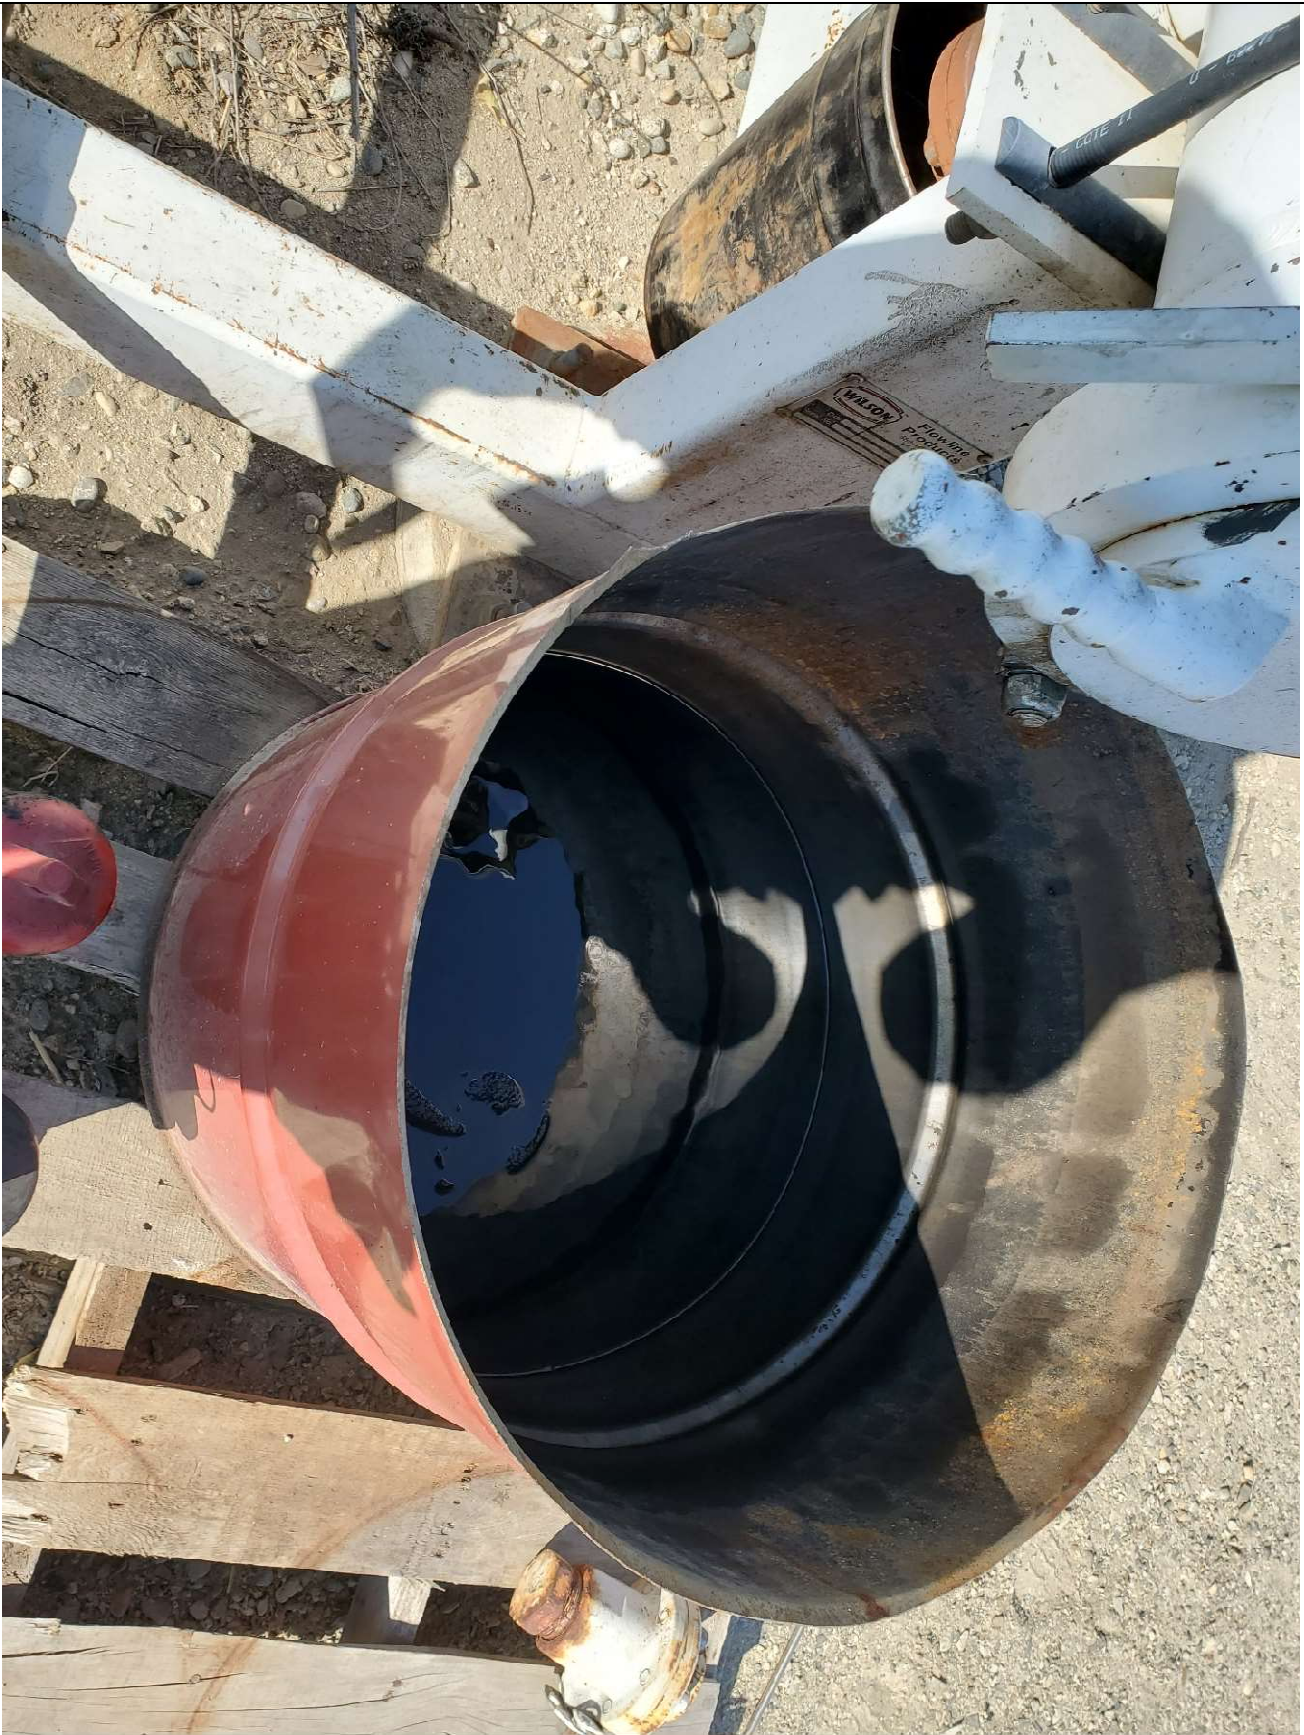
Palletized barrel containing fluids being used for spill prevention at pig launcher.

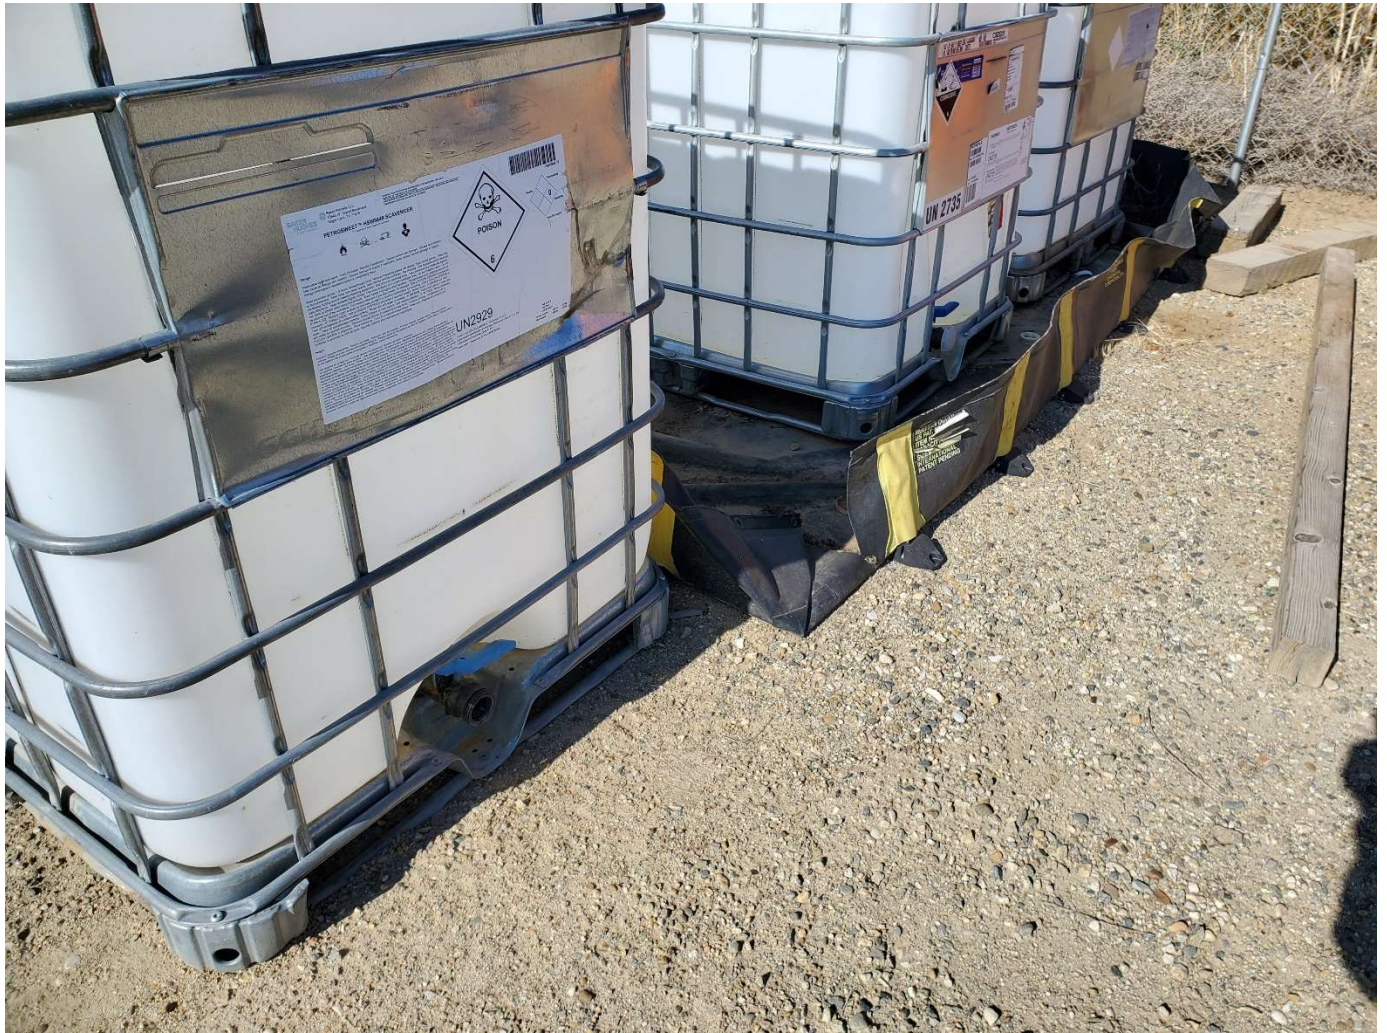
Chemicals outside of portable spill containment device, NW side of facility. Ripped containment device, center of photo.

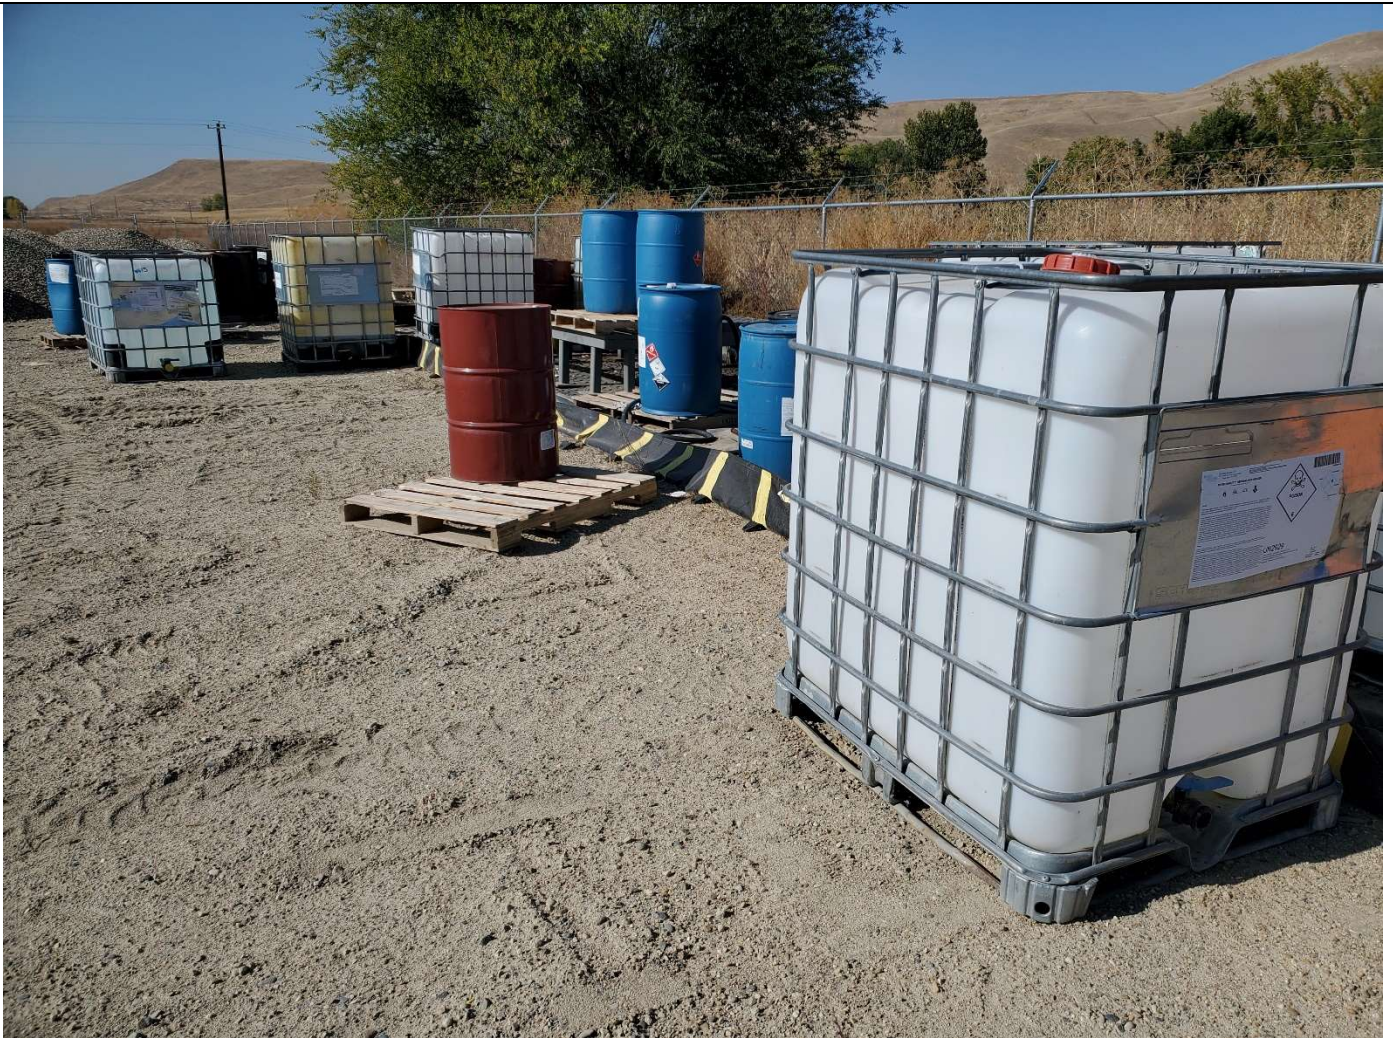
Chemicals outside of portable spill containment device, NW perimeter of facility. View is SW/

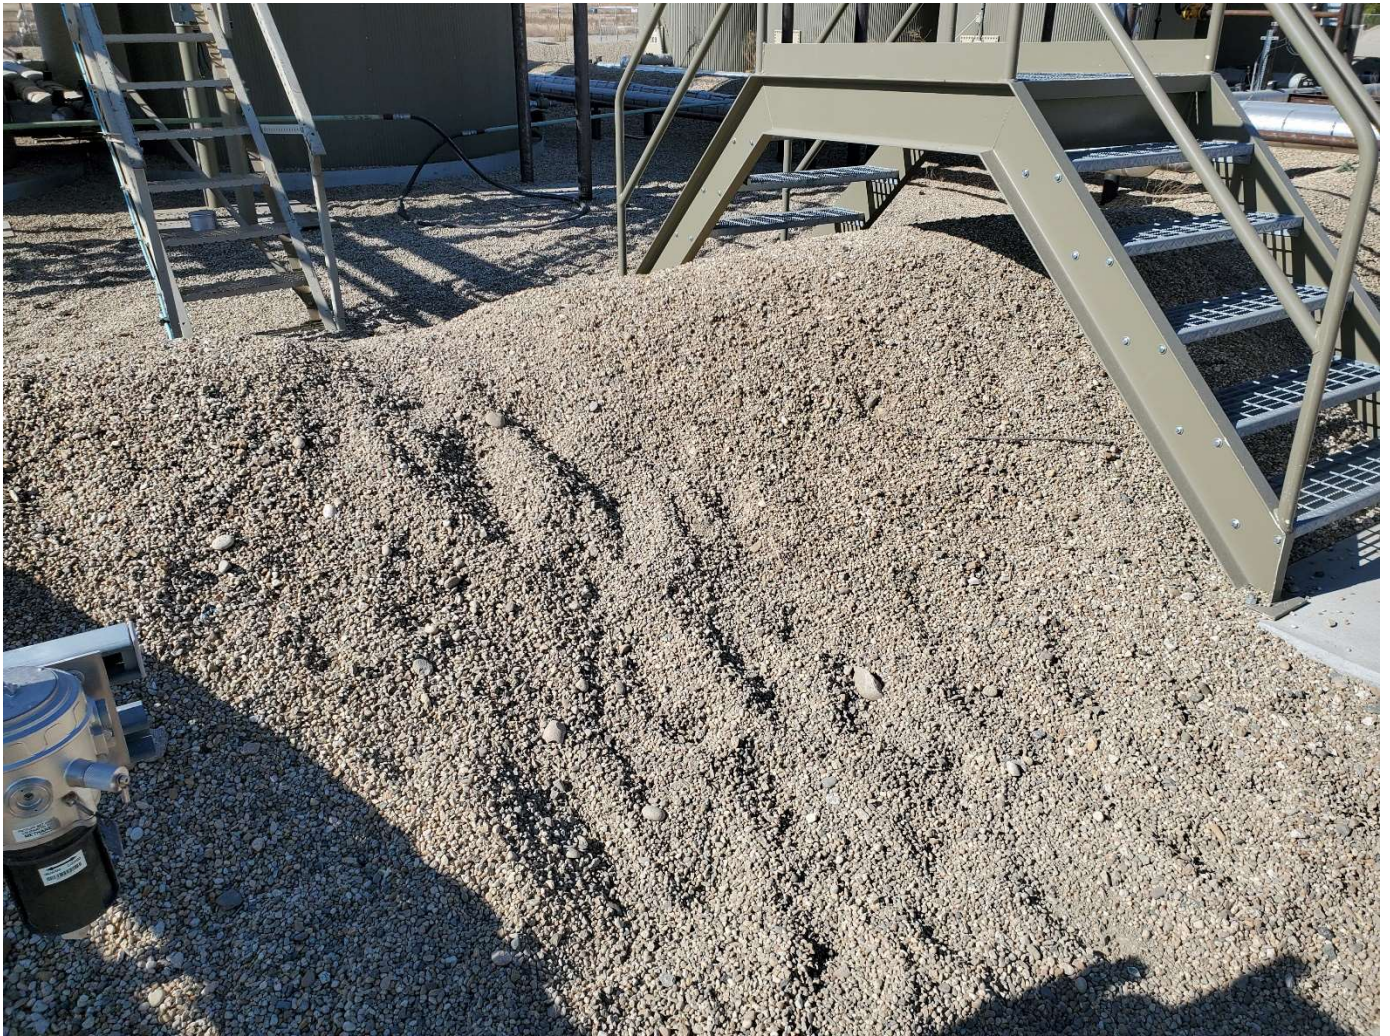
NE perimeter of tank containment dike showing foot traffic in vicinity of access ladder. View SW.

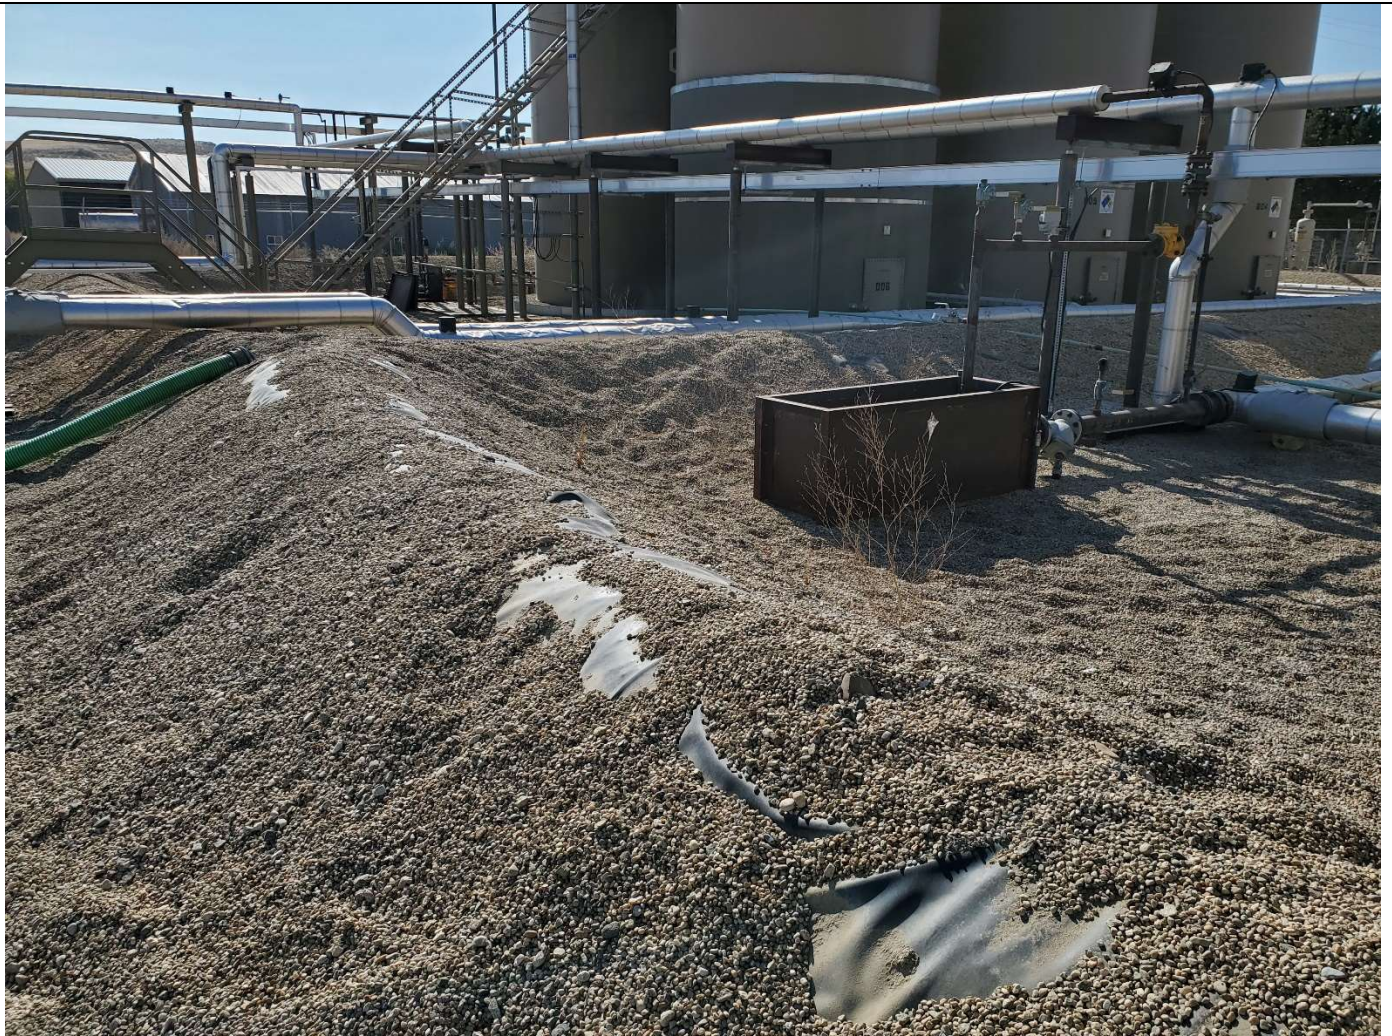
Foot traffic causing deterioration of tank containment dike, NE side. View SE.
