Section 4: Location Operations**IDAPA 20.07.02.301**

Section 10: Inspection Comments

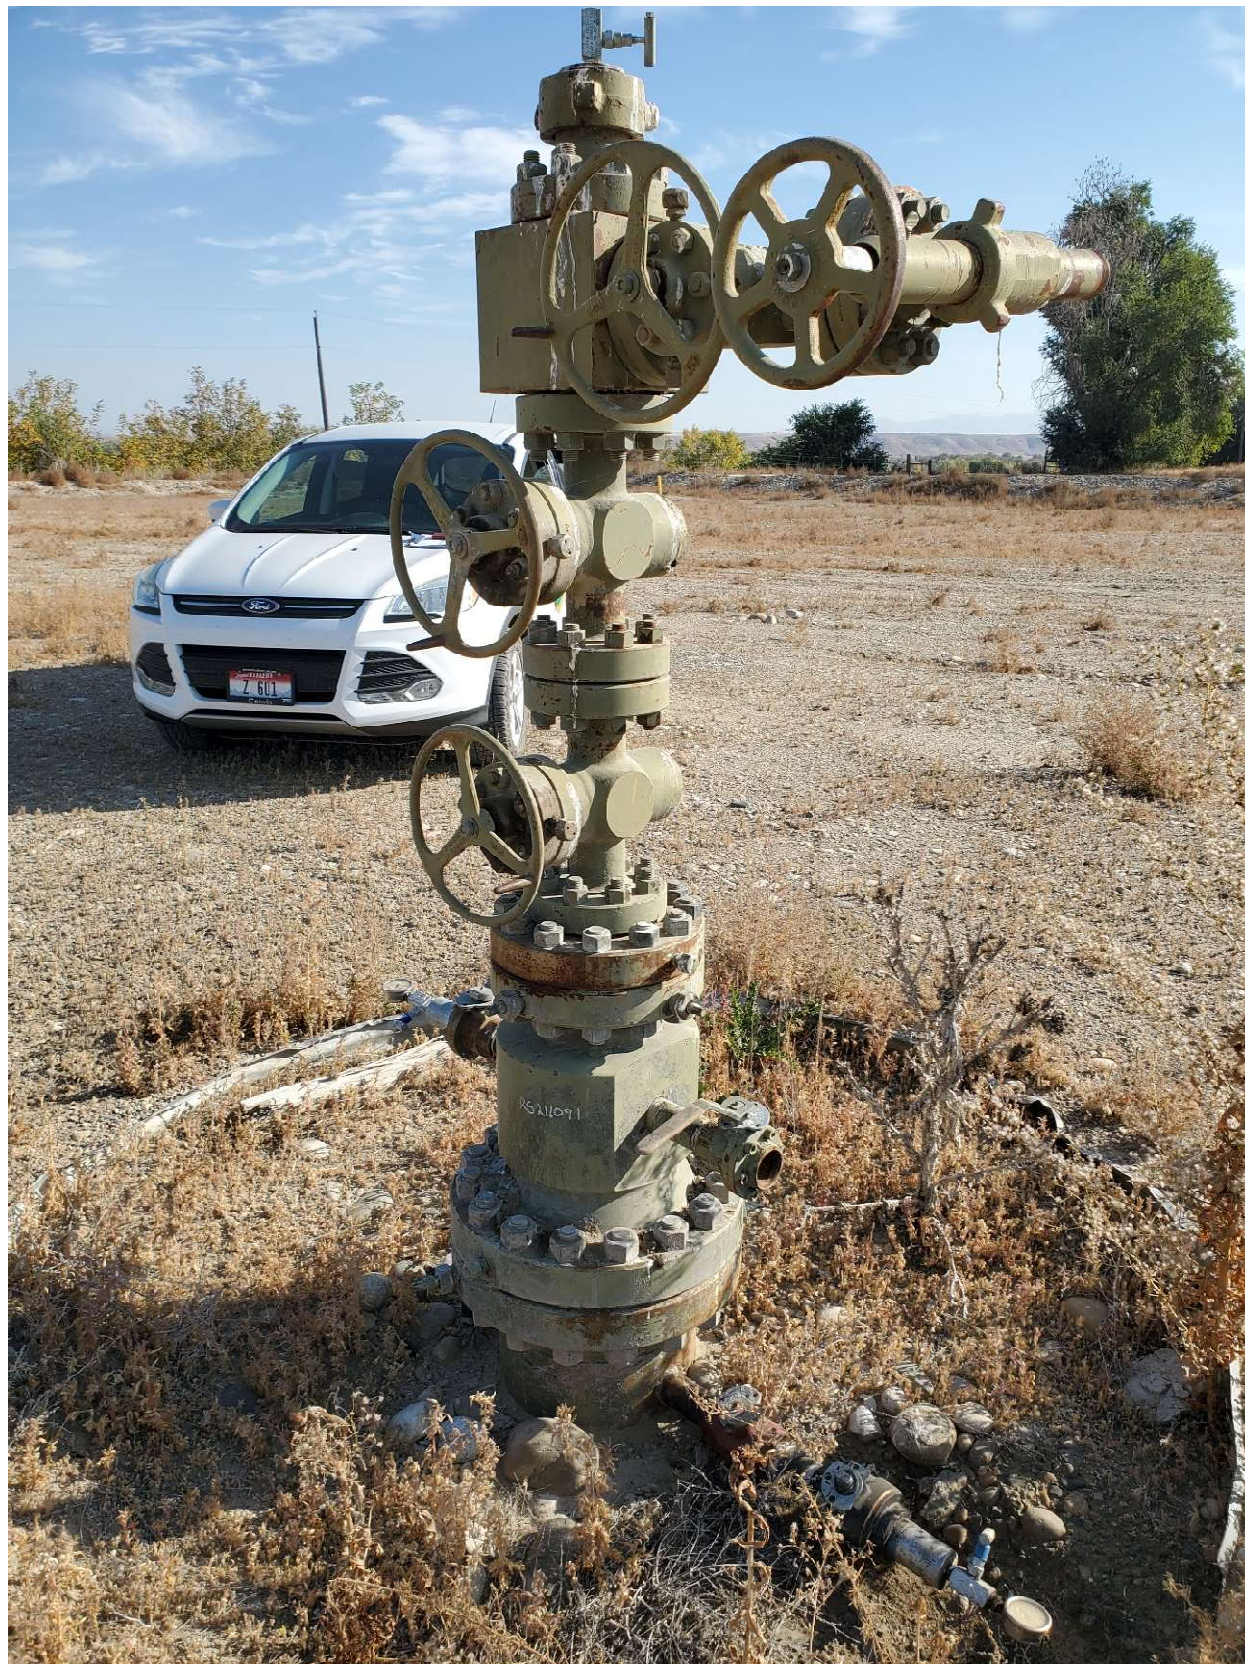
2. Is there less than 5% vegetation on site? **At least 50% covered with weeds** Yes No
3. Has it been more than six months since the removal of the drilling rig? Yes No

Wellhead, view NE, Note weed encroachment in cellar and east side of well pad/

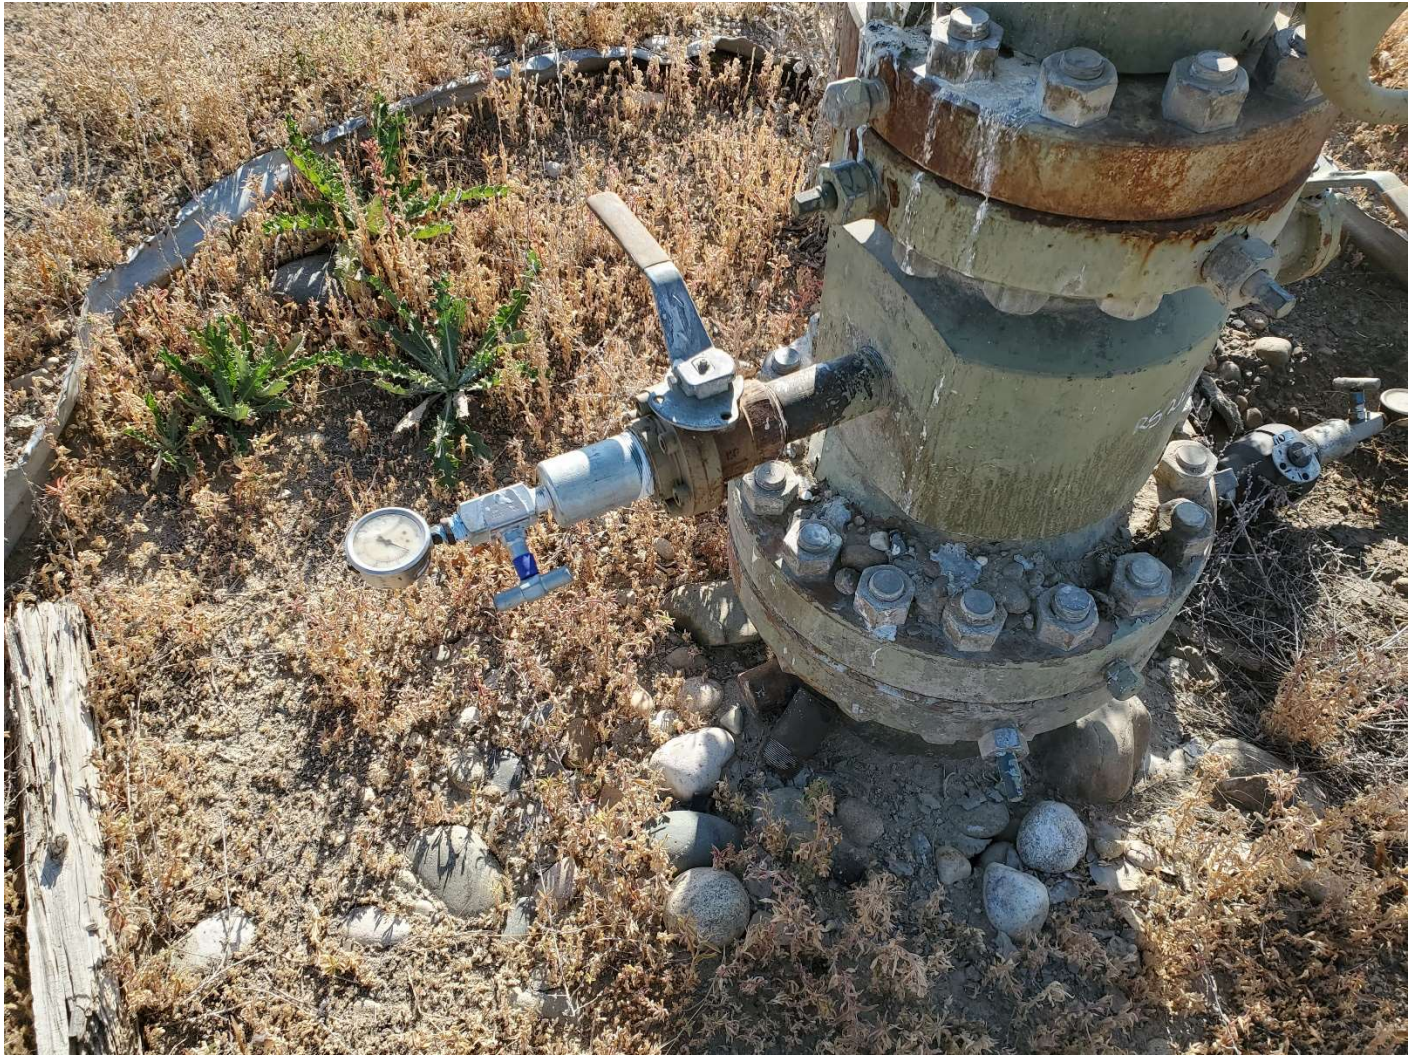
All analog pressure gauges (Surface and Production casing) show 0 psi; but unsure if they are functioning.

Wellhead detail showing production casing pressure gauge (inoperable?).

Per OGCC commissioners, this well needs P&A'd soon.

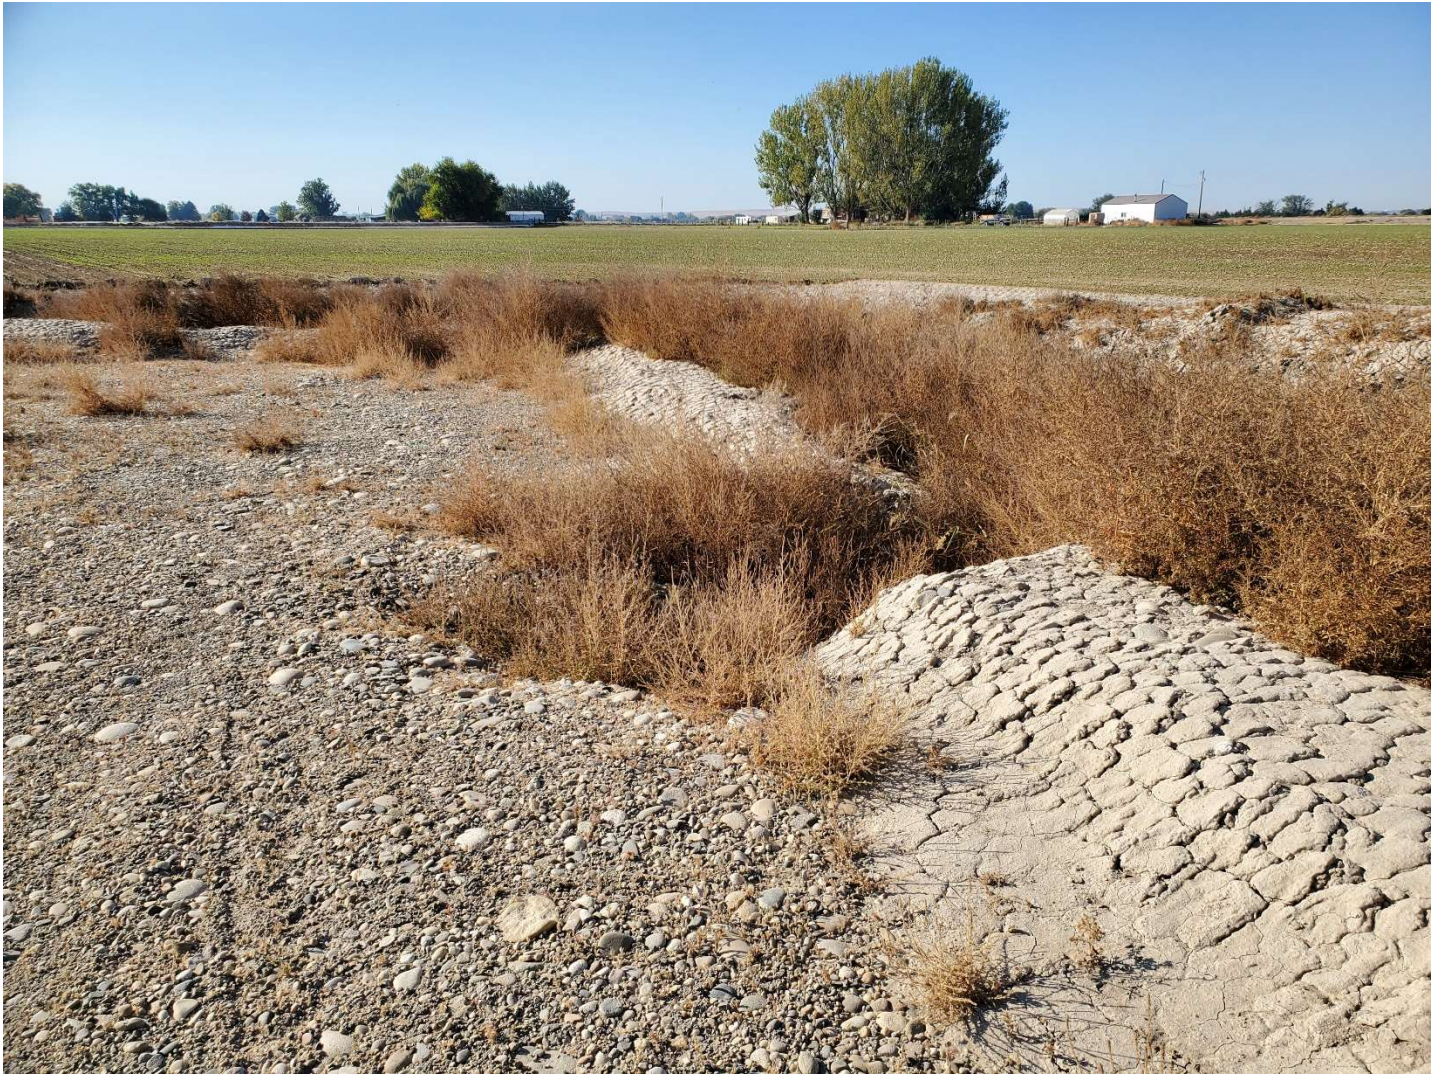
View SSW at SW corner of well pad showing continued erosion of the pad into an active irrigation ditch.

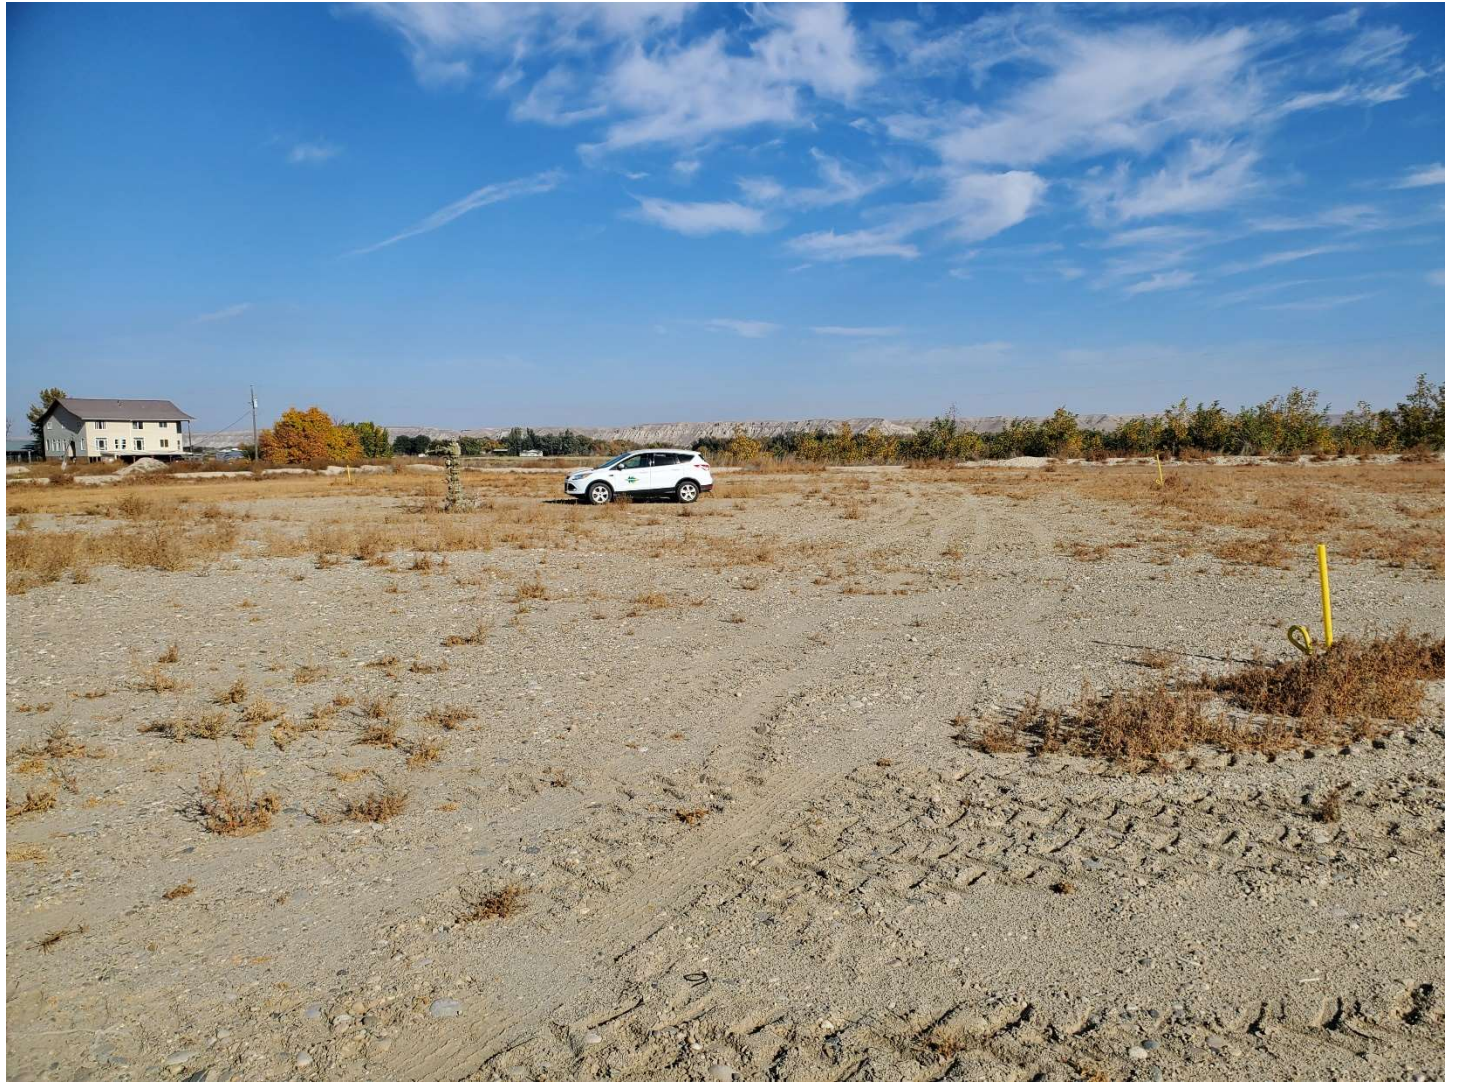
Well pad and wellhead, view NW. Weed encroachment occurring over most of well pad.
