## **Post Drilling/Annual Well Site Inspection Form**

Section 1: General Information			
Operation Data	Inspection Data		
Operator Name Snake River Oil + Gas, LLC	Inspector Name James Thum		
Well Name	Area Office		
Barlow #1-14, USWN 11-075-20033	Boise / Director's		
Barlow #2-14, USWN 11-075-20034			
Barlow #3-14, USWN 11-075-20040			
Authorized Contact Dan Johanek (208)707-7867 112 N. Plymouth, New Plymouth ID	Inspection Date 1/12/2023, 4:30 PM		
County	Report Date		
Payette	1/18/2023		
Inspector's Signature:	Inspection Summary:		
	Operation appeared to be in complication the inspection.	ance at the time of	
	Issues of concern identified at the ti	me of the	
Date of Signature:	inspection.	. 1 . 1 . 5	
<b>Location Description:</b> 1.0 miles ENE from Hwy 30 and Hwy 95 intersection in Fruitland, ID, large island in Payette River. Google Maps location Latitude 44.029862, Longitude -116.904138. Well pad contains 3 wells: Barlow #1-14, directionally-drilled Barlow #2-14 and Barlow #3-14, completed in separate sources of supply. Wells are currently producing (Harmon Field).  Weather- Mostly cloudy, calm wind 45°F.

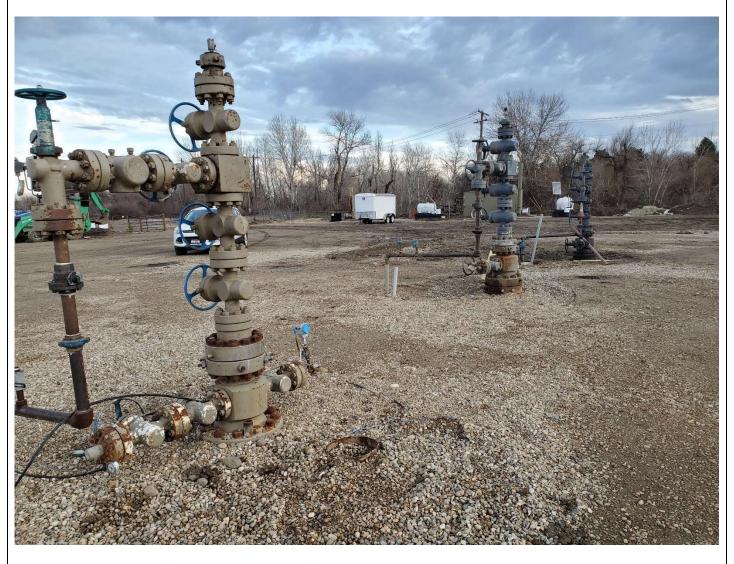
View east from center of Barlow well pad. Barlow 1-14 in left foreground, Barlow 2-14 in right middle, newly-installed Barlow 3-14 far right. Dual separator for 1-14, 2-14 behind Barlow 2-14 well head. Scavenger unit chem tanks, utility trailer to rear of photo.

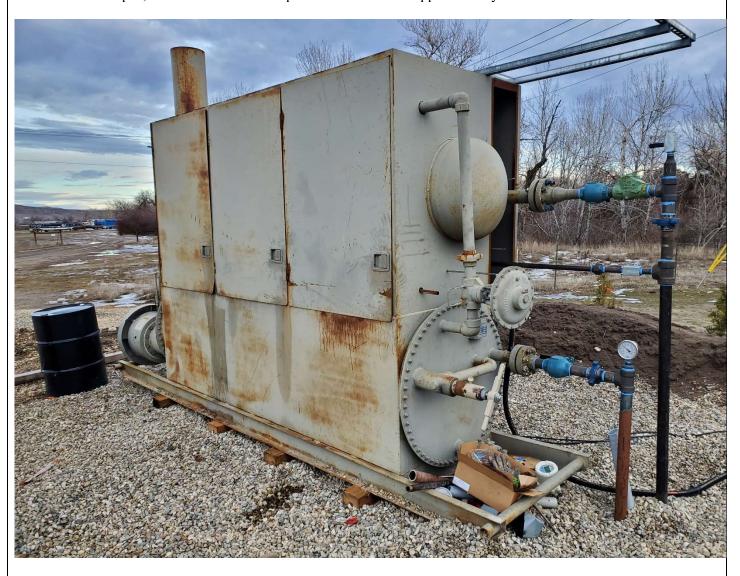
Separator Unit from Kauffman #1-9 location installed and operational for the 3-14 well. Separator is near the east corner of the well pad, northeast of the dual separator unit. View is approximately east.

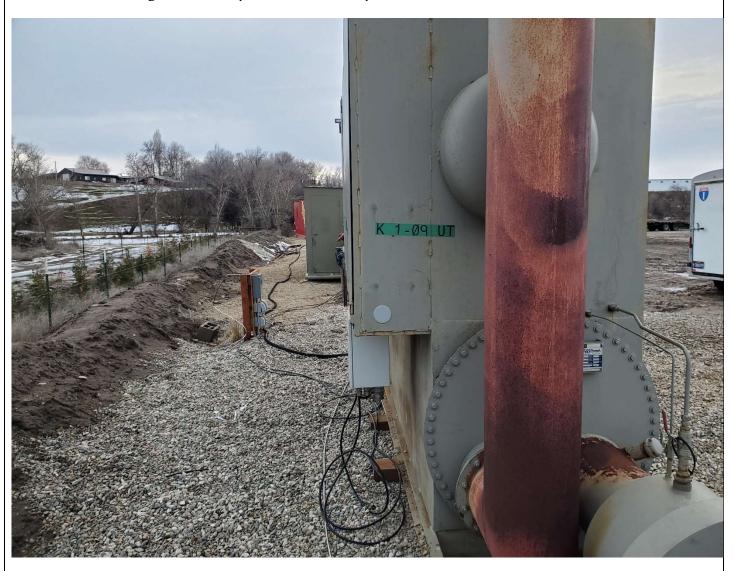
Barlow 3-14 separator unit (from the Kauffman 1-9 well. Dual unit is partially visible in center, behind the single unit. View is southwest along the southeast perimeter of the well pad.
