## **Post Drilling/Annual Well Site Inspection Form**

Section 1: General Information				
Operation Data	Inspection Data			
Operator Name	Inspector Name			
Snake River Oil + Gas, LLC	James Thum			
Well Name Fallon #1-10, USWN 11-075-20032	Area Office Boise / Director's			
Authorized Contact Dan Johanek (208)707-7867	Inspection Date			
112 N. Plymouth, New Plymouth ID	1/12/2023 2:15 pm; follow-up 4/12/2023, 3:00 PM			
County	Report Date			
Payette	4/23/2023			
Inspector's Signature:	Inspection Summary:			
James Thum	Operation appeared to be in compliance at the time of the inspection.			
/s/ James Thum 4/27/2023	Issues of concern identified at the time of the			
Date of Signature:	inspection.			
Location Description: 1.40 miles NNW from Hwy 30 and Hwy 95 intersection in Fruitland, ID, west side of Hwy 95 north of the Payette River. Google Maps location Latitude 44.045495, Longitude -116.927641 1/12/2023 weather: 45°F, mostly cloudy, calm winds 4/12/2023 weather: 52°F, overcast, south wind 5-10 MPH

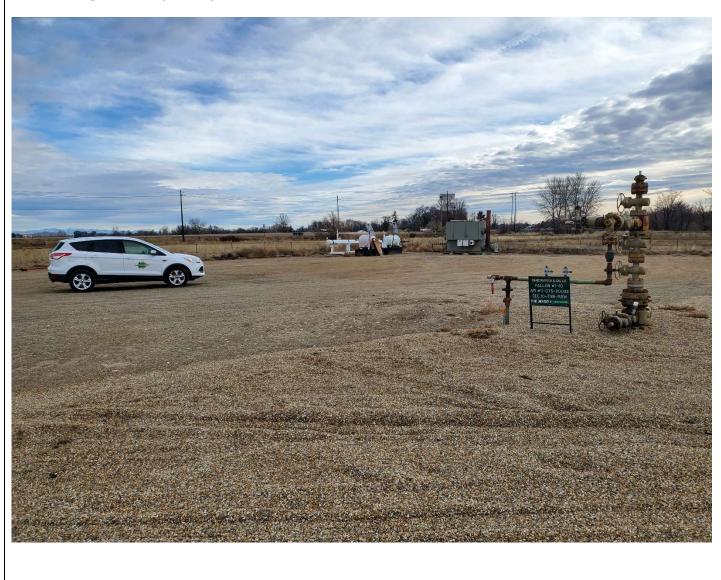
Well head, separator and gathering line riser, view southeast 1/12/2023

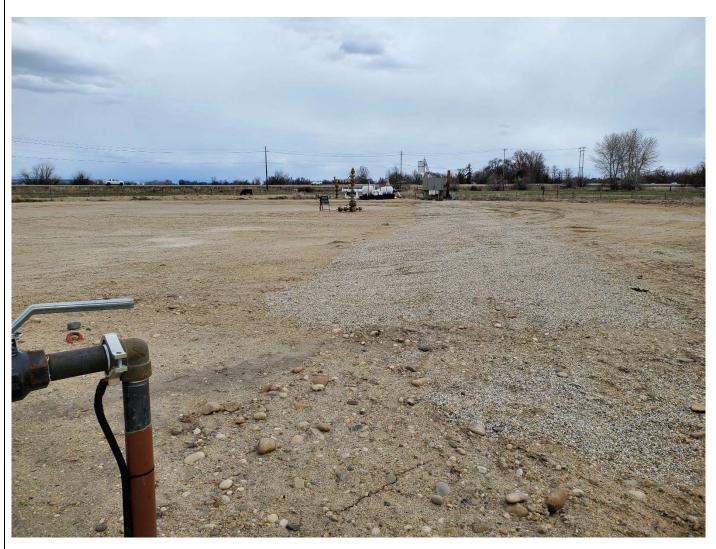
Well head from tank dike in northwest corner of pad, view southeast 4/12/2023. Disturbed / new gravel installed where water gathering line is located.

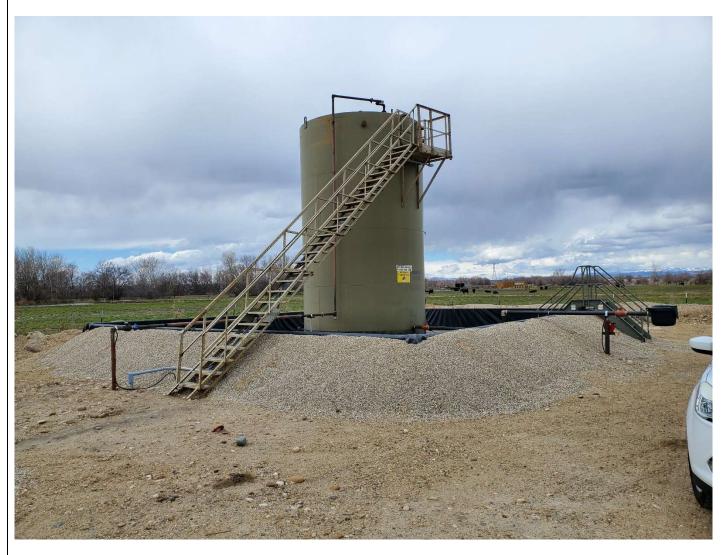
400 barrel capacity produced water tank and containment dike installed in northwest corner of the well pad, view northwest 4/12/2023. Piping, ladders and valve with spill containment device installed per Rule.

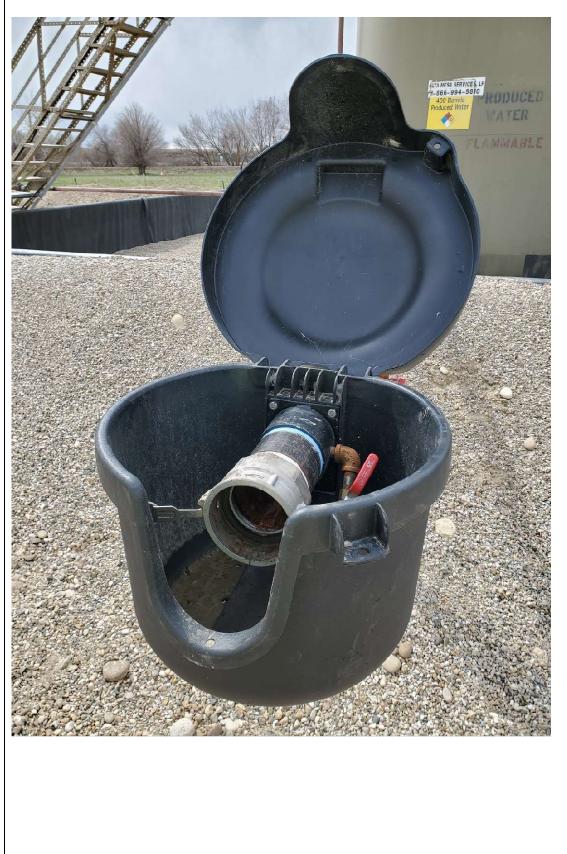
Spill prevention device installed around quick-connect coupler extending beyond dike wall. This is a current industry BMP which does not conform to IDAPA 20.07.02.420.01.c. but variance is approved by the department.

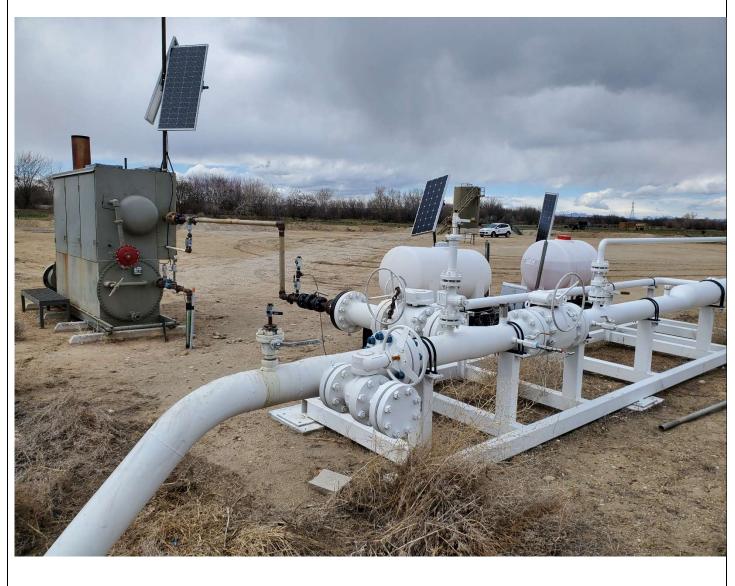
Separator, gathering line riser, and chemical treatment tanks in the southeast corner of the Fallon 1-10 well pad. View is northwest past the well head to the produced water storage tank located in the northwest corner of the well pad.
