Gas Processing Facility Inspection Form

Operation Data	Inspection Data
Operator Name: NW Gas Processing LLC / SROG	Inspector Name: James Thum
Location Name: Little Willow Gas Gathering Facility	Area Office: Boise / Director's office
Authorized Contact: Dan Johaneck (208) 707-7867 Tyler Hartung (208) 412-5475	Inspection Date: 6/20/2023 11:00 AM
County: Payette	Report Date: 6/23/2023
Inspector's Signature: <i>James Thum</i> Date of Signature: 6/23/2023	Inspection Summary: <input type="checkbox"/> Operation appeared to be in compliance at the time of the inspection. <input checked="" type="checkbox"/> Issues of concern identified at the time of the inspection.

Location Description: 4649 Little Willow Road, Payette ID 83661. SE side of Little Willow Road, 2.5 miles NE of the intersection of Idaho SR 52, 6 miles east of Payette ID. Weather- 56°F, partly cloudy, calm winds. Production appears to be shut-in.

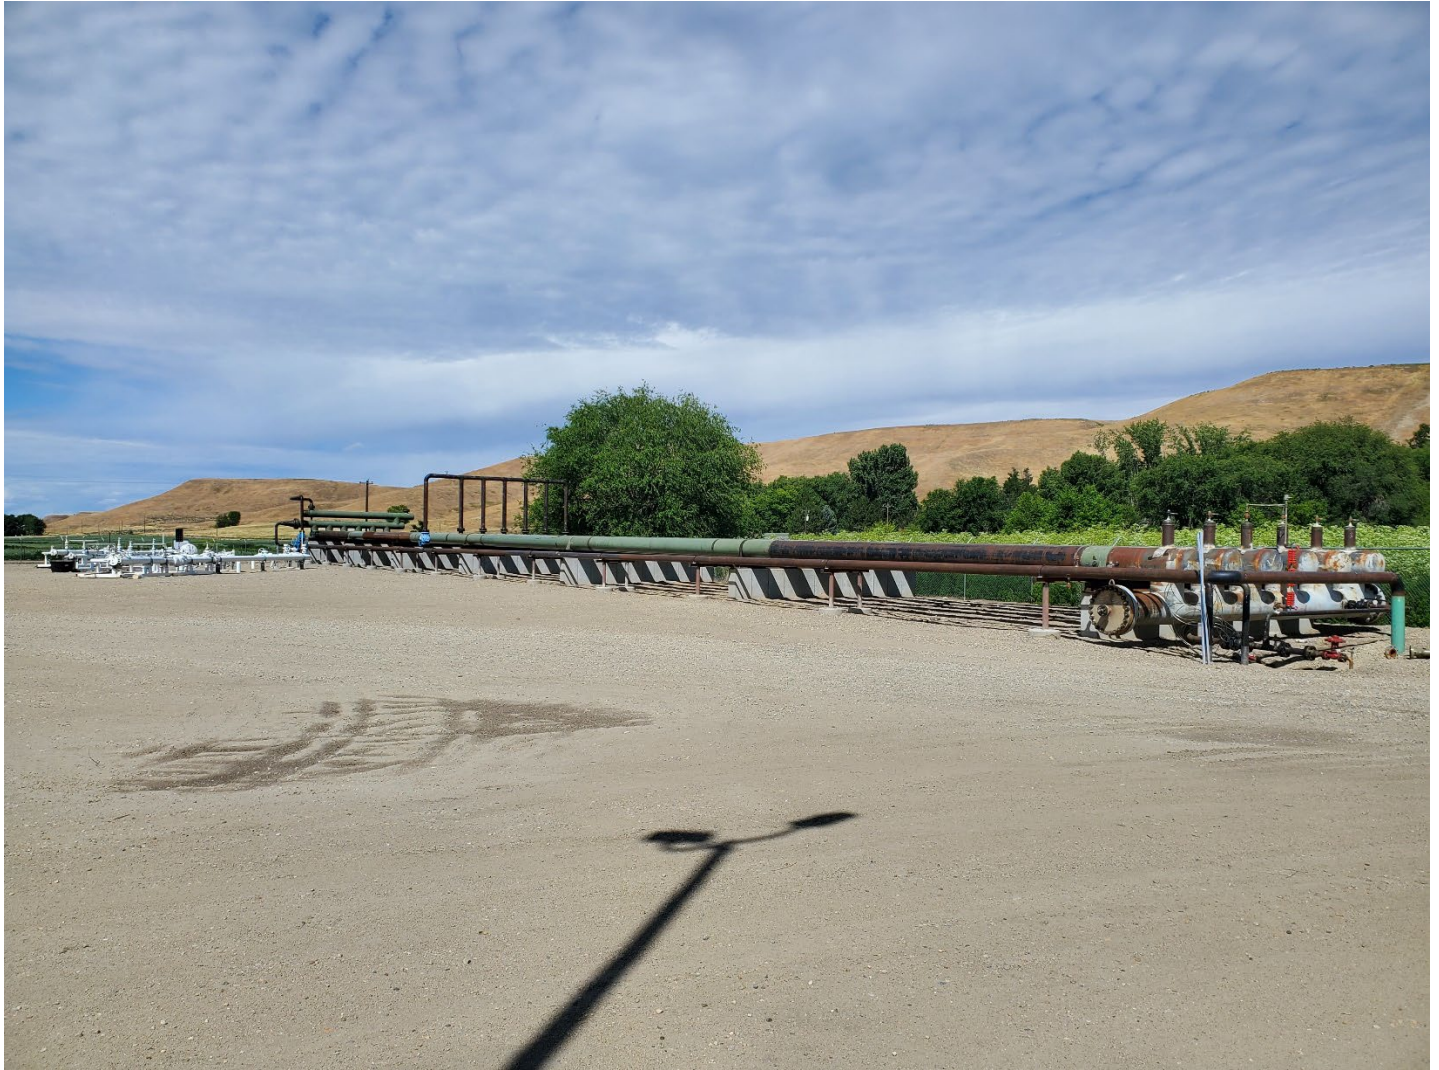
View west of 6-finger slug catcher with gathering system riser on left.

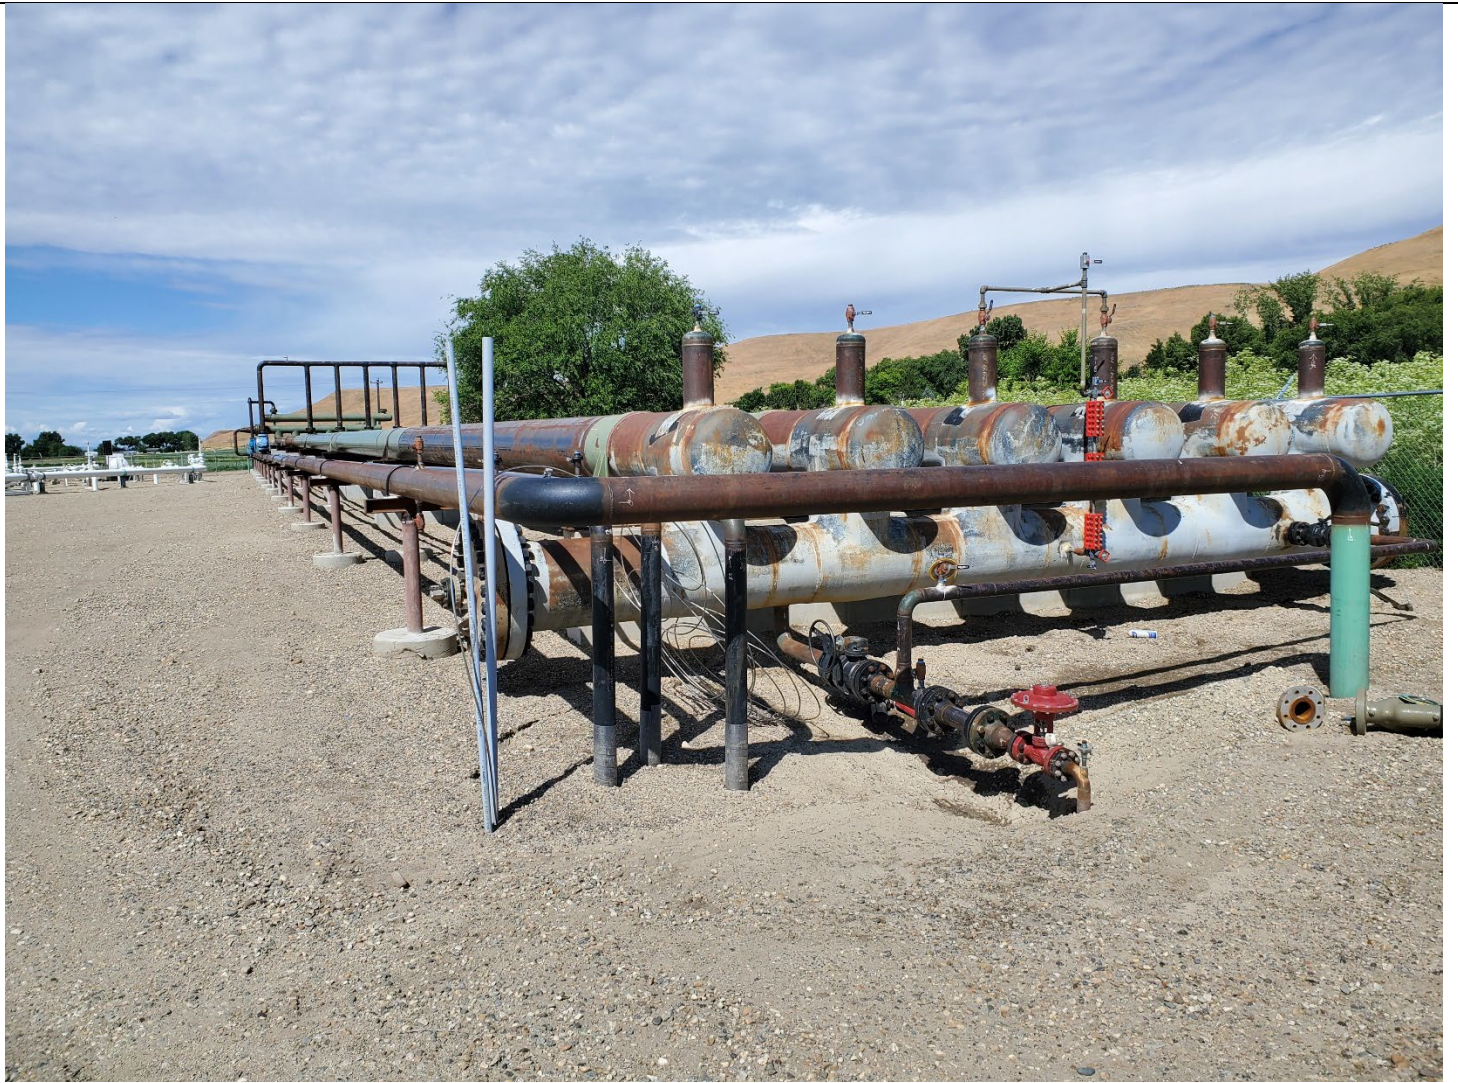
Detailed view of east side of 6-finger slug catcher, looking west.

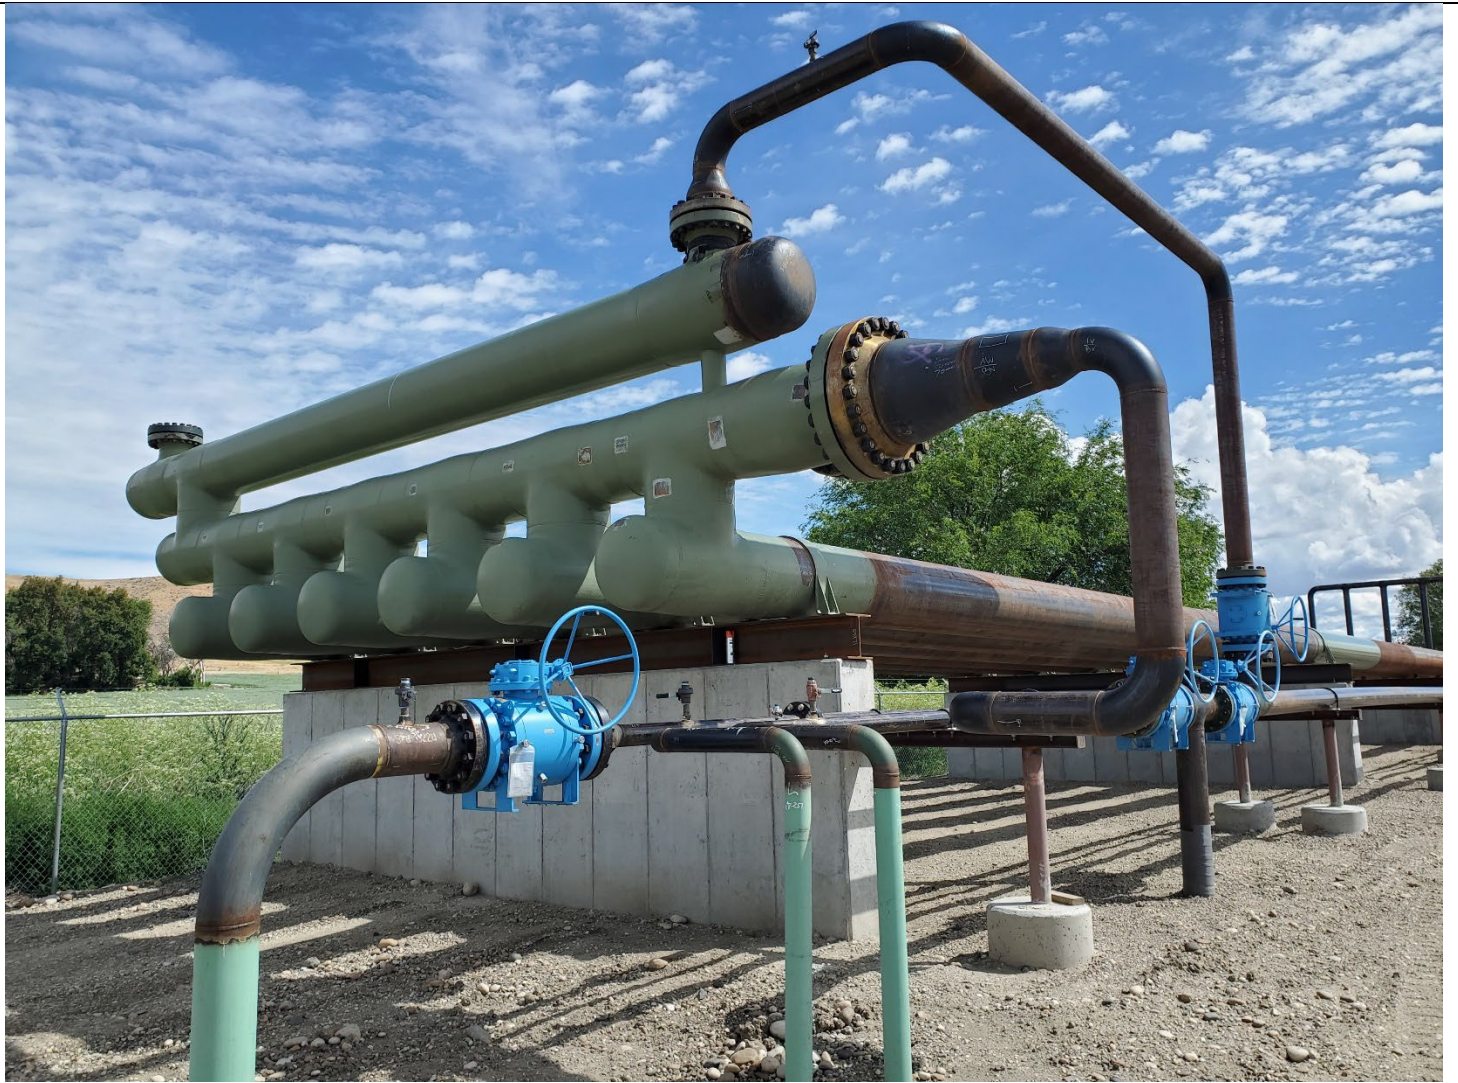
Detailed view of west side of 6-finger slug catcher, looking north.

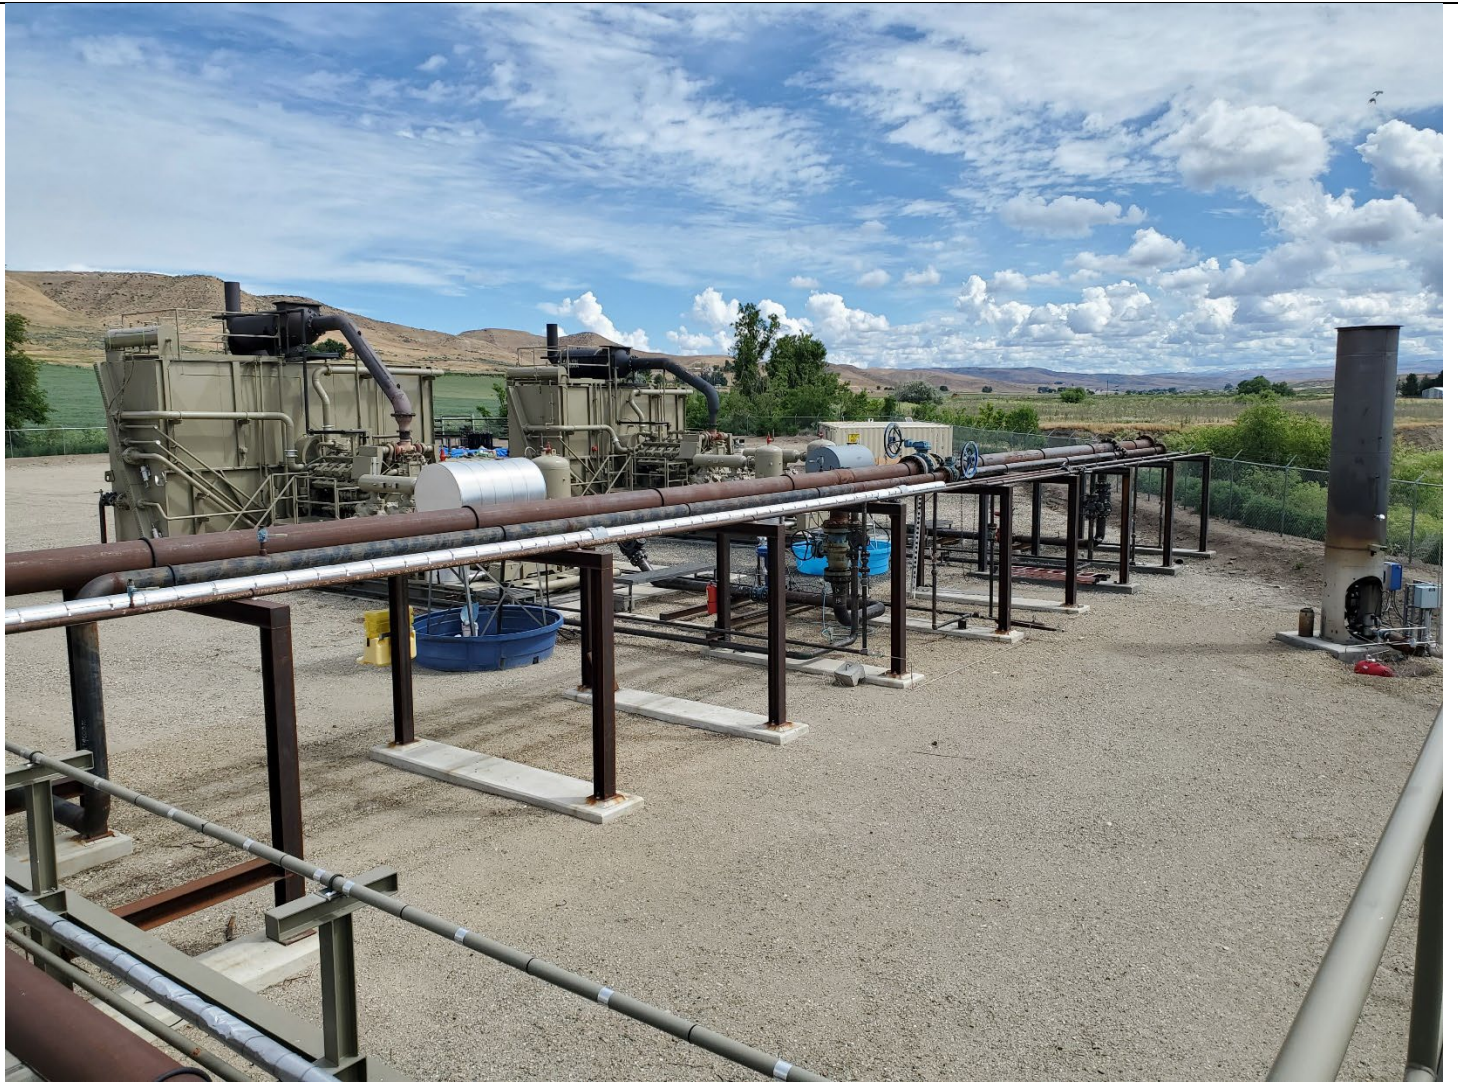
Section 6 Comments: As-built facility plans will need revisions submitted to reflect dual compressors installed to replace single compressor, new installation of 6-finger slug catcher and de-commissioned well separator units.

View north of new compressors installed to replace the former single compressor.

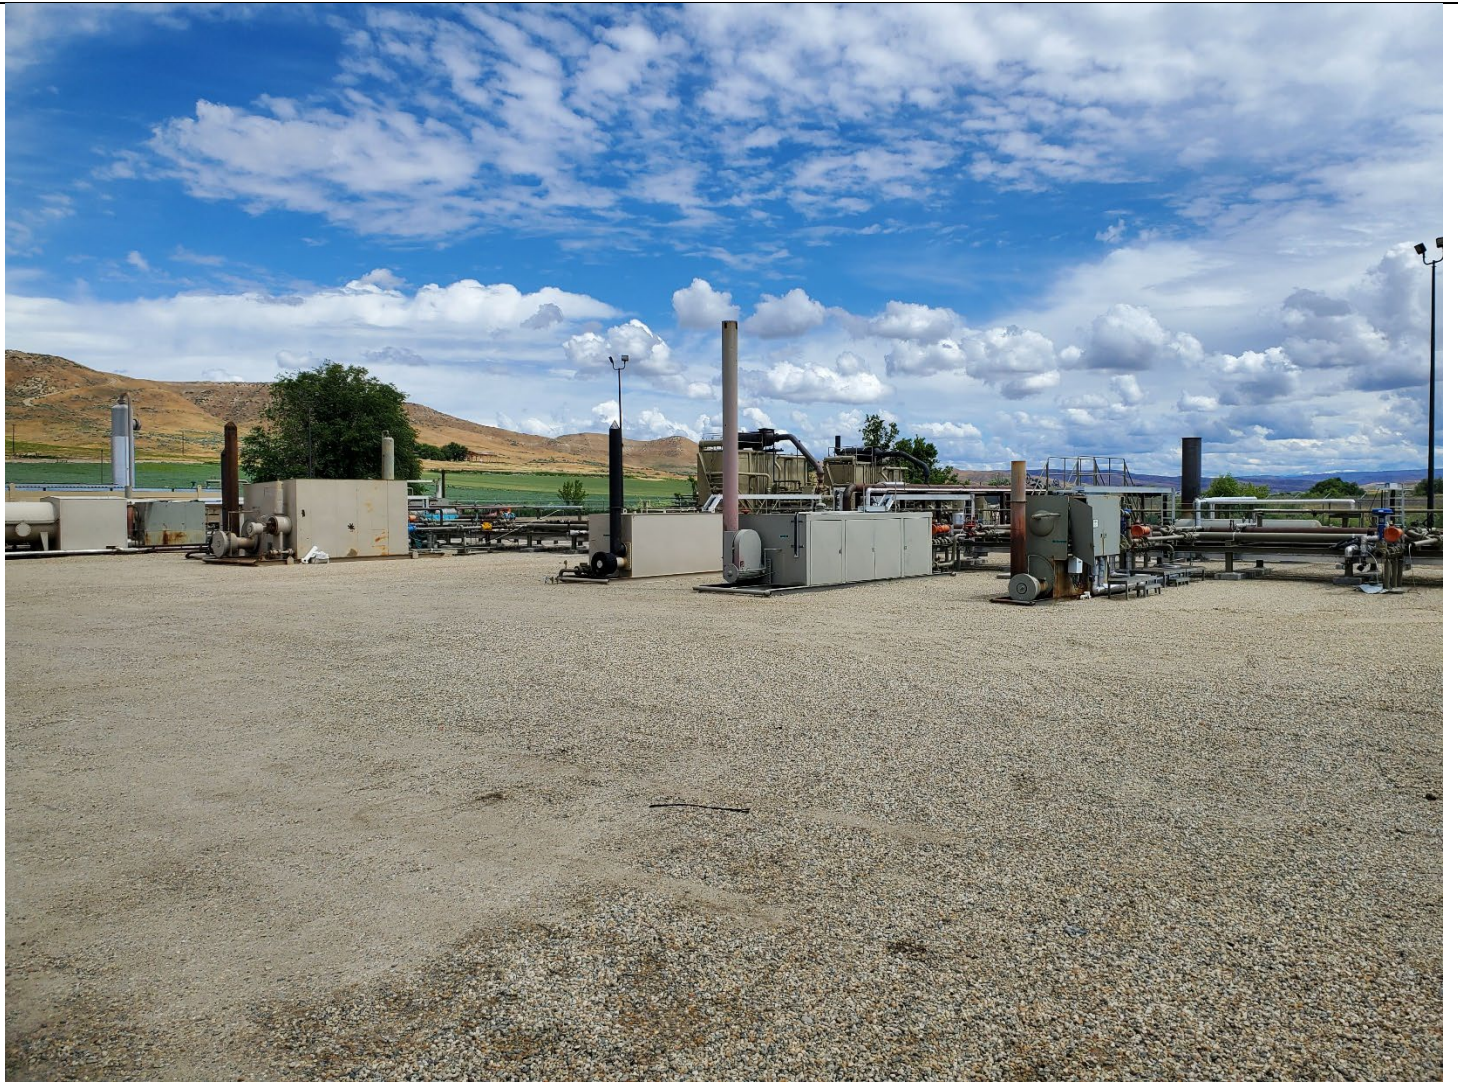
View north of well separator units. From left to right: combined well (Kauffman 1-34, ML 1-3, ML 2-3), ML 3-10, ML 2-10 and ML 1-11 UT. ML 1-11 LT separator has been removed.

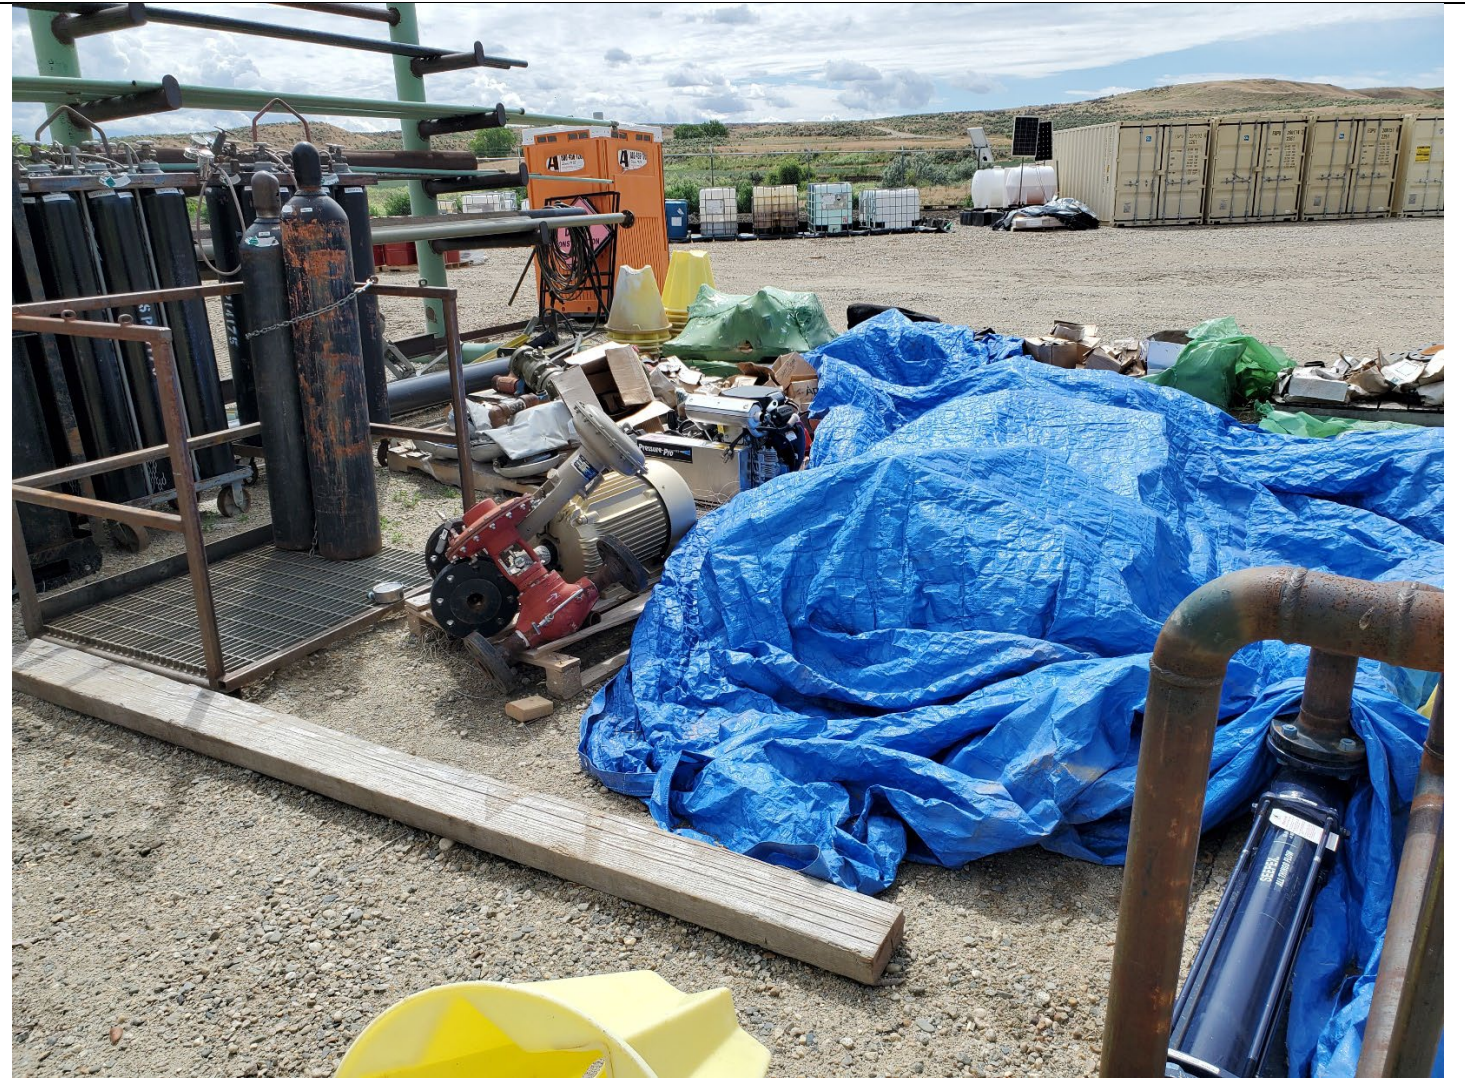
All production appears to be shut-in on day of inspection. Facility in need of general clean-up from on-going maintenance and recent upgrade installations for compressors and slug catcher. An additional dual gate has been installed at the west side of the perimeter fence and the western end of the slug catcher. Gate was locked on day of inspection.

Temporary storage location of equipment and materials being utilized for current maintenance and installation operations. Stockpile is located in the northeast corner of the facility. View is south-southeast. Portable spill containment berm with palletized chemicals in background center.

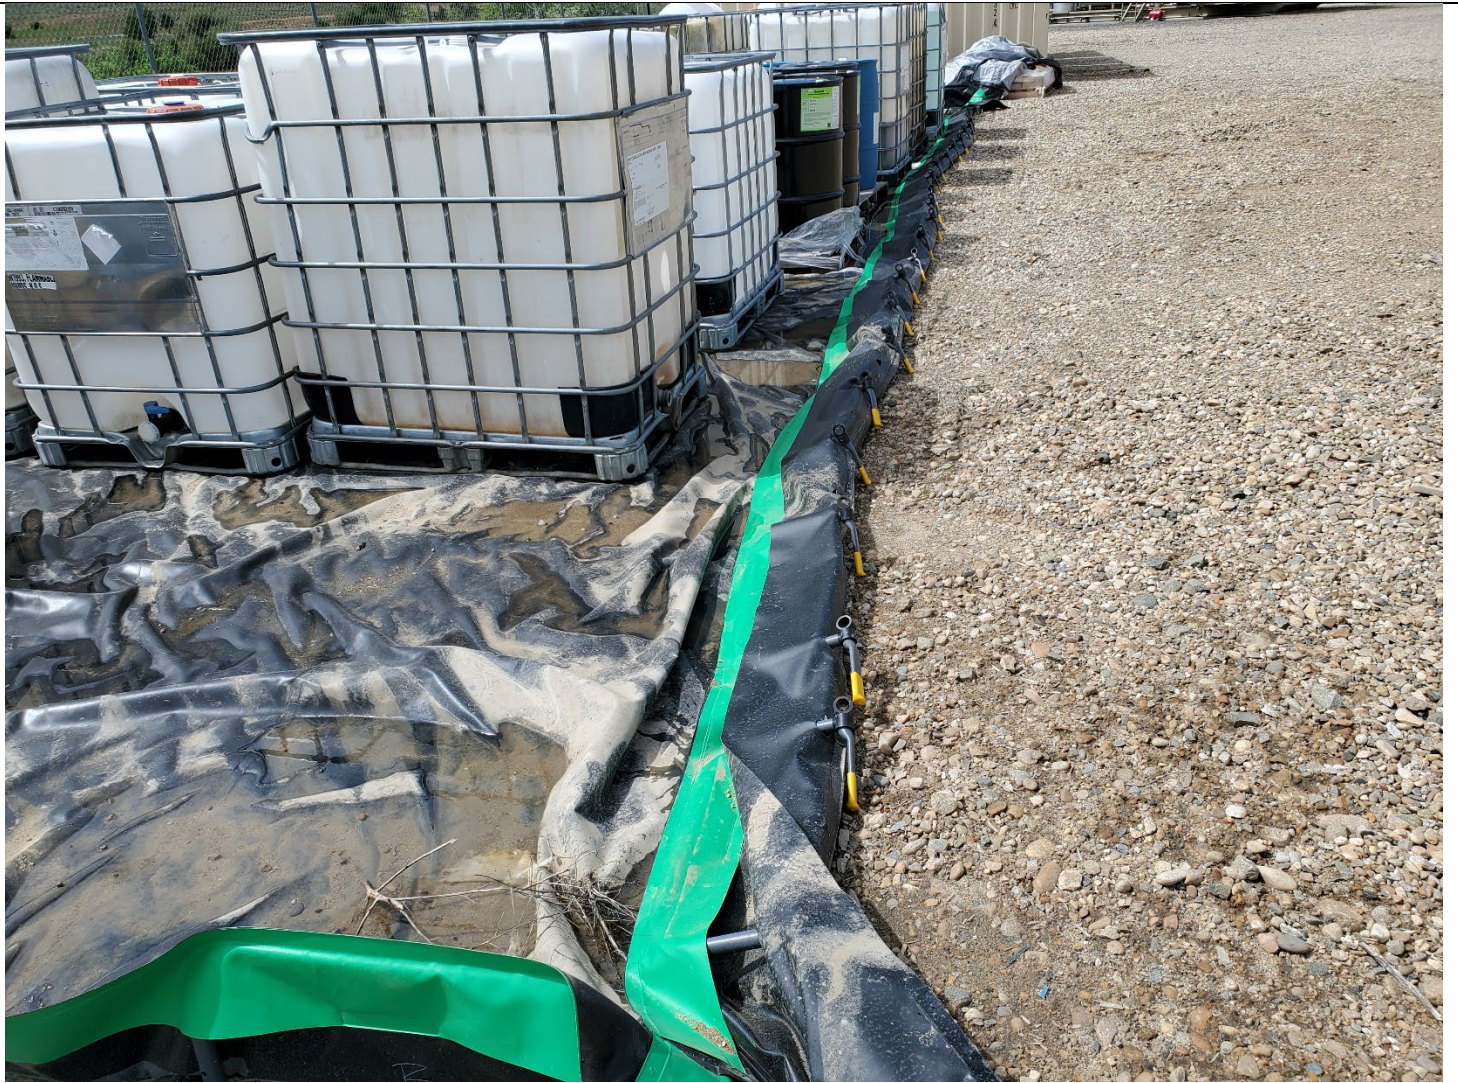
Portable spill containment berm has been relocated to the east corner / southeast side of the facility to accommodate the slug catcher installation. The northwest side of the berm was not staked and was lying flat which would not contain any potential spills.

Portable spill containment berm with palletized chemical containers, east side of facility. View is southwest. Spill containment berm is not staked properly and north perimeter is flat.

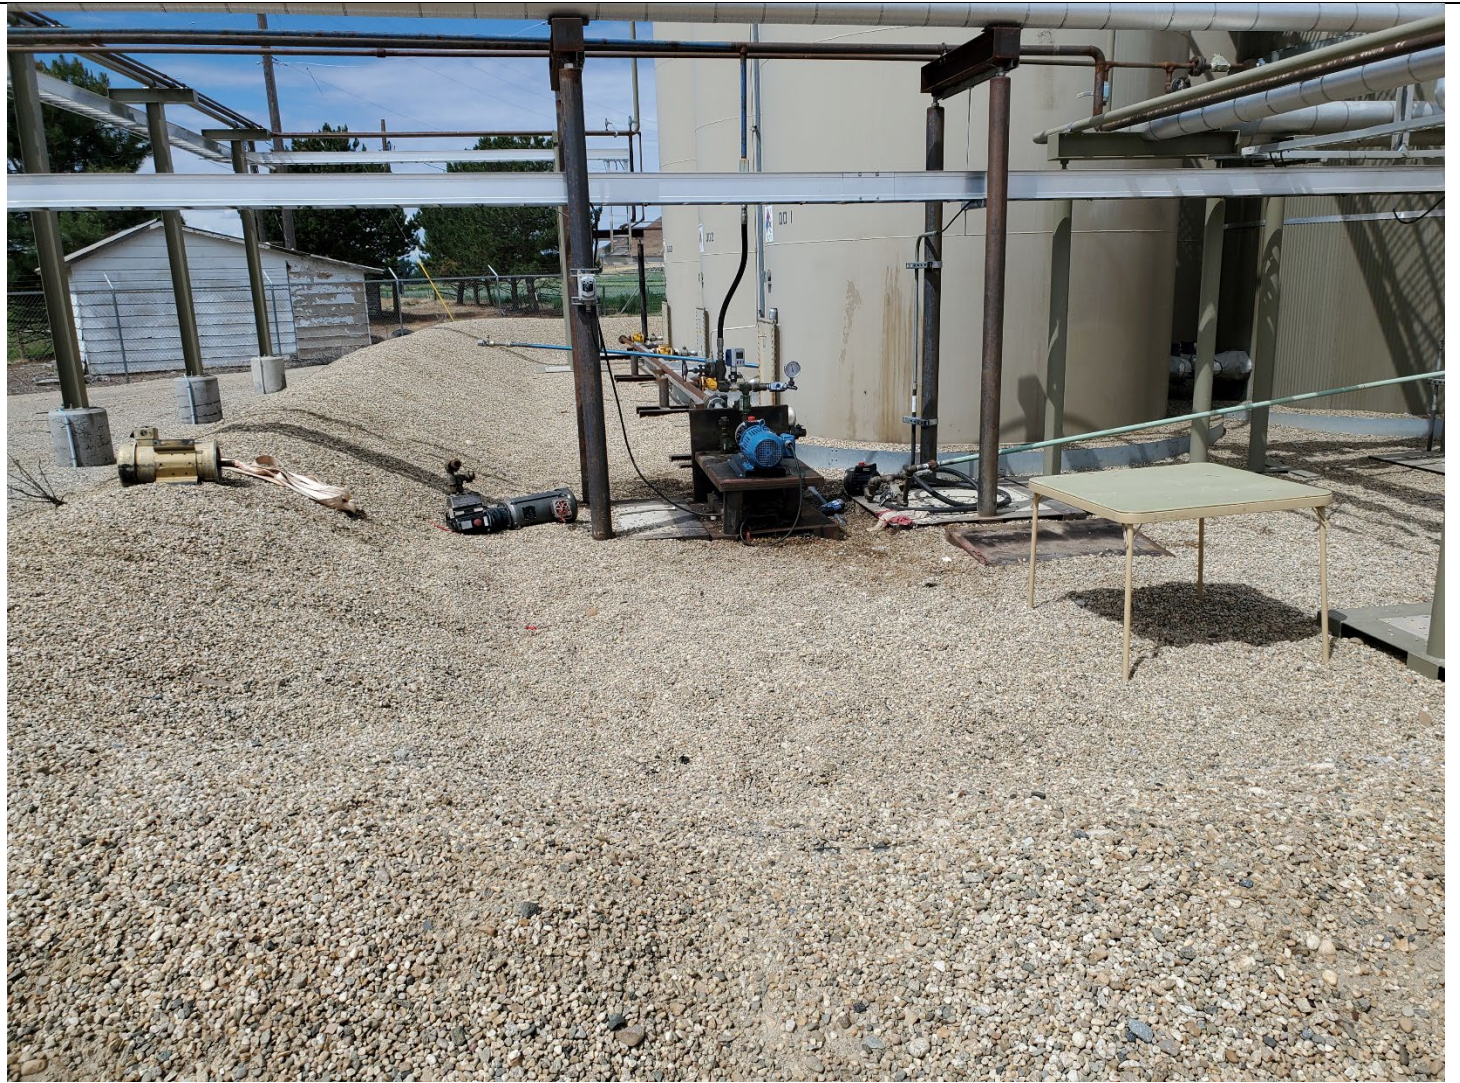
- iv. Is vegetation on top and outside surface properly maintained? Yes No
- v. Is a ladder or other permanent device installed over the tank dike to access the containment reservoir? **Not always utilized** Yes No

“Southeast (produced water)” tank dike volume calculations (See Section 7 above):

Inside dike dimensions: 28 inches high X 80 feet long X 50 feet wide = 9,333.32 feet³

1 US barrel = 5.61 feet³ 400 bbl = 400 X 5.61 feet³ = 2244 feet³

9,333.32 feet³ / 2244 feet³ = 4.16 times (minimum requirement = 1.5X per IDAPA 20.07.02.420.02.a)

400 barrel produced water tanks and southeast side of containment dike, view southwest. Equipment inside containment dike from recent maintenance and installation operations. Worn foot paths over the dike indicates the access ladders are not being fully utilized and the liner is exposed in multiple areas on both dikes.
