Post Drilling/Annual Well Site Inspection Form

Section 1: General Information	
Operation Data	Inspection Data
Operator Name Snake River Oil + Gas, LLC	Inspector Name James Thum
Well Name Tracy Trust #3-2, USWN 11-075-20011	Area Office Boise / Director's
Authorized Contact Dan Johaneck (208)800-9503 112 N. Plymouth, New Plymouth ID	Inspection Date 10/6/2023; 8:30 AM
County Payette	Report Date 10/16/2023
Inspector's Signature: <div style="text-align: center; font-family: cursive; font-size: 1.2em; margin: 10px 0;">James Thum</div> Date of Signature: 10/16/2023	Inspection Summary: <input type="checkbox"/> Operation appeared to be in compliance at the time of the inspection. <input checked="" type="checkbox"/> Issues of concern identified at the time of the inspection.
Location Description: 1.5 miles east of New Plymouth, Payette Co. Idaho. Due east of the intersection of Idaho Street and Blaine Road. Google map location Latitude 43.973024, Longitude -116789054. Contacted Tyler Hartung, SROG two days in advance to meet me at the well site with a digital pressure gauge to take pressures on the surface and production casing strings. Well has been partially plugged since November 2019.

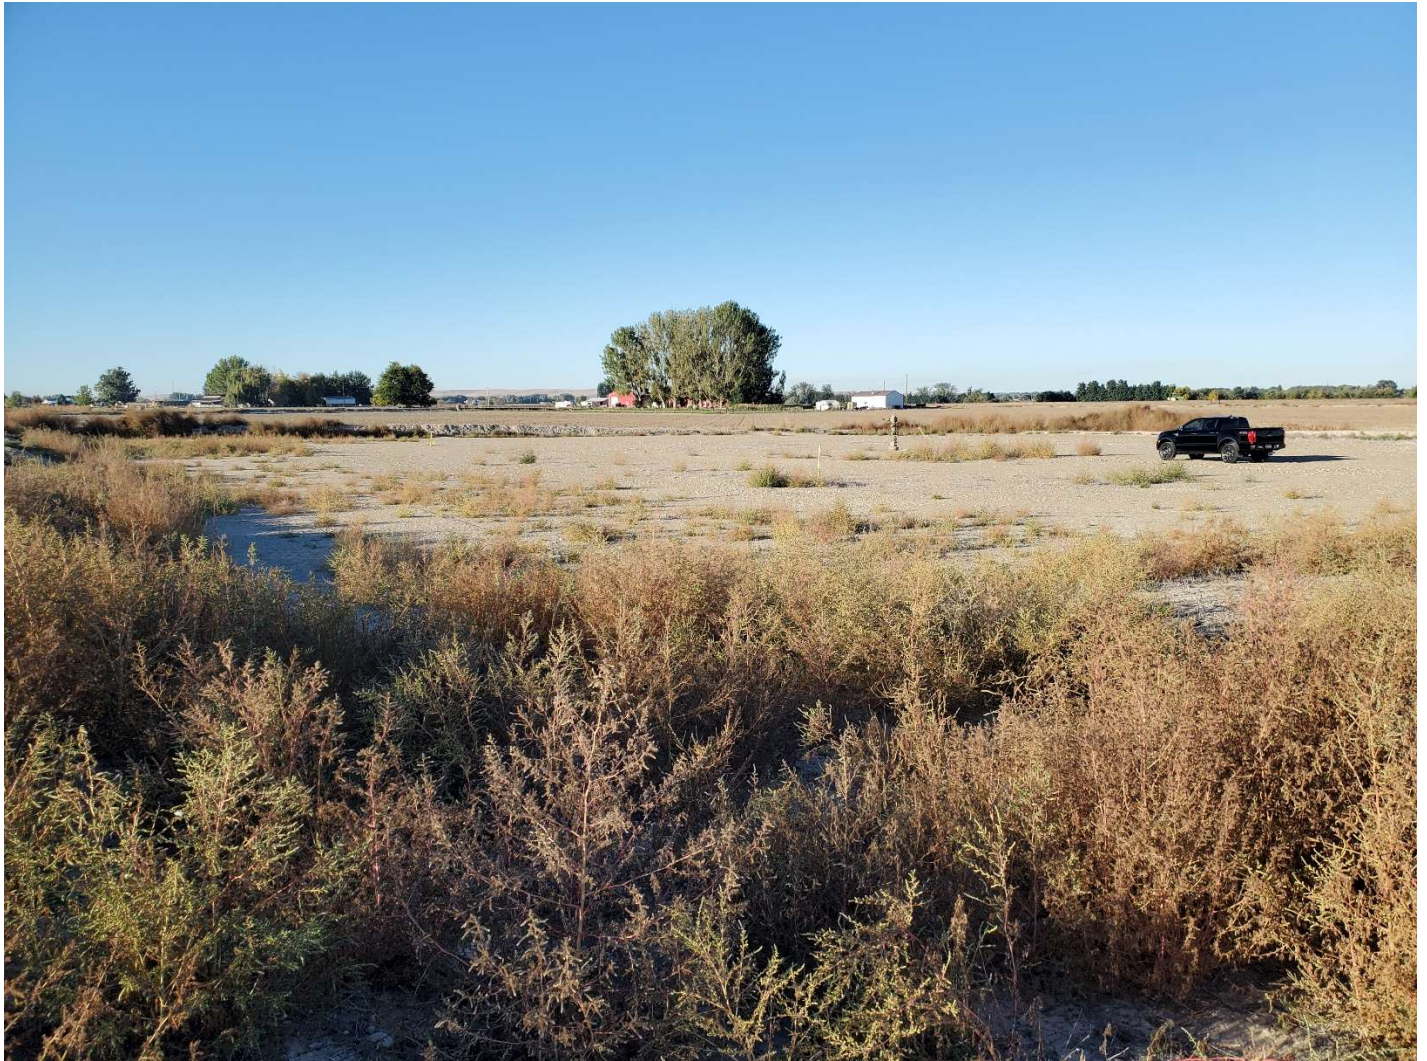
Location needs weed abatement (5% to 10% coverage). Some pad erosion near southwest corner. No well signage at entrance or at well head.

Well pad overview from NE corner, looking southwest. Well head is in right-center, just left of inspection vehicle.

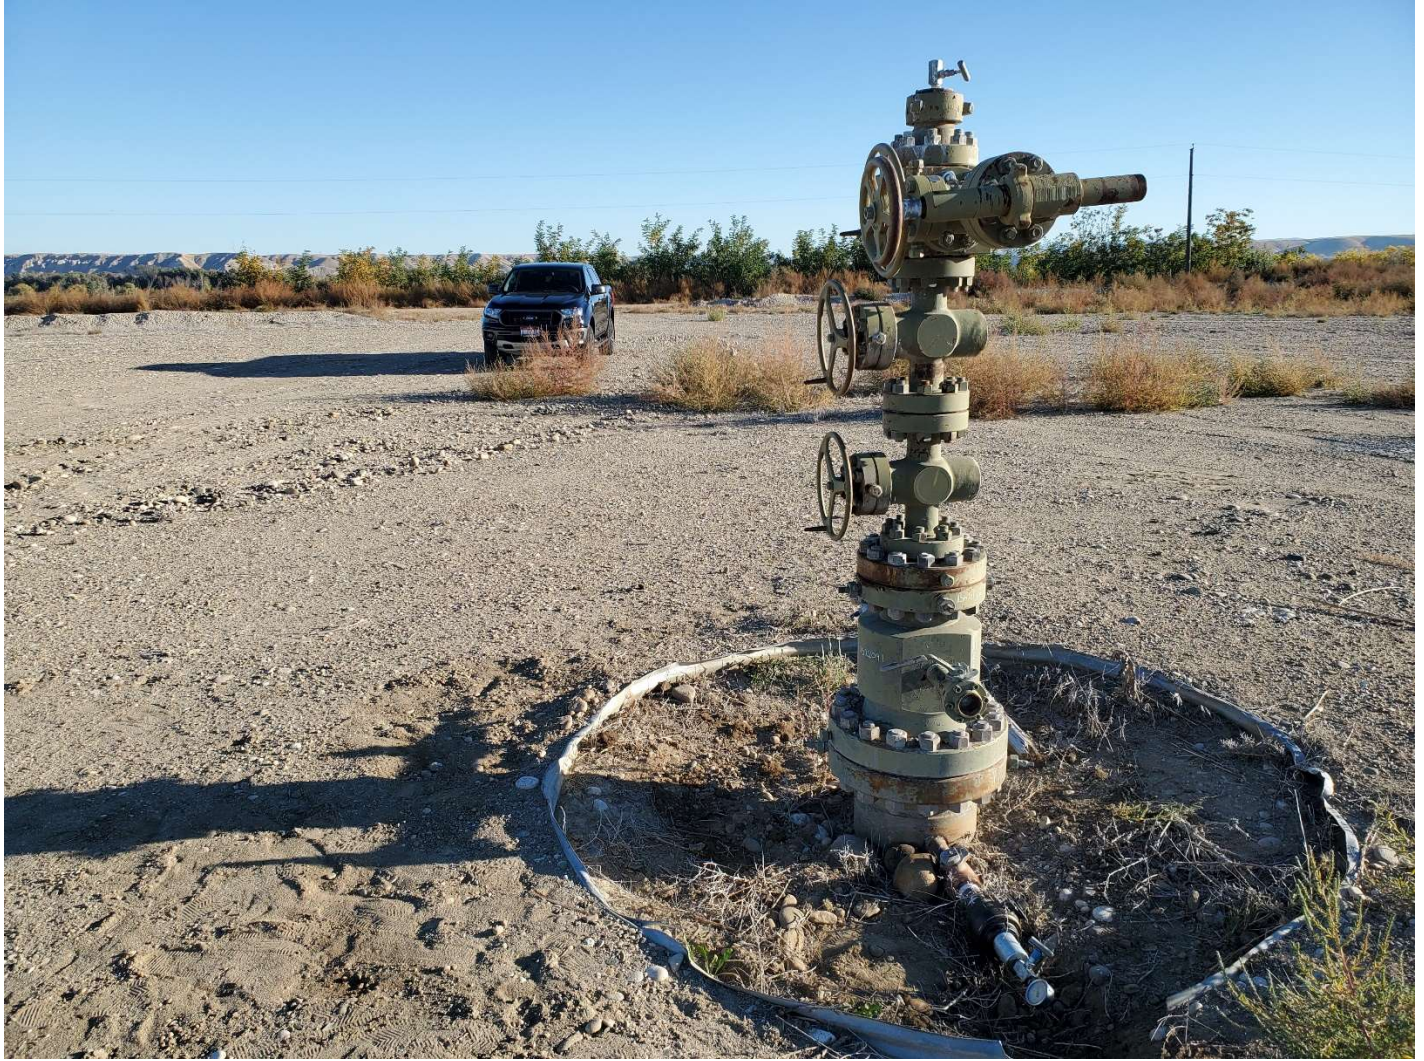
Analog gauges are installed but possibly not functioning. Met SROG field staff Tyler Hartung on location with digital gauge to verify pressure readings. Measured for 1-2 minutes each, with no change in pressures observed.

Surface casing = 0.2 PSI

Production casing = 0.5 PSI

Tubing string N/A (cemented to surface during November 2019 plugging operations).

View of Christmas tree looking NE.

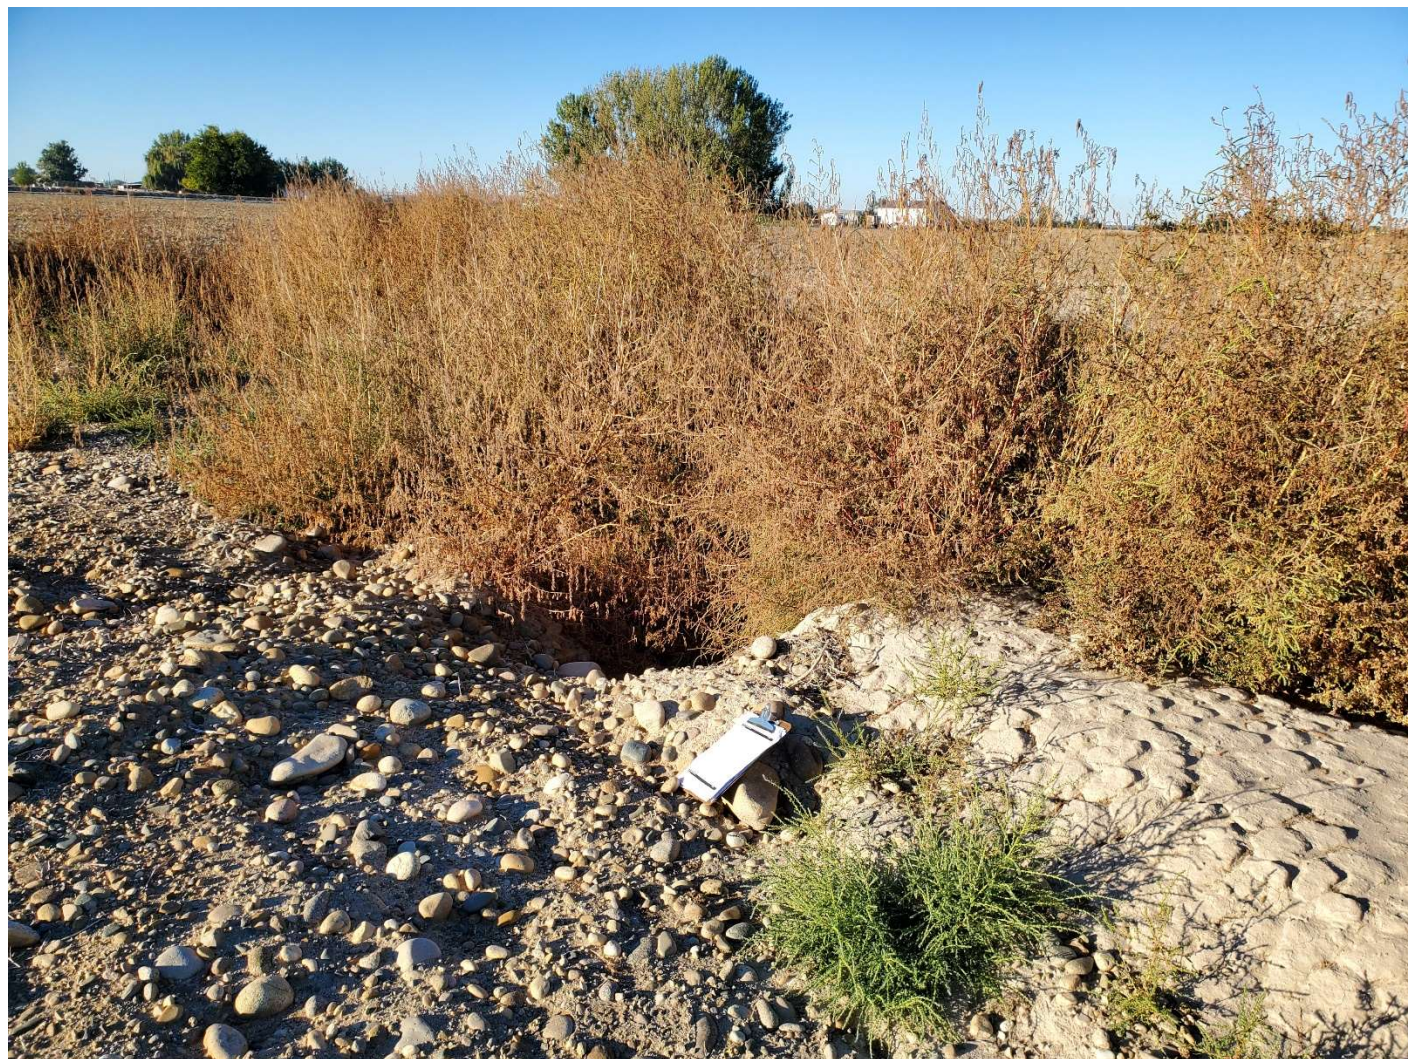
View of southwest corner of well pad, looking southwest showing area of pad erosion into irrigation ditch beyond vegetation.
