Section 4: Location Operations
20.07.02.301

Section 10: Inspection Comments

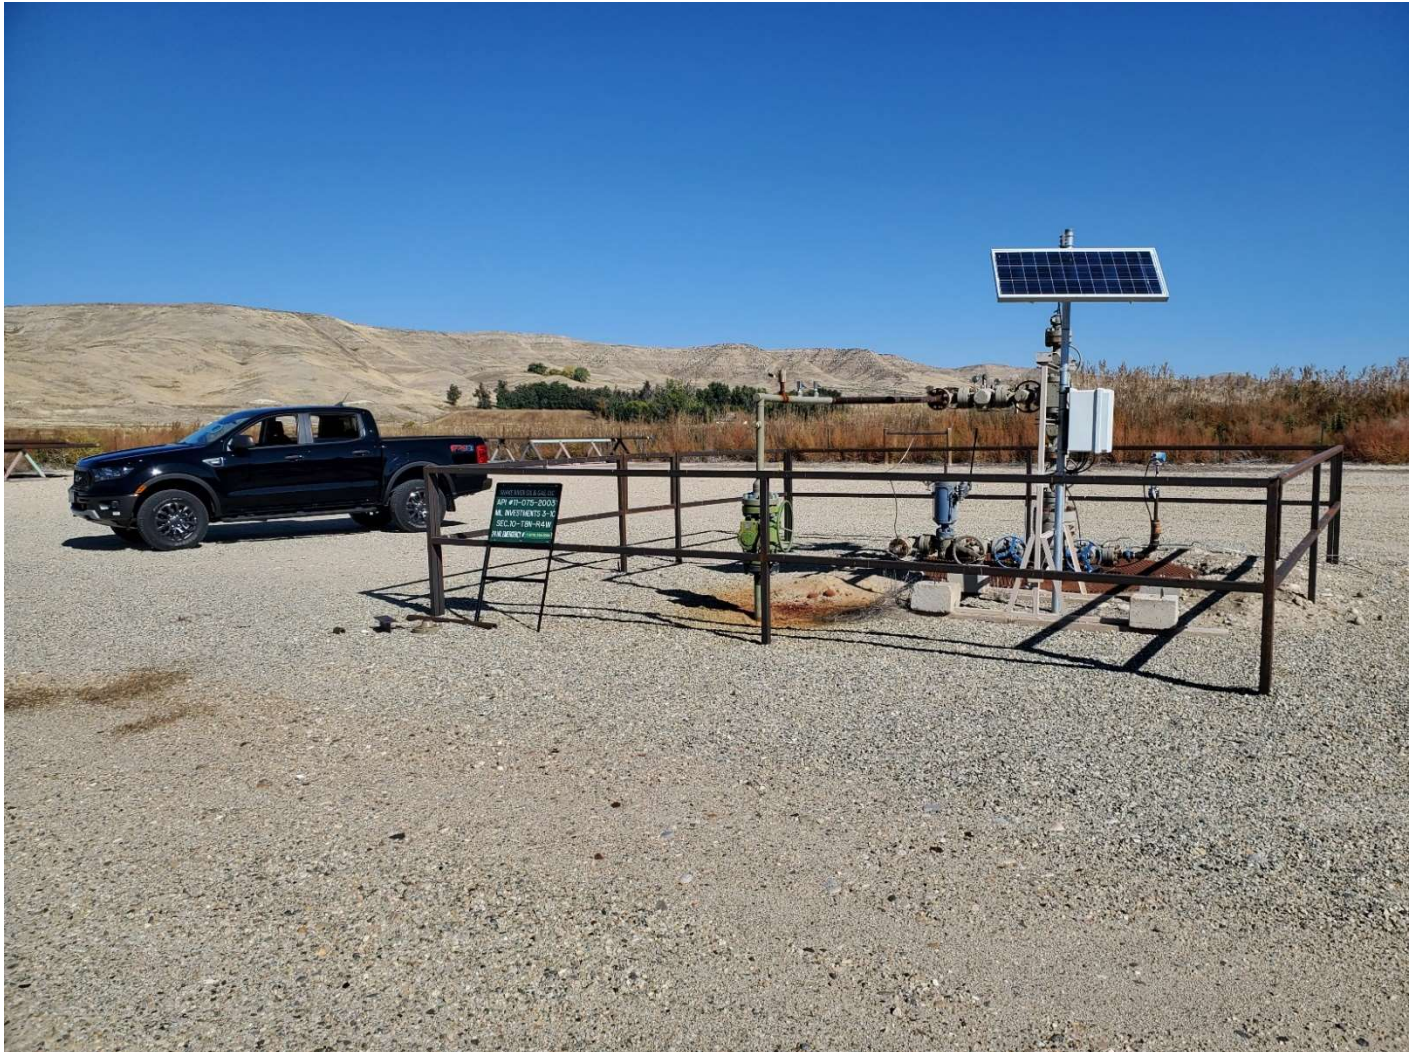
Well head, solar panel and internal metal fence. View North-Northwest

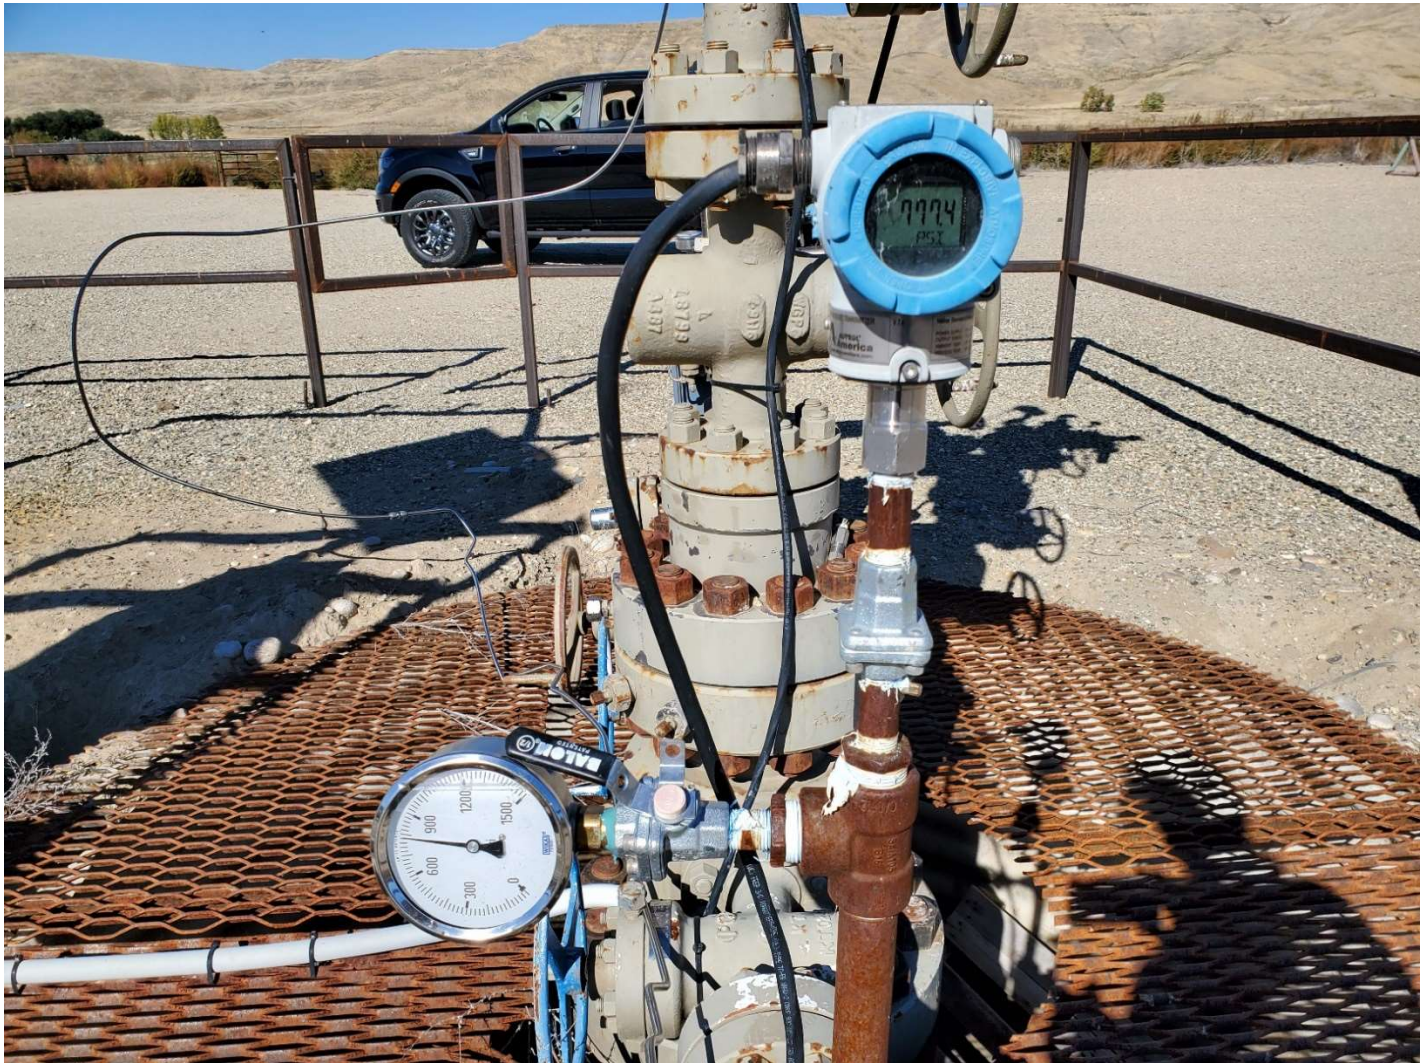
Production casing: 777.4 PSI (analog and digital gauges; this well has a sliding sleeve on the 2 7/8” tubing string)

Tubing string: 481 PSI (digital gauge; analog appears inoperative)

Production casing analog and digital gauges. View is Northwest

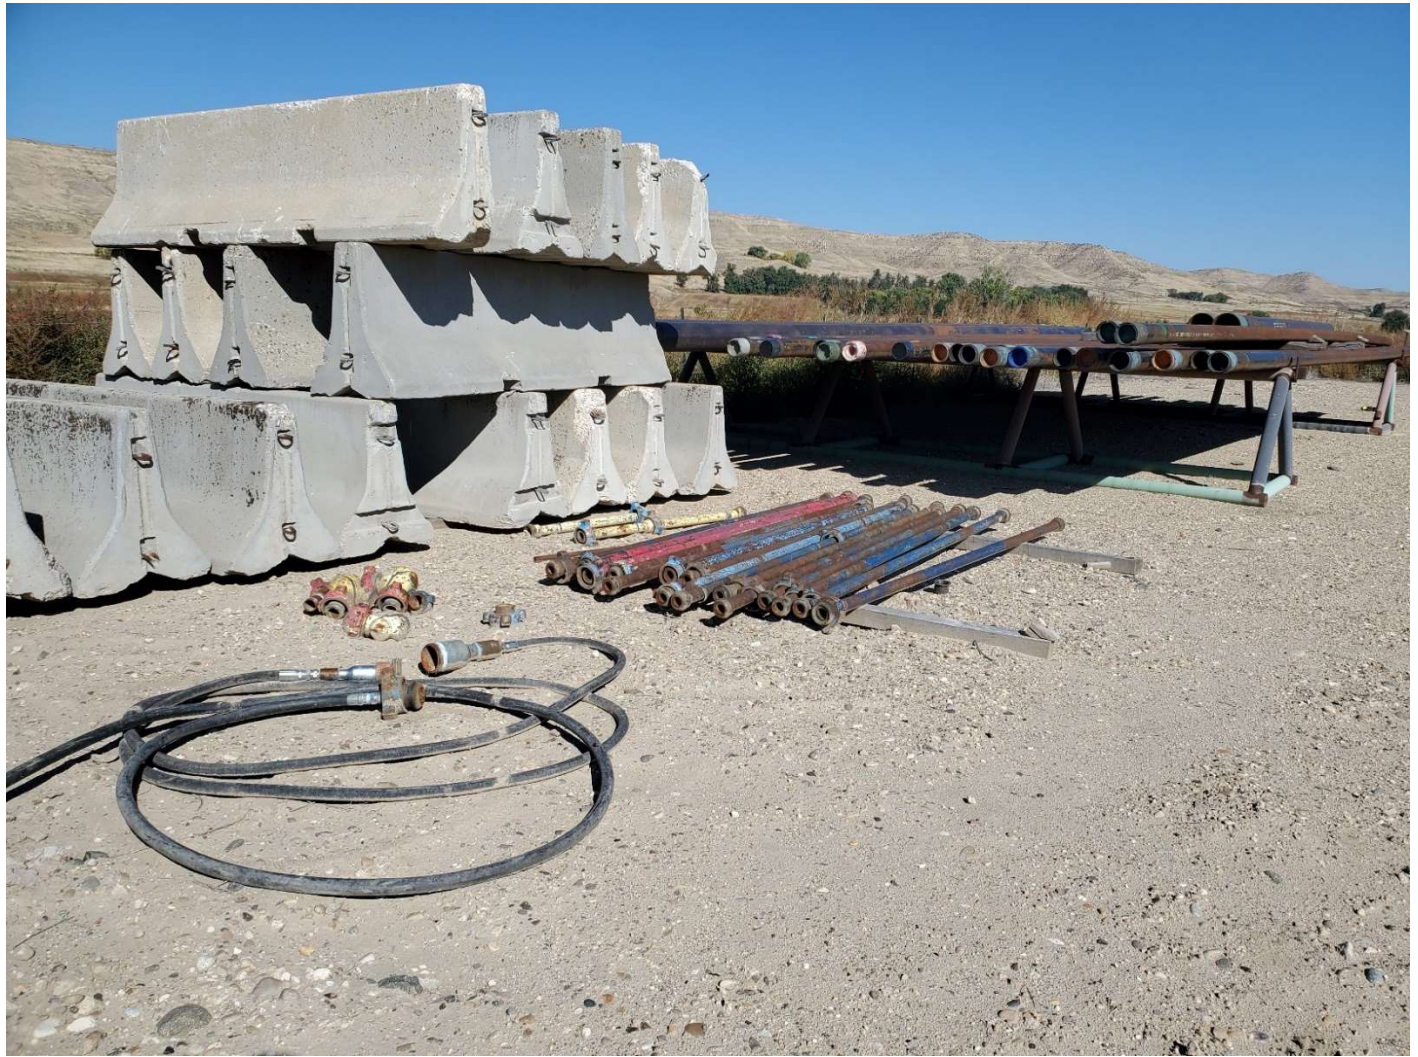
Casing, tubing and miscellaneous equipment stored on northwest perimeter of well pad. View is North.

Several pieces of equipment need secured and/or palletized if they will remain on the pad long-term.

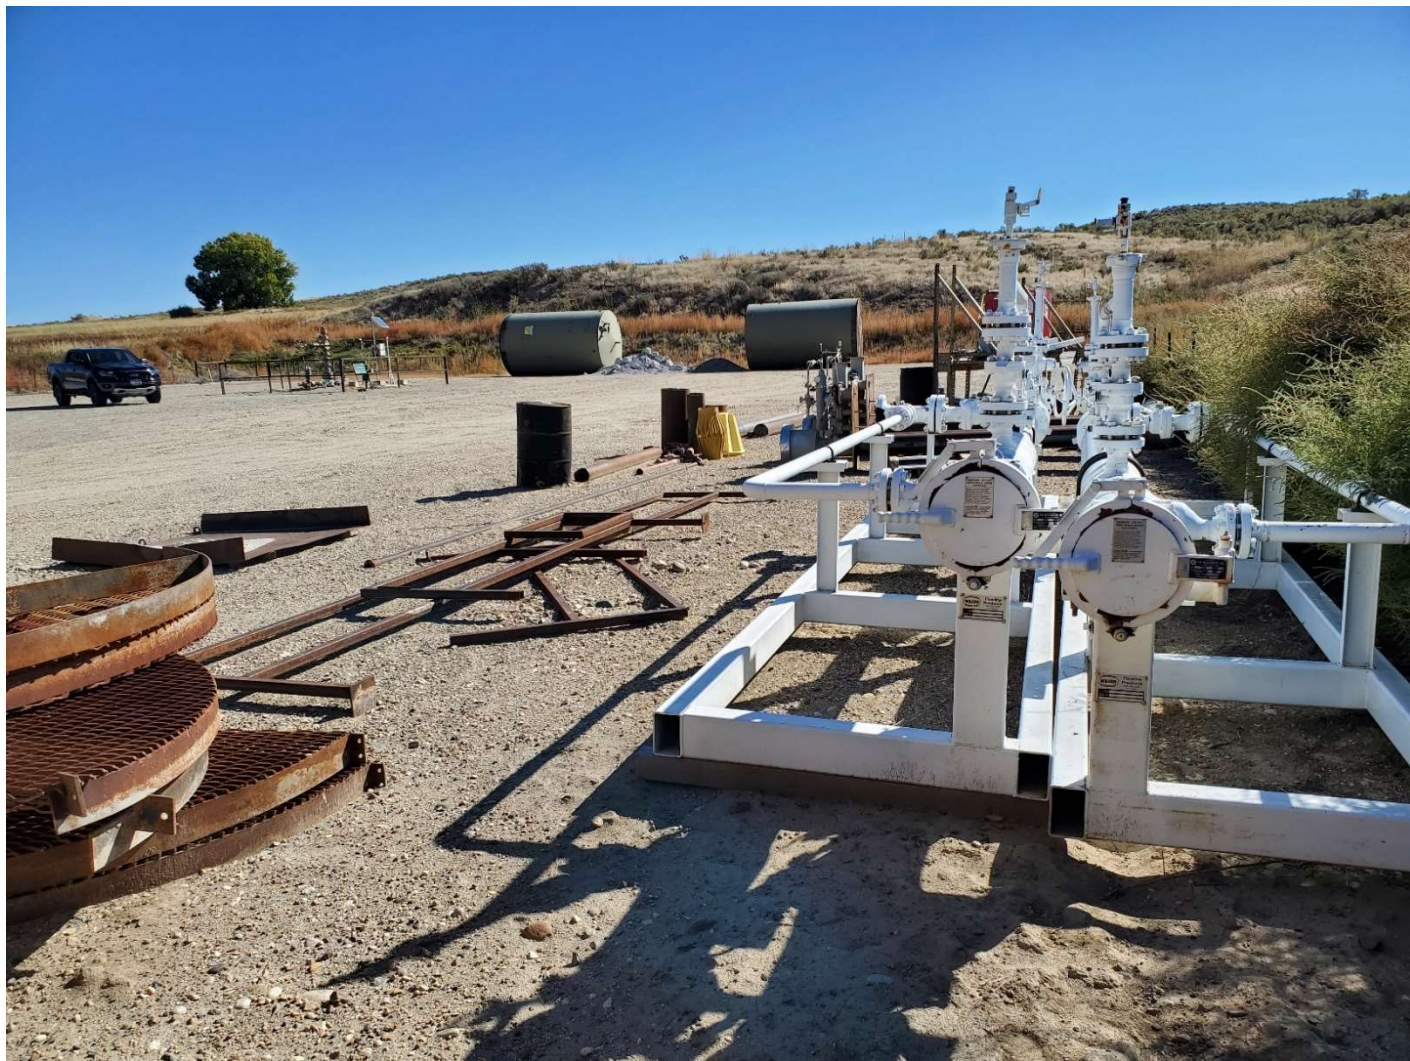
- B. If Yes;
- i. Are all debris and waste materials including, but not limited to, concrete, sack bentonite and other drilling mud additives, sand, plastic, pipe, and cable associated with the drilling and completion operations removed and disposed of properly? **Concrete pile east side of pad** Yes No

Equipment stored at southwest and southeast perimeters of well pad. Well head is in left background, 400-bbl storage tanks and cement pile are in center background, spare pig launchers and miscellaneous equipment at right foreground. View is East.

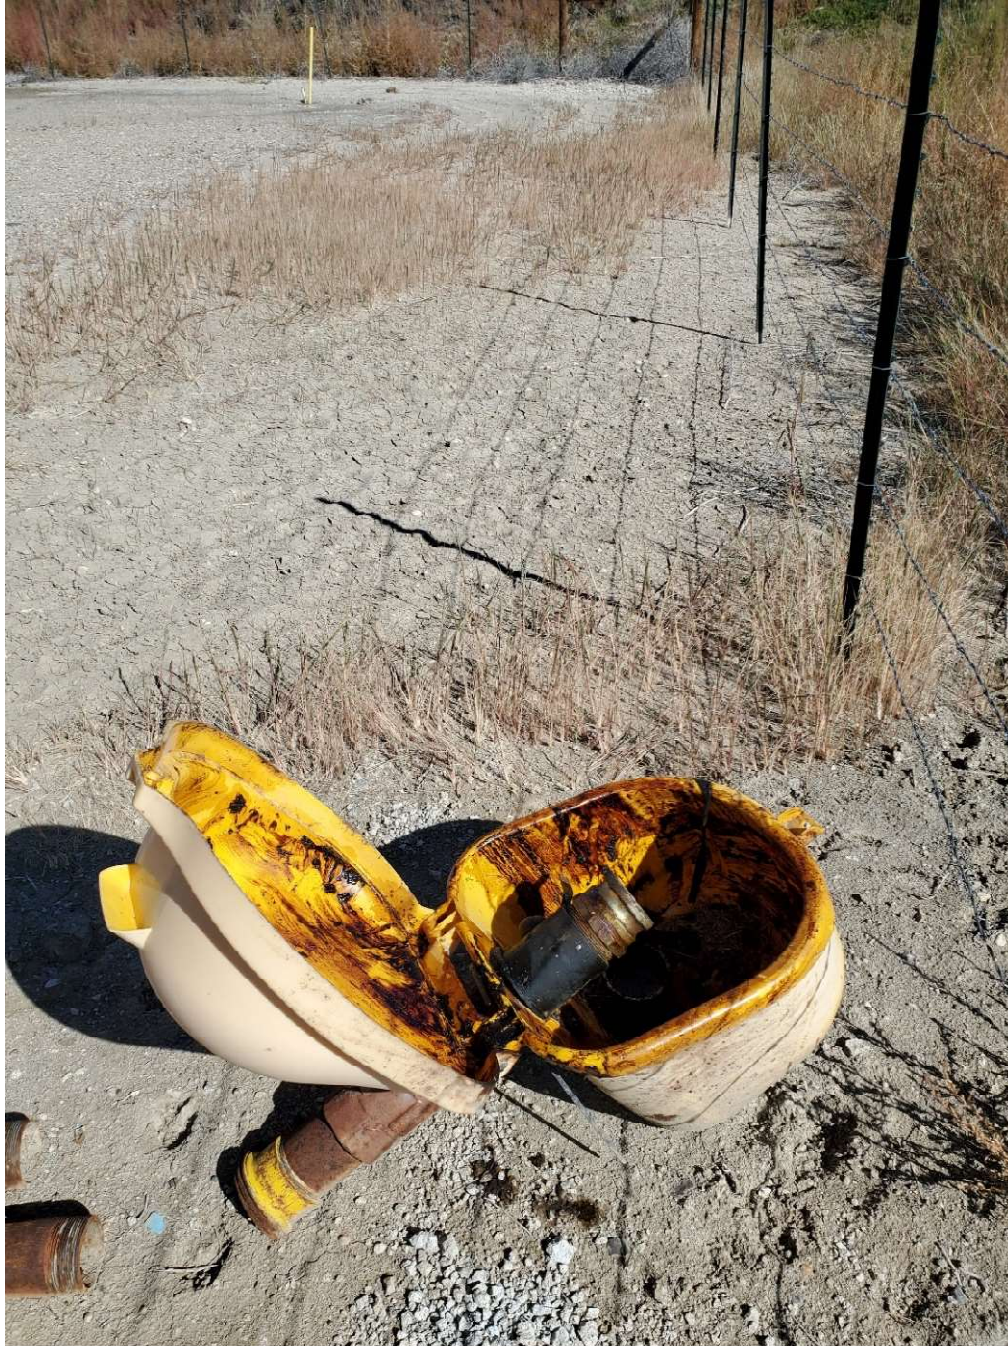
Spill containment catch basin for storage tank valves at Southeast perimeter of well pad. Equipment should be palletized and secured. View is Northeast.
