# Post Drilling/Annual Well Site Inspection Form

Section 1: General Information	
<b>Operation Data</b>	<b>Inspection Data</b>
<b>Operator Name</b> Snake River Oil + Gas, LLC	<b>Inspector Name</b> James Thum
<b>Well Name</b> Irvin #1-19, USWN 11-075-20039	<b>Area Office</b> Boise / Director's
<b>Authorized Contact</b> Dan Johaneck (208)800-9503 112 N. Plymouth, New Plymouth ID Tyler Hartung (208) 412-5475	<b>Inspection Date</b> 10/6/2023 9:45 AM
<b>County</b> Payette	<b>Report Date</b> 10/17/2023
<b>Inspector's Signature:</b>

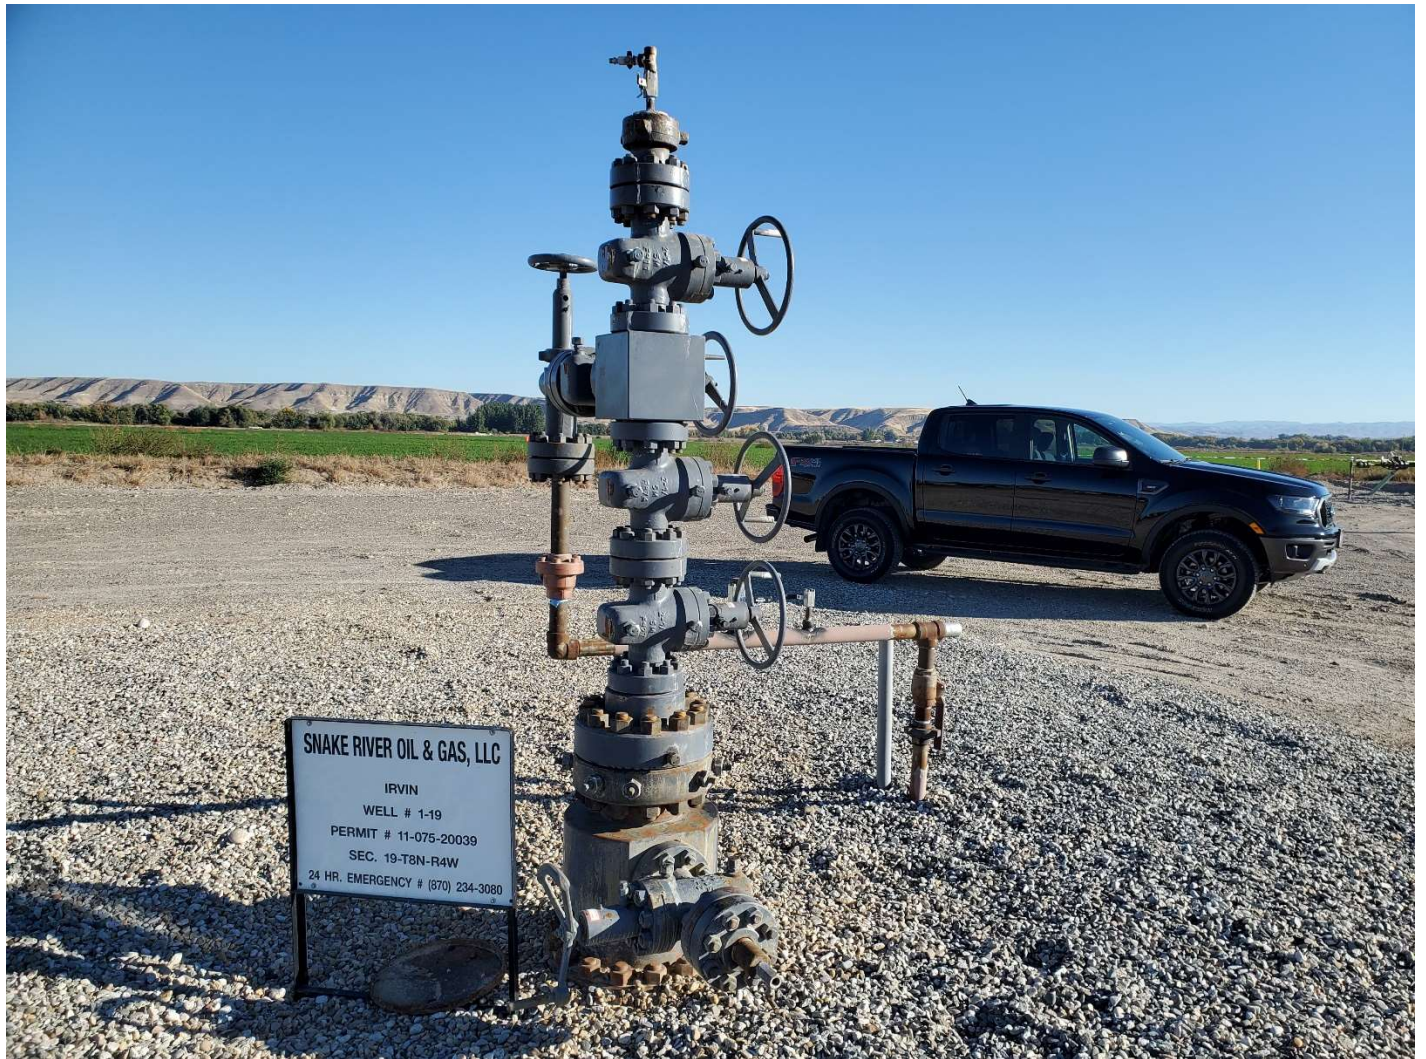
Valves are installed at the well head to accommodate pressure gauges, but no analog nor digital gauges were installed on the date of inspection. No pressure readings were obtained on the surface casing, production casing or tubing string. Meter calibration tags are no longer kept on separator unit. Request them from Tyler Hartung who now receives them via email.

Well head looking NE.

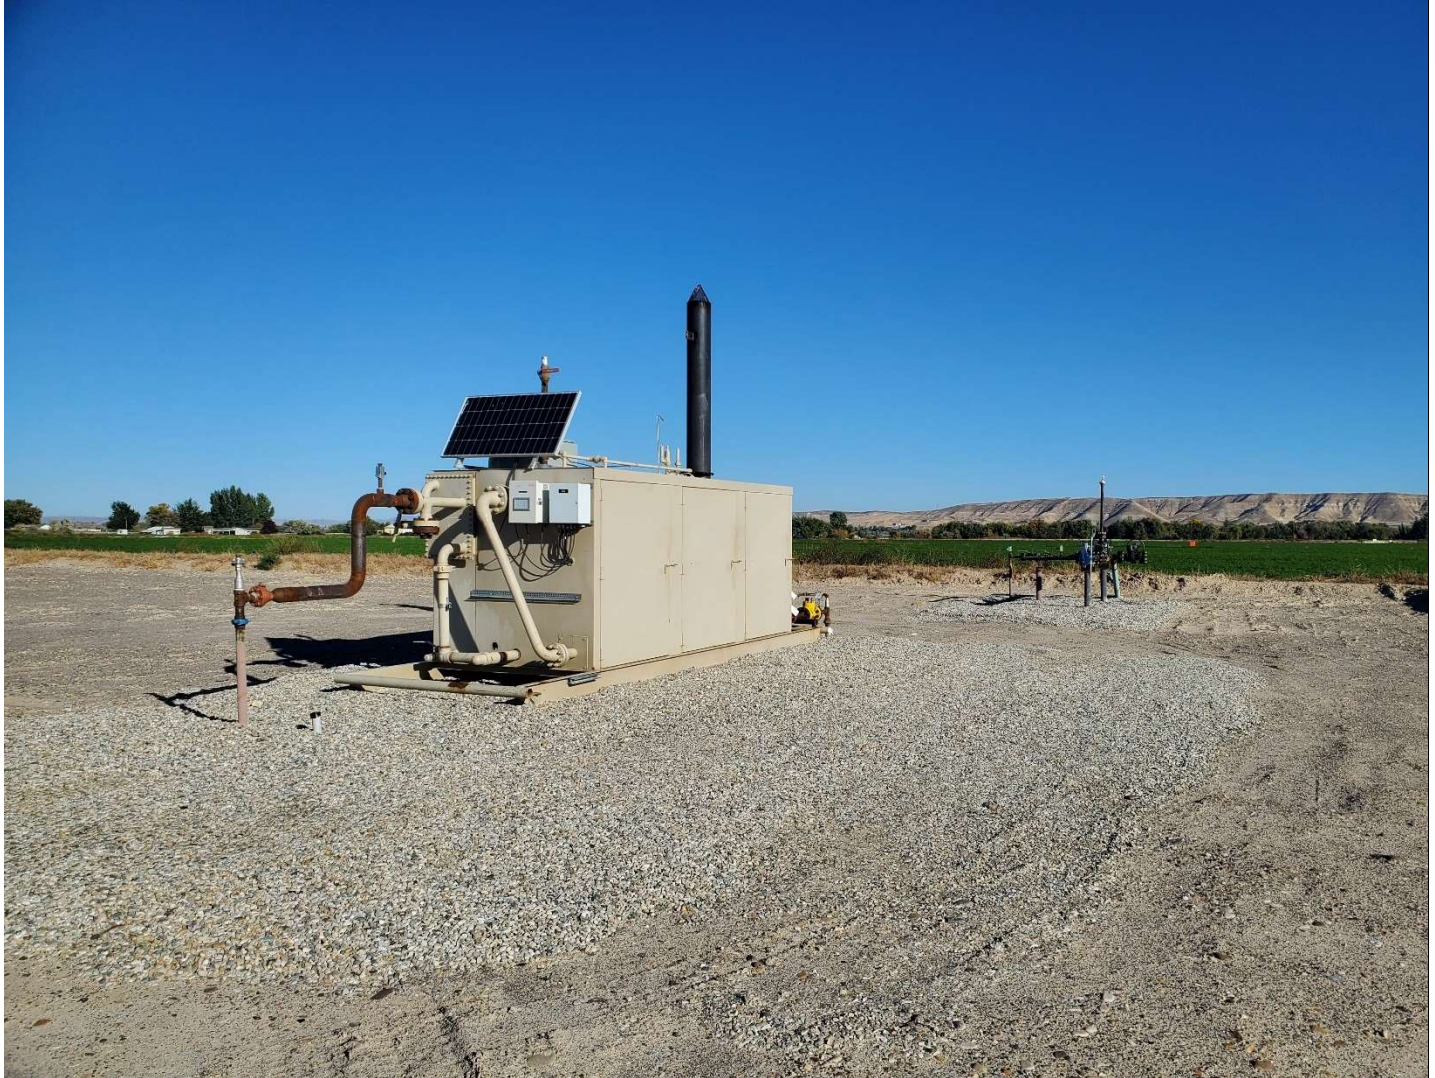
No chemicals stored or utilized on site. Emergency response plan and chemical SDS sheets are at the New Plymouth office. The separator unit installed was formerly on the ML Investments 2-3 well site. Inspection of that well 10/13/2023 confirms that it has been removed.

Separator Unit, northeast side of well pad looking NNW. Riser for gathering line to the right.

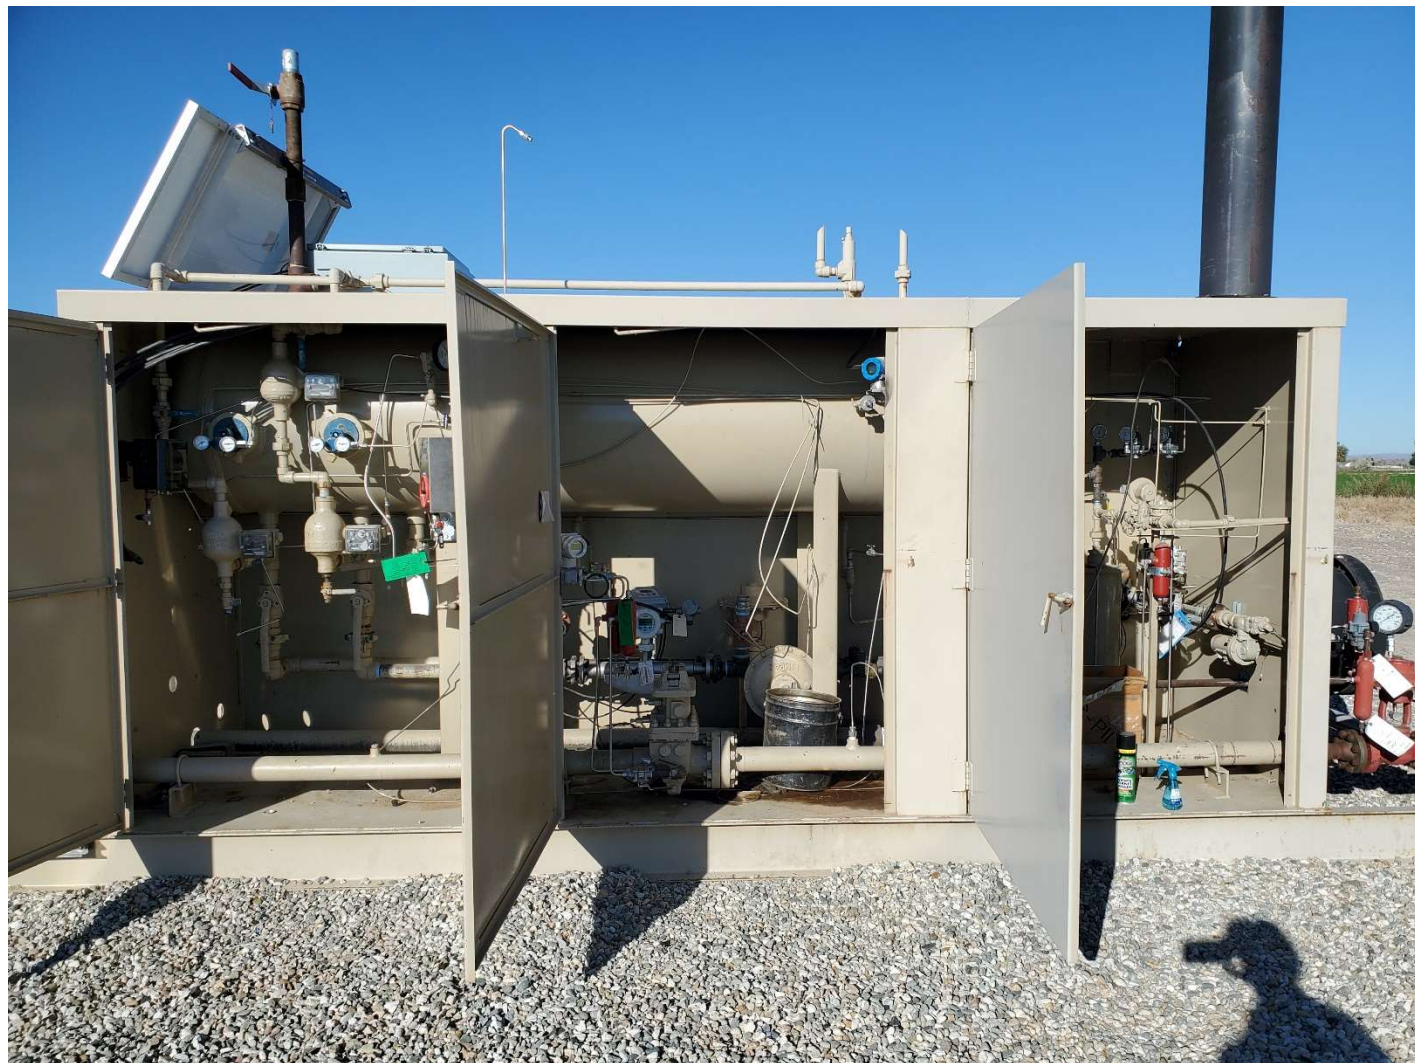
Separator Unit, doors opened. Green and white leak tags are seen at several fittings. View is west.

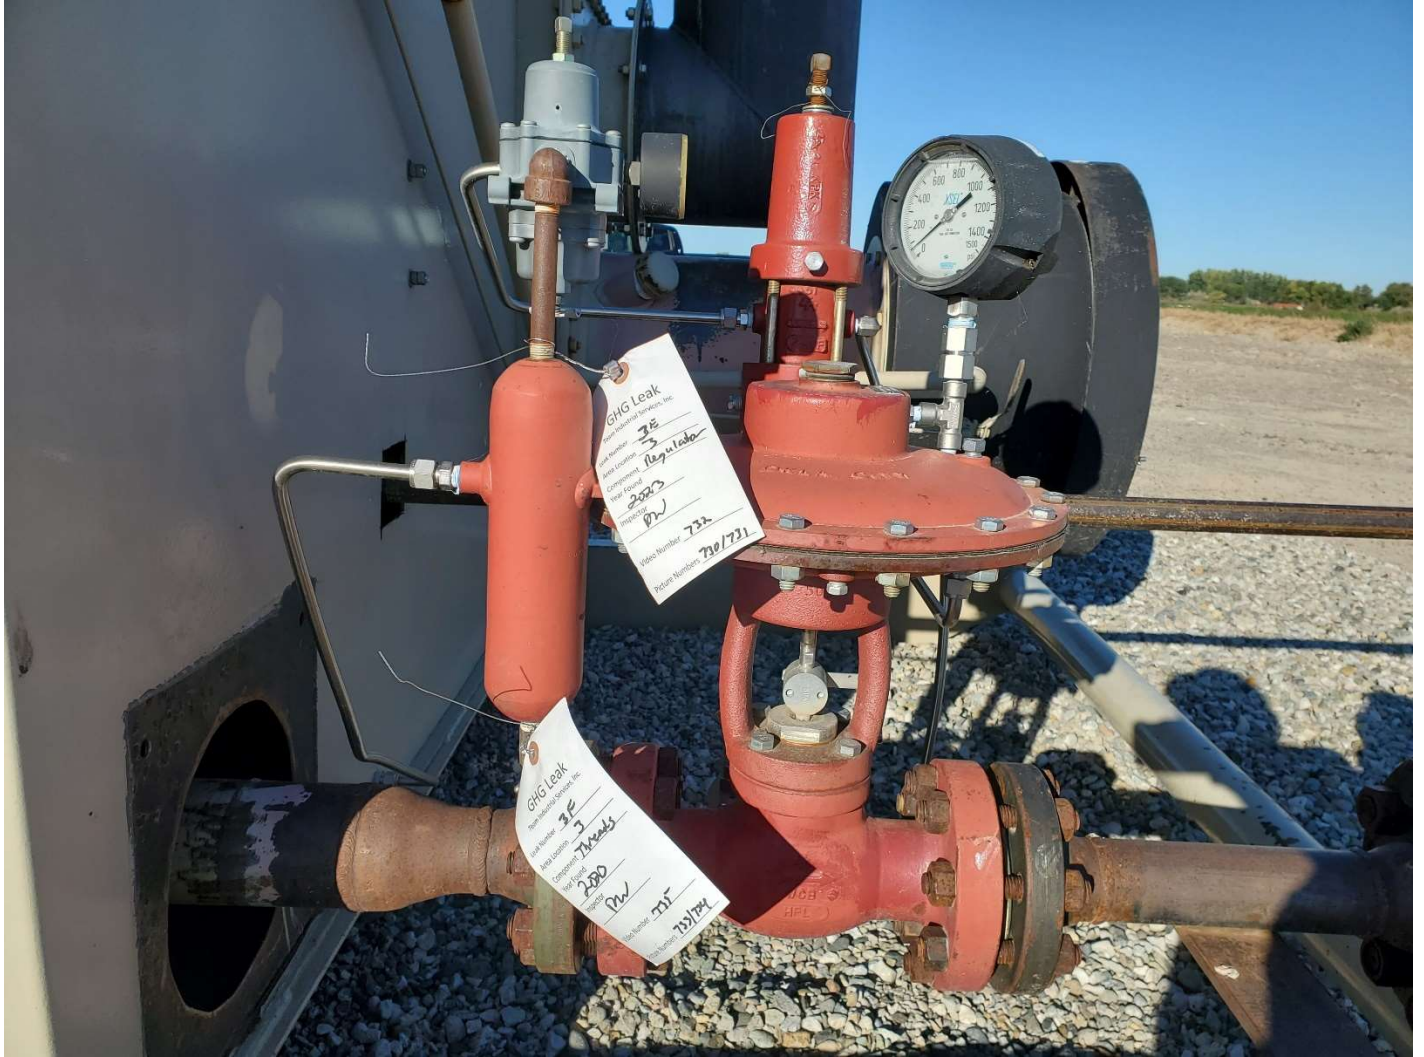
Leak tags on north exterior of separator unit.

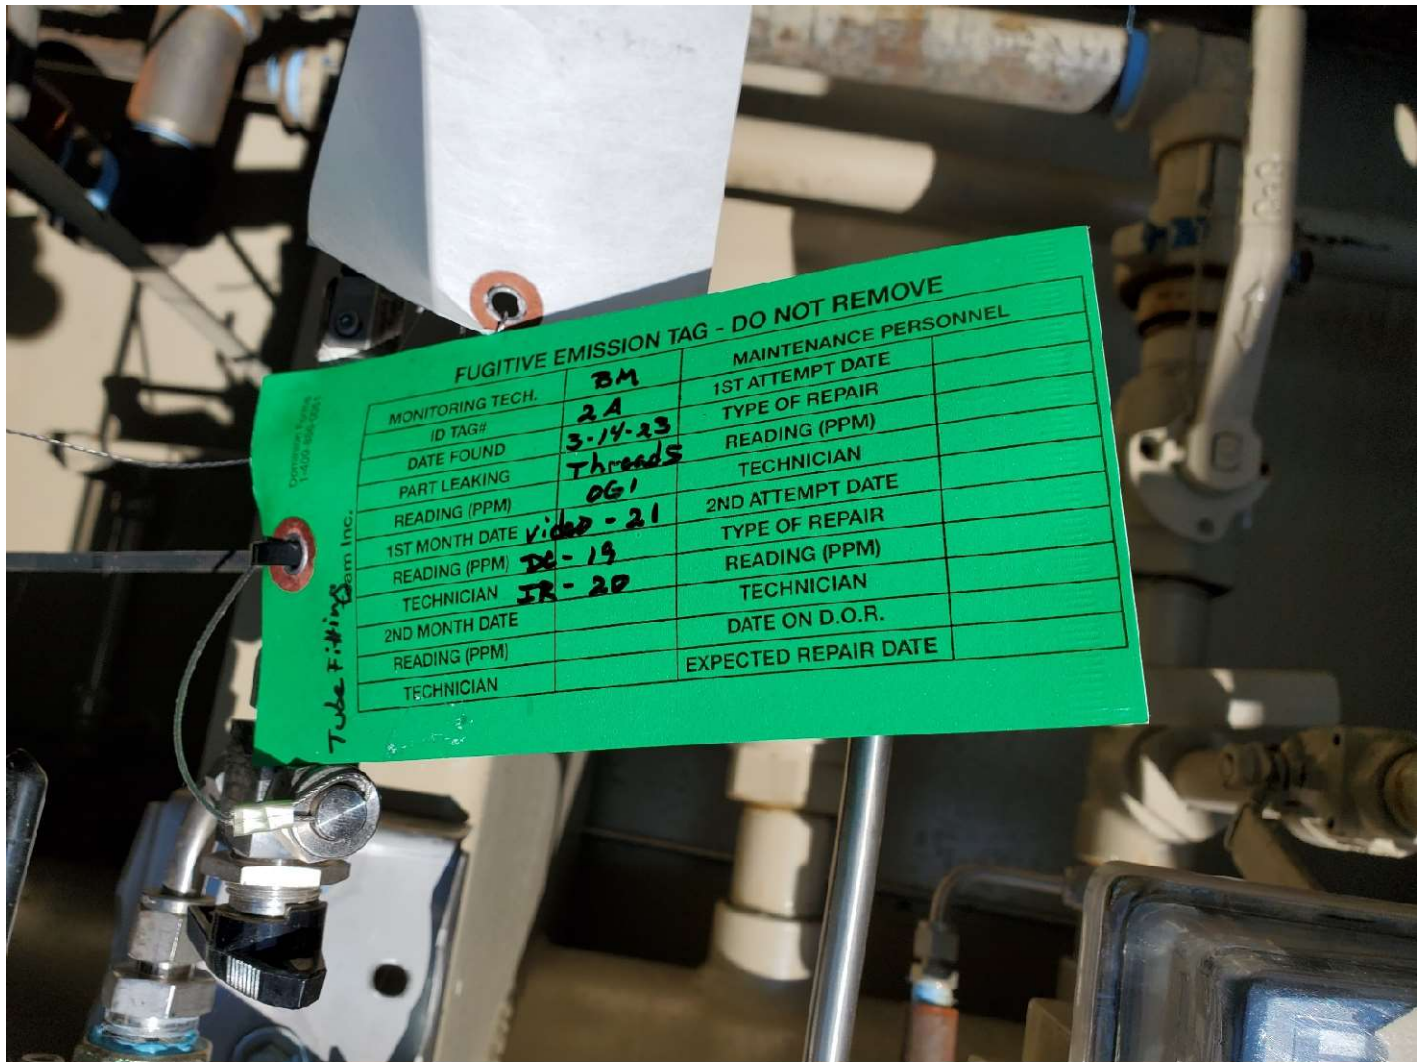
Separator interior, leak tag detail.

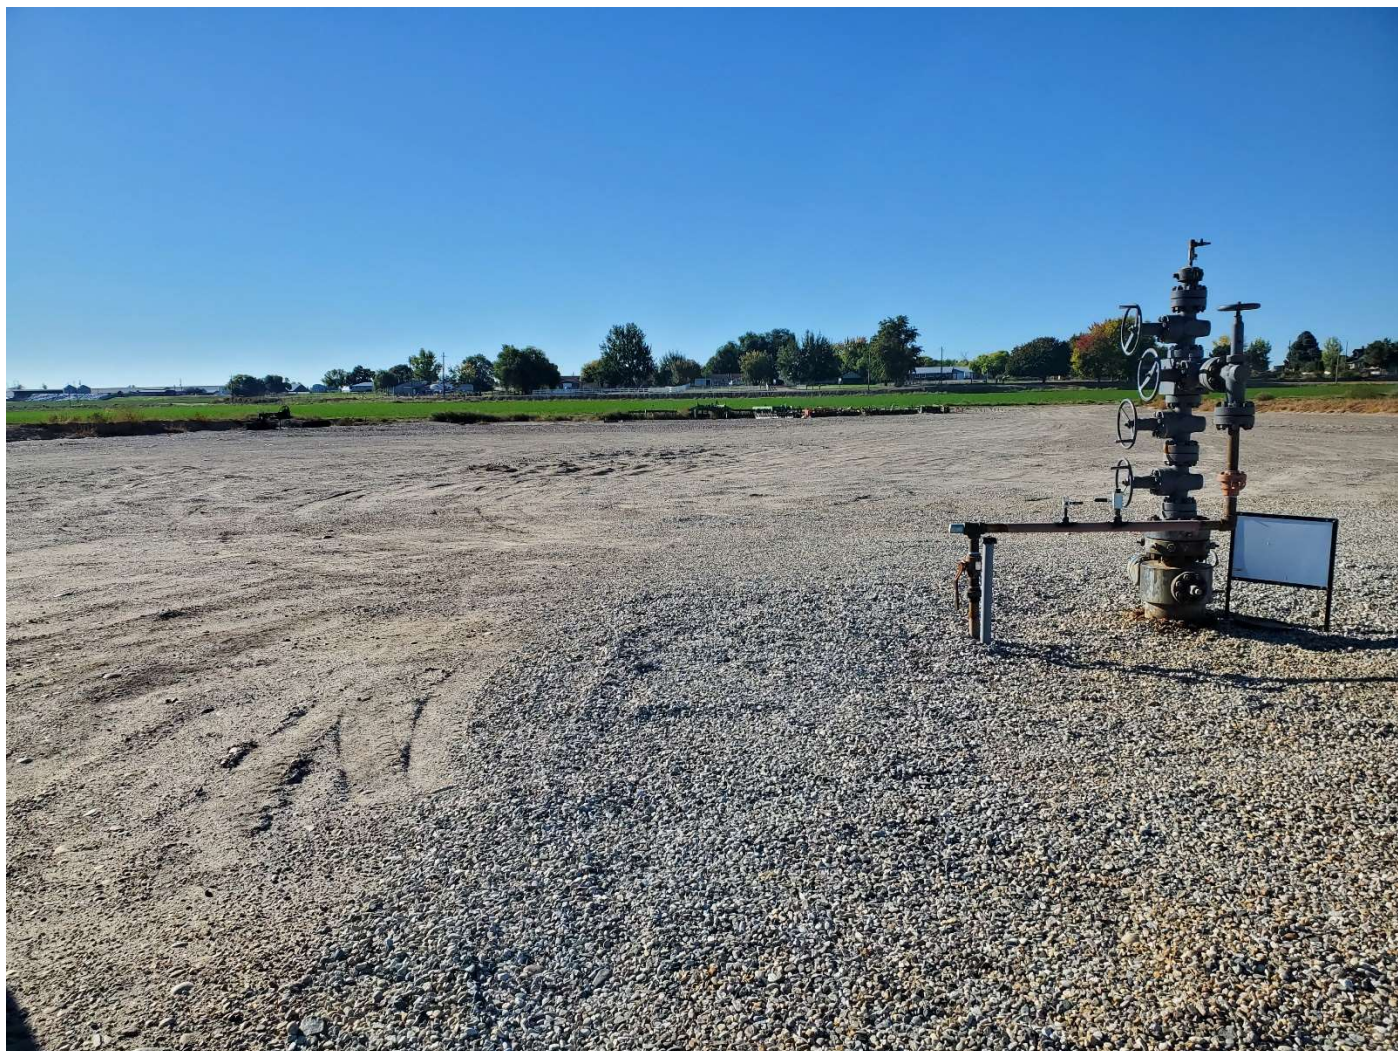
Notes on well pad: ad was constructed 2X as large as needed due to revised well location after pad construction. Farmer is currently using the south side of the well pad to store farm equipment.

Well pad view, looking south. Well head to right side. Note farmers equipment along south perimeter of the pad.
