## **Post Drilling/Annual Well Site Inspection Form**

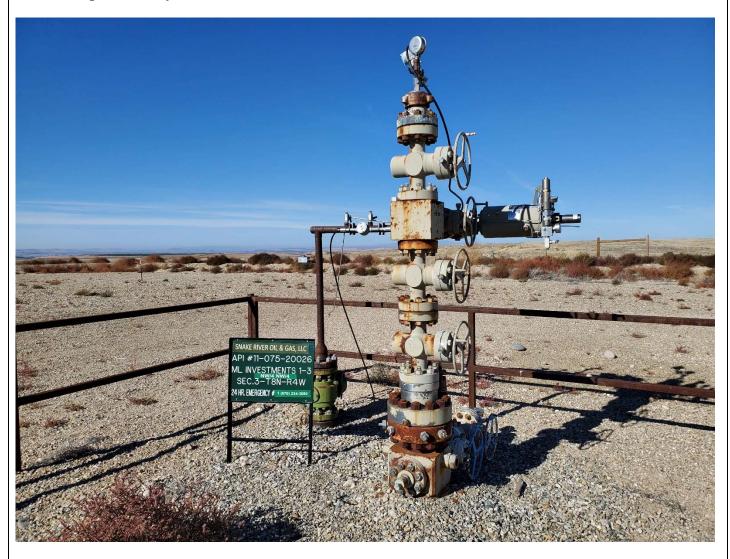
Wellhead, sign and inner protective metal fence. View is west.

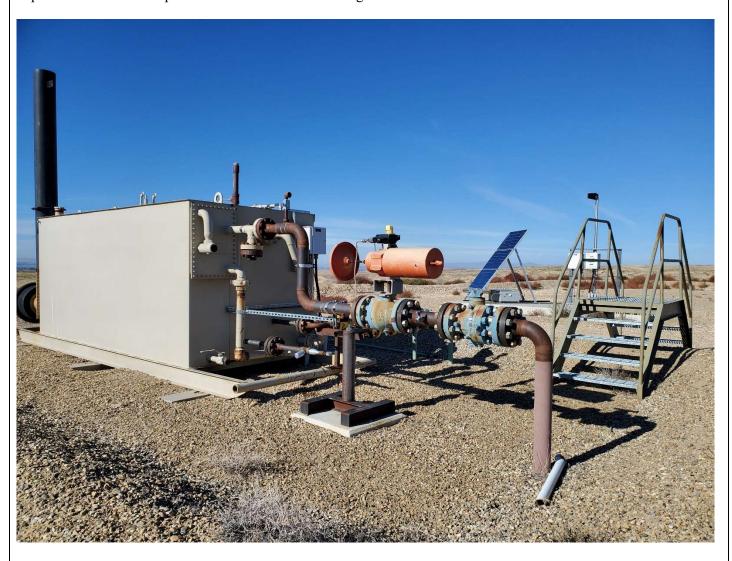
Separator unit with solar panels and control boxes in background. View is west.

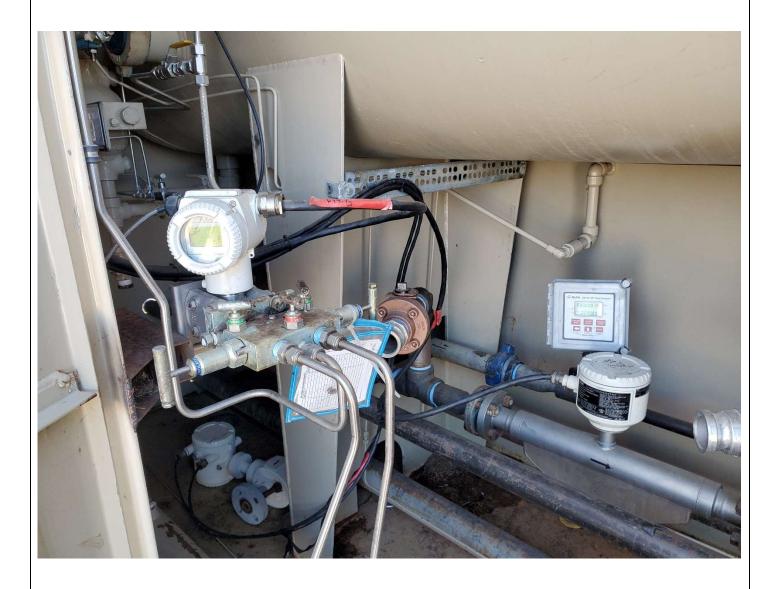
Separator unit, interior view of left side.

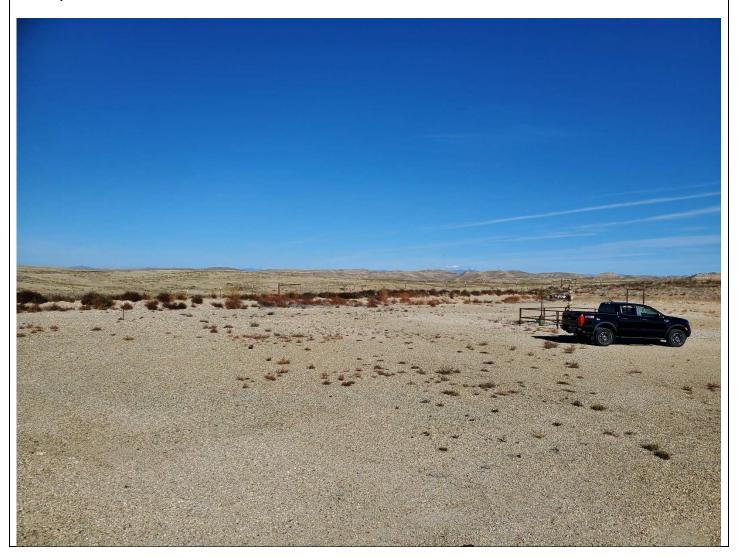
E. Do drain li	nes have a valve installed, closed and capped off if not in use?	Yes No
Section 10: Inspection	n Comments	
Comments and Issues		
Surface casing = 220 Production casing = 0 F	SI (analog)	
All meters and separate	or gauges are powered up and appear to be functioning.	
Vegetation cover ~ 5%	bur encroaching on pad, particularly on the northwest perimeter.	
Section 8 Meters – com	nments: all meter calibration results are now received by Tyler Hartung via ema	ail.
1

View of wellpad, wellhead in right background. View is west-northwest showing vegetation encroachment on west side of pad.
