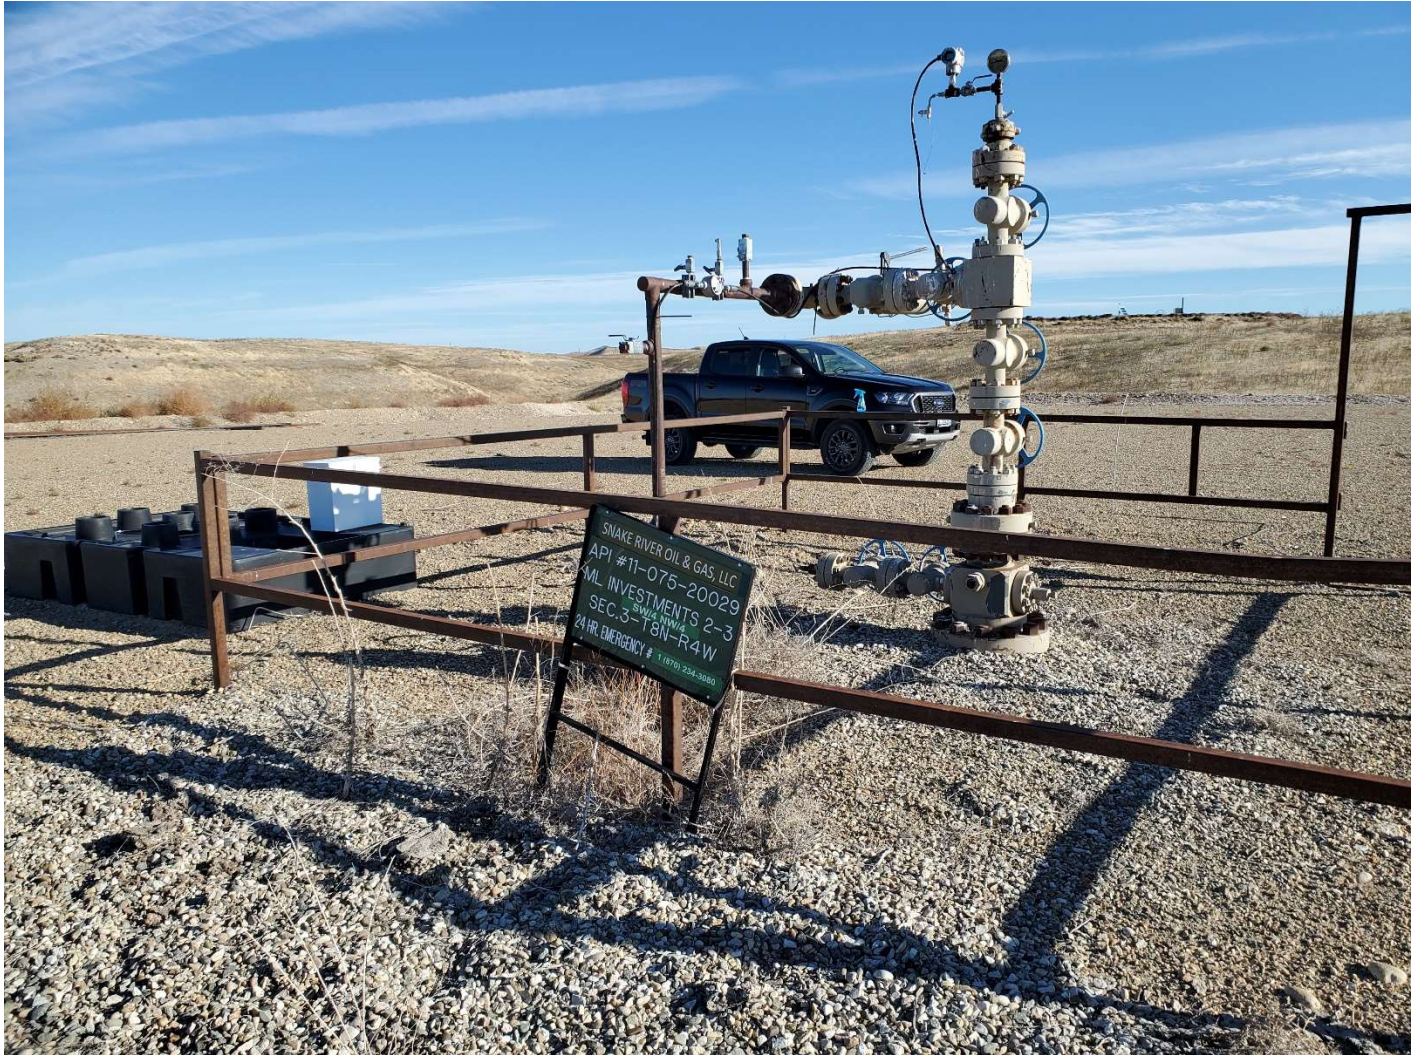
Tubing string: 600 PSI (analog gauge, uncertain if functioning at time of inspection)

Well head and internal steel fencing. View is Northeast. Analog& tubing string gauges visible but only analog gauge may be functioning.

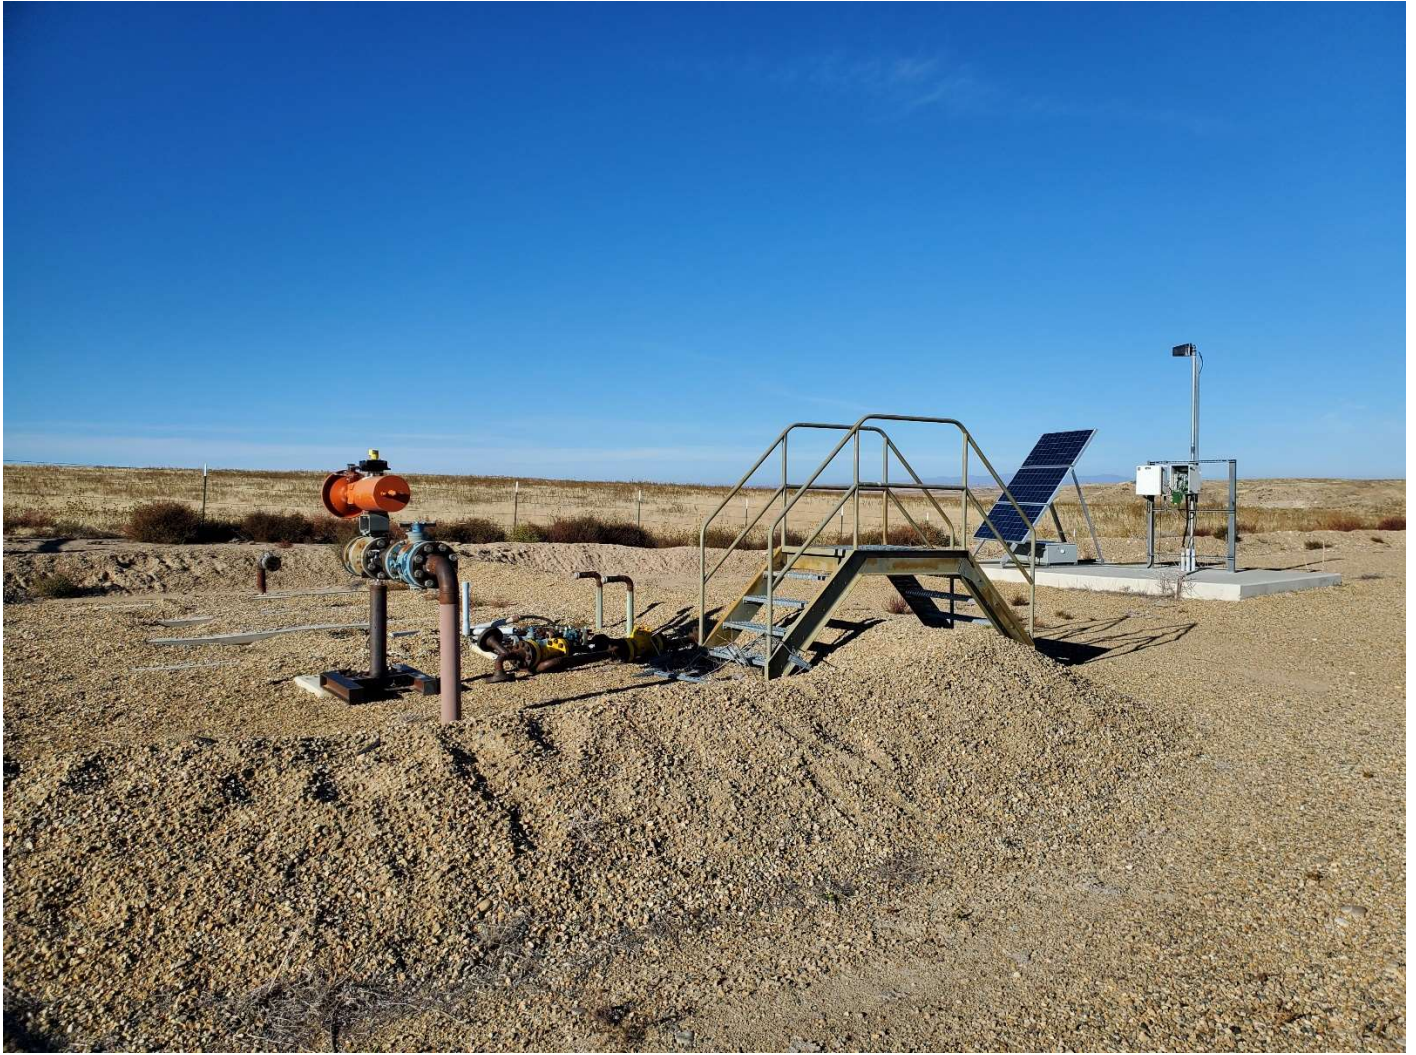
Former location of Separator Unit which has been removed during the 2023 calendar year. View is West.

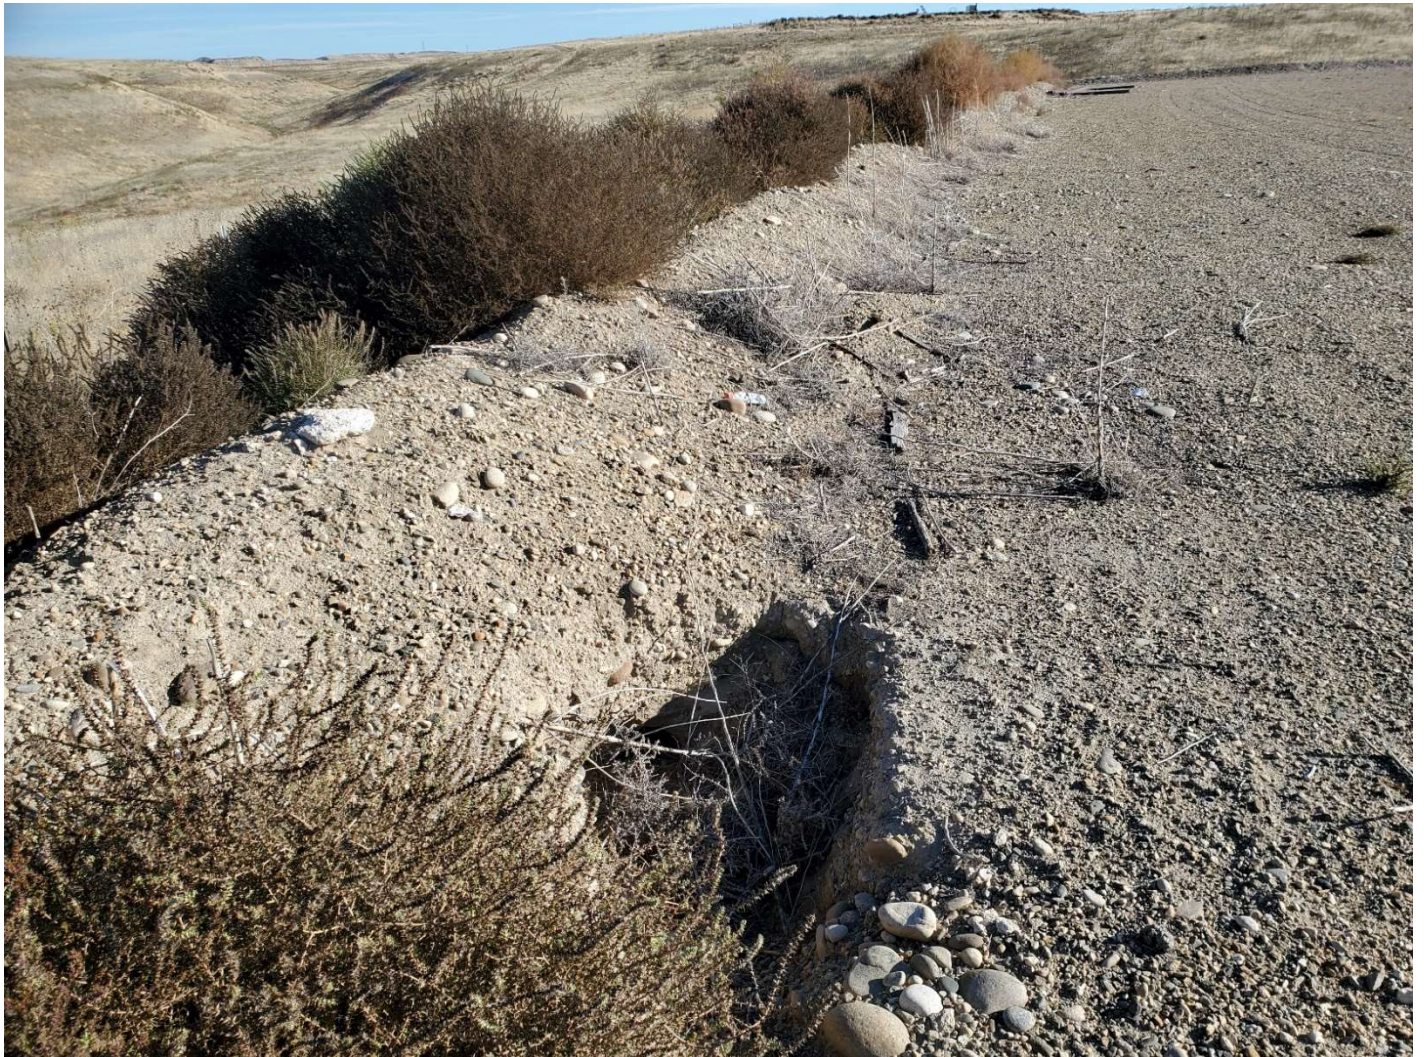
Small area of pad erosion developing near west end of northwest pad dike berm (see photo). Vegetation <5% but beginning to increase.

Small area of pad erosion developing near west end of northwest pad dike berm. Vegetation <5% but beginning to increase. View is Northeast along northwest pad perimeter dike.

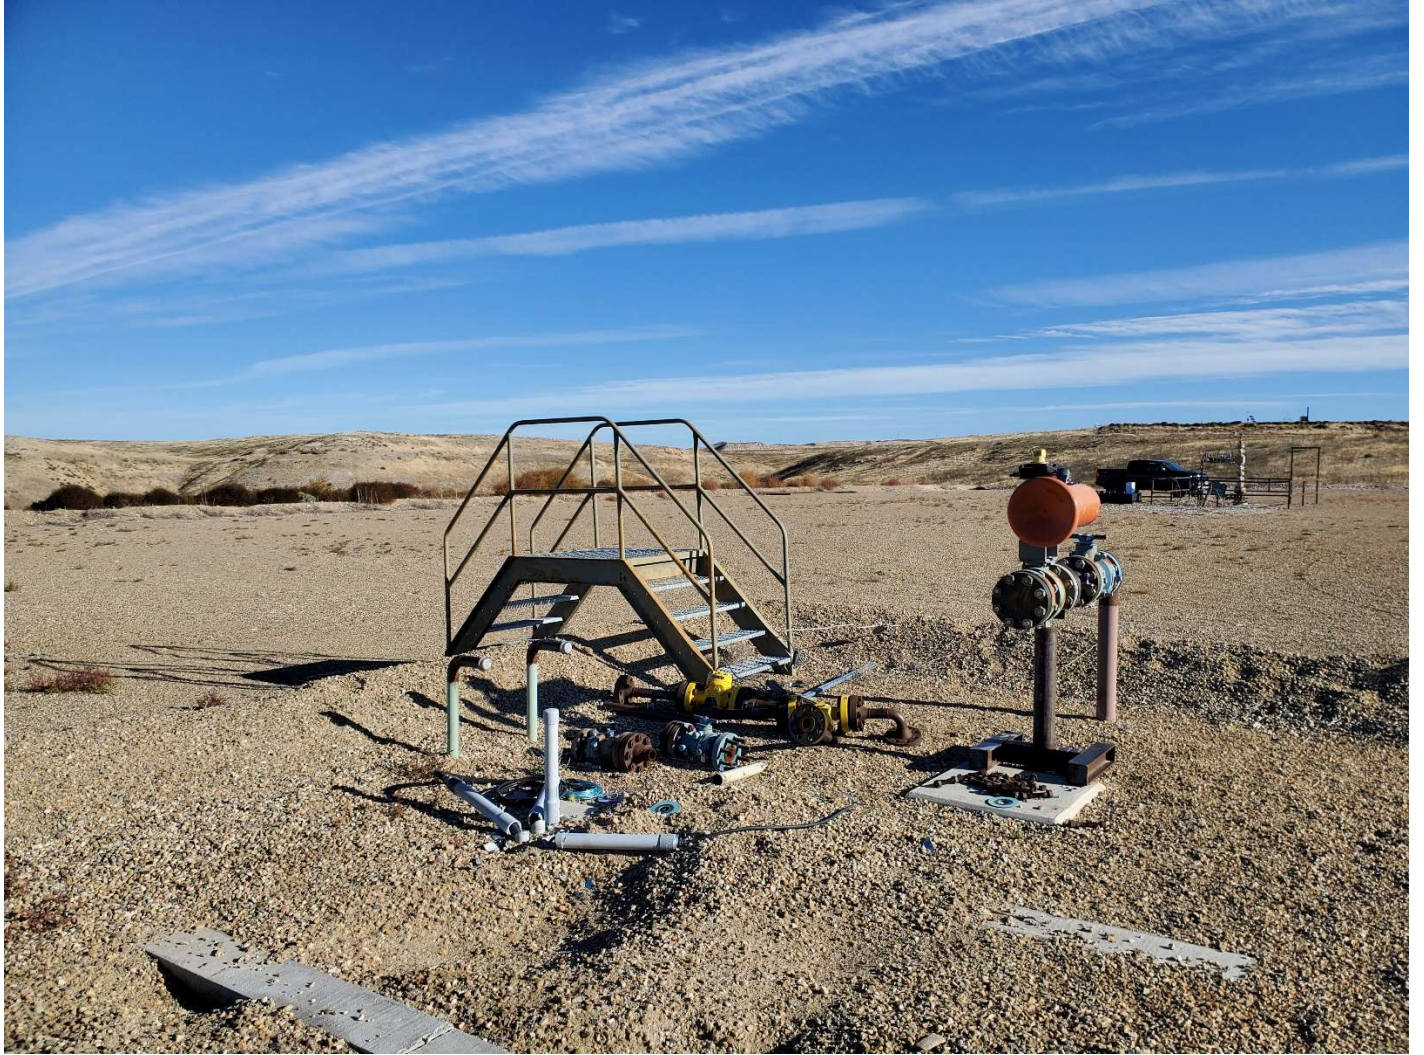
Former location of Separator Unit with remaining equipment. Well head is at right background, view is Northeast.
