# Post Drilling/Annual Well Site Inspection Form

Section 1: General Information	
<b>Operation Data</b>	<b>Inspection Data</b>
Operator Name Snake River Oil + Gas, LLC	Inspector Name James Thum
Well Name <b>DJS Properties #1-15, USWN 11-075-20020</b>	Area Office Boise / Director's
Authorized Contact      Dan Johaneck (208)800-9503 112 N. Plymouth, New Plymouth ID	Inspection Date 11/13/2023, 10:00 AM
County Payette	Report Date 12/6/2023
<b>Inspector's Signature:</b>  <i>James Thum</i>  <b>Date of Signature:</b> 12/6/2023	<b>Inspection Summary:</b>  <input type="checkbox"/> Operation appeared to be in compliance at the time of the inspection.  <input checked="" type="checkbox"/> Issues of concern identified at the time of the inspection.
<b>Location Description:</b> 1.09 miles SSE from Little Willow Gathering Facility, 4649 Little Willow Road. Google Maps location Latitude 44.034893, Longitude -116.800803	
Weather: Overcast, calm winds 40°F. Well was producing at time of inspection.

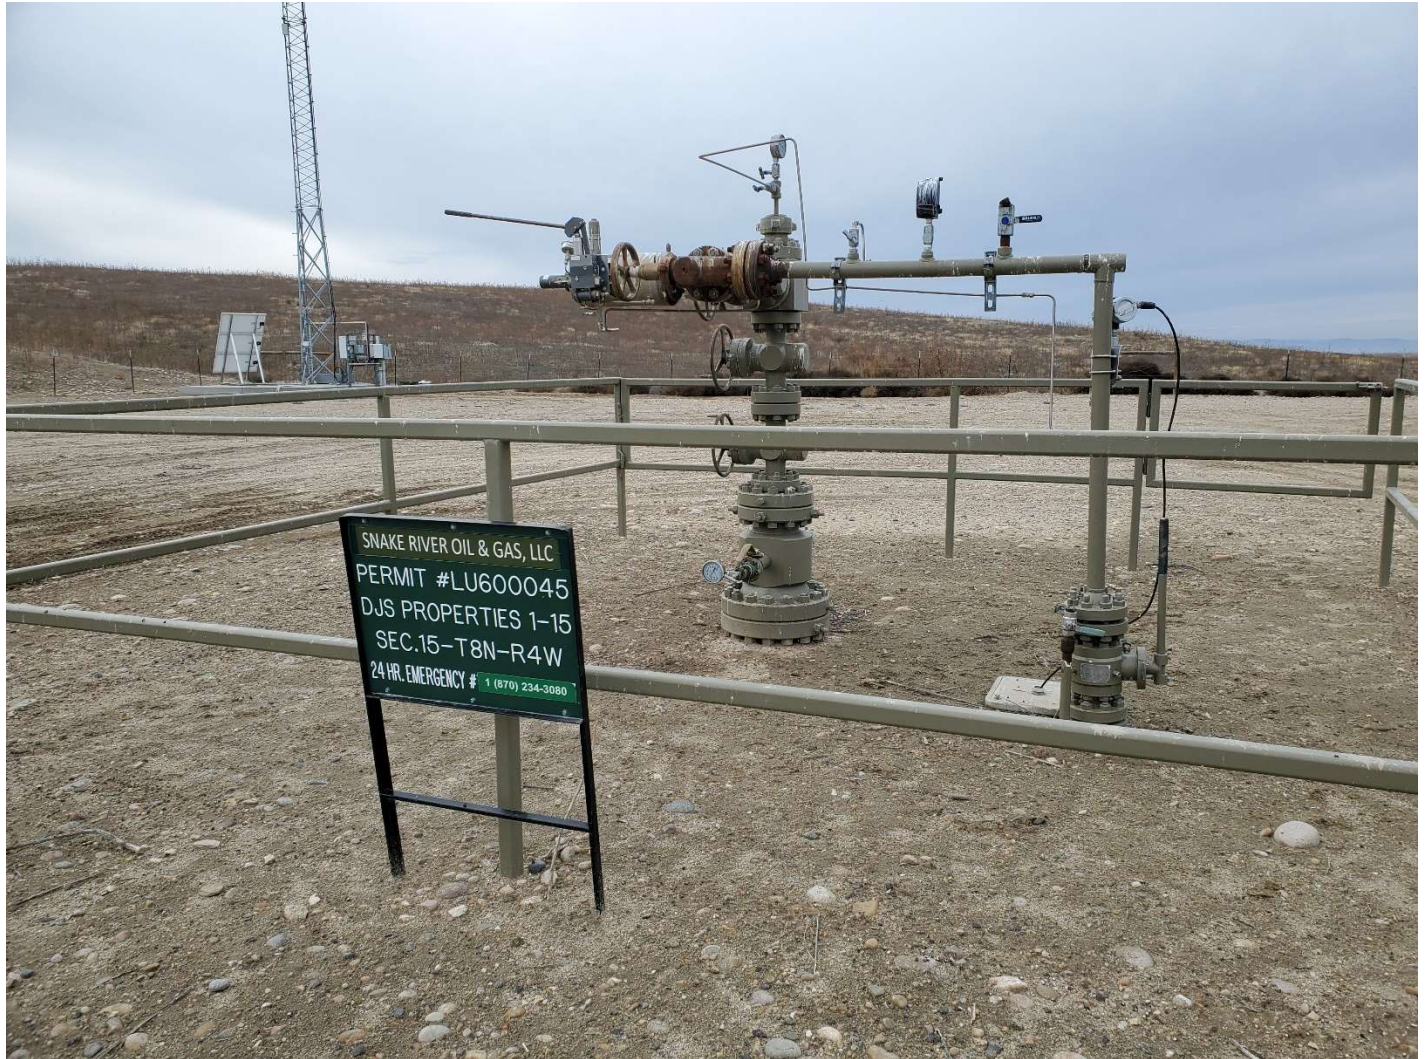
Wellhead and sign, SCADA tower in left rear. View is South.

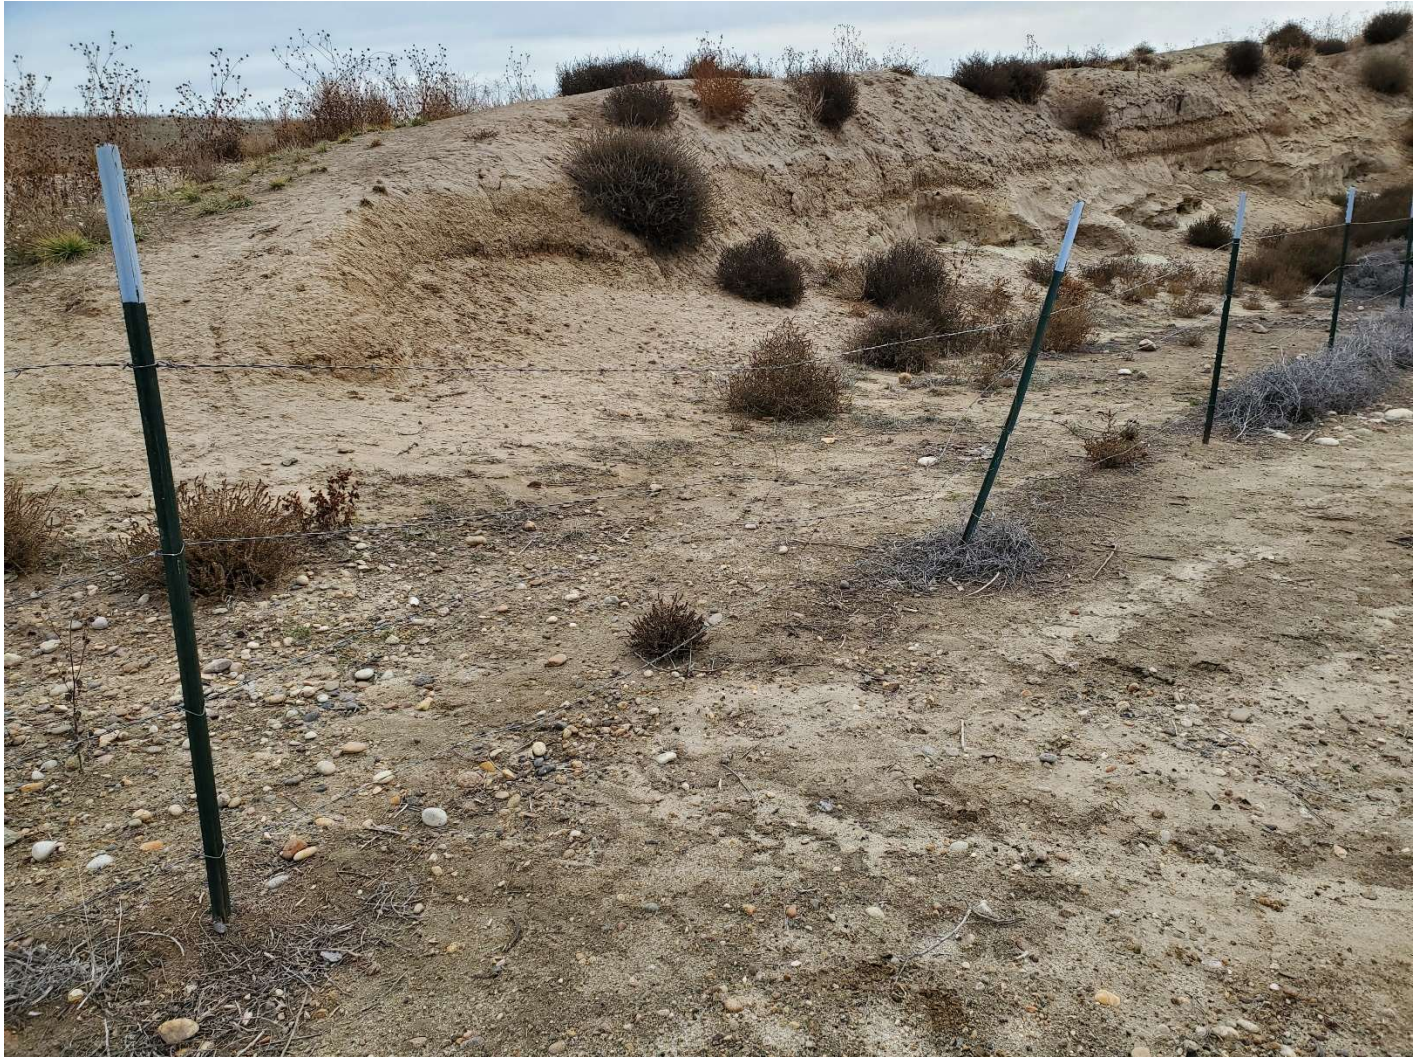
Section 4, Item 1A: fence needs minor repair on the northeast perimeter just east of the entrance gate.

Area of needed fence maintenance southeast of entrance gate. View is Southeast.

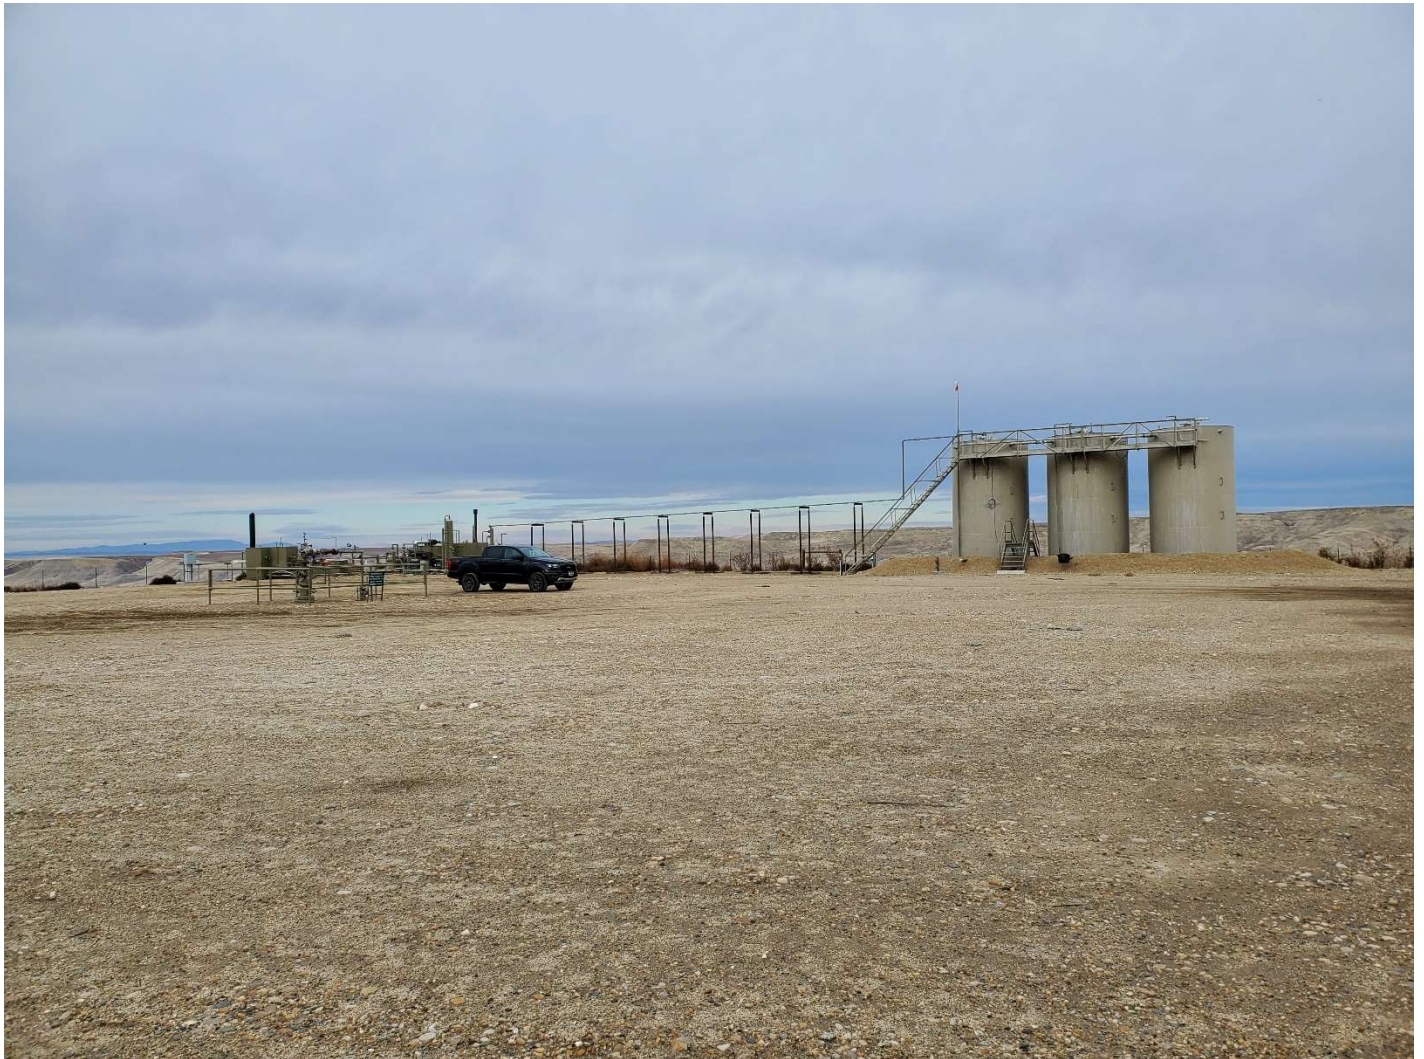
Dike dimensions as measured: 23 feet X 53 feet X 2 feet (18 inches nominal /effective height)

Dike volume = 23 feet X 53 feet X 2 feet = 2438 Ft<sup>3</sup> / 2244 Ft<sup>3</sup> = 1.09 times the volume of one tank. Minimum requirement per IDAPA 20.07.02.420.01.a is 1.5 times the volume of the largest tank.

Separator at left rear, wellhead to left of inspection vehicle, produced water tanks and containment dike on right. View is Northwest.

Recommend general maintenance to containment dike with possible increase in height of dike walls to meet minimum specifications.

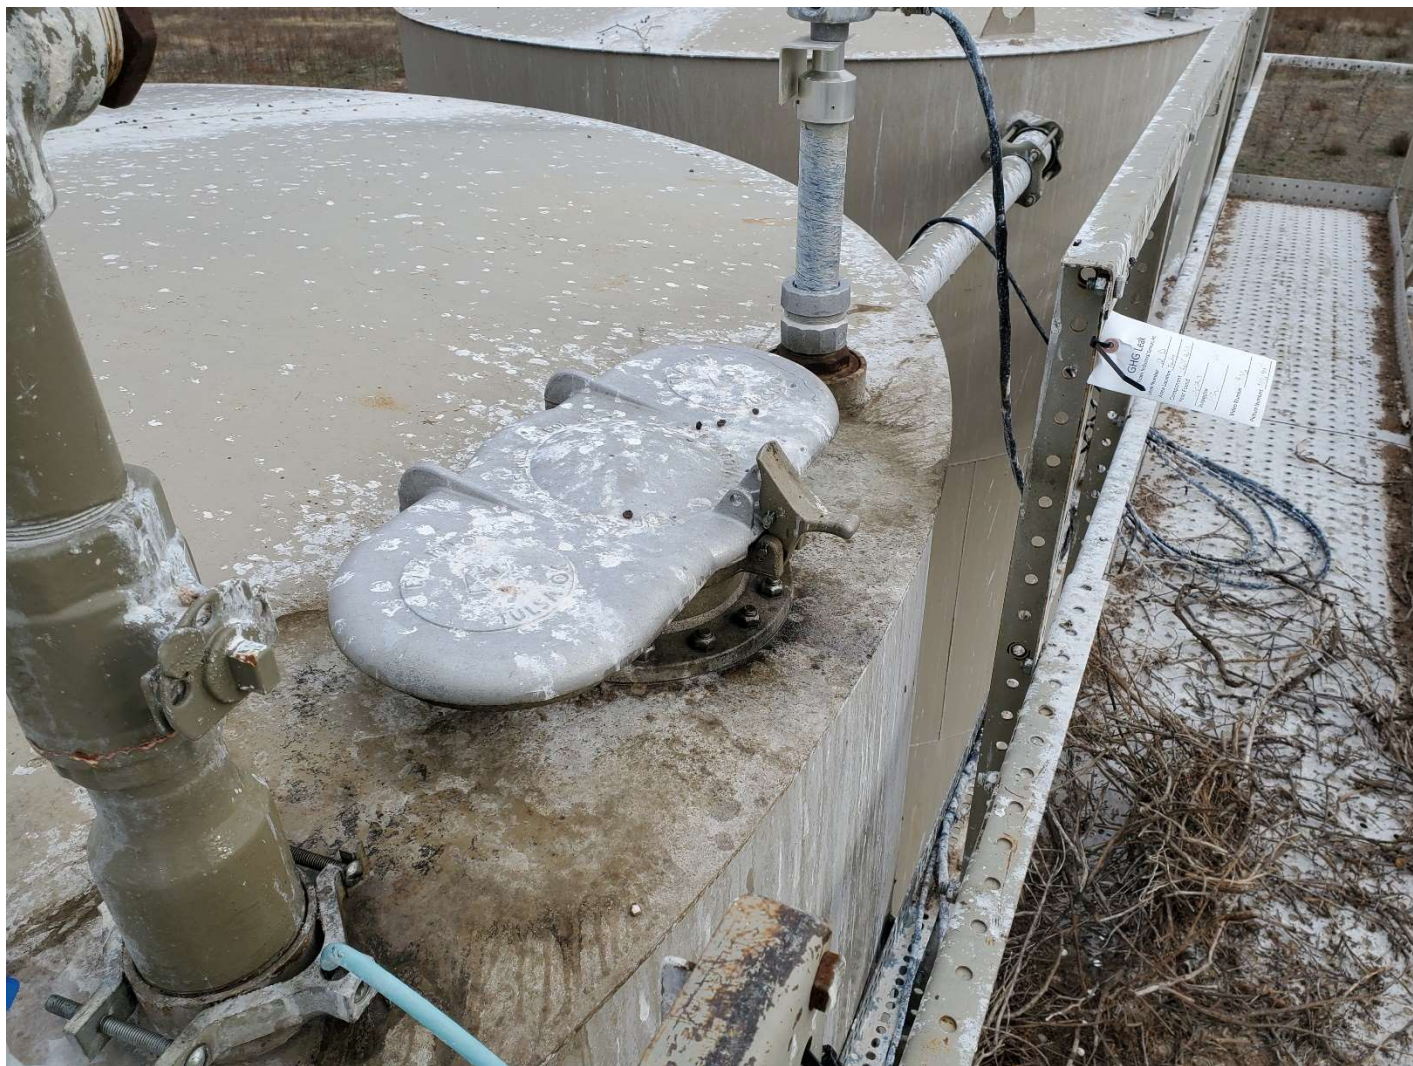
Middle tank has 2023 leak tag attached at the thief hatch with strong smell of petroleum noted.

Leak tag attached at railing by thief valve on middle produced water tank.
