Post Drilling/Annual Well Site Inspection Form

Section 1: General Information	
Operation Data	Inspection Data
Operator Name	Inspector Name
Snake River Oil + Gas, LLC	James Thum
Well Name	Area Office
ML Investments #2-10, USWN 11-075-20022 Authorized Contact Dan Johanek (208)800-9503	Boise / Director's Inspection Date
112 N. Plymouth, New Plymouth ID	11/13/2023 11:30 AM
County	Report Date
Payette	12/7/2023
Inspector's Signature:	Inspection Summary:
	\boxtimes Operation appeared to be in compliance at the time of
James Thum	the inspection.
	Issues of concern identified at the time of the
Date of Signature: 12/7/2023	inspection.
Location Description: 1800 feet ESE from Little Willow C	Gathering Facility, 4649 Little Willow Road. Google Maps
location Latitude 44.049326, Longitude -116.796756

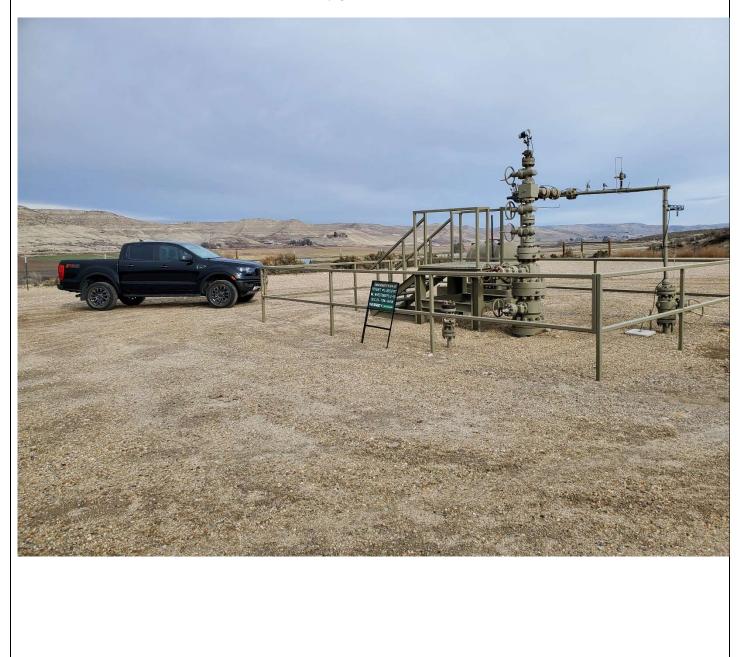
ML Investments #1-10 well head and internal security gate. View is Northwest

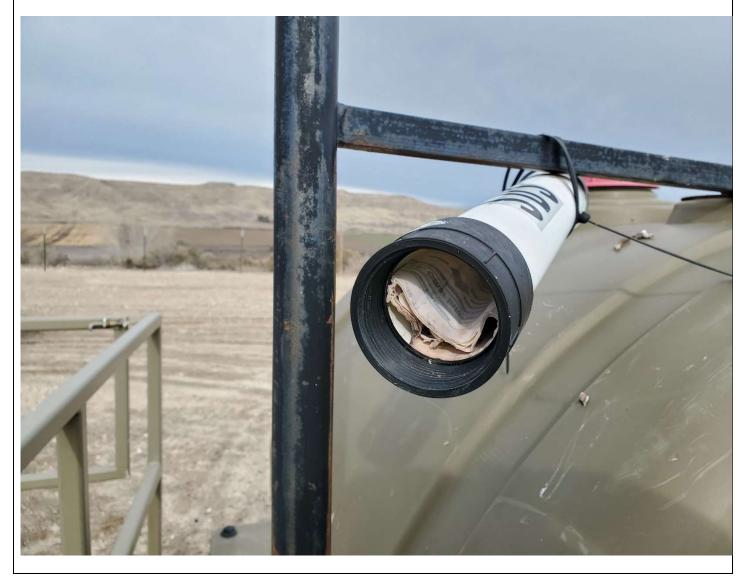
c. d. e. f.		Го То Го
Section 10: Inspe Comments and Is		
Section 5, Item 3: site but documents	SPCC documentation at New Plymouth office and Little Willow GF. SDS chemical documents on s are wet and cannot be removed from tube. Recommend that it be replaced.	
	A (no gauge installed) = NA (no gauge installed) psi

Chemical SDS paperwork is wet and cannot be removed from protective tubing. Recommend replacement.
