Post Drilling/Annual Well Site Inspection Form

Operation Data	Inspection Data
Operator Name Snake River Oil + Gas, LLC	Inspector Name James Thum
Well Name ML Investments #1-11, USWN 11-075-20025	Area Office Boise / Director's
Authorized Contact Dan Johaneke (208)800-9503 112 N. Plymouth, New Plymouth ID	Inspection Date 11/13/2023
County Payette	Report Date 12/7/2023
Inspector's Signature:

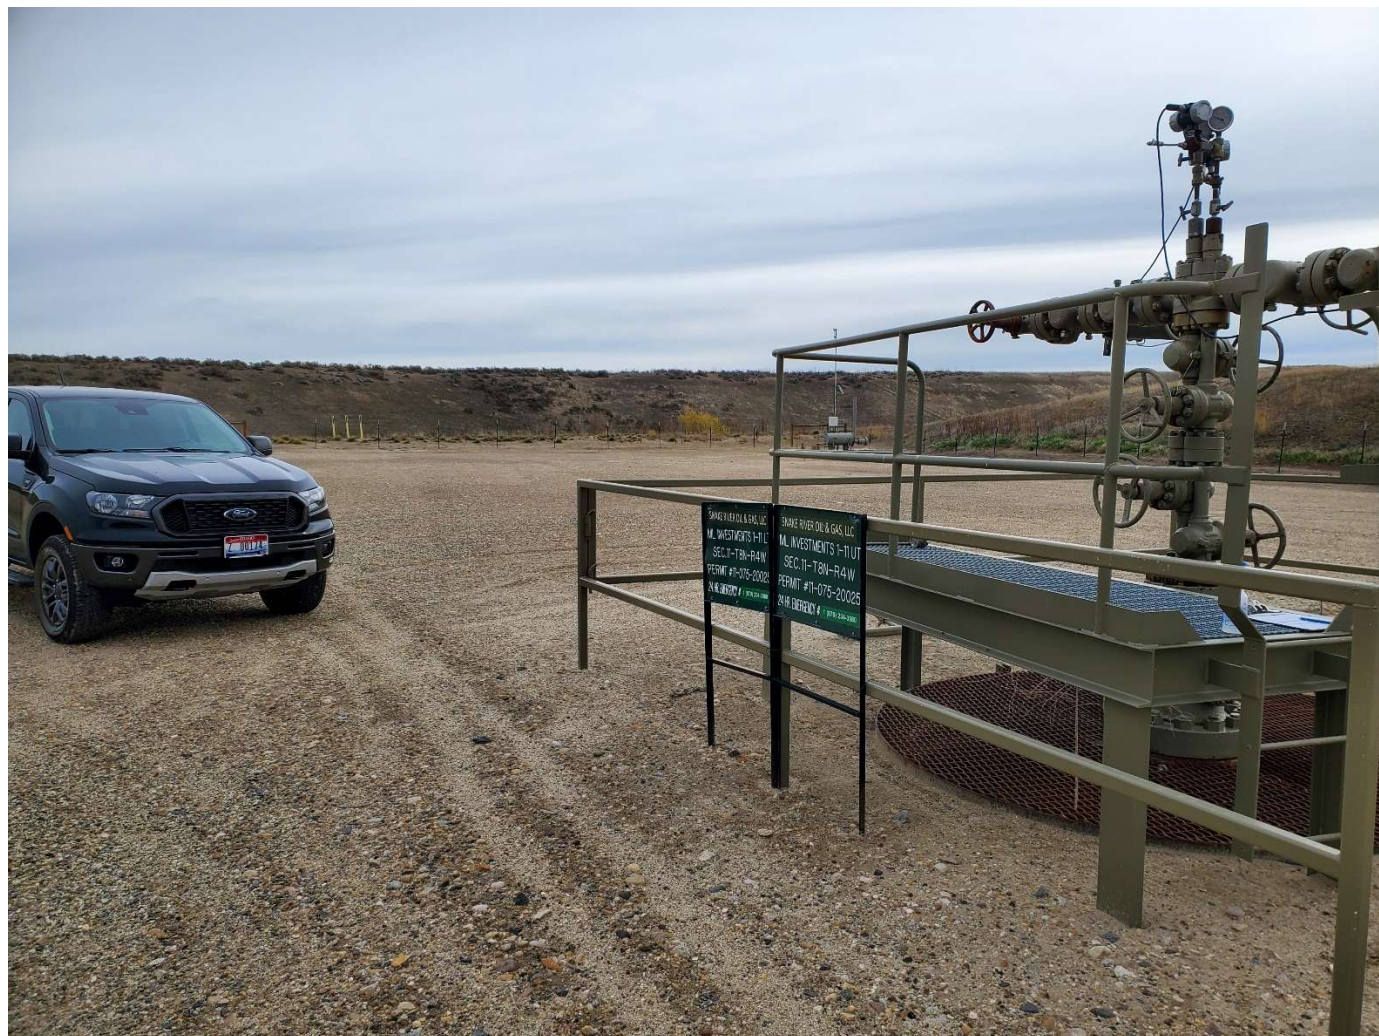
ML Investments #1-11 wellhead and internal security fence. View is East-Southeast

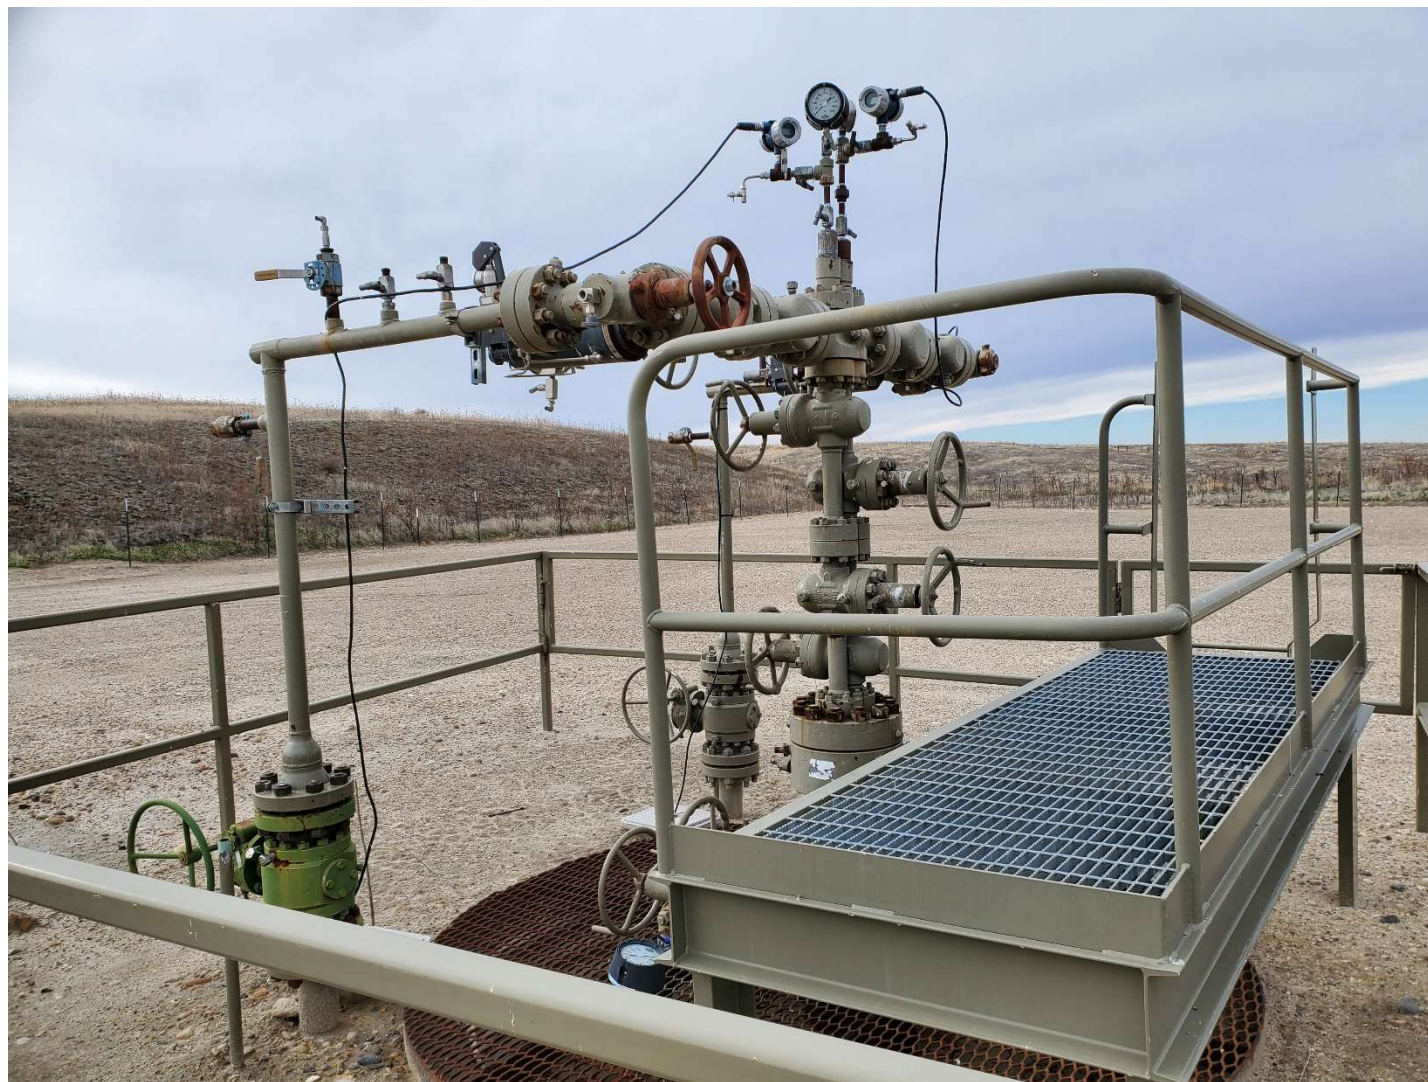
Surface casing= NA (no gauge installed)

Production casing= 0 psi

LT tubing string= 0 psi

UT tubing string= 400 psi (analog gauge only; no electrical power on location)

Wellhead showing pressure gauges installed on tree. View is Southwest.
