# Post Drilling/Annual Well Site Inspection Form

Operation Data	Inspection Data
<b>Operator Name</b> Snake River Oil + Gas, LLC	<b>Inspector Name</b> James Thum
<b>Well Name</b> Barlow #1-14, USWN 11-075-20033 Barlow #2-14, USWN 11-075-20034 Barlow #3-14, USWN 11-075-20040	<b>Area Office</b> Boise / Director's
<b>Authorized Contact</b> Dan Johaneck (208)707-7867 112 N. Plymouth, New Plymouth ID	<b>Inspection Date</b> 4/24/2024, 9:30 AM
<b>County</b> Payette	<b>Report Date</b> 5/9/2024
<b>Inspector's Signature:</b>

**Location Description:** 1.0 miles ENE from Hwy 30 and Hwy 95 intersection in Fruitland, ID, large island in Payette River. Google Maps location Latitude 44.029862, Longitude -116.904138. Well pad contains 3 wells: directionally-drilled Barlow #2-14 and Barlow #3-14, completed in separate sources of supply. Wells are currently shut-in (Harmon Field).

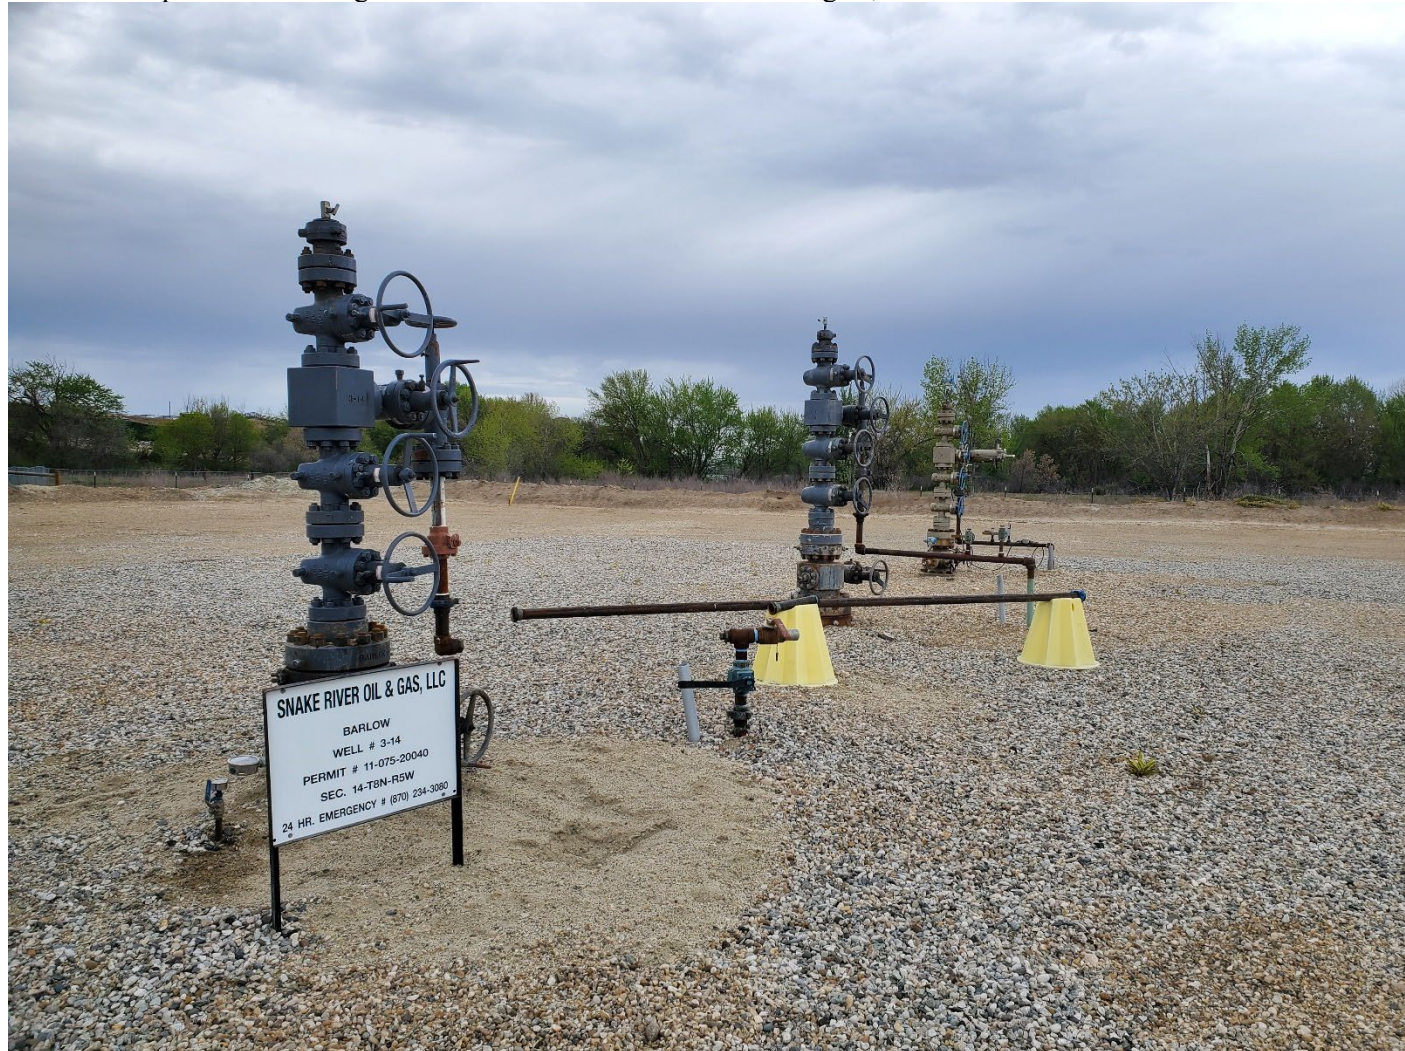
Section 3, #2: Barlow #3-14 sign is at the wellhead, #1-14 and #2-14 are at the gate. No method of identification is located at the #1 and #2.

Photo 093911: Three wellheads, left to right: Barlow #3-14, Barlow #2-14, Barlow #1-14. Barlow 3-14 not connected at time of inspection. Well signs for 2-14 and 1-14 are located at the gate, but should be at wellhead. View is WNW.

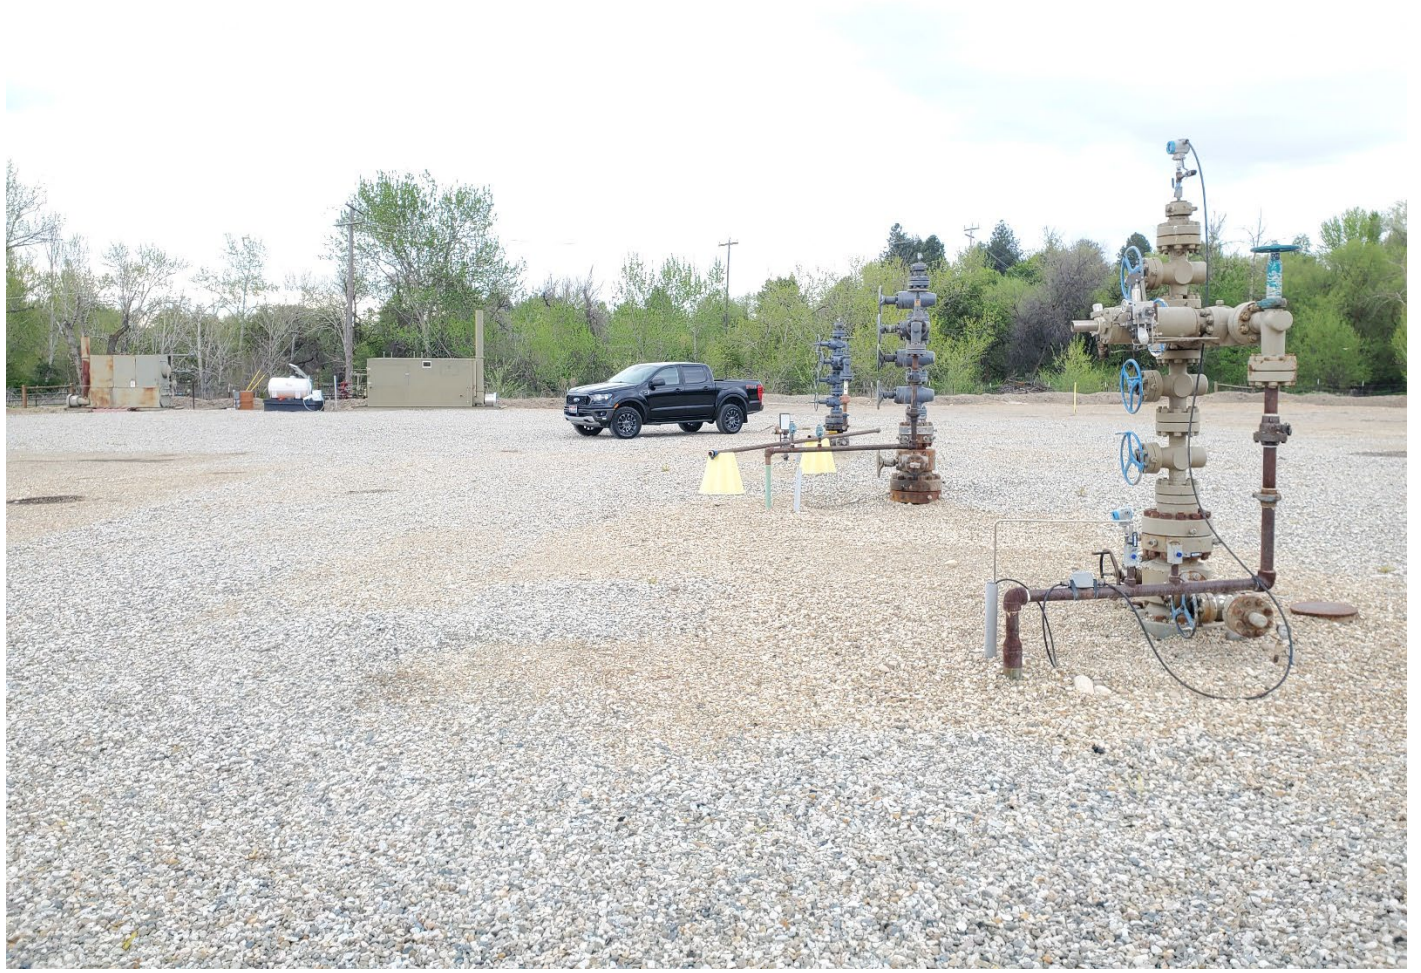
Photo 094139: Three wellheads, left to right: Barlow #3-14, Barlow #2-14, Barlow #1-14. Separator units (1 single, one dual) at left rear. View is SSE.

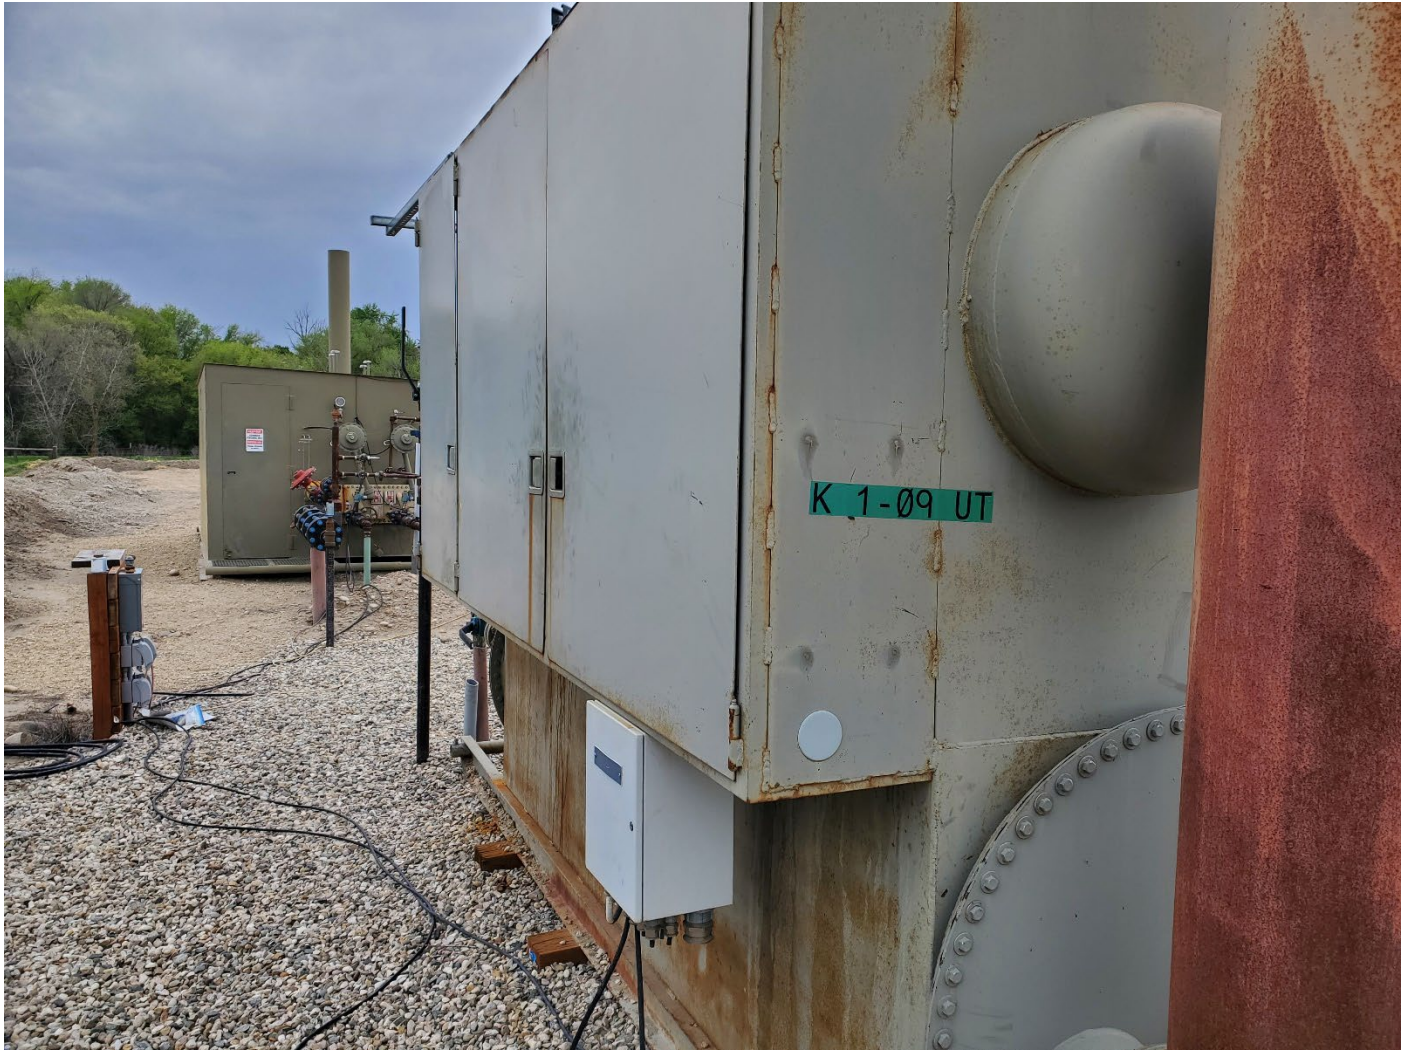
Section 7, #2: Separators need identification, recycled units from P&A'd wells still have old labels.

Photo 094815: Barlow #3-14 separator unit recycled from Kauffman #1-9 UT. Dual separator for Barlow #1-14 and #2-24 at left background. View is SW.

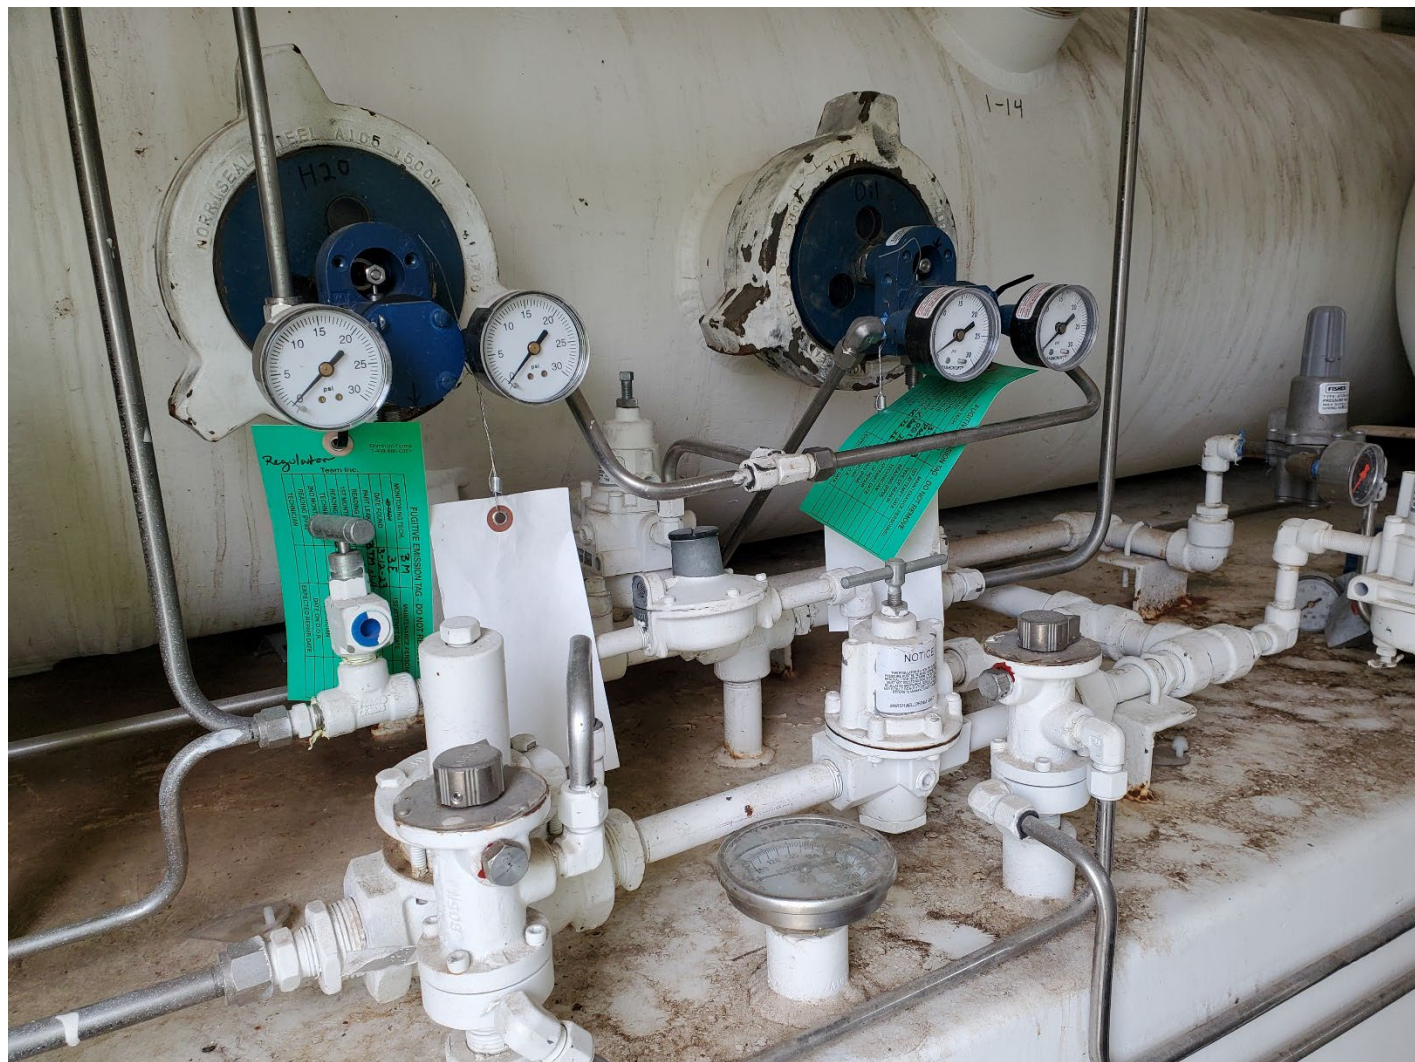
Photo 095408: Leak tags on dual separator unit from TEAM inspections. Operator is in the process of converting pneumatic valve systems to nitrogen-activated to comply with 2024 EPA emissions requirements.

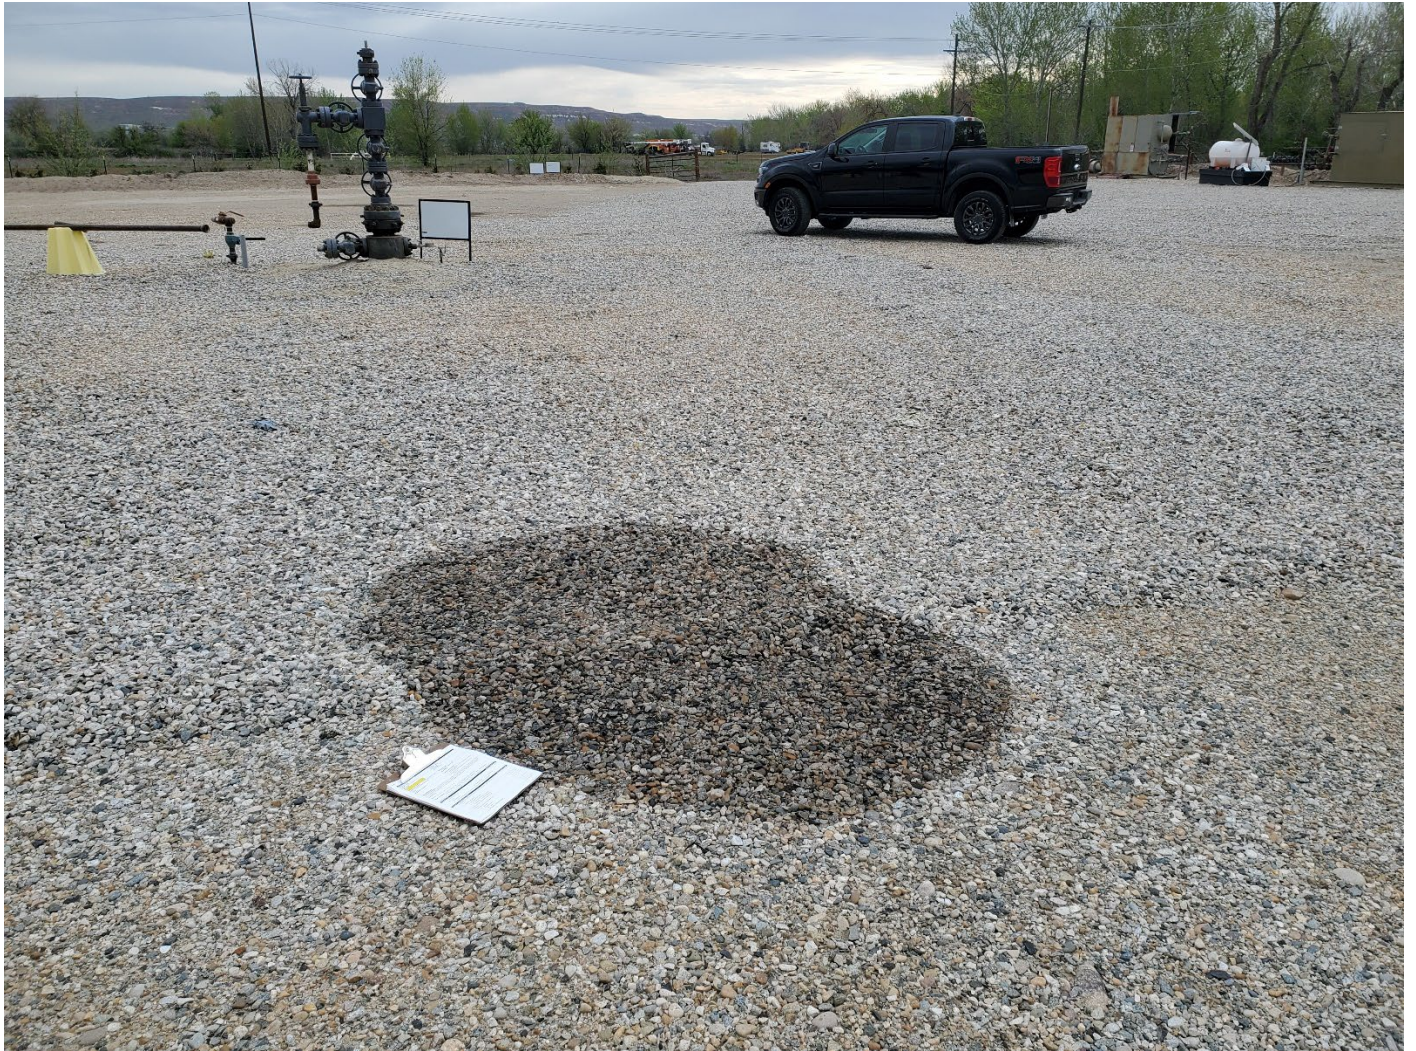
Photo 095630: approximately 4 feet diameter gravel stain. View is east.
