# Post Drilling/Annual Well Site Inspection Form

Section 1: General Information	
<b>Operation Data</b>	<b>Inspection Data</b>
Operator Name Snake River Oil + Gas, LLC	Inspector Name James Thum
Well Name Fallon #1-10, USWN 11-075-20032	Area Office Boise / Director's
Authorized Contact     Dan Johaneck (208)800-9503 112 N. Plymouth, New Plymouth ID	Inspection Date 4/24/2024, 10:50 AM
County Payette	Report Date 5/9/2024
<b>Inspector's Signature:</b>  <div style="text-align: center; font-family: cursive; font-size: 1.2em; margin: 10px 0;">James Thum</div> <b>Date of Signature:</b> 5/9/2024	<b>Inspection Summary:</b> <input checked="" type="checkbox"/> Operation appeared to be in compliance at the time of the inspection.  <input type="checkbox"/> Issues of concern identified at the time of the inspection.
<b>Location Description:</b> 1.40 miles NNW from Hwy 30 and Hwy 95 intersection in Fruitland, ID, west side of Hwy 95 north of the Payette River. Google Maps location Latitude 44.045495, Longitude -116.927641 All production is shut-in at the time of inspection. Weather: Rain, overcast 49°F, calm winds.

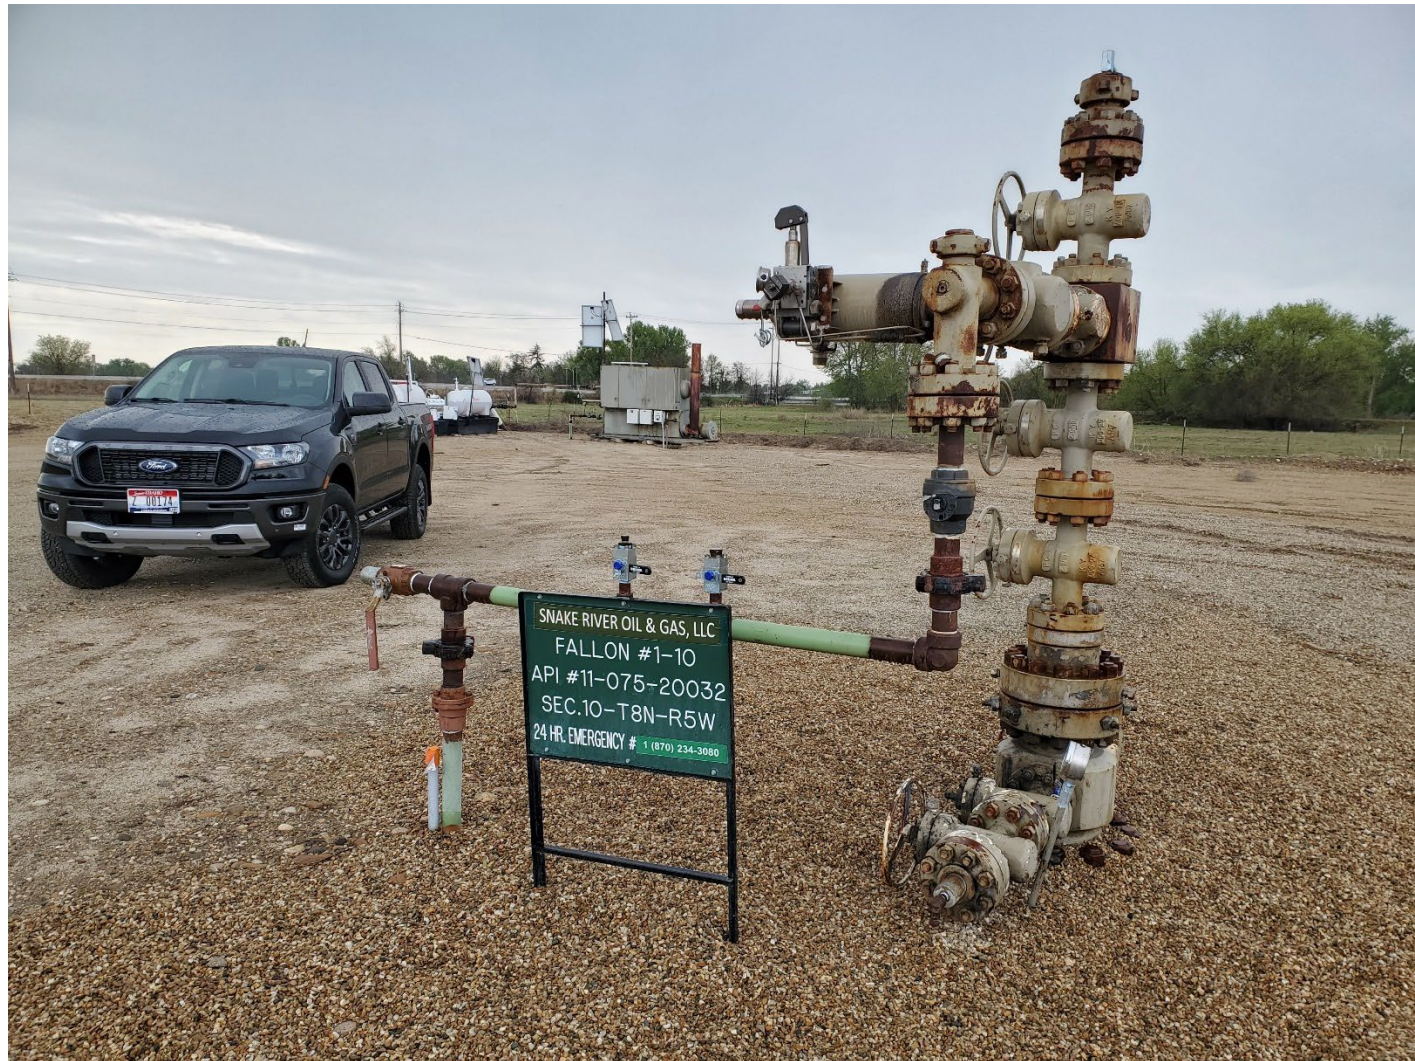
Photo 110449: Wellhead with separator in center background, chem tanks behind inspection vehicle. View SE.

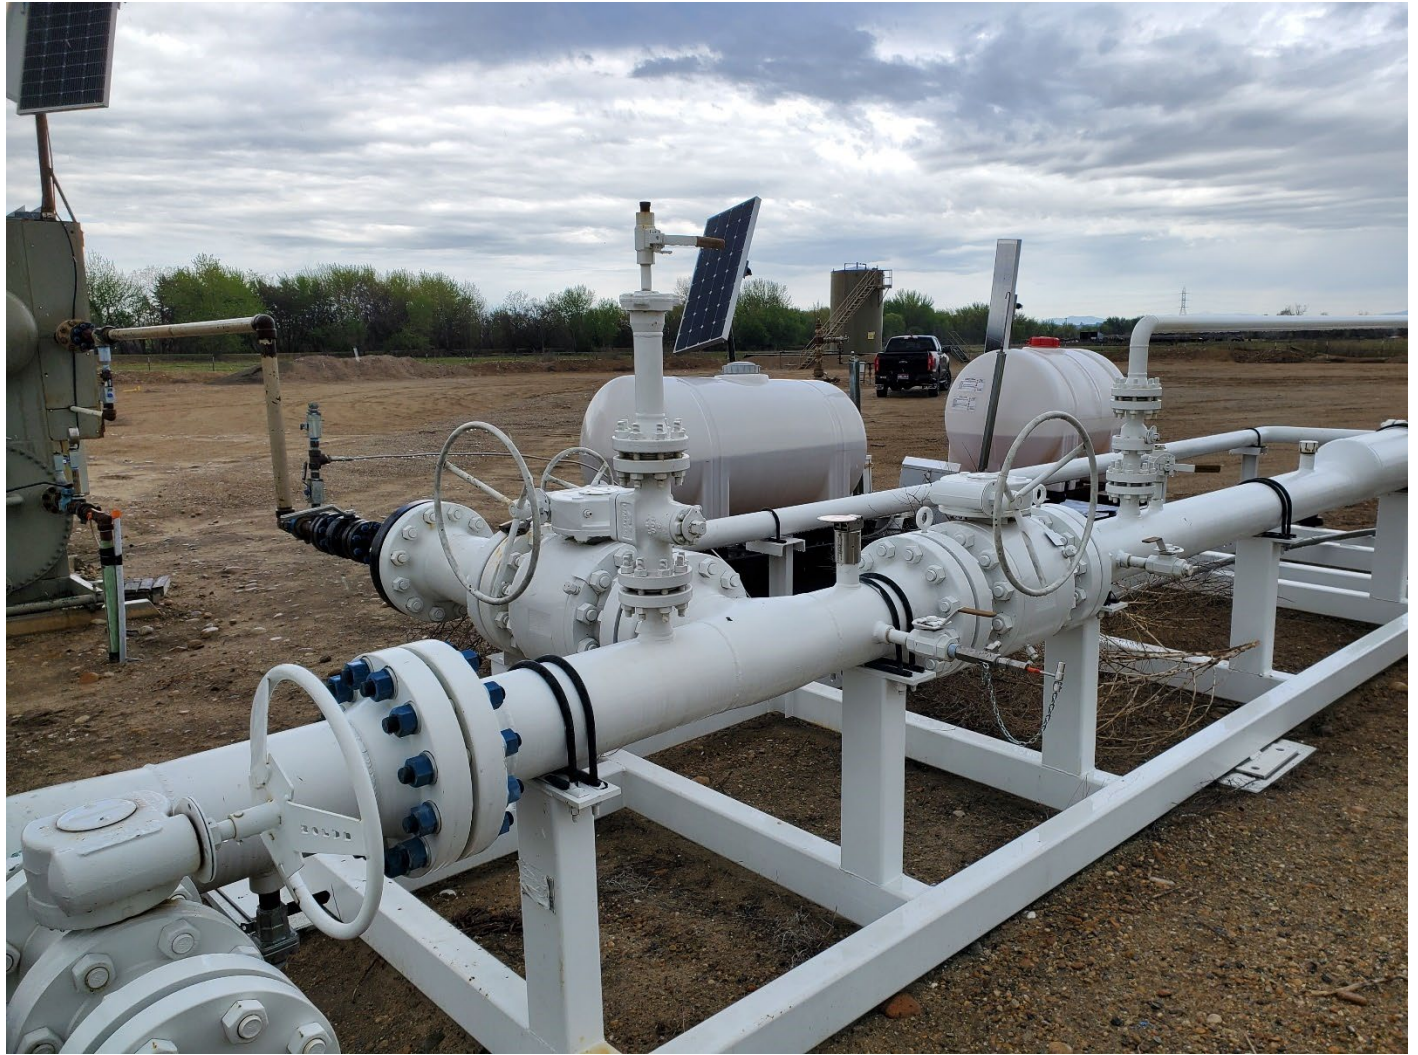
Photo 110846: Pig launcher and chem tanks, separator on left. View northwest.

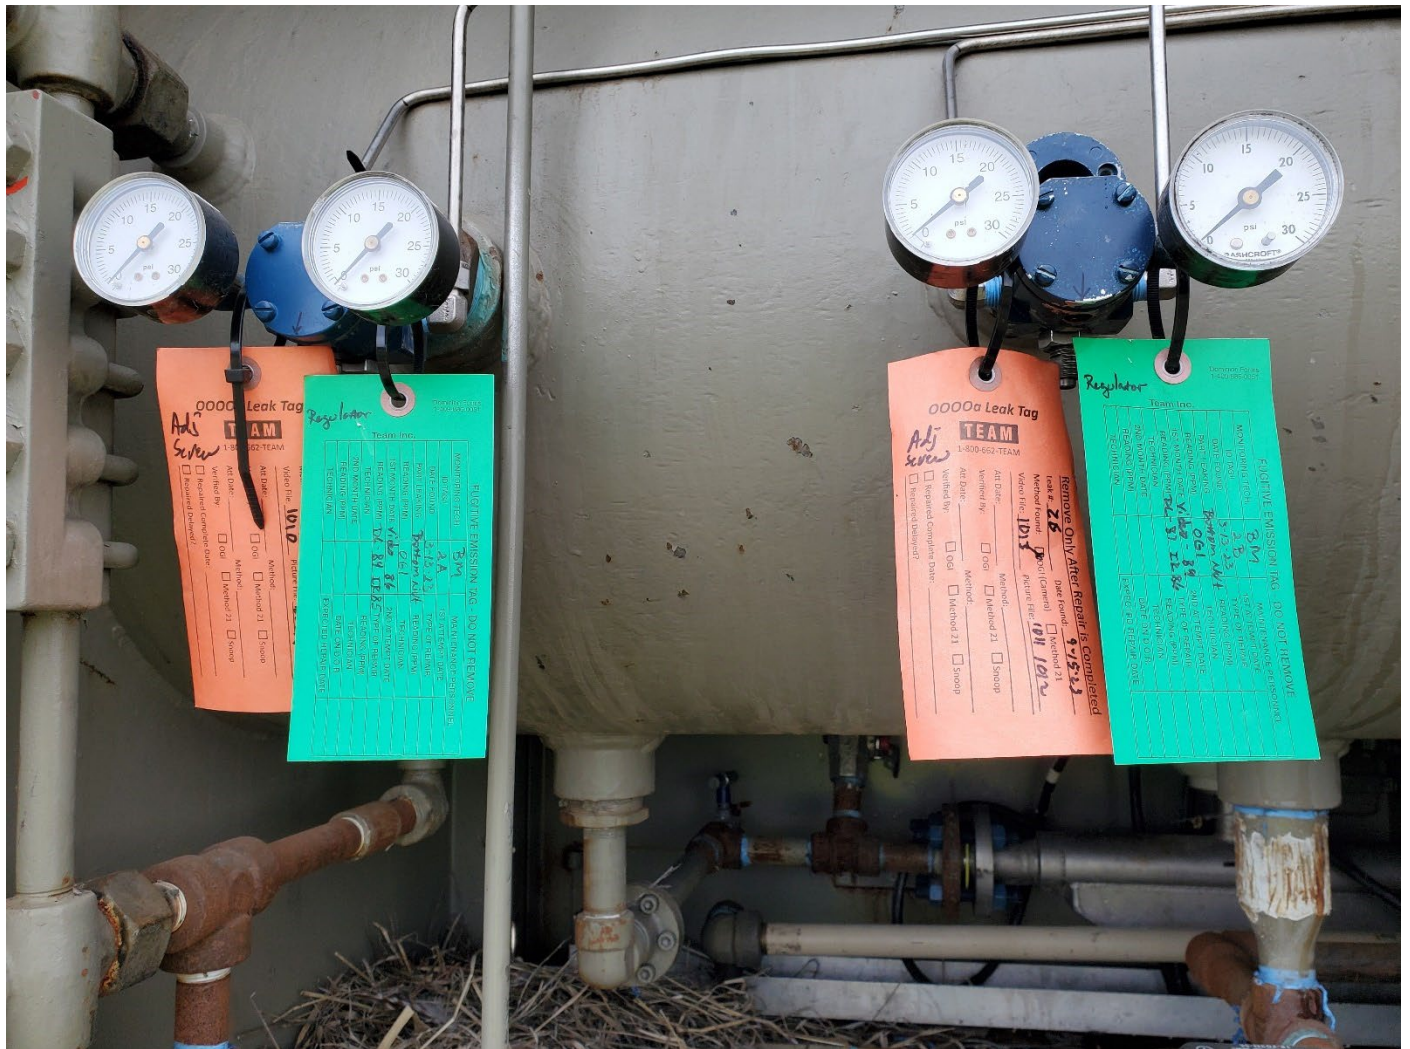
Other: Leak tags noted on pneumatic valves in separator, and at vent on top of produced water tank. Operator is in the process of replacing methane-actuated system with nitrogen-actuated system to comply with 2024 EPA emissions standards. Separator unit needs labeled with current well number (now reads “ML 1-11 LT”).

Photo 110604: Leak tags on pneumatic valves in separator. Operator is in the process of converting valves to nitrogen-actuated to comply with new 2024 EPA requirements.

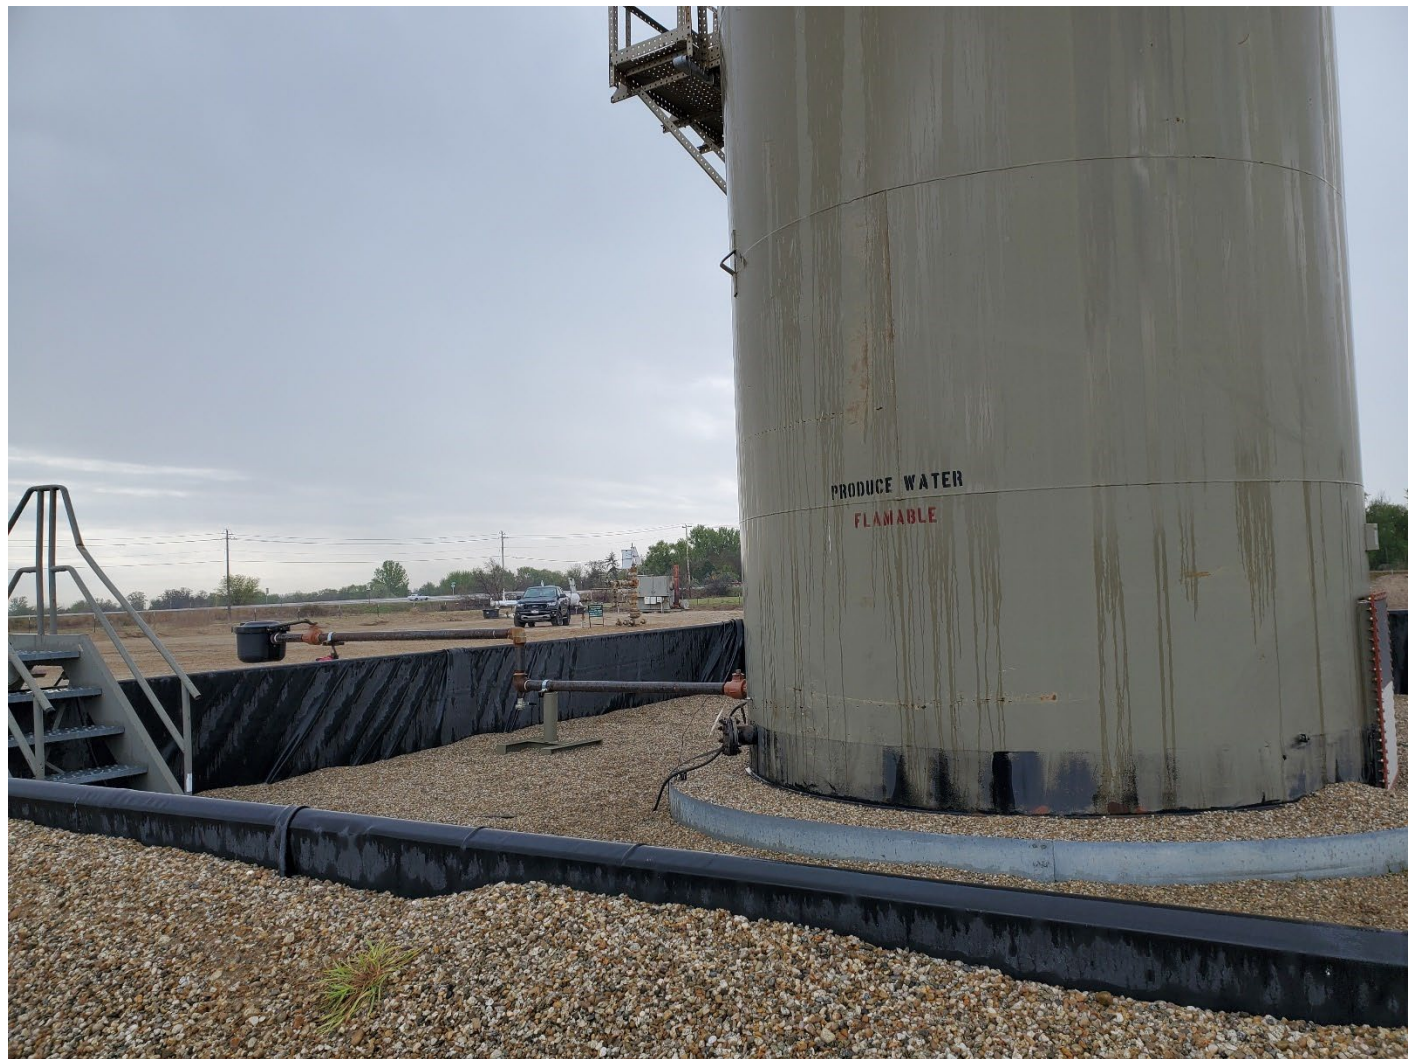
Section 9, D(a): Containment dike is 1.64 times the capacity of the 400-bbl tank; calculated 4/12/2023.

Section 9, D(f): Minor amount of standing water within the containment dike (raining at time of inspection).

Photo 111026: Produced water tank and containment dike. View is SE.

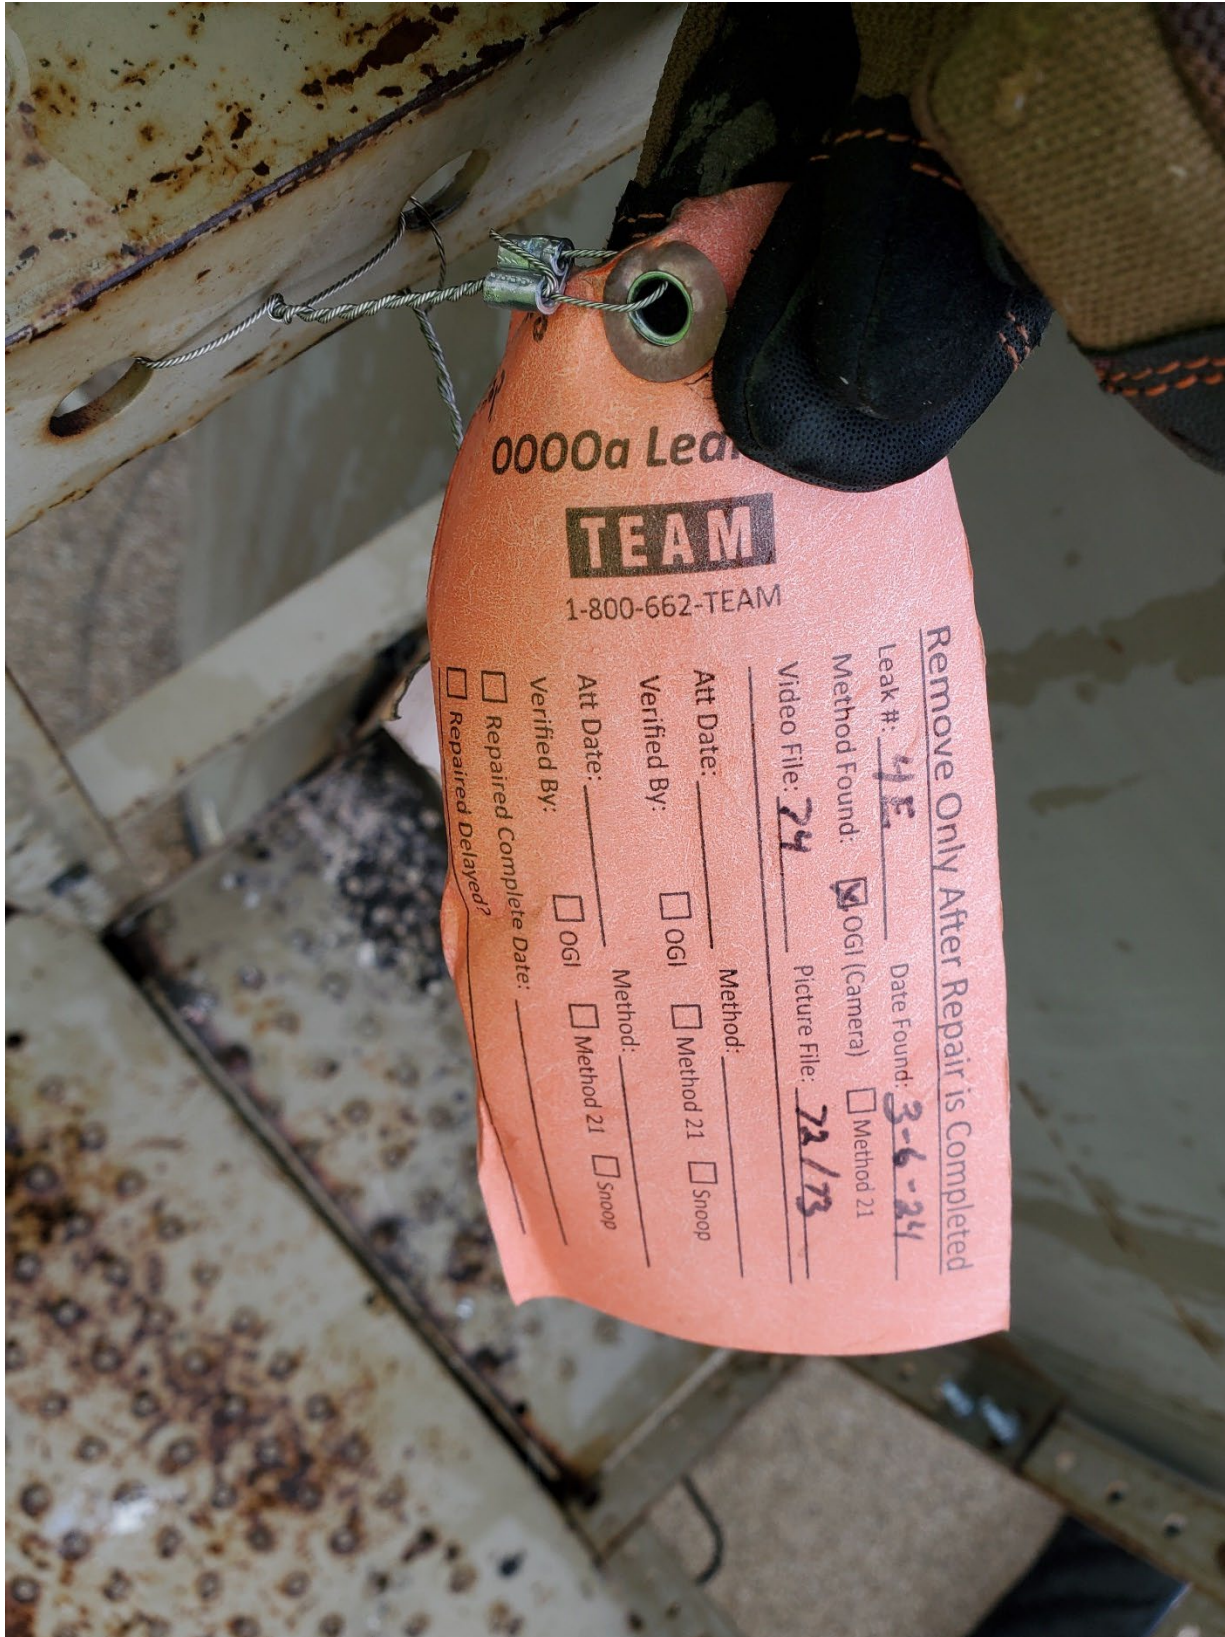
Photo #111330: Leak tag on top of produced water storage tank.
