Post Drilling/Annual Well Site Inspection Form

Section 1: General Information	
Operation Data	Inspection Data
Operator Name Snake River Oil + Gas, LLC	Inspector Name
Well Name Dutch Lane #1-13, USWN 11-075-20038	Area Office
Authorized Contact Dan Johaneck (208)800-9503 112 N. Plymouth, New Plymouth ID Tyler Hartung (208) 412-5475	Inspection Date 4/24/2024, 11:45 AM
County Payette	Report Date 5/10/2024
Inspector's Signature:

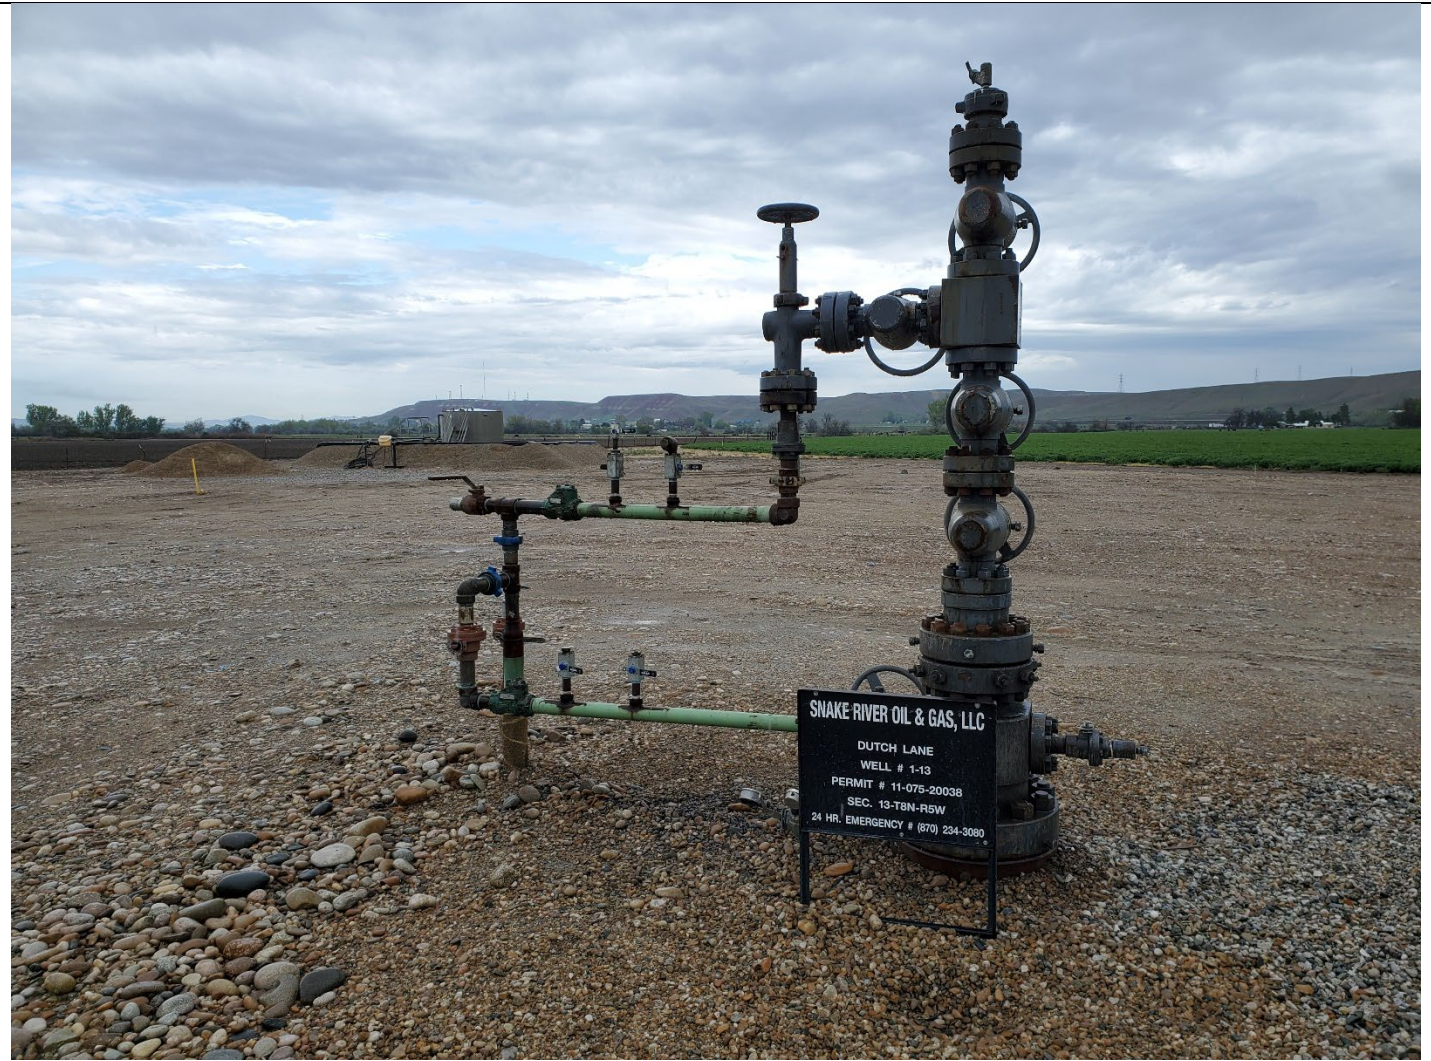
Photo 114627: Wellhead and tank battery, view is northwest

Section 4, #1: Well pad is not currently fenced. Department recommends installing heavy steel wellhead fencing of the type removed from recently P&A'd wells to protect wellhead from vehicle traffic on site. Spoke with surface owner Blaine May for 30 minutes. He was agreeable to the fence and had no other concerns regarding operations.

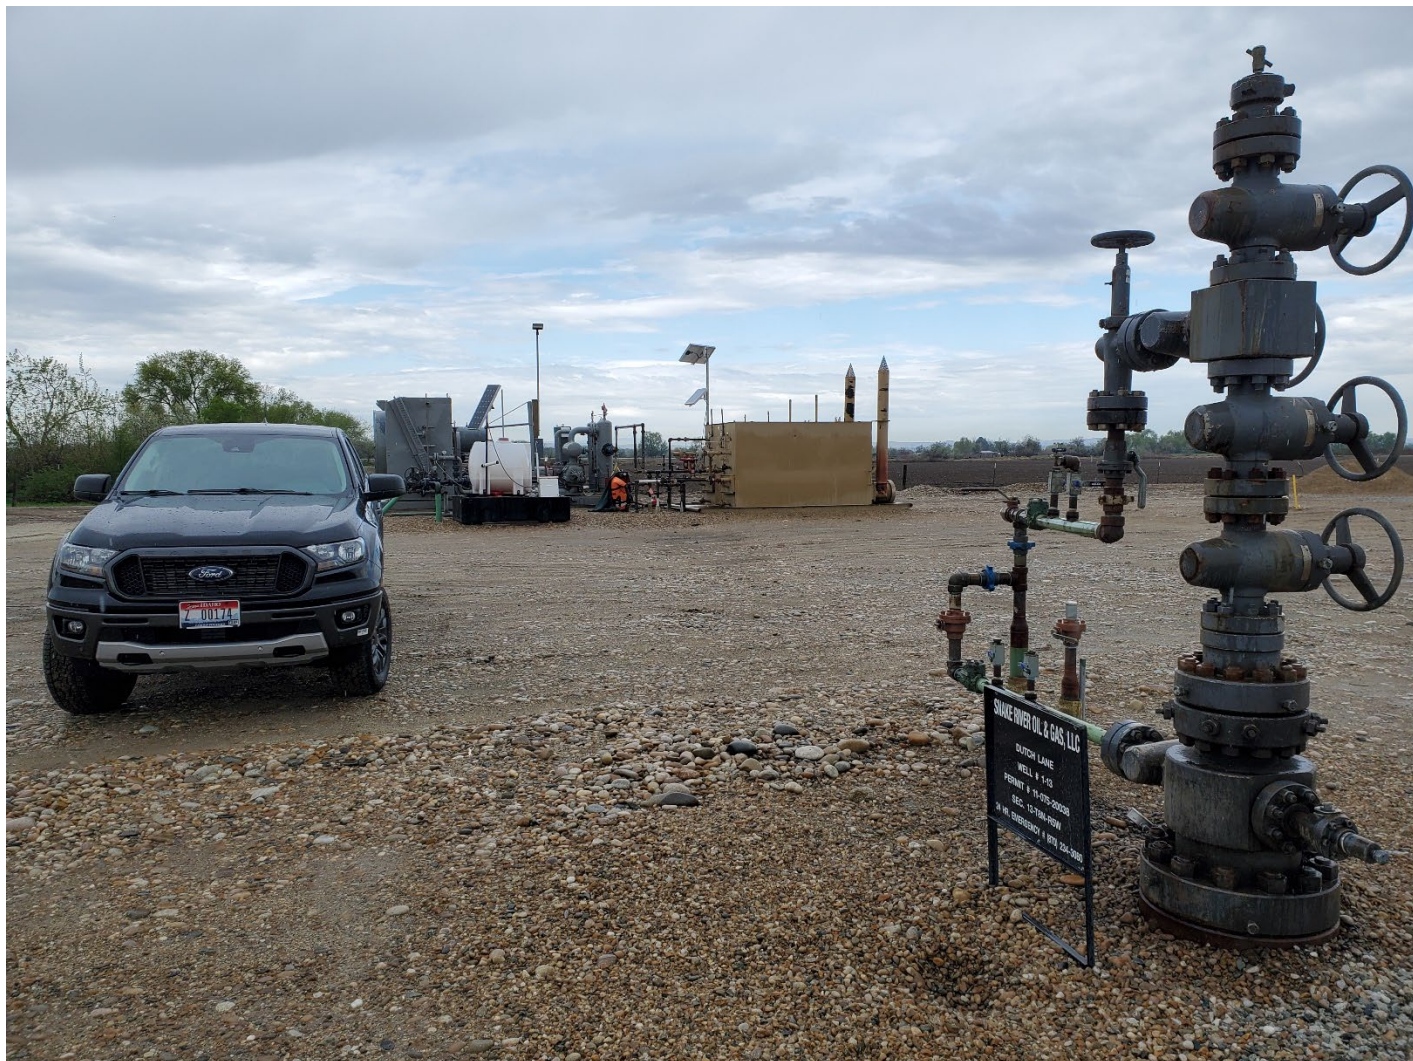
Photo 114636: Wellhead to right, separator at center rear, compressor unit to left rear behind inspection vehicle. View is west.

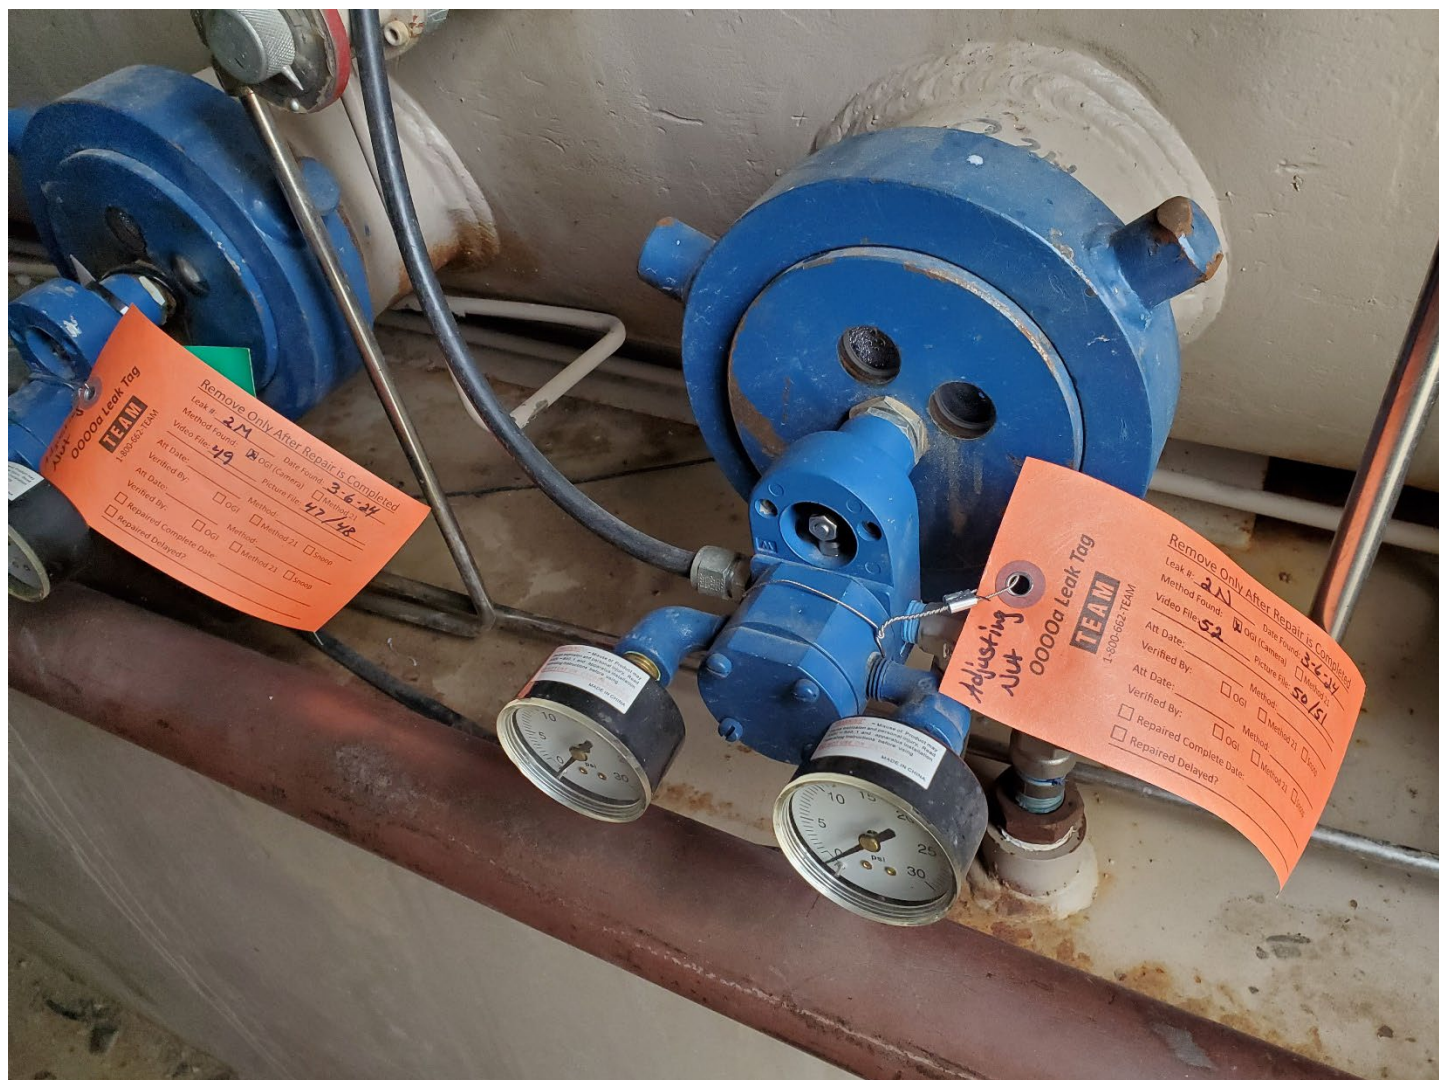
Section 7, #2: Leak tags dated 3/6/2024 were noted on separator, gathering line and produced water tank vent (not inspected). Operator is in the process of converting pneumatic valves from methane-actuated to nitrogen-actuated to comply with 2024 EPA emissions guidelines

Photo 114902: Leak tags on pneumatic valves on separator, dated 3/6/2024. Operator is currently converting pneumatic valves to nitrogen-actuated systems for all wells and facilities to comply with 2024 EPA emissions requirements.

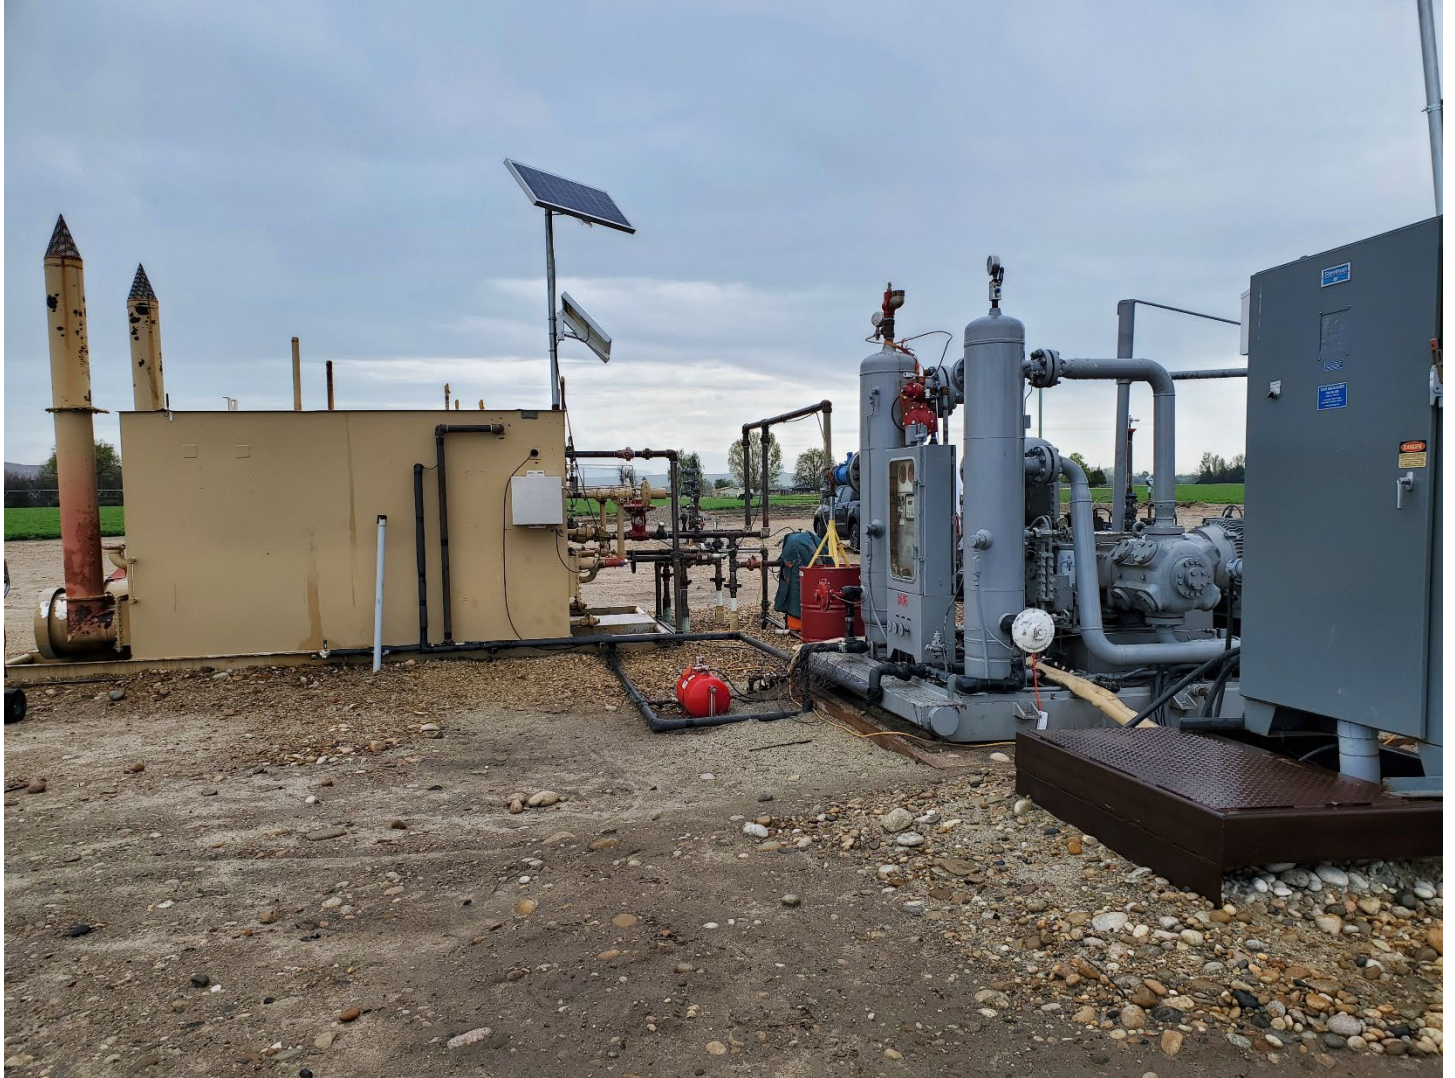
Photo 115120: Partial view of compressor unit on right, separator unit on left. View is east.

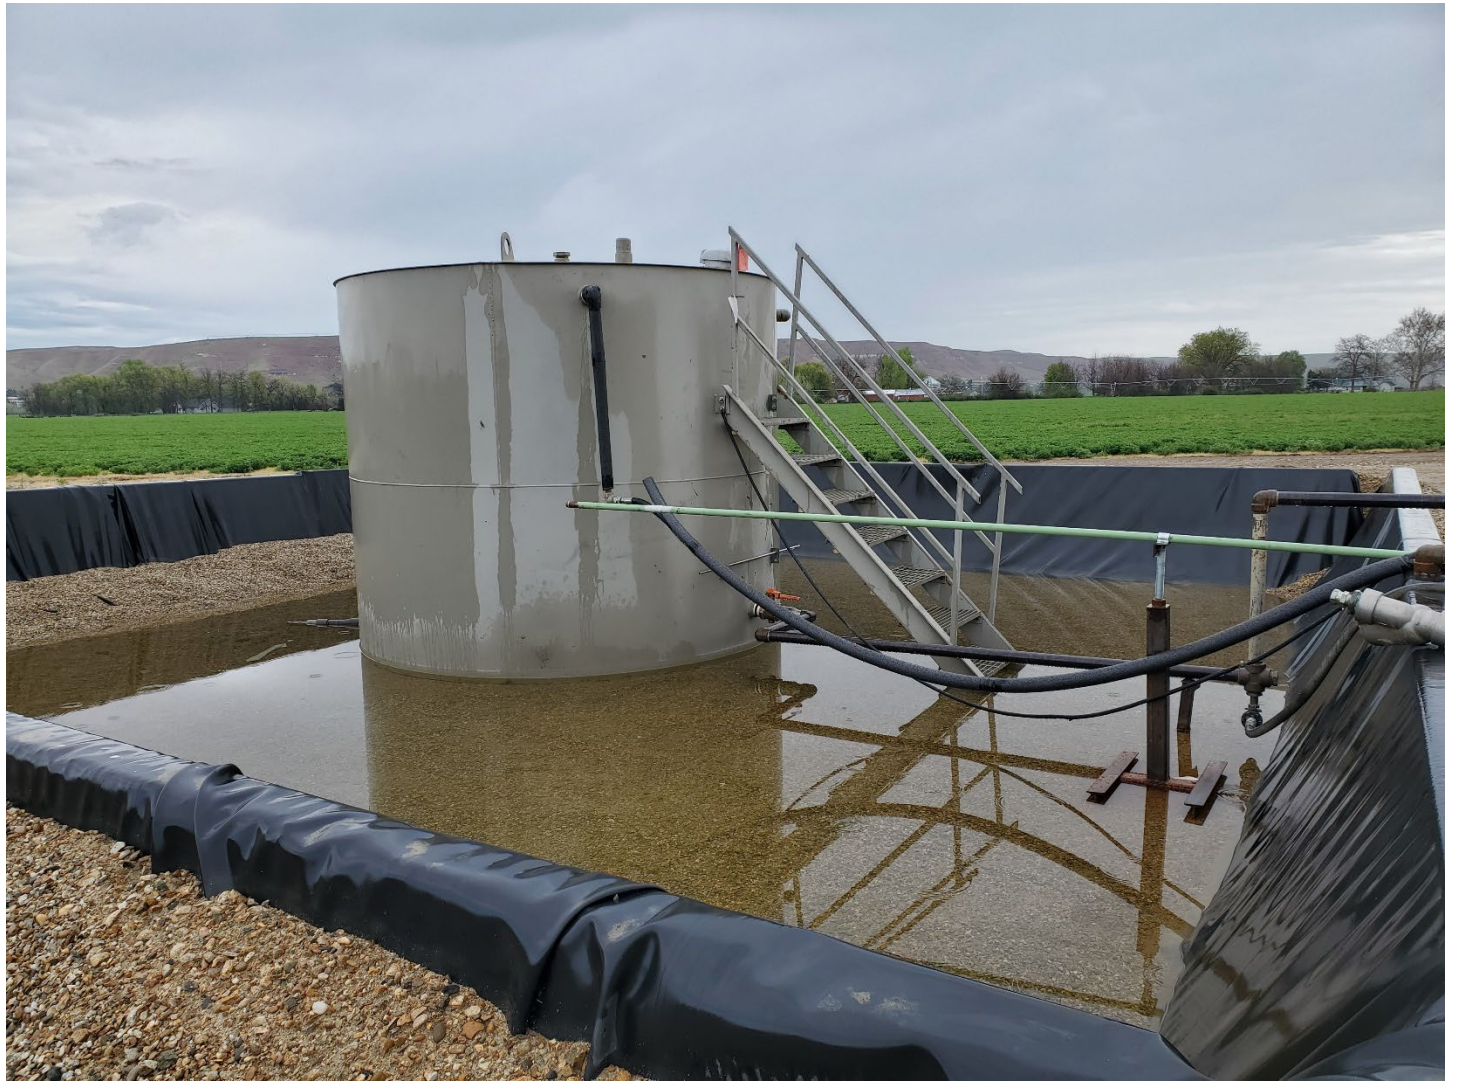
Section 9: Tank dike containment volume is 5.5 times the tank capacity per April 2023 calculation (minimum requirement is 1.5 times). Approximately 9 inches of water was within the dike due to recent rain (raining at the time of the inspection). Inside of dike was only inspected visually.

Photo #115231: Produced water tank and containment dike, view northeast. Leak tag at top of ladder, top right side of water tank (tag not inspected). Approximately 9 inches of water in containment dike from recent rain.
