Post Drilling/Annual Well Site Inspection Form

Section 1: General Information	
Operation Data	Inspection Data
Operator Name	Inspector Name James Thum
Snake River Oil + Gas, LLC Well Name	Area Office
DJS Properties #1-15, USWN 11-075-20020	Boise – Director's
Authorized Contact Dan Johanek (208)800-9503	Inspection Date
112 N. Plymouth, New Plymouth ID	10/3/2024 12:00 PM
County	Report Date
Payette	10/16/2024
Inspector's Signature:	Inspection Summary:
James Thum	Operation appeared to be in compliance at the time of the inspection.
	☐ Issues of concern identified at the time of the
Date of Signature: 10/16/2024	inspection.
Location Description: 1.09 miles SSE from Little Willow Ga	athering Facility, 4649 Little Willow Road. Google Maps
location Latitude 44.034893, Longitude -116.800803	
Weather: 50° F, SW wind < 5 MPH, clear with high hazy clou	ds. Well S/I at time of inspection.
Scope of Inspection (check all that apply and, or, were verifie	d during the inspection):

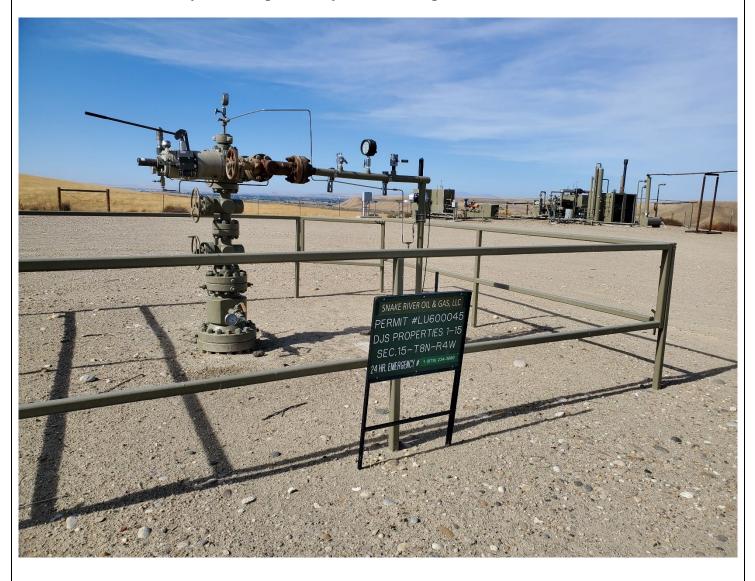
Wellhead and internal security fence, foreground. Separator unit background. View is west.

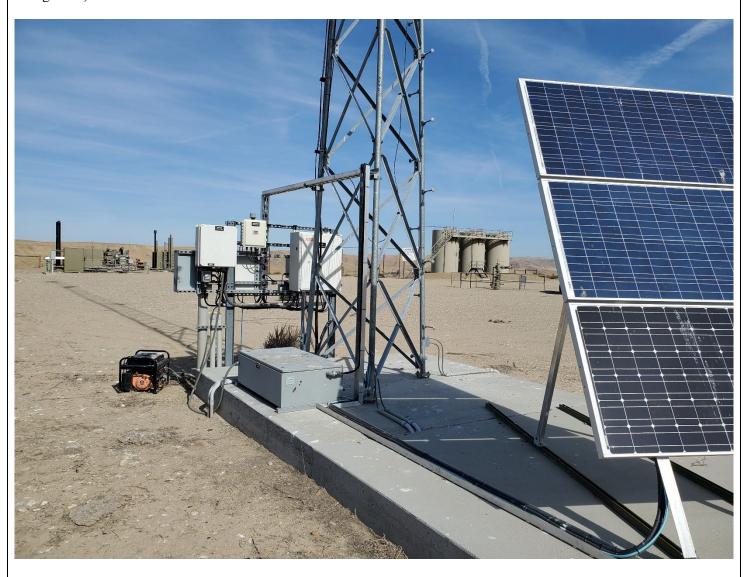
SCADA system and solar panels (foreground), separator unit (left background), tank battery and wellhead (center background). View is north.

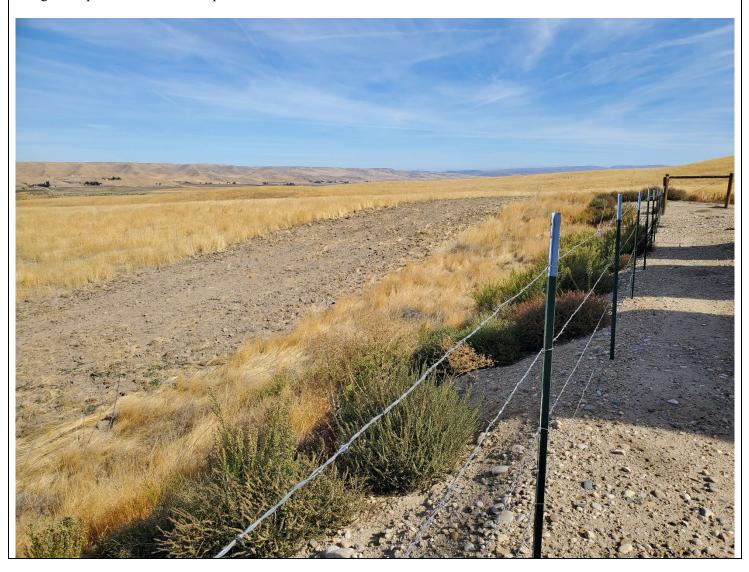
Bladed firebreak around pad for protection from August 2024 Paddock Fire. View is Northeast up Little Willow Canyon along north perimeter of the well pad.
