Post Drilling/Annual Well Site Inspection Form

Section 1: General Information	
Operation Data	Inspection Data
Operator Name Snake River Oil + Gas, LLC	Inspector Name James Thum
Well Name ML Investments #2-10, USWN 11-075-20022	Area Office Boise – Director’s
Authorized Contact Dan Johaneck (208)800-9503 112 N. Plymouth, New Plymouth ID	Inspection Date 10/3/2024 11:30 AM
County Payette	Report Date 10/15/2024
Inspector’s Signature: <div style="text-align: center; font-family: cursive; font-size: 1.2em; margin: 10px 0;">James Thum</div> Date of Signature: 10/15/2024	Inspection Summary: <input checked="" type="checkbox"/> Operation appeared to be in compliance at the time of the inspection. <input type="checkbox"/> Issues of concern identified at the time of the inspection.
Location Description: 1800 feet ESE from Little Willow Gathering Facility, 4649 Little Willow Road. Google Maps location Latitude 44.049326, Longitude -116.796756 Weather: 48° F, SW wind <5 MPH, clear with high scattered / thin clouds

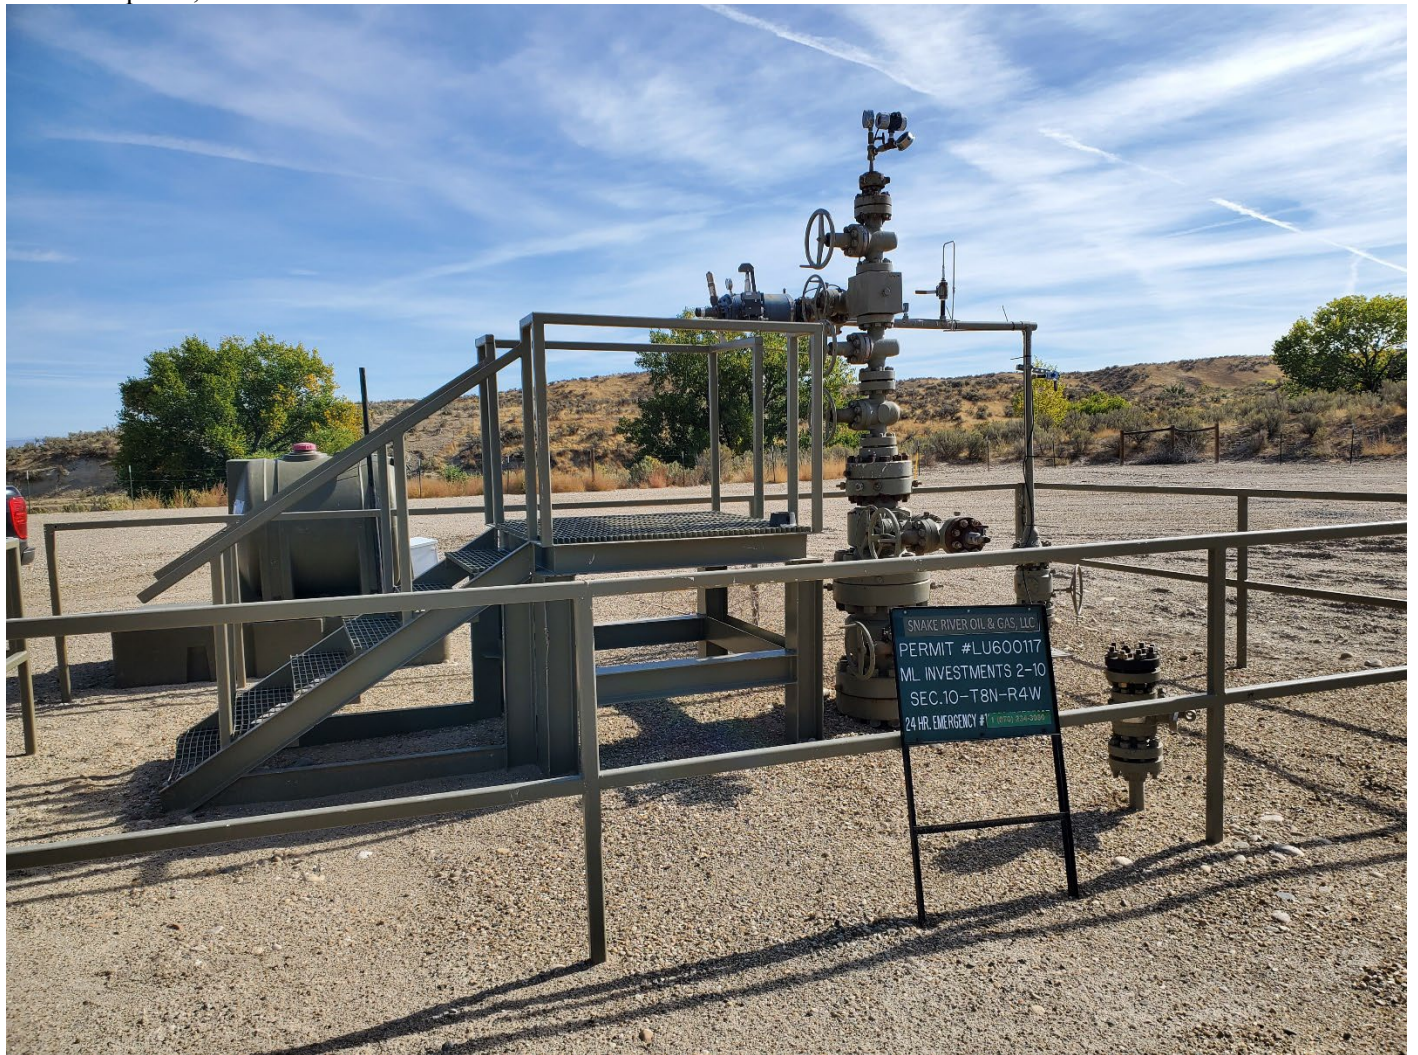
Cellar is gravel-filled

No leaks detected on wellhead with soapy water spray tests

Wellhead photo, view is east.
