Post Drilling/Annual Well Site Inspection Form

Location Description: 3550 feet SE from Little Willow Gathering Facility, 4649 Little Willow Road. Google Maps location Latitude 44.045964, Longitude -116.791613. **Well declared inactive 8/15/2023** as a result of consecutive 24 months of no production. Plugging deadline extended to December 19, 2024.

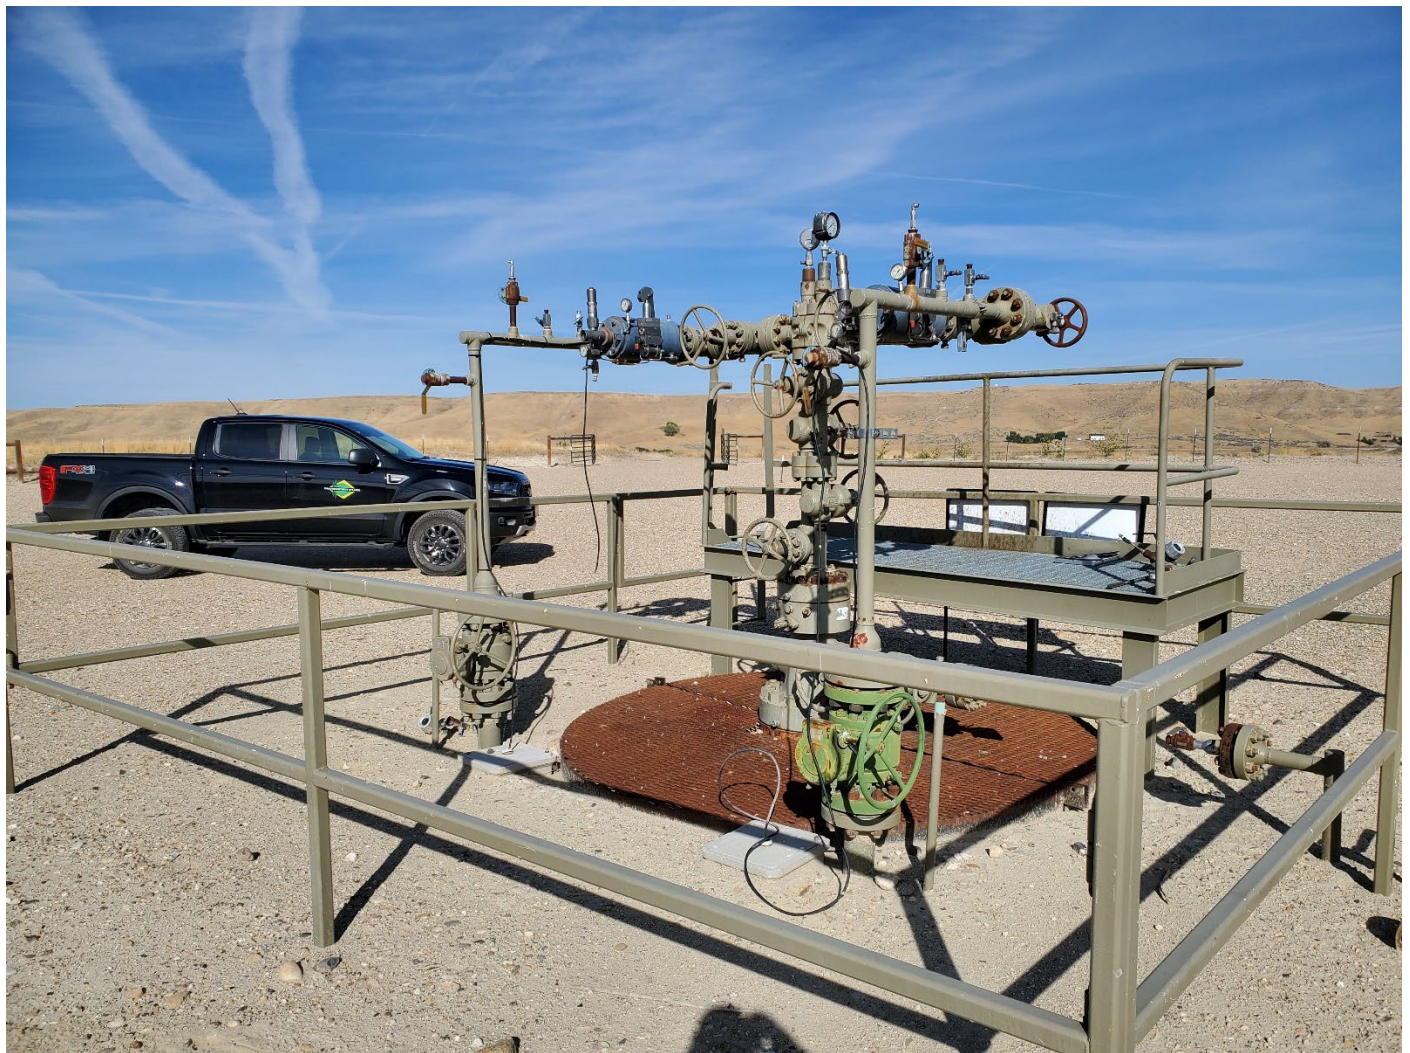
Cellar is open (not gravel filled) and dry.

Dual completion wellhead with UT completion on the right, LT completion on the left. Open cellar (not gravel-filled) with safety grate over cellar. View is northwest.

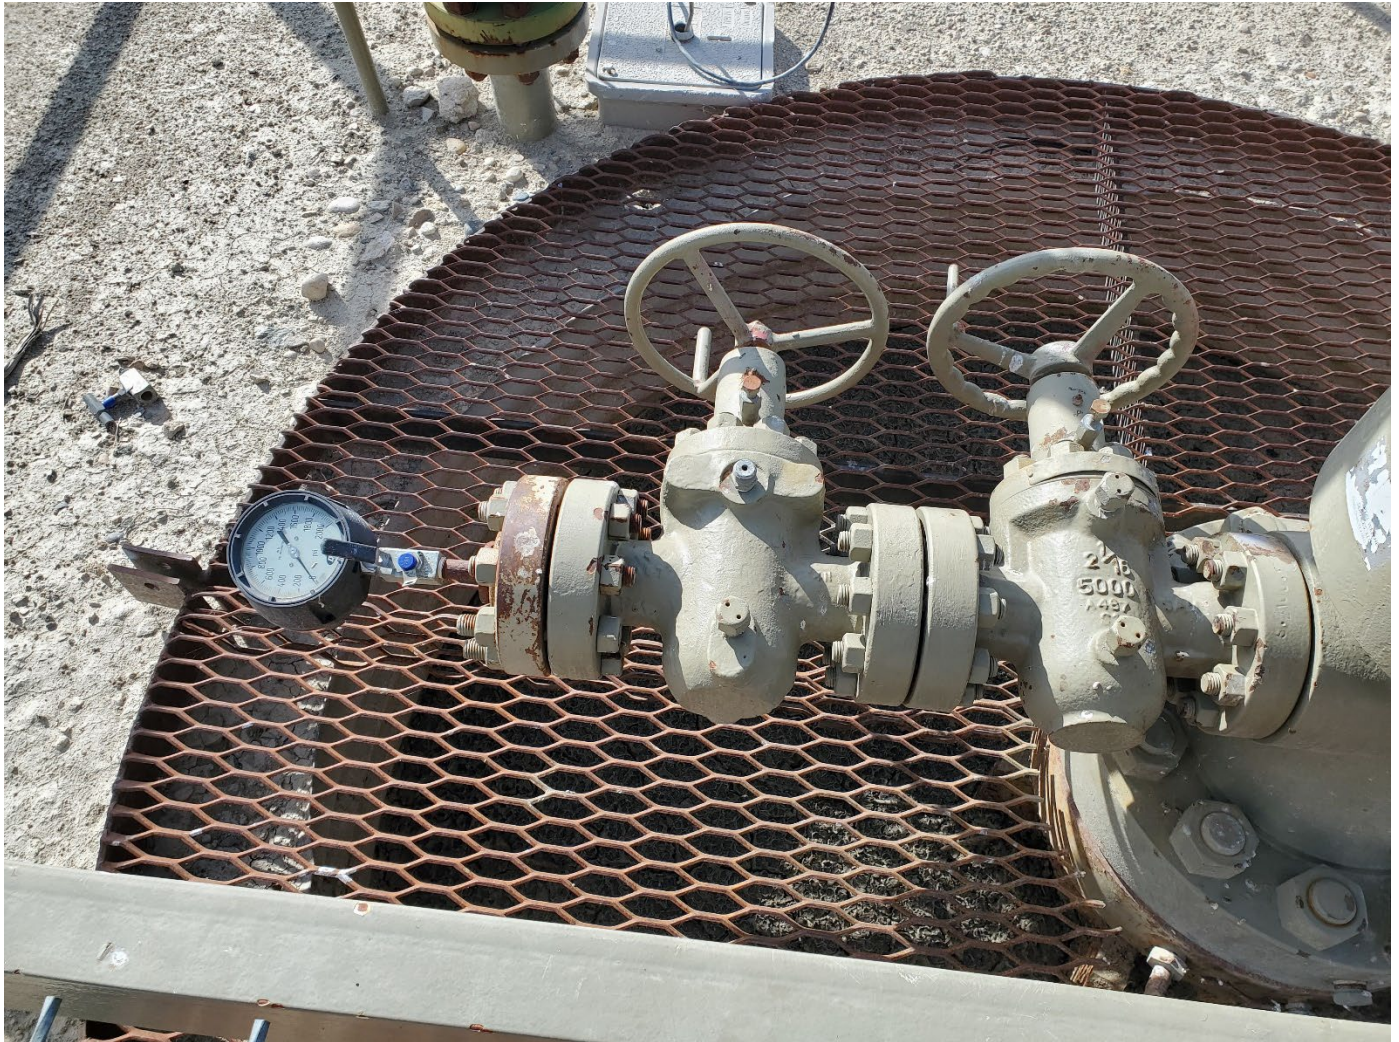
Production casing: 0 PSI (analog)

View of production casing gauge and cellar on UT completion side.

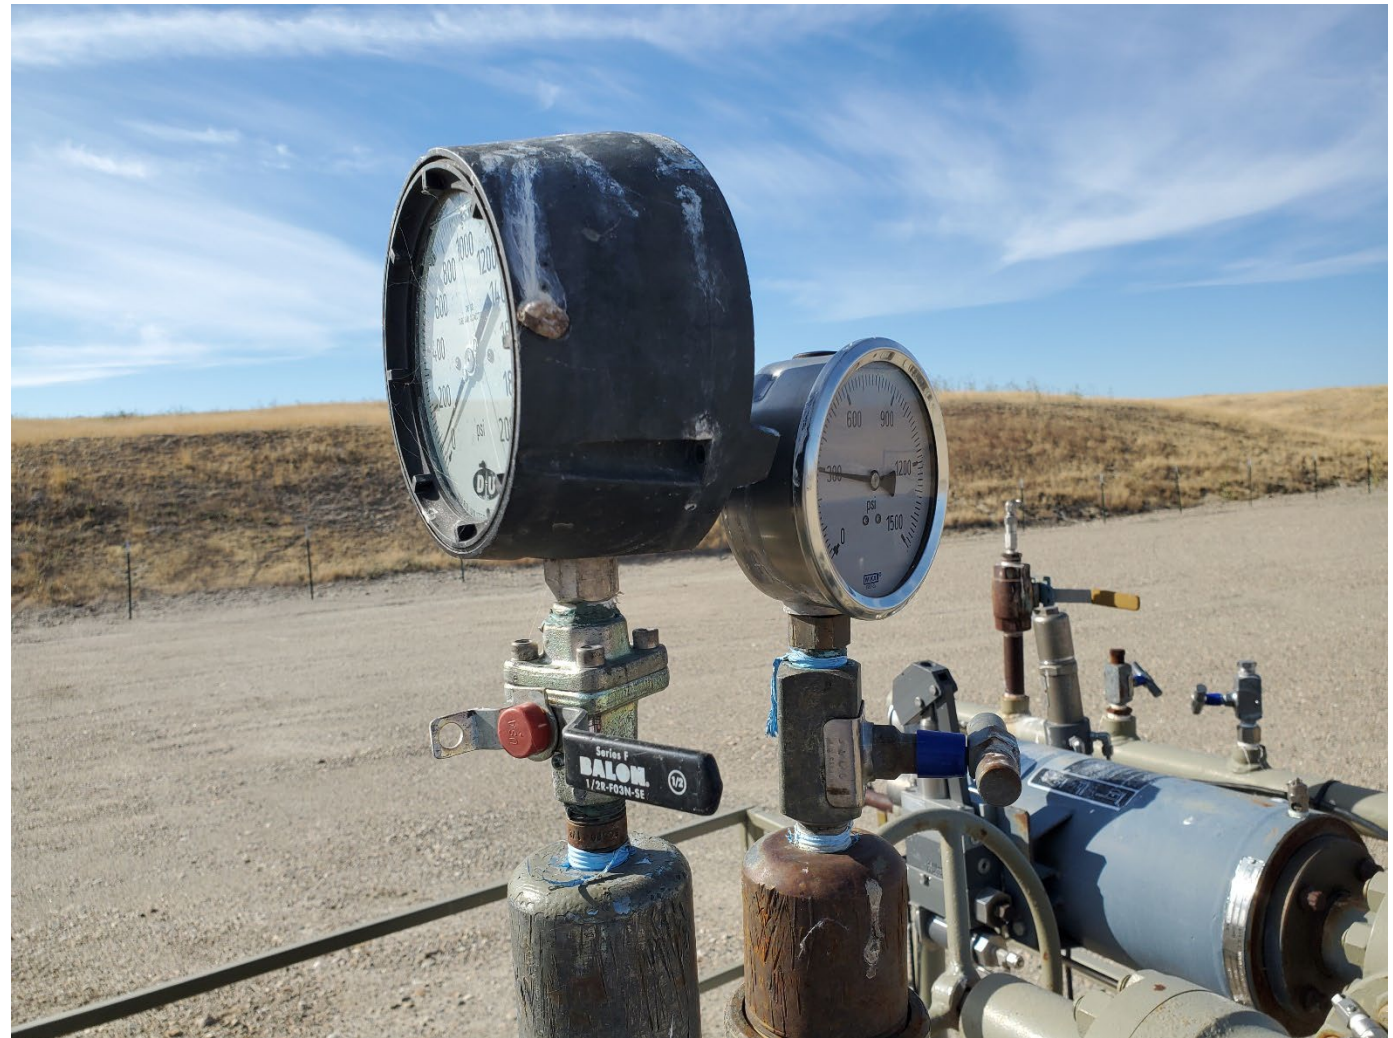
LT tubing string= 300 psi (analog)

UT tubing string= 0 psi (analog)

UT tubing string gauge on left (0 psi), LT tubing string gauge on right (300 psi).
