# Post Drilling/Annual Well Site Inspection Form

Section 1: General Information	
<b>Operation Data</b>	<b>Inspection Data</b>
Operator Name Snake River Oil + Gas, LLC	Inspector Name James Thum
Well Name <b>ML Investments #1-3, USWN 11-075-20026</b>	Area Office Boise – Director’s
Authorized Contact      Dan Johaneck (208)800-9503 112 N. Plymouth, New Plymouth ID	Inspection Date 10/3/2024  2:00 PM
County Payette	Report Date 10/17/2024
<b>Inspector’s Signature:</b>  <div style="text-align: center; font-family: cursive; font-size: 1.2em; margin: 10px 0;">James Thum</div> <b>Date of Signature:</b> 10/17/2024	<b>Inspection Summary:</b> <input checked="" type="checkbox"/> Operation appeared to be in compliance at the time of the inspection.  <input type="checkbox"/> Issues of concern identified at the time of the inspection.
<b>Location Description:</b> 4420 feet NNW from Little Willow Gathering Facility, 4649 Little Willow Road. Google Maps location Latitude 44.062918, Longitude -116.804583  Weather: SSW wind <5 MPH, clear 70° F, scattered high clouds. Well S/I

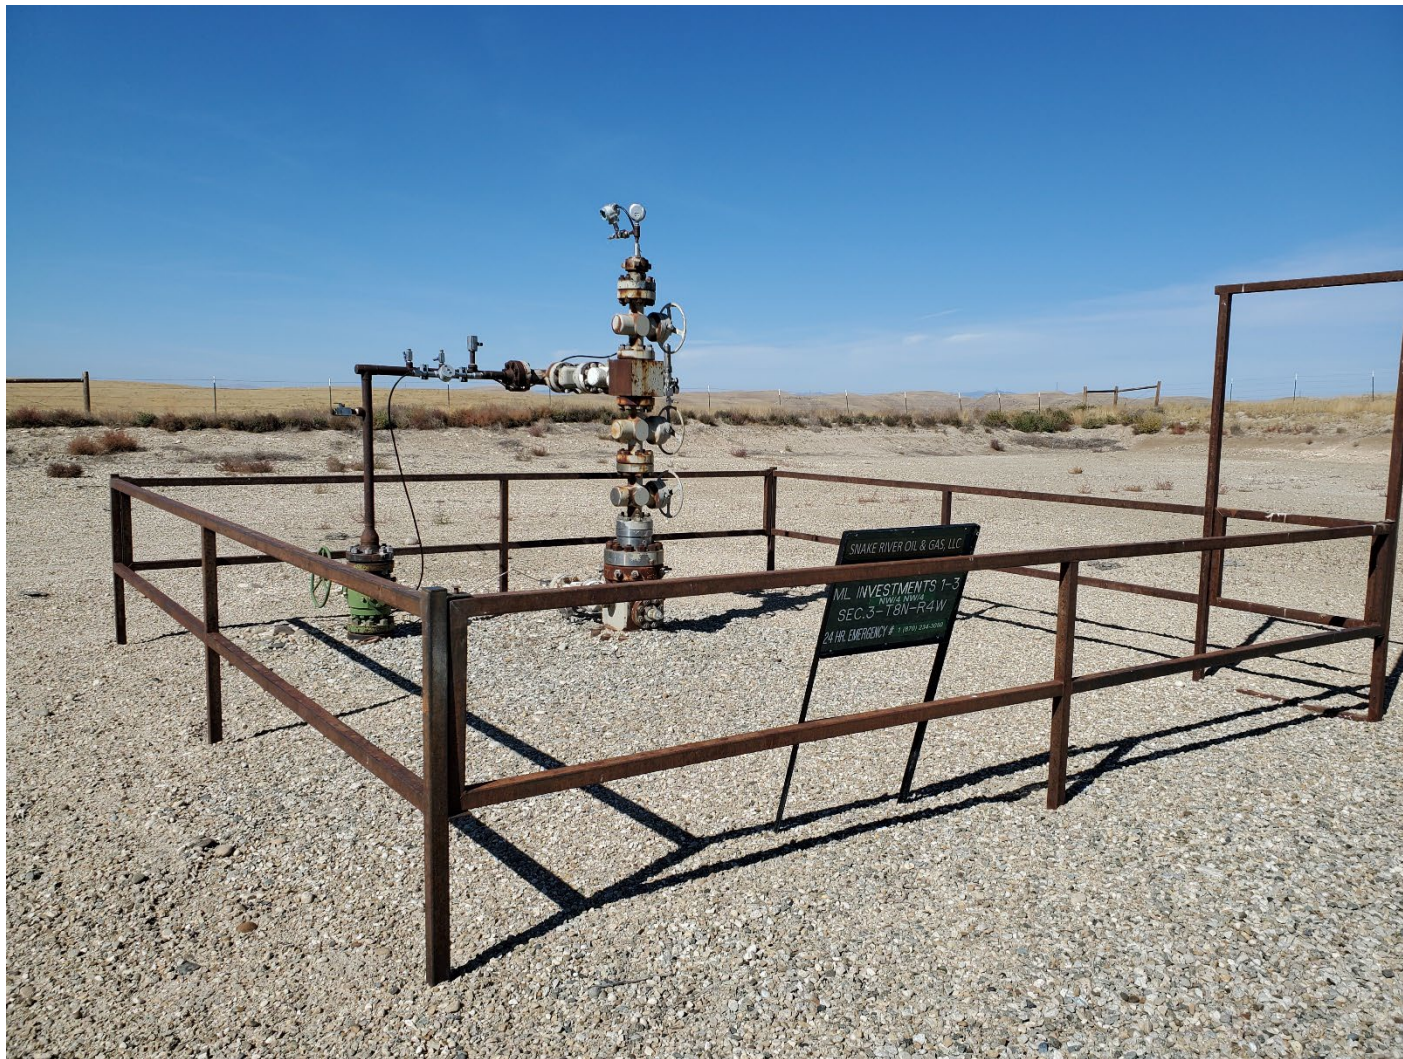
Wellhead and safety fence, view Northwest. Wellhead identification sign was found face down, repositioned during inspection.

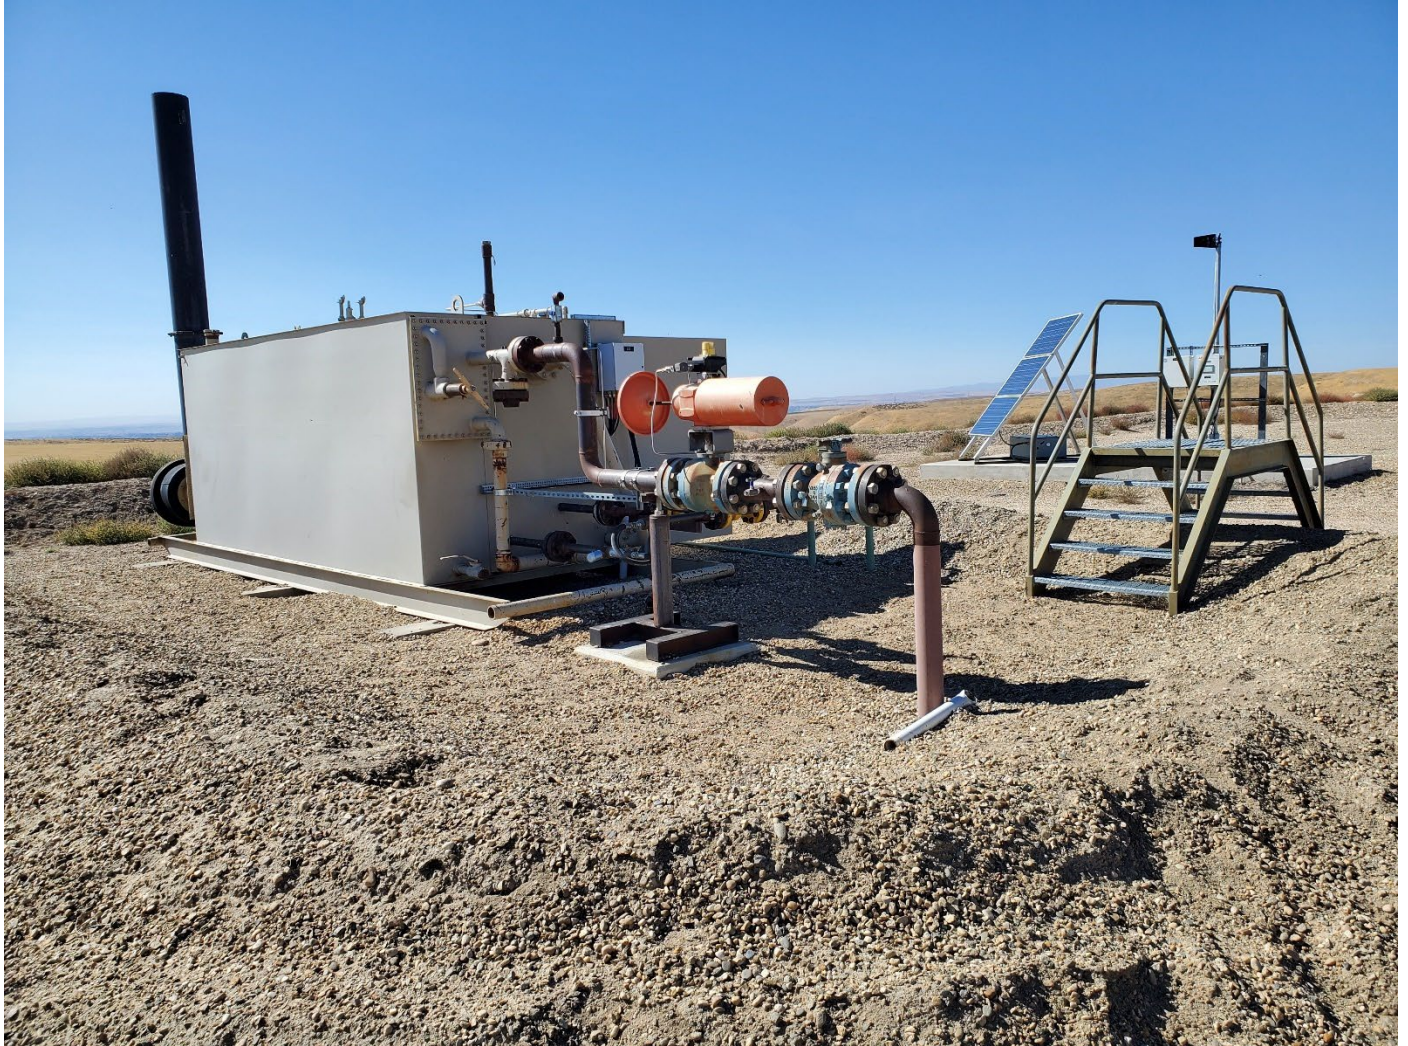
Separator unit and access ladder over retention barrier. SCADA system solar panel in background. View is West.

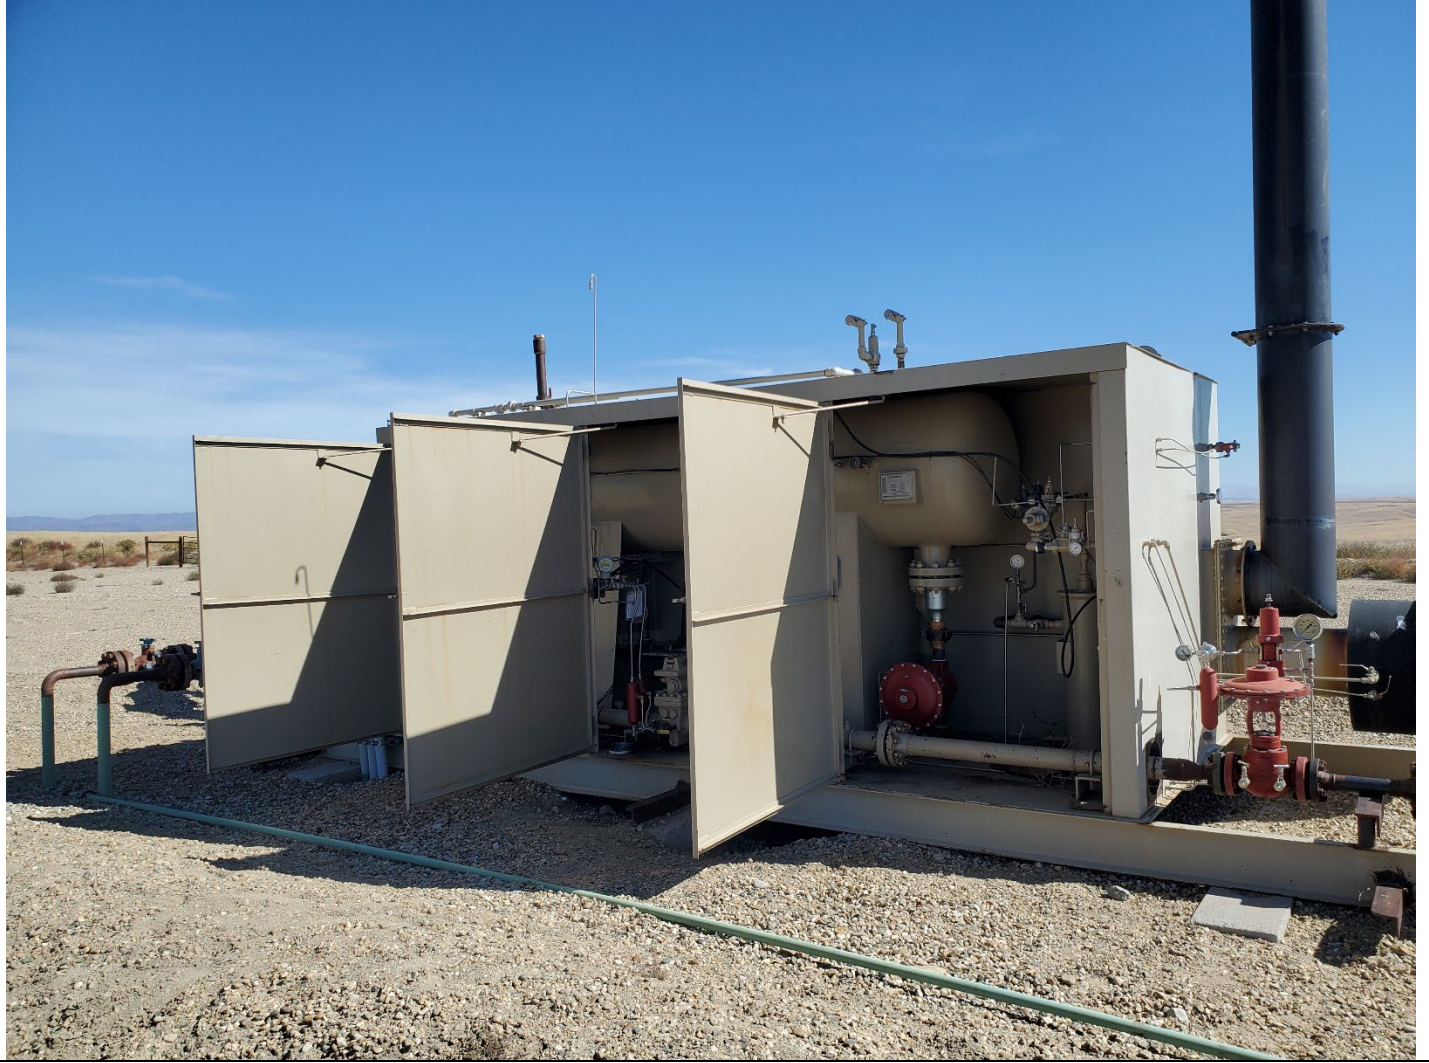
Separator unit; doors were open at time of inspection. View is East.
