Section 4: Location Operations
20.07.02.301

Section 10: Inspection Comments

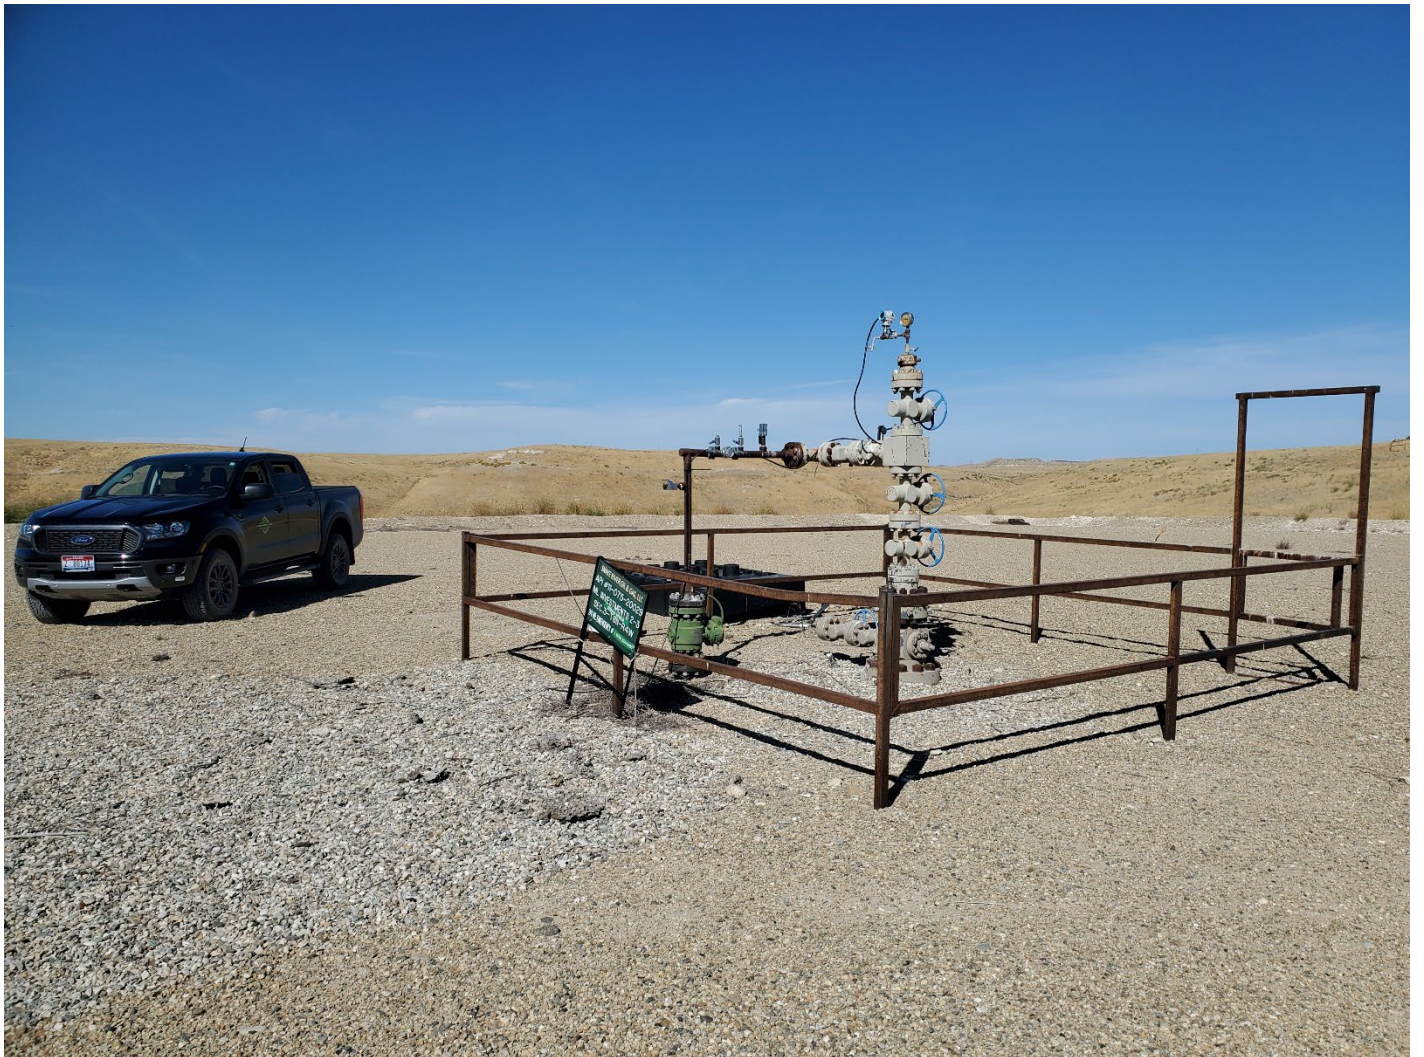
- ii. Does the fence appear to:
- a. Maintain safe working conditions? Yes No
- b. Secure the well site? Yes No
- c. Prevent access by wildlife and livestock? **Both gates open at time of inspection** Yes No

Wellhead and safety fence, view is North.

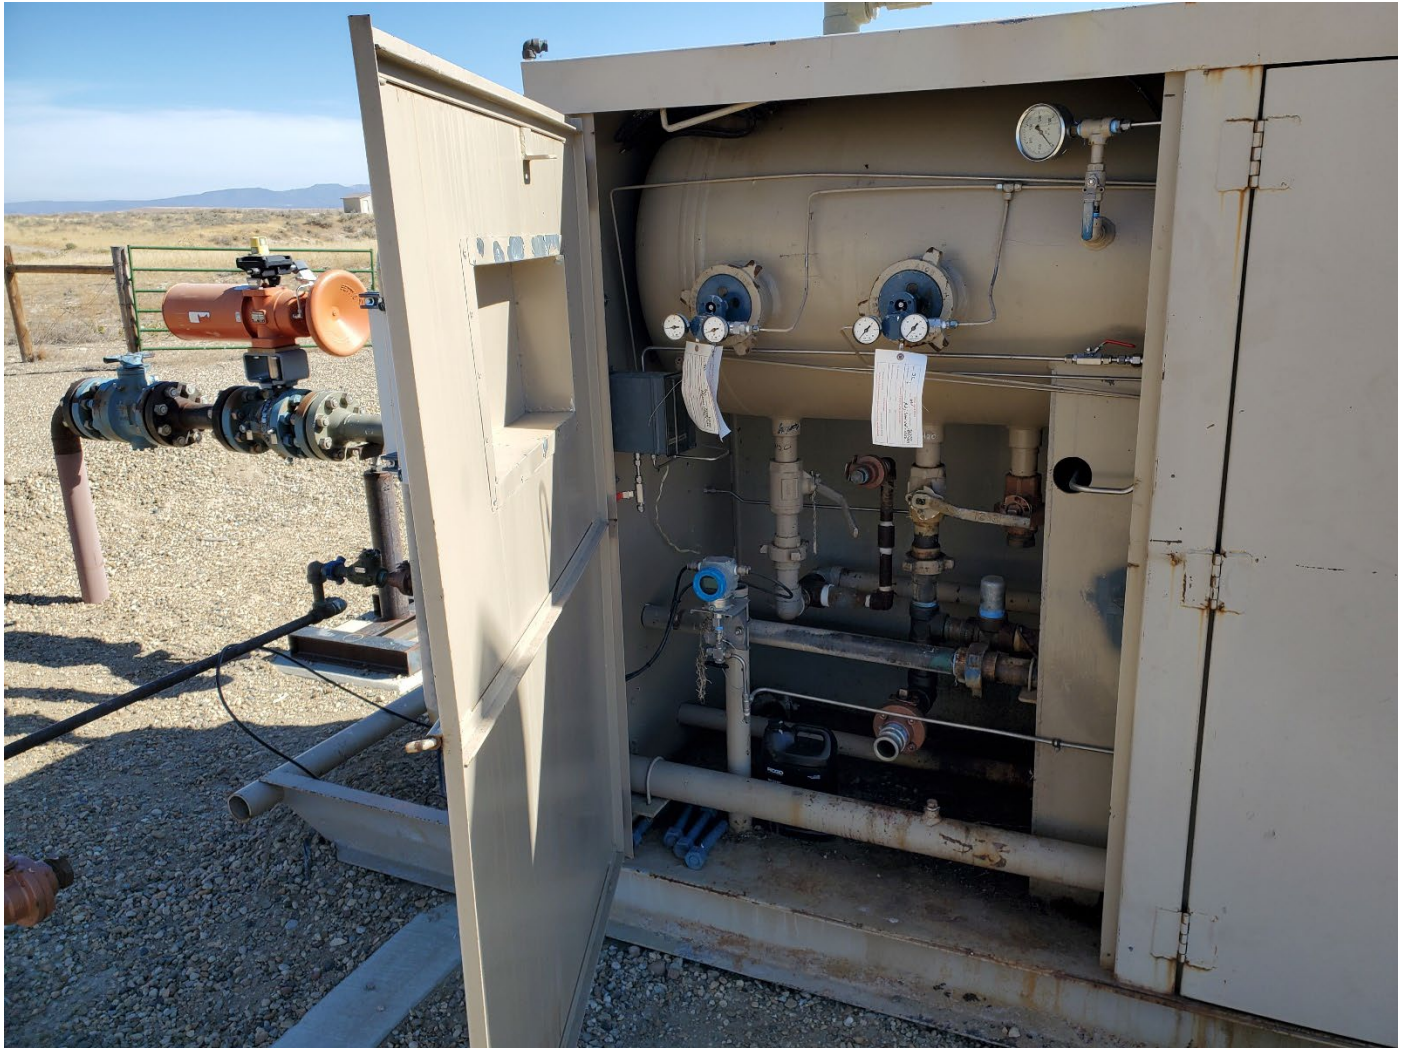
Separator unit reinstalled (removed when inspected 10/13/2023), last production reported July 2024. 4 leak tags noted on separator dated 9/12/2024. Well S/I, no leaks detected using soap test.

Leak tags noted inside separator, dated 9/12/2024.

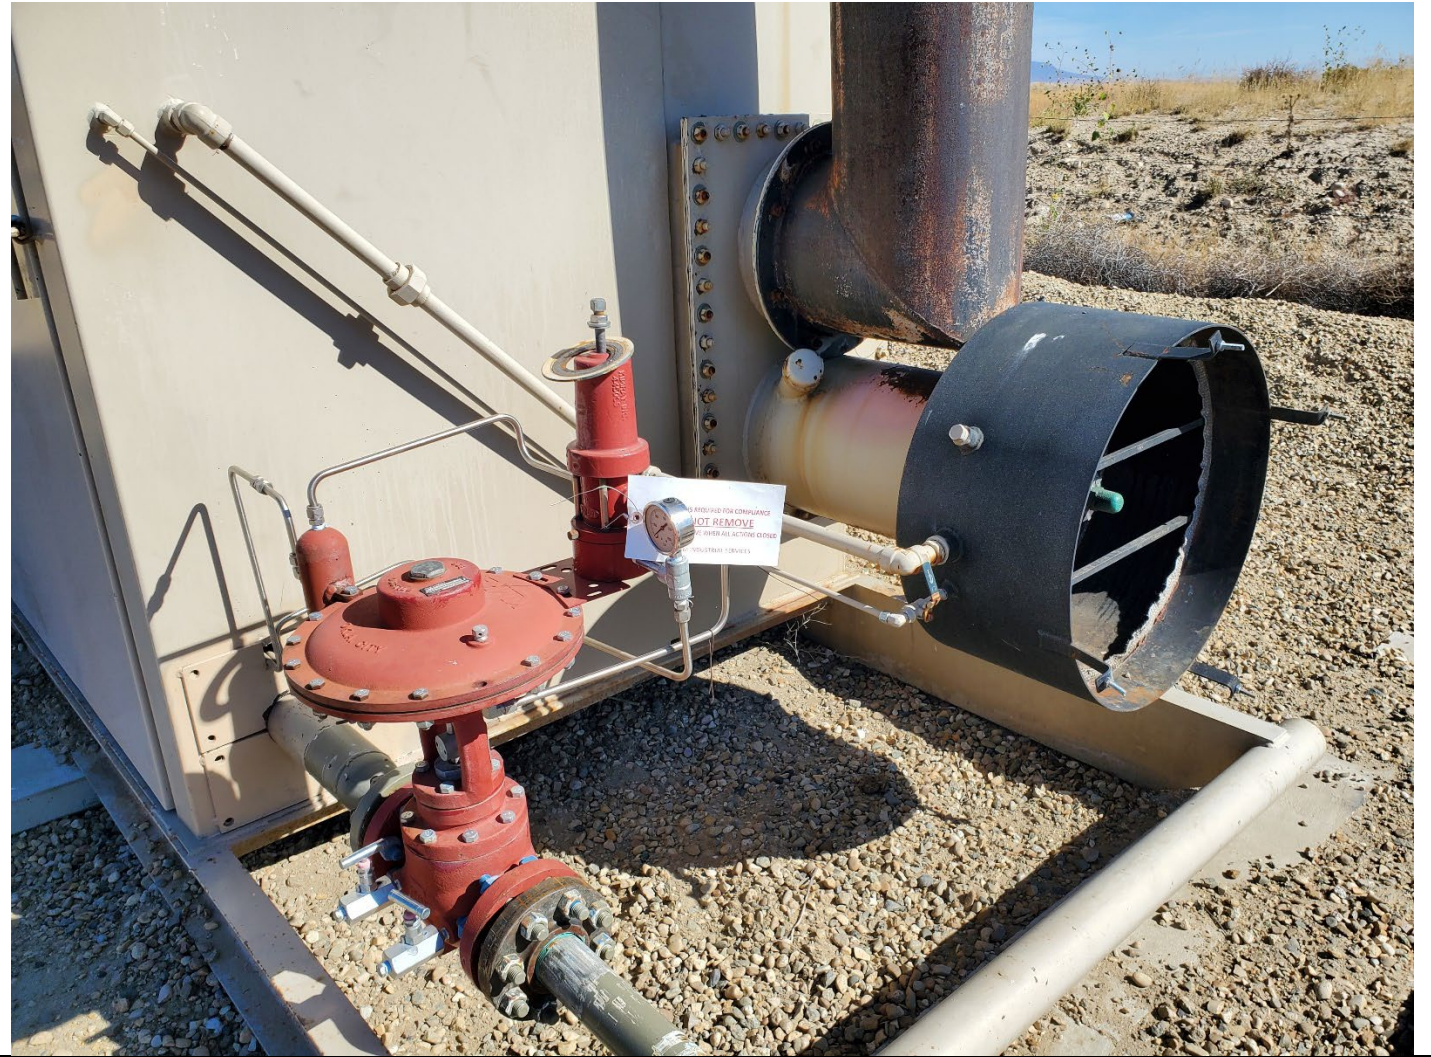
Leak tag outside separator dated 9/12/2024. Well was S/I, no leaks detected using soap test.
