Gas Processing Facility Inspection Form

Section 1: General Information					
Operation Data	Inspection Data				
Operator Name:	Inspector Name:				
NW Gas Processing LLC / SROG					
Location Name:	Area Office:				
Highway 30 Gas Processing Facility	Boise / Director's office				
Authorized Contact: Dan Johanek (208) 800-9503	Inspection Date:				
Tyler Hartung (208) 412-5475	10/3/2024 3:30 PM				
County:	Report Date:				
Payette	10/10/2024				
Inspector's Signature:	Inspection Summary:				
James Thum	☐ Operation appeared to be in compliance at the				
	time of the inspection.				
Date of Signature: 10/10/2024					
3 111 1 1 1	inspection.				
Location Description: 4201 US 30, New Plymouth ID	83655. West side of Highway 30, 3/4 mile north of I-84				
Exit 9. Facility is no longer manned 24 hours. SROG h	as re-located the field office to a store front located at				
112 N. Plymouth Ave, New Plymouth ID 83655.					
Weather: sunny, clear 73°, light and variable breeze	050 MOED 000 '

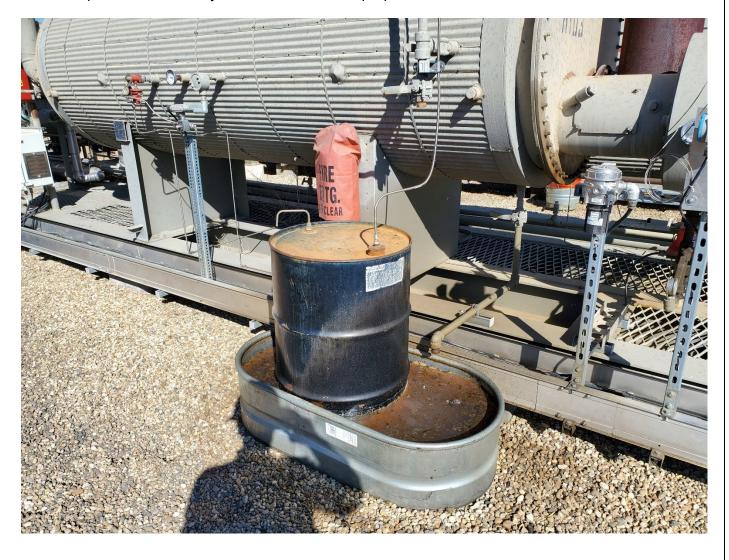
Several plastic buckets and steel barrels are being utilized for drip control which should be contained within portable spill containment trays. Examples from Uline: https://www.uline.com/BL 1492/Flexible-Spill-Trays

Portable spill containment tray needed for orange overflow bucket, H-1 Reboiler. View is northeast.

Portable spill containment tray needed for overflow spill prevention.

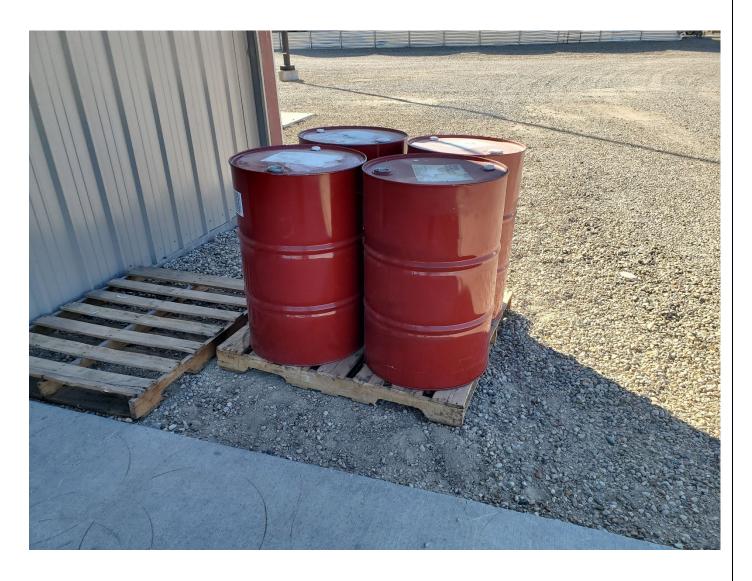
5.	Do drain lines have a valve installed, closed and capped off if not in use?	⊠ Yes □ No				
Se	ection 8: Inspection Comments					
Comments and Issues of Concern:						
Section 4, Item #2: One pallet (4 bbls) of natural gas engine oil was outside the north door of the compressor building but was not within a portable spill container. Unsure if this was a recent delivery or was being moved inside the compressor building for immediate use.

Portable spill containment tray needed for overflow spill prevention. View is outside north door of compressor building.

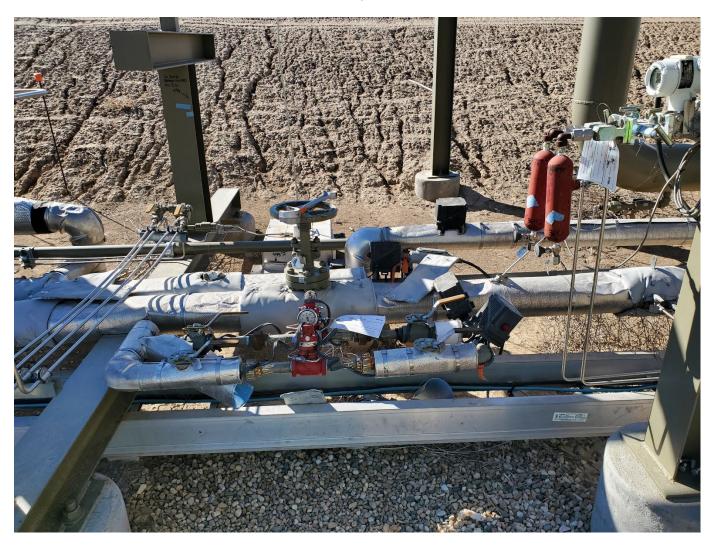
Other: Leak tags noted on condenser tower, flare scrubber area and condenser unit dated 10/2/2024 (day before inspection).

Leak tags near the flare scrubber unit, west perimeter of facility. View is west. Leak tags were noted in several locations and are dated 10/2/2024, the day prior to IDL's inspection.

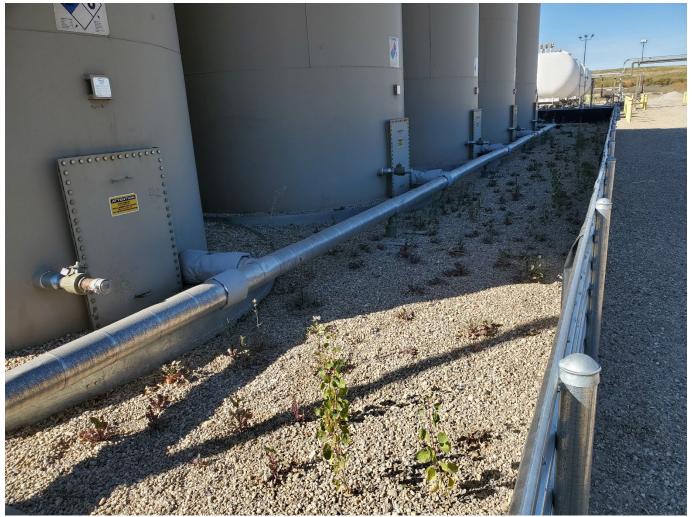
Section 7, Item #4 vi: Vegetation control within the tank battery containment dike needs remediation, especially during fire season.

Vegetation within the condensate tank dike, west side of facility. View is north-nothwest.

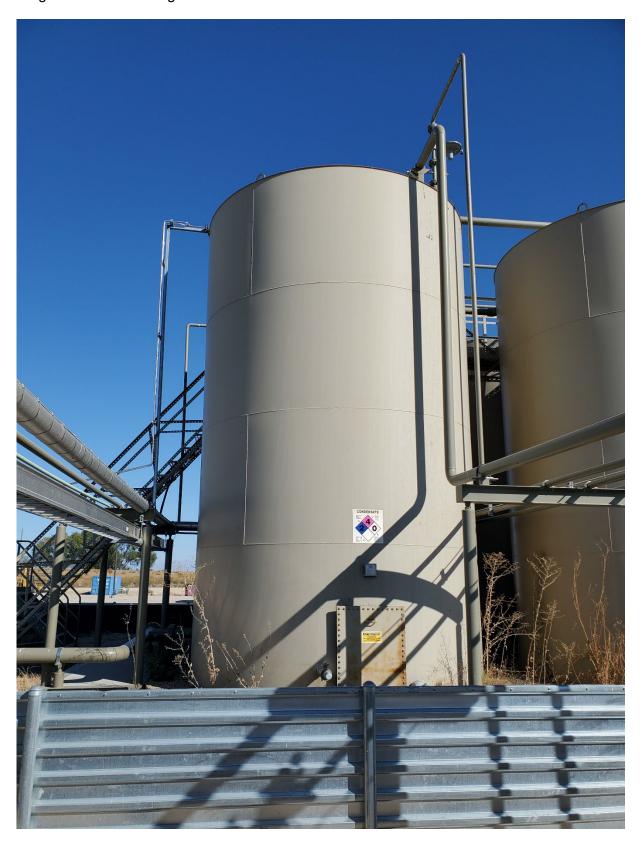
Vegetation visible along west side of tank dike. View is east of northernmost condensate tank.

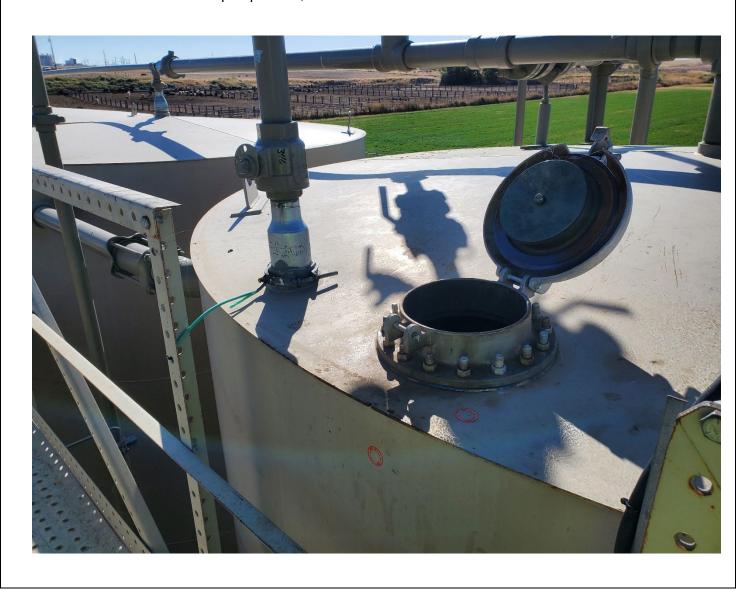
Vent lid on northwesternmost condensate tank was in the open position. Dan Johanek was notified immediately.

Condensate tank vent lid in open position, northwestern-most condensate tank. View is southwest.
