# Post Drilling/Annual Well Site Inspection Form

| Section 1: General Information | |
|---|---|
| Operator Name<br>Snake River Oil + Gas, LLC | Inspector Name<br>James Thum / Derek Kraft |
| Well Name<br><b>Fallon #1-10, USWN 11-075-20032</b> | Area Office<br>Boise / Director's & Southwest Supervisory Area |
| County<br>Payette | Report Date<br>5/17/2025 |

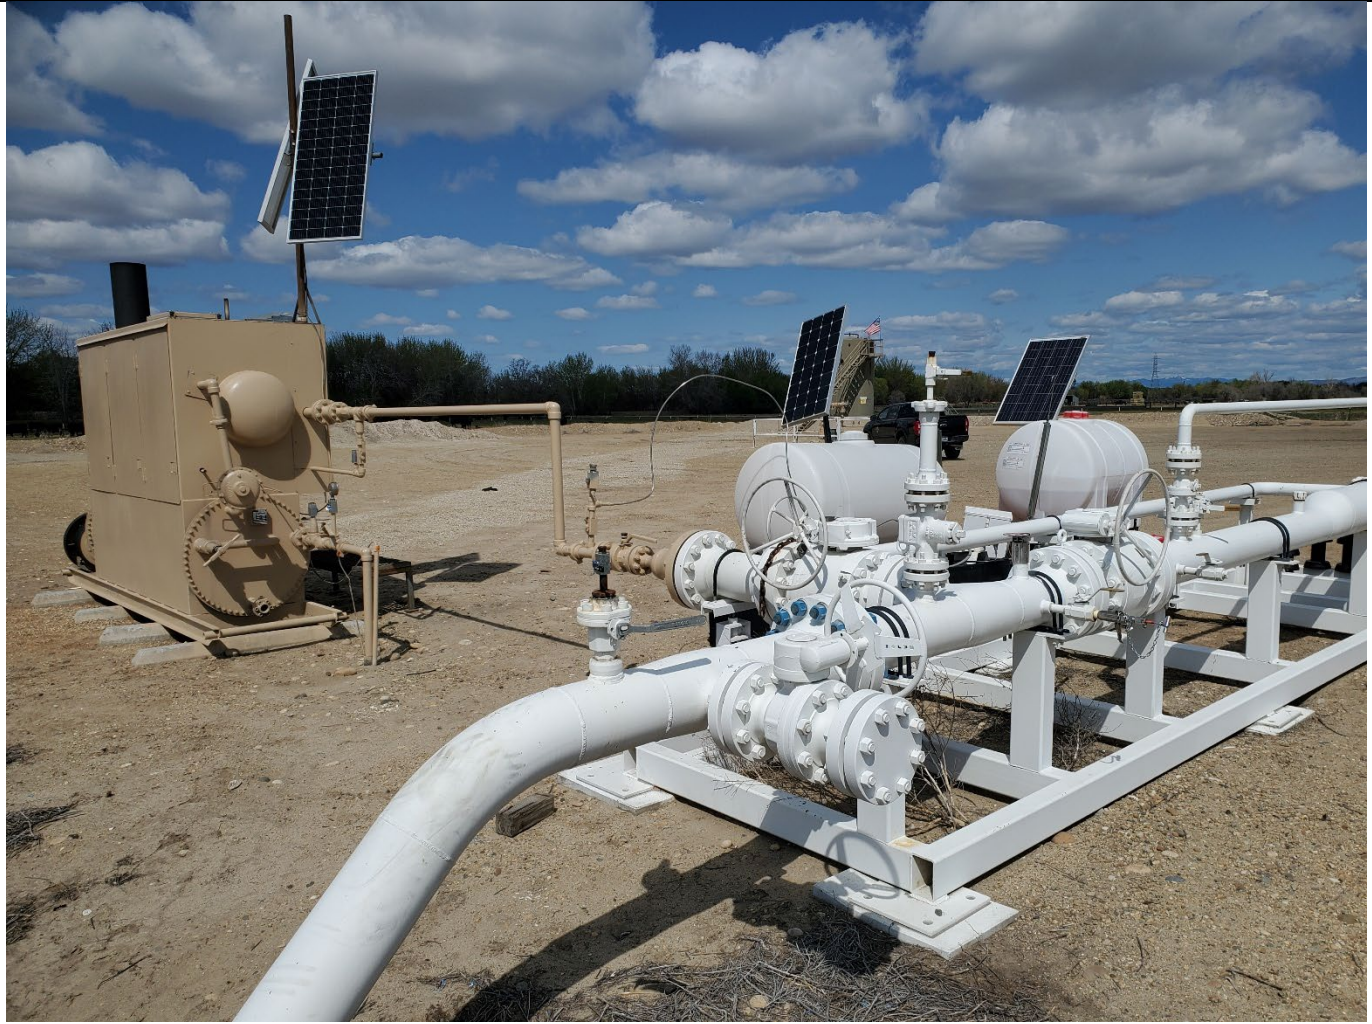
Pig launcher has been upgraded, new paint on wellhead and separator (correctly labeled).

Gathering line riser, pig launcher far right. Wellhead and produced water tank rear center, separator at left. View is northwest.

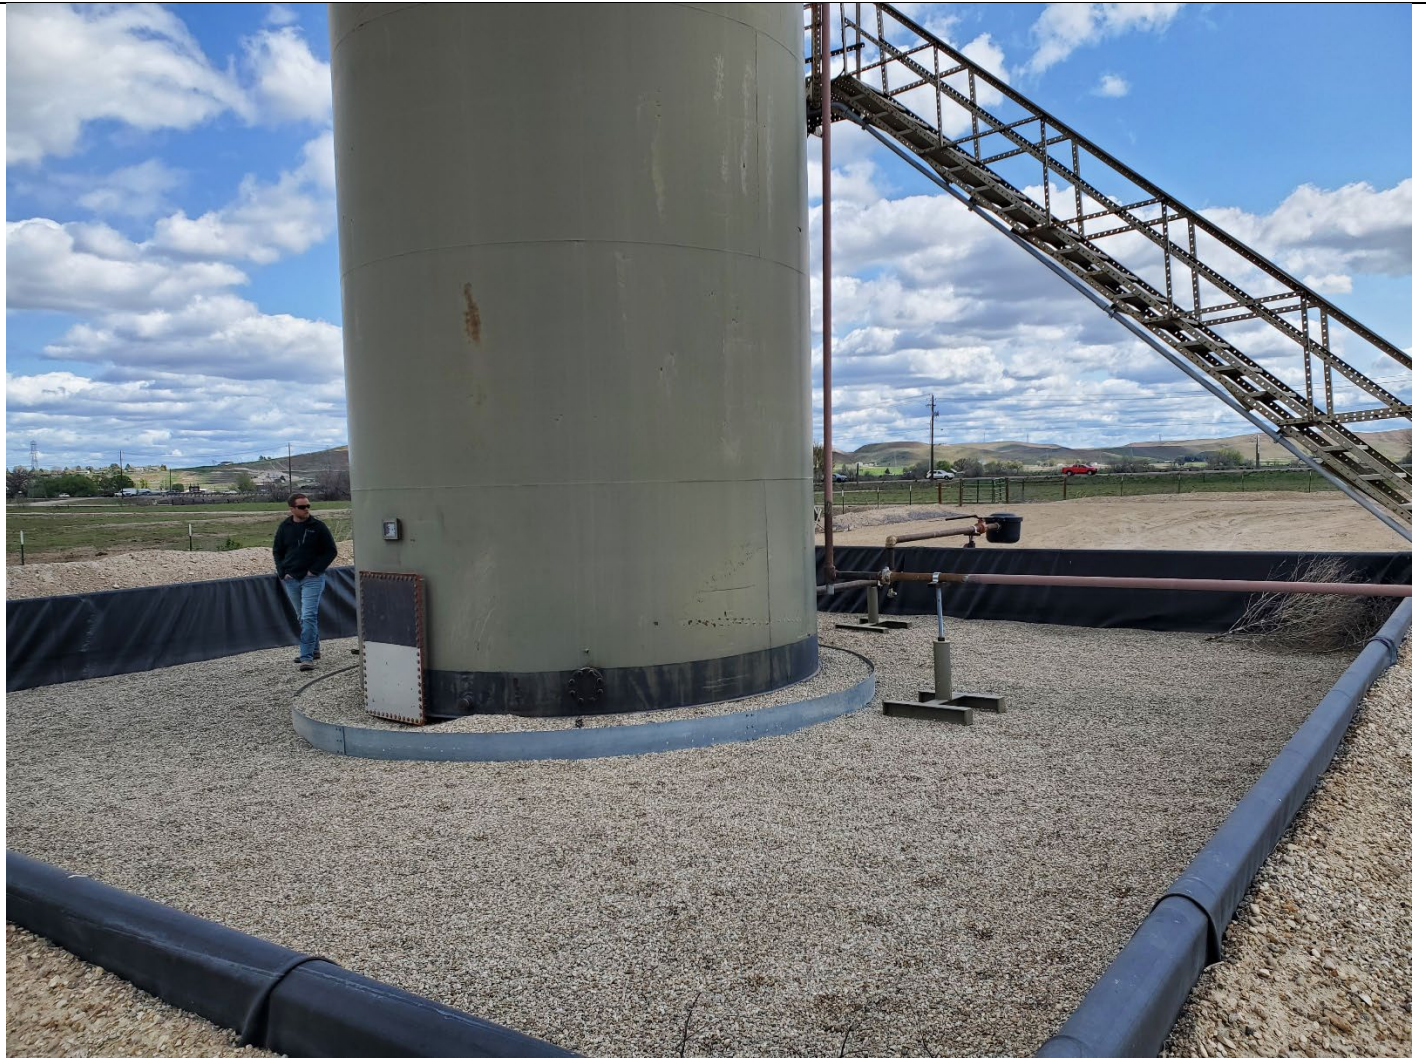
Section 9.1.D.i.c. Couplers located outside containment wall with spill containment devices per BMPs.

400 bbl produced water tank and containment berm. View is northeast.
