# Post Drilling/Annual Well Site Inspection Form

| Section 1: General Information | |
|---|---|
| <b>Operation Data</b><br><b>Operator Name</b><br>Snake River Oil + Gas, LLC<br><b>Well Name</b><br>Fallon #1-11, USWN 11-075-20037<br><b>Authorized Contact</b> Dan Johaneck (208)800-9503<br>112 N. Plymouth, New Plymouth ID; Tyler Hartung (208)<br>412-5475<br><b>County</b><br>Payette<br><b>Inspector's Signature:</b><br><div style="text-align: center; margin-top: 20px;"> </div> <b>Date of Signature:</b> 9/23/2025 | <b>Inspection Data</b><br><b>Inspector Name</b><br>James Thum / Derek Kraft<br><b>Area Office</b><br>Boise – Director's / Southwest Supervisory Area<br><b>Inspection Date</b><br>4/21/2025 1:30 PM<br><b>Report Date</b><br>5/17/2025<br><b>Inspection Summary:</b><br><input type="checkbox"/> Operation appeared to be in compliance at the time of the inspection.<br><input checked="" type="checkbox"/> Issues of concern identified at the time of the inspection. |

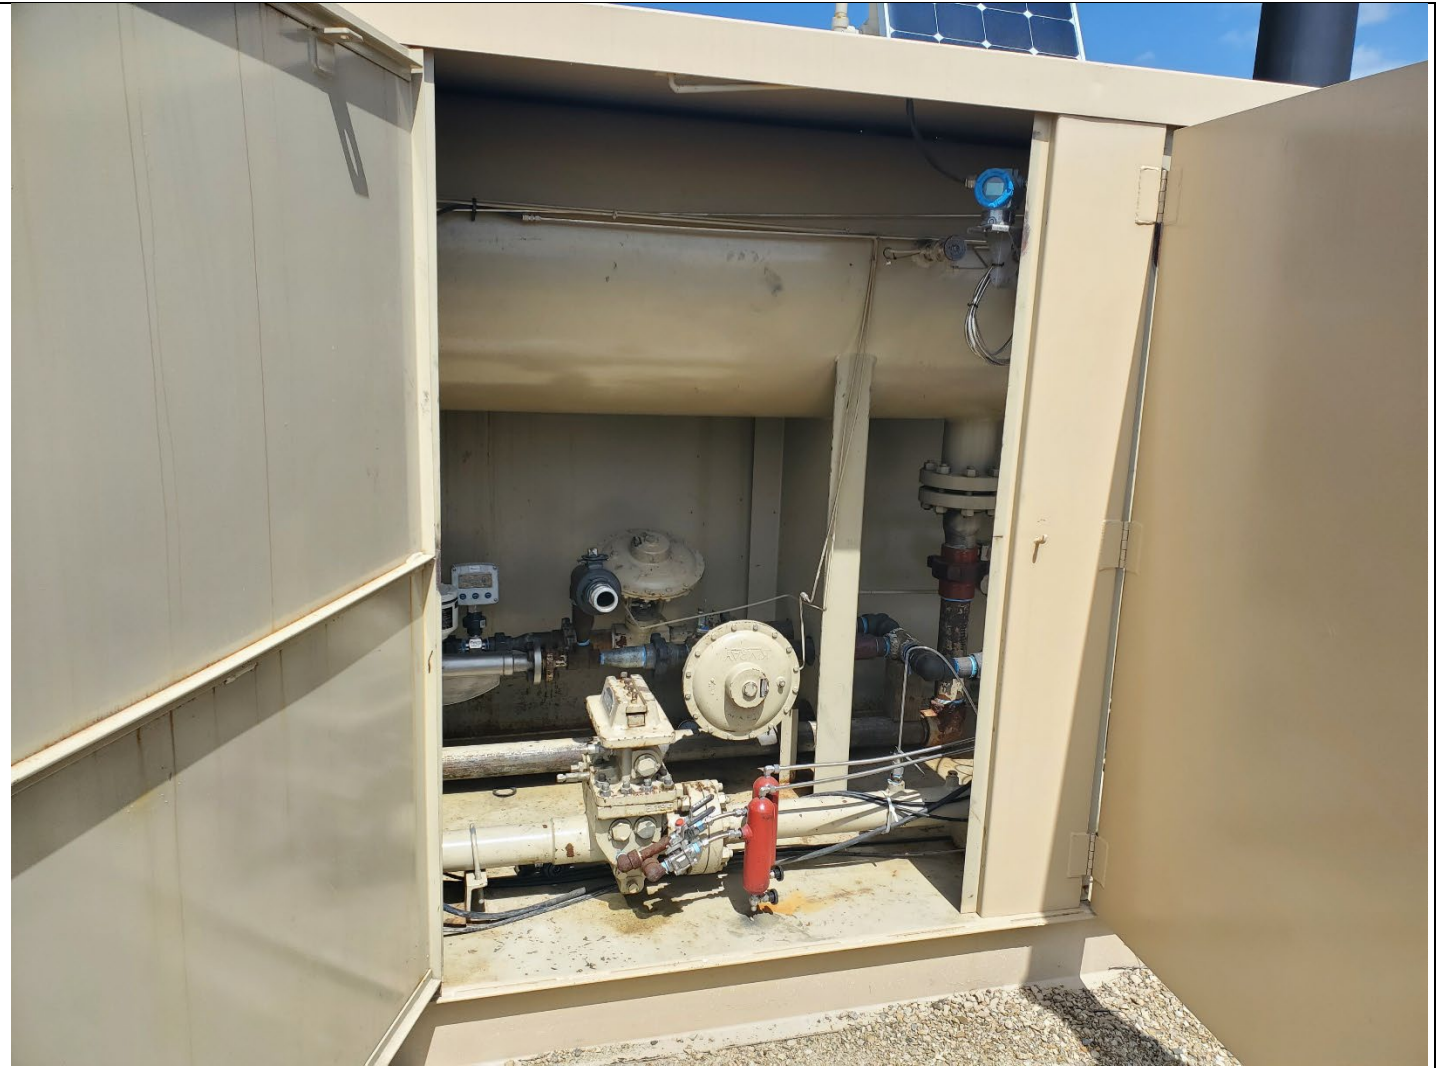
Right side interior of separator unit.

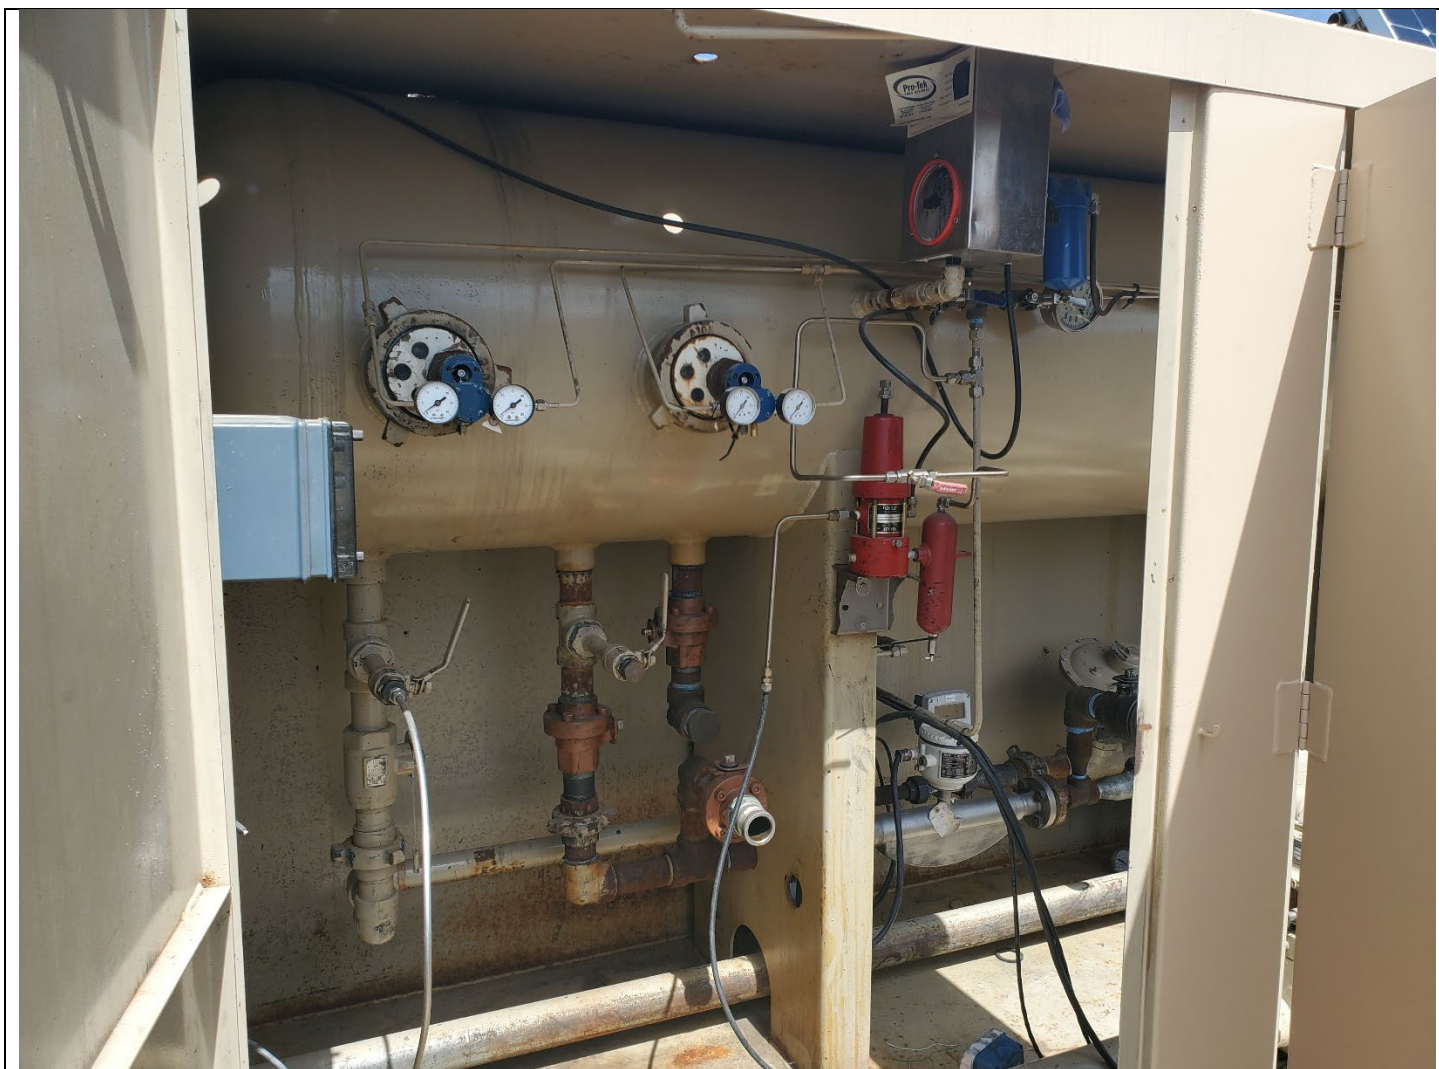
Left side interior of separator unit, coriolis flow meter at lower right.

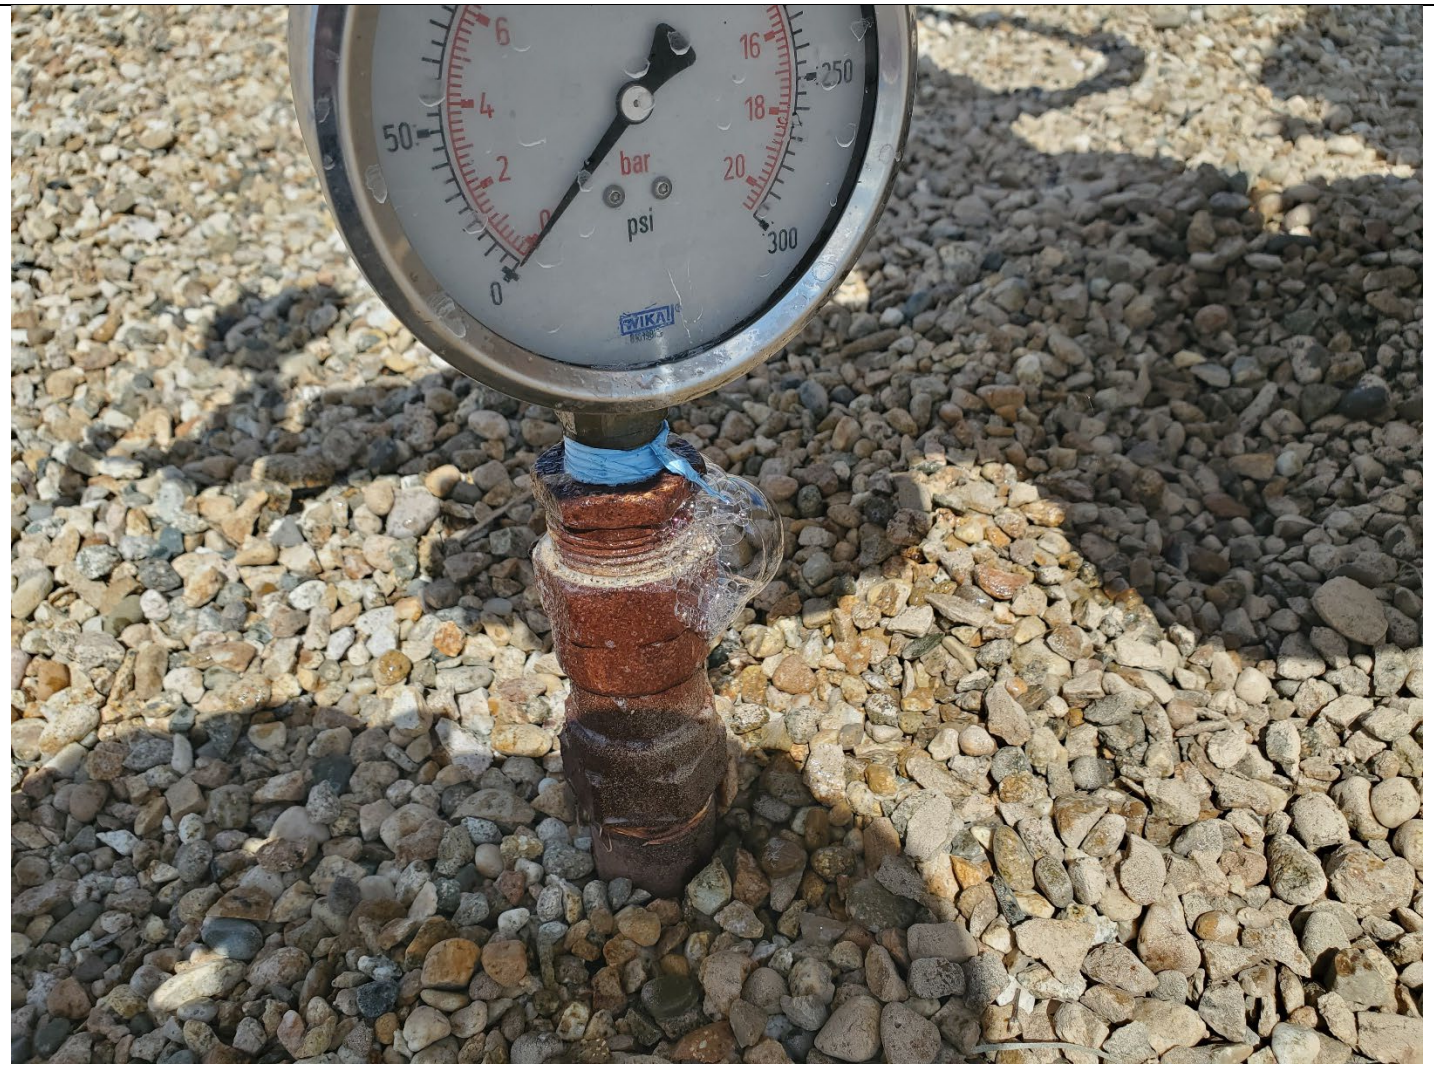
Small leak on surface casing pressure gauge (analog; shows 0 PSI); bubbling noted with soapy water test.

Surface csg: 0 PSI (analog)

Analog pressure gauge for surface casing with small leak. Note pressure indicated as 0 PSI.

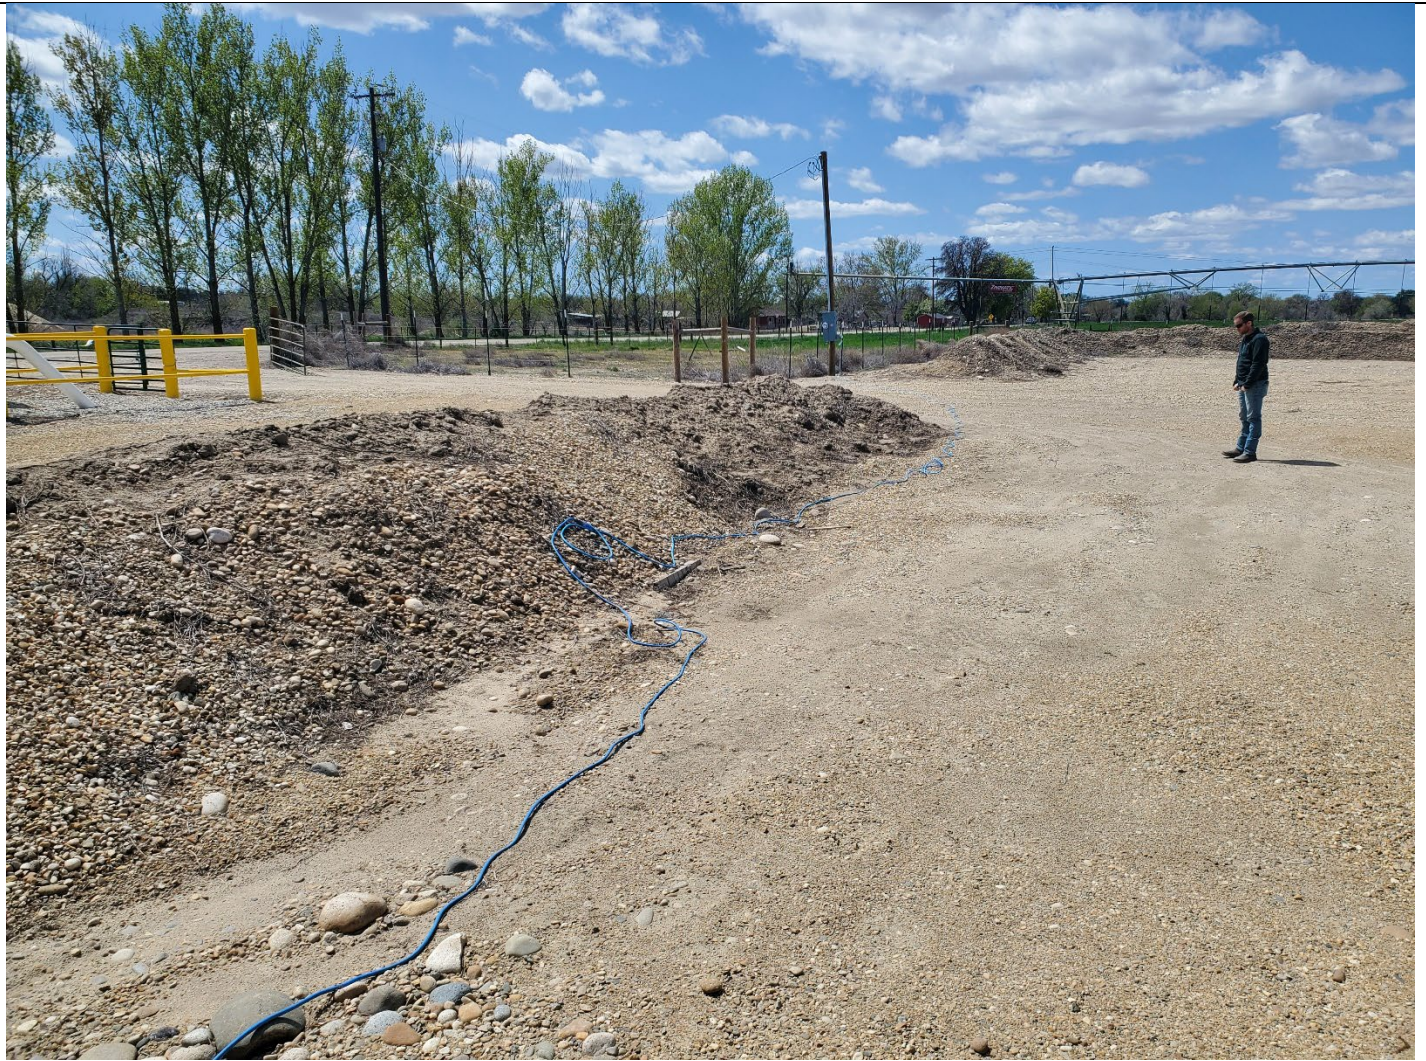
Temporary use of blue extension cords- power running from light post west of gate to separator unit.

Blue extension cord as temporary power from separator unit to electric service box at pad gate.
