Post Drilling/Annual Well Site Inspection Form

Section 1: General Information	
Operation Data	Inspection Data
Operator Name	Inspector Name
Snake River Oil + Gas, LLC Well Name	James Thum / Derek Kraft
Dutch Lane #1-13, USWN 11-075-20038	Area Office Boise Director's / Southwest Supervisory Area
Authorized Contact Dan Johanek (208) 800-9503	Inspection Date
112 N. Plymouth, New Plymouth ID Tyler Hartung (208)	4/21/2025 2:30 PM
412-5475	
County	Report Date
Payette Inspector's Signature:	5/17/2025 Inspection Summary:
inspector's Signature.	^
	Operation appeared to be in compliance at the time of the inspection.
James Ihm	
James Then	Issues of concern identified at the time of the
Date of Signature: 9/26/2025	inspection.
Location Description: 2.0 miles SE from Hwy 95 and Kille	brew Road intersection north of Fruitland, Idaho. Survey
location Latitude 44.04031, Longitude -116.906395. Well pa	
Road. Well is currently producing from the "C" and "D" san	ds.
W d C d 1 1 66°F d 1 1671 MV	,

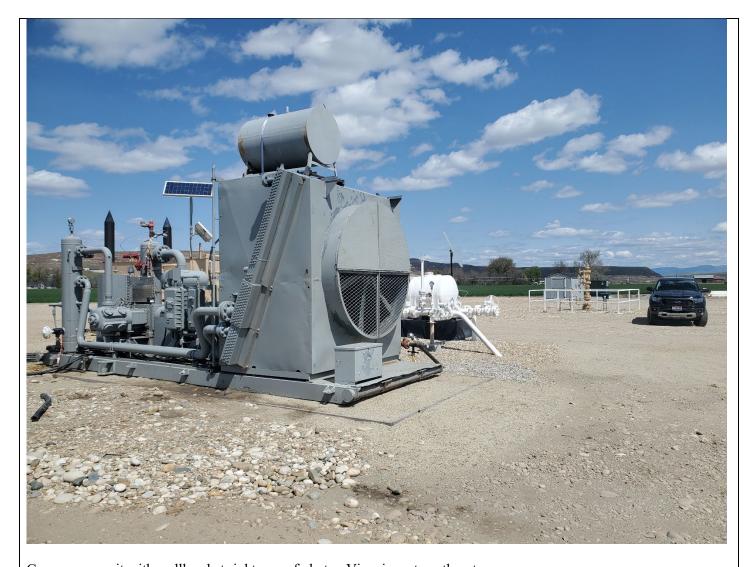
Compressor unit with wellhead at right rear of photo. View is east-northeast.

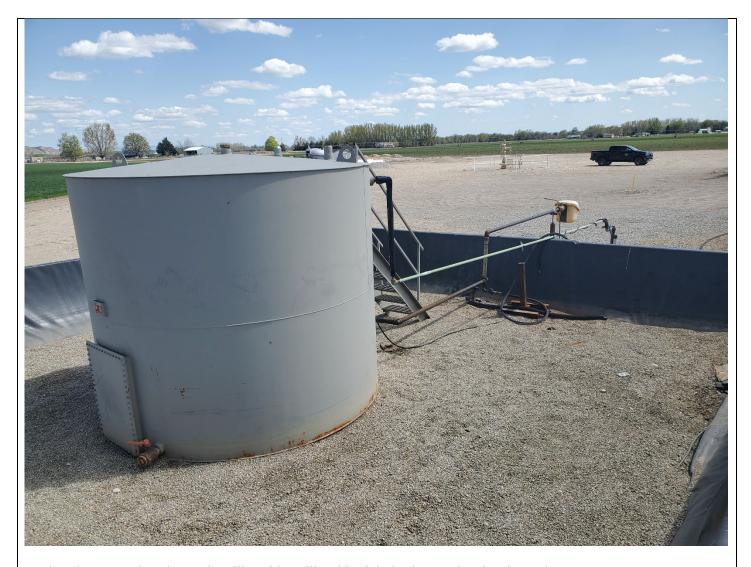
Produced water tank and retention dike with wellhead in right background. View is southeast.
