# Post Drilling/Annual Well Site Inspection Form

| Section 1: General Information | |
|---|---|
| <b>Operation Data</b><br><b>Operator Name</b><br>Snake River Oil + Gas, LLC<br><b>Well Name</b><br>Irvin #1-19, USWN 11-075-20039<br><b>Authorized Contact</b> Dan Johaneck (208) 800-9503<br>112 N. Plymouth, New Plymouth ID Tyler Hartung (208)<br>412-5475<br><b>County</b><br>Payette<br><b>Inspector's Signature:</b><br><div style="text-align: center; margin-top: 20px;"> </div> <b>Date of Signature:</b> 9/22/2025 | <b>Inspection Data</b><br><b>Inspector Name</b><br>James Thum / Derek Kraft<br><b>Area Office</b><br>Boise Director's / Southwest Supervisory Area<br><b>Inspection Date</b><br>4/21/2025 9:15 AM<br><b>Report Date</b><br>5/17/2025<br><b>Inspection Summary:</b><br><input checked="" type="checkbox"/> Operation appeared to be in compliance at the time of the inspection.<br><input type="checkbox"/> Issues of concern identified at the time of the inspection. |

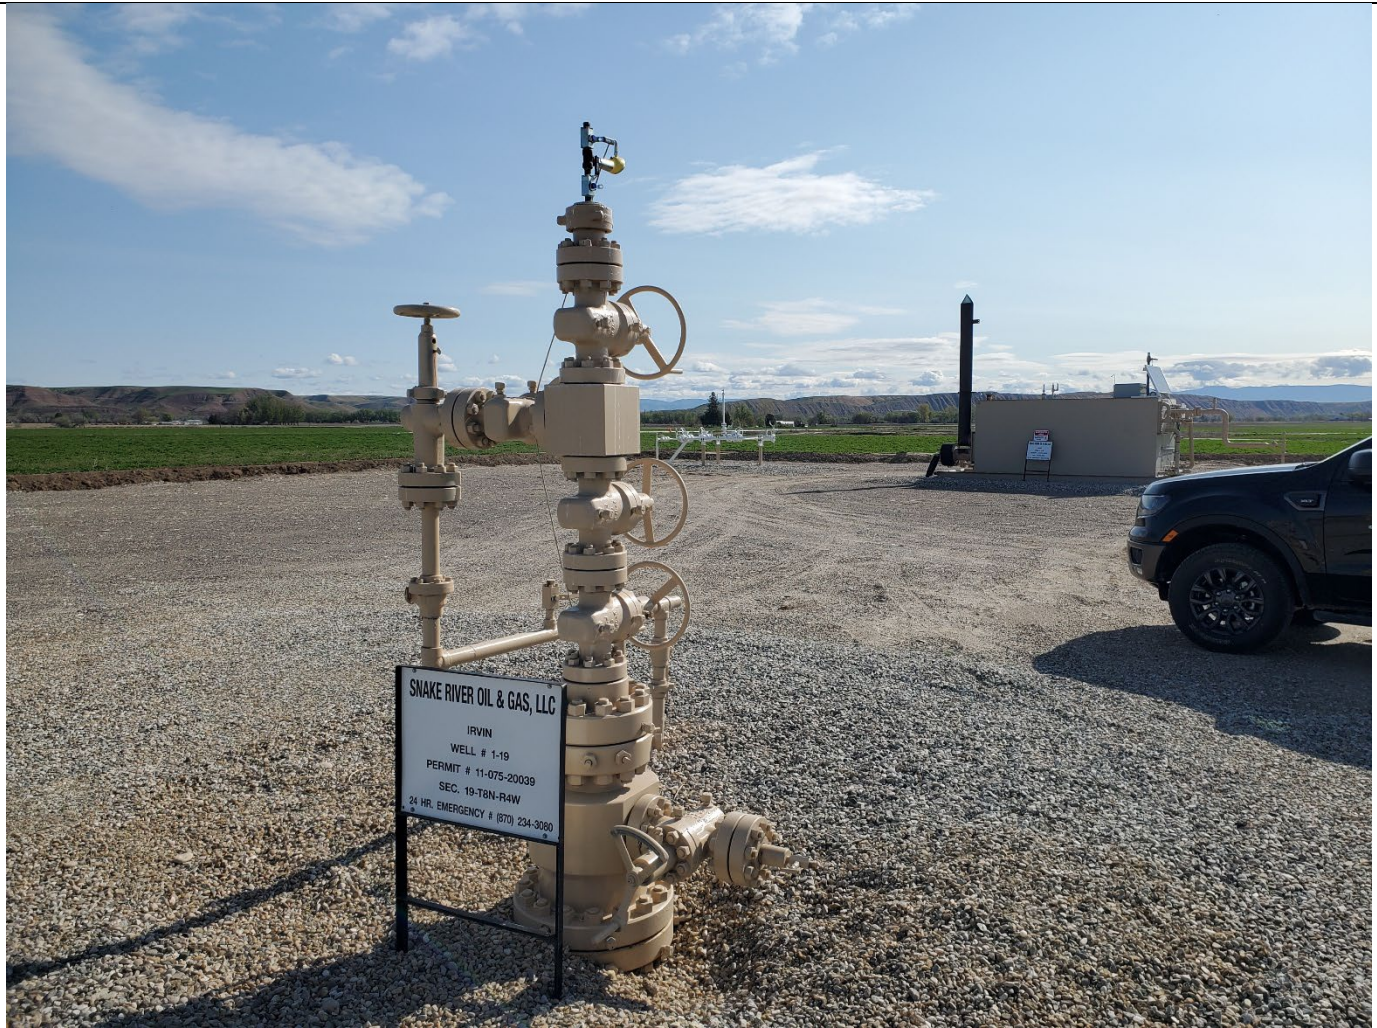
Wellhead left foreground with separator right background. Gathering riser center background. View is northeast.

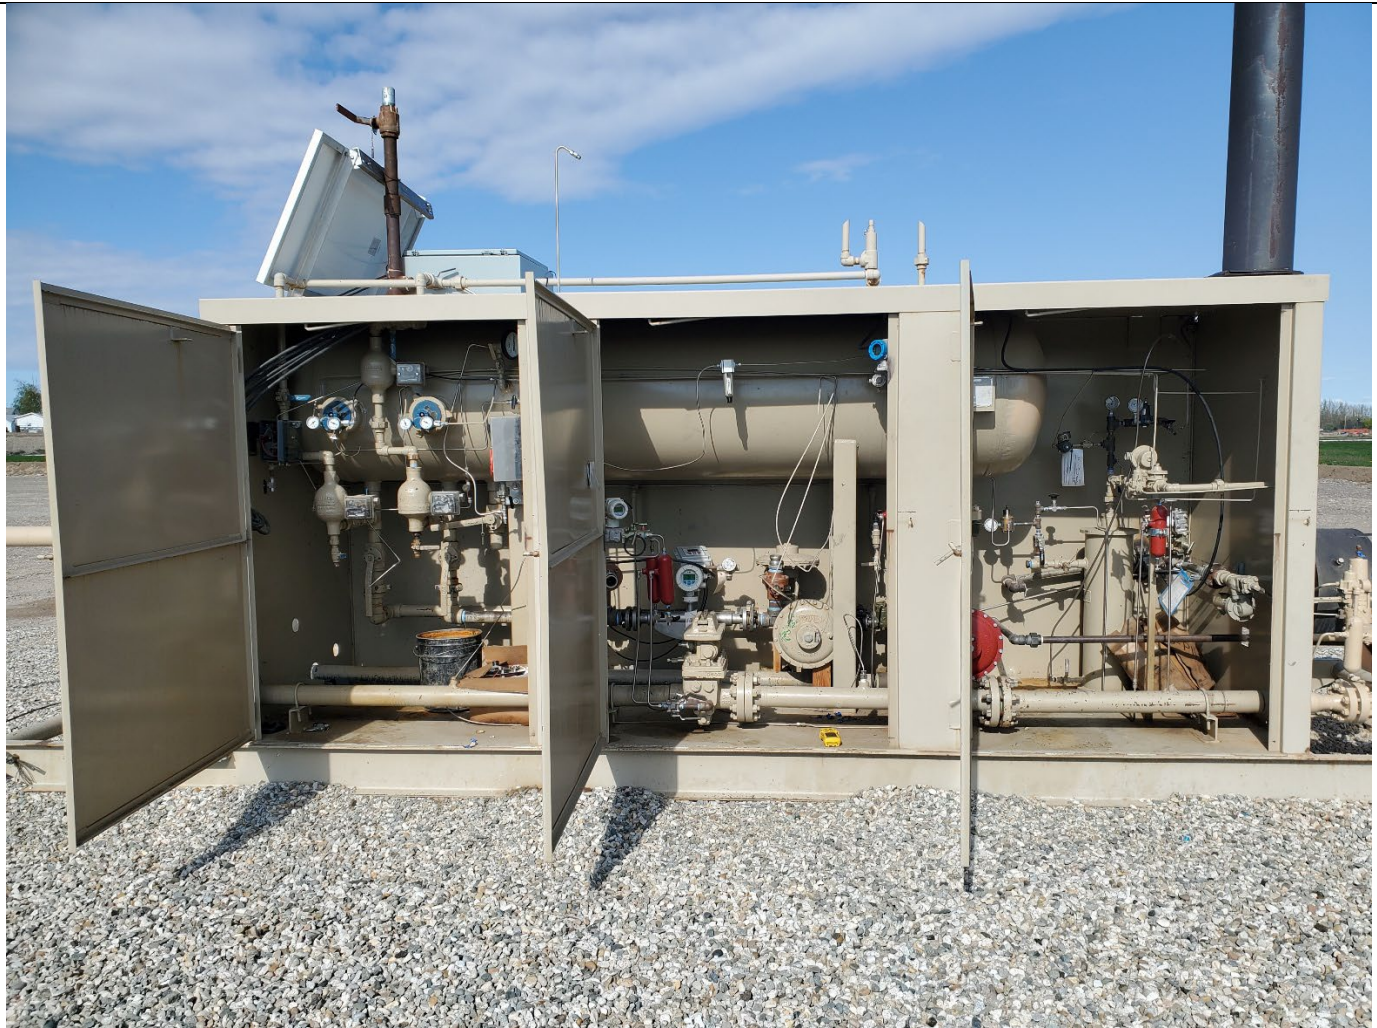
Site is in good condition, wellhead newly painted, separator unit correctly labeled. Only one leak tag dated 3/15/2025 inside separator.

Interior Irvin #1-19 separator unit.
