# Gas Processing Facility Inspection Form

Operator Name:  
NW Gas Processing LLC / SROG

Location Name:  
**Little Willow Gas Gathering Facility**

Inspection Date:  
4/25/2025 11:45 AM

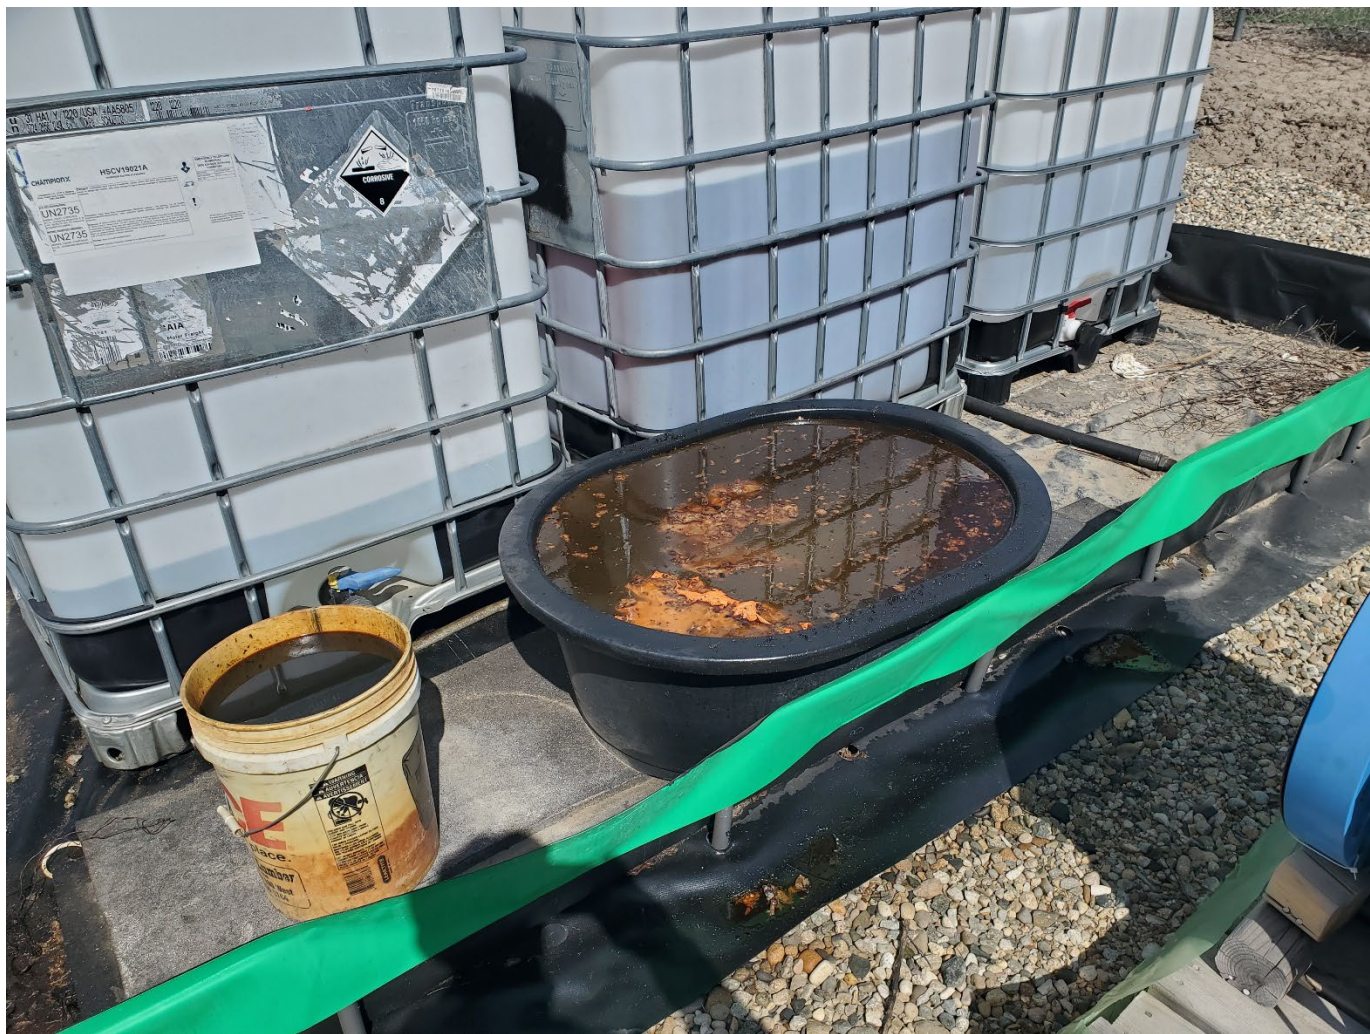
Chemicals stored within portable containment device near northern corner of facility.

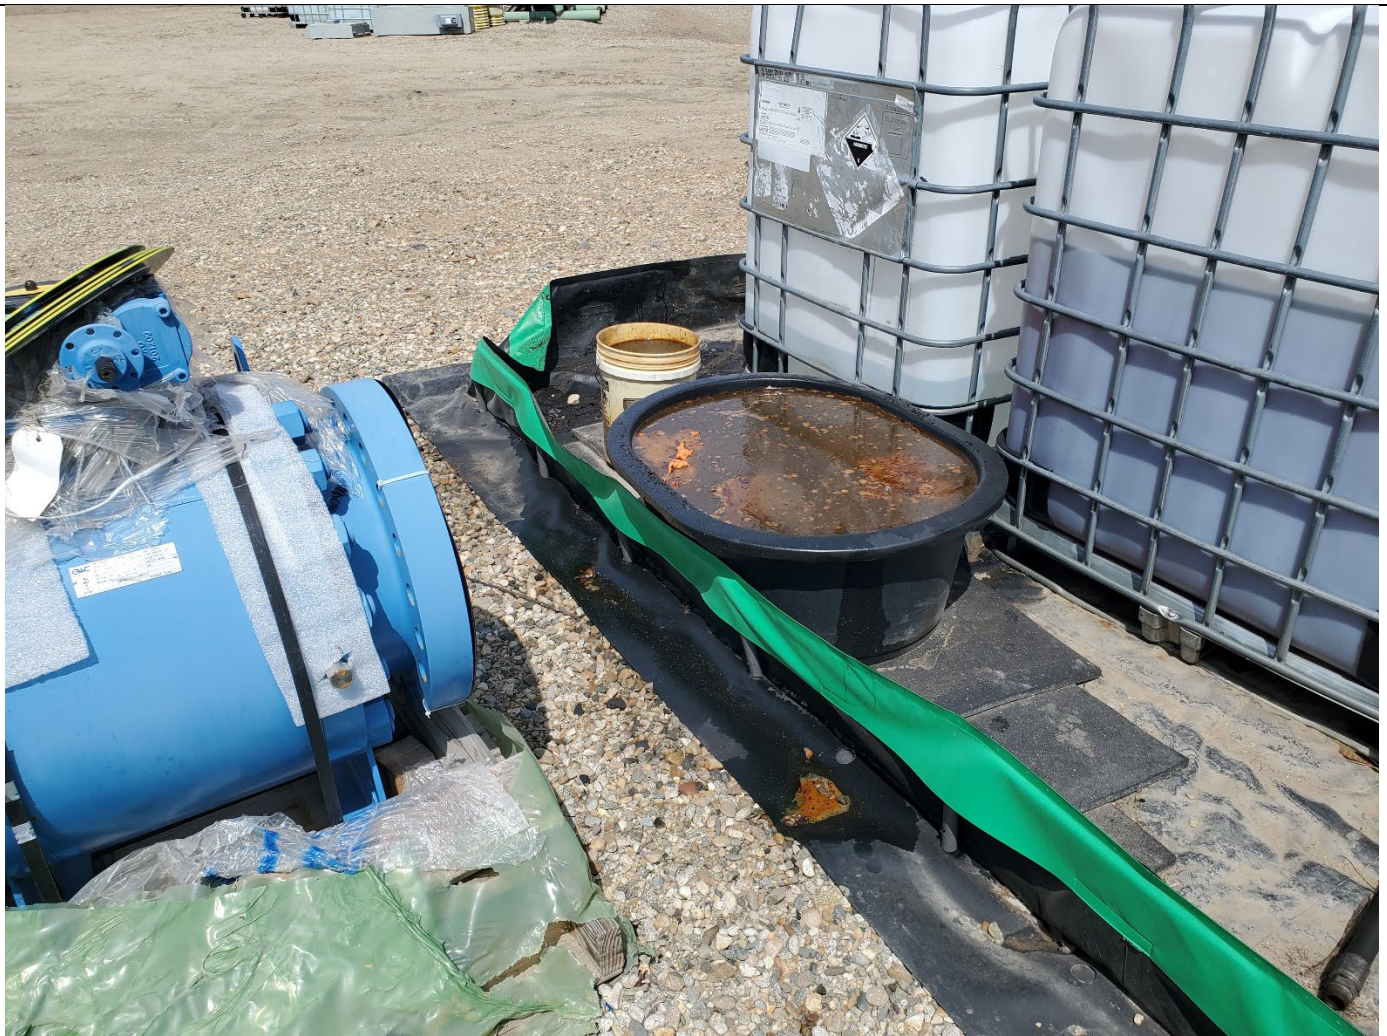
Second view of chemicals stored within portable containment device near northern corner of facility.

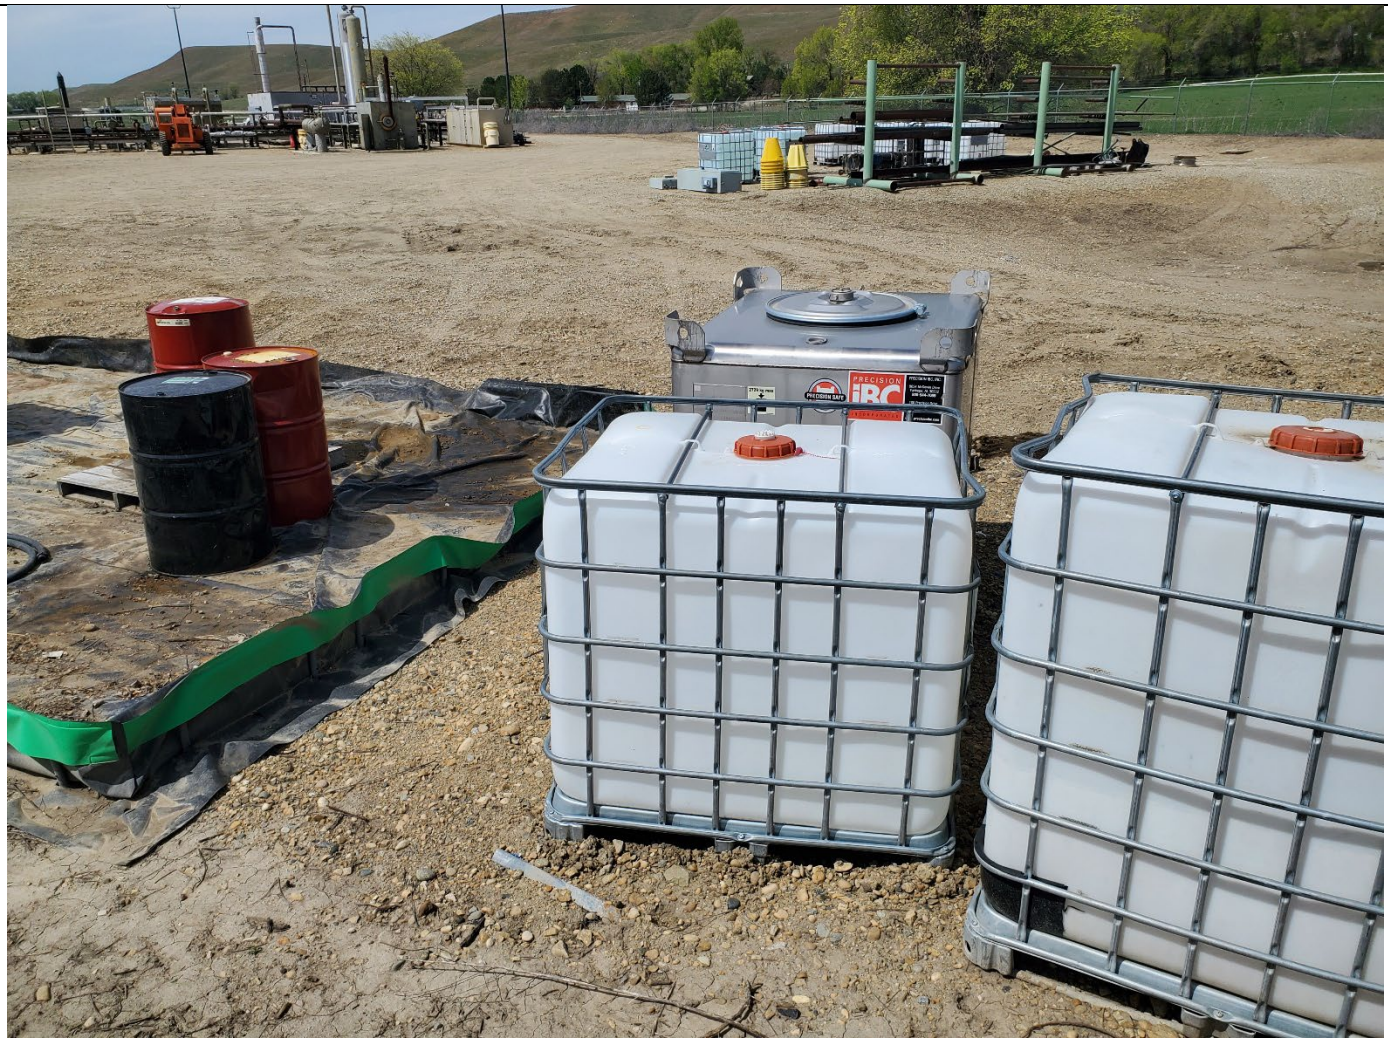
Portable spill containment barrier on north side of facility needs repair; some chemical pallets need moved inside barrier.

Chemical containers outside portable containment device near northern corner of facility. View is west with pipe rack in background..

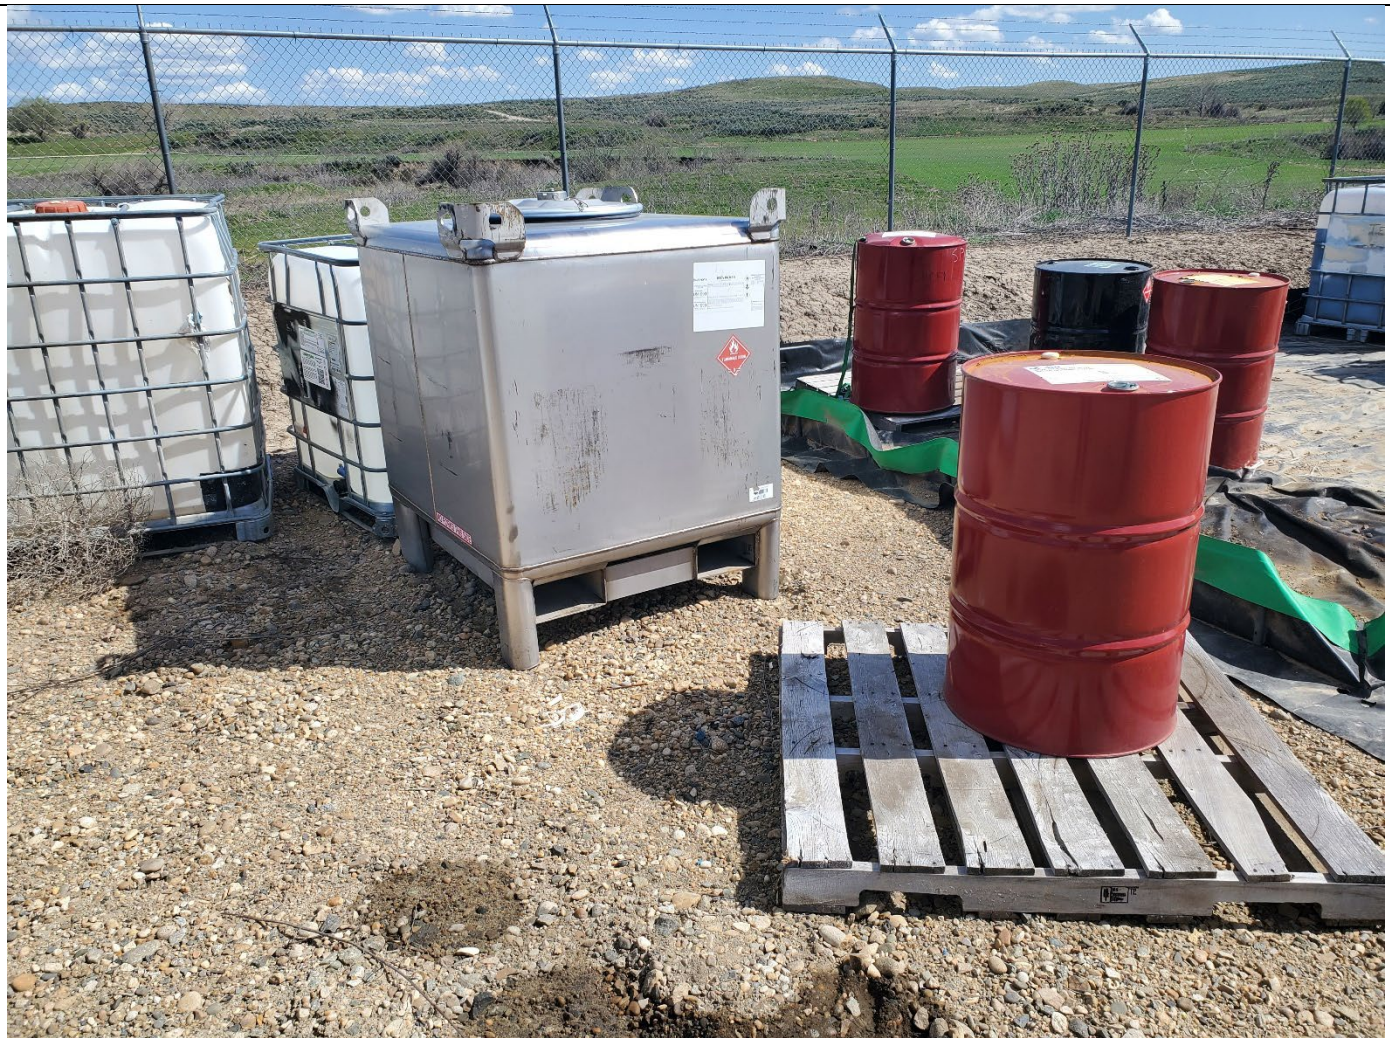
Chemical containers outside portable containment device near north corner of facility. View is east.

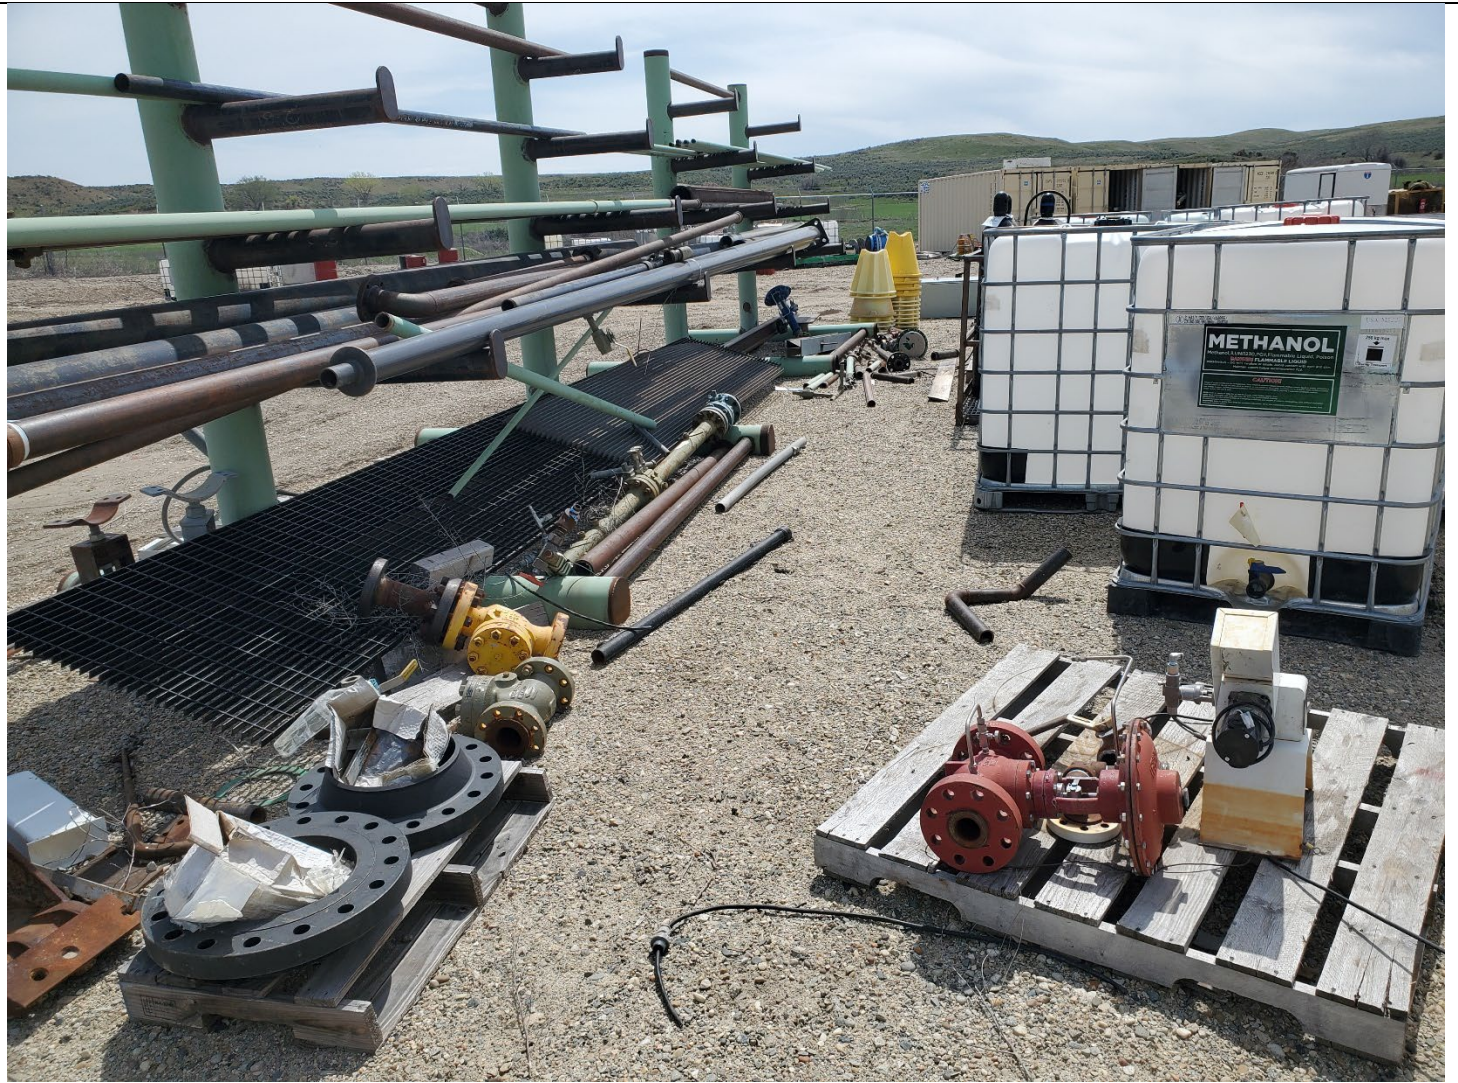
Pipe rack and other equipment located on north side of facility. View is east.
