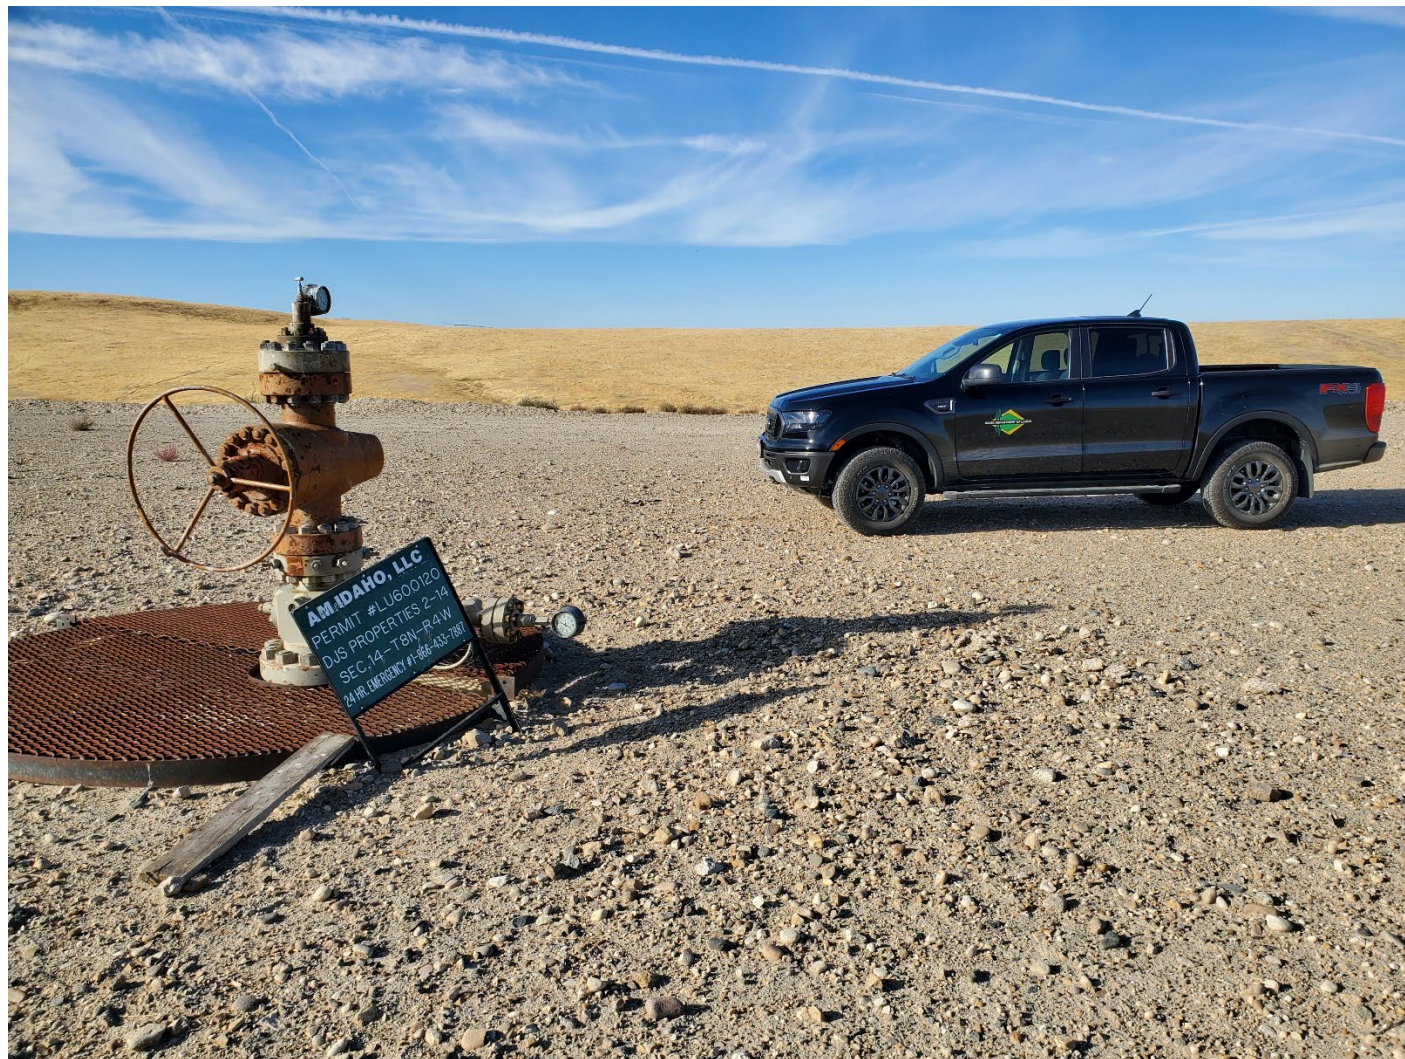
Wellhead and sign, view southeast. Operator information and emergency number are out of date.

Section 3, Items 1 and 2: Sign entering lease has fallen from frame, face down near access road entrance. Both the lease sign and wellhead signs are out of date and show the name of the former operator. The emergency contact number is also out of date. Both signs need updated and repaired.

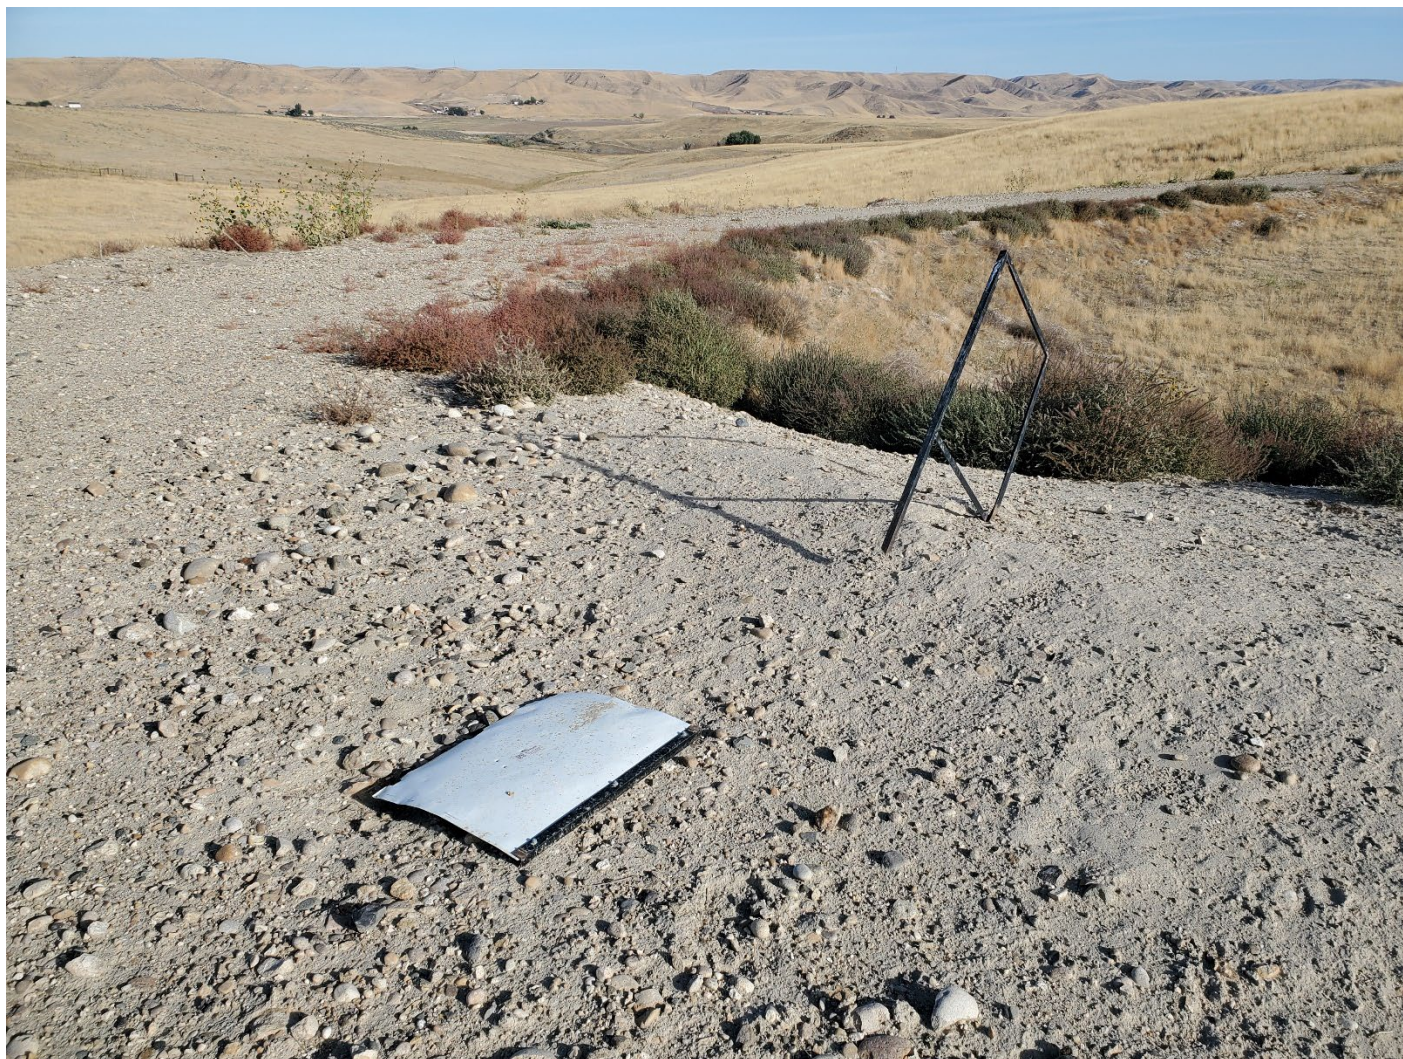
Sign at lease entrance is out of frame and face down, and operator and emergency number is out of date. View is north from well pad to lease access road.

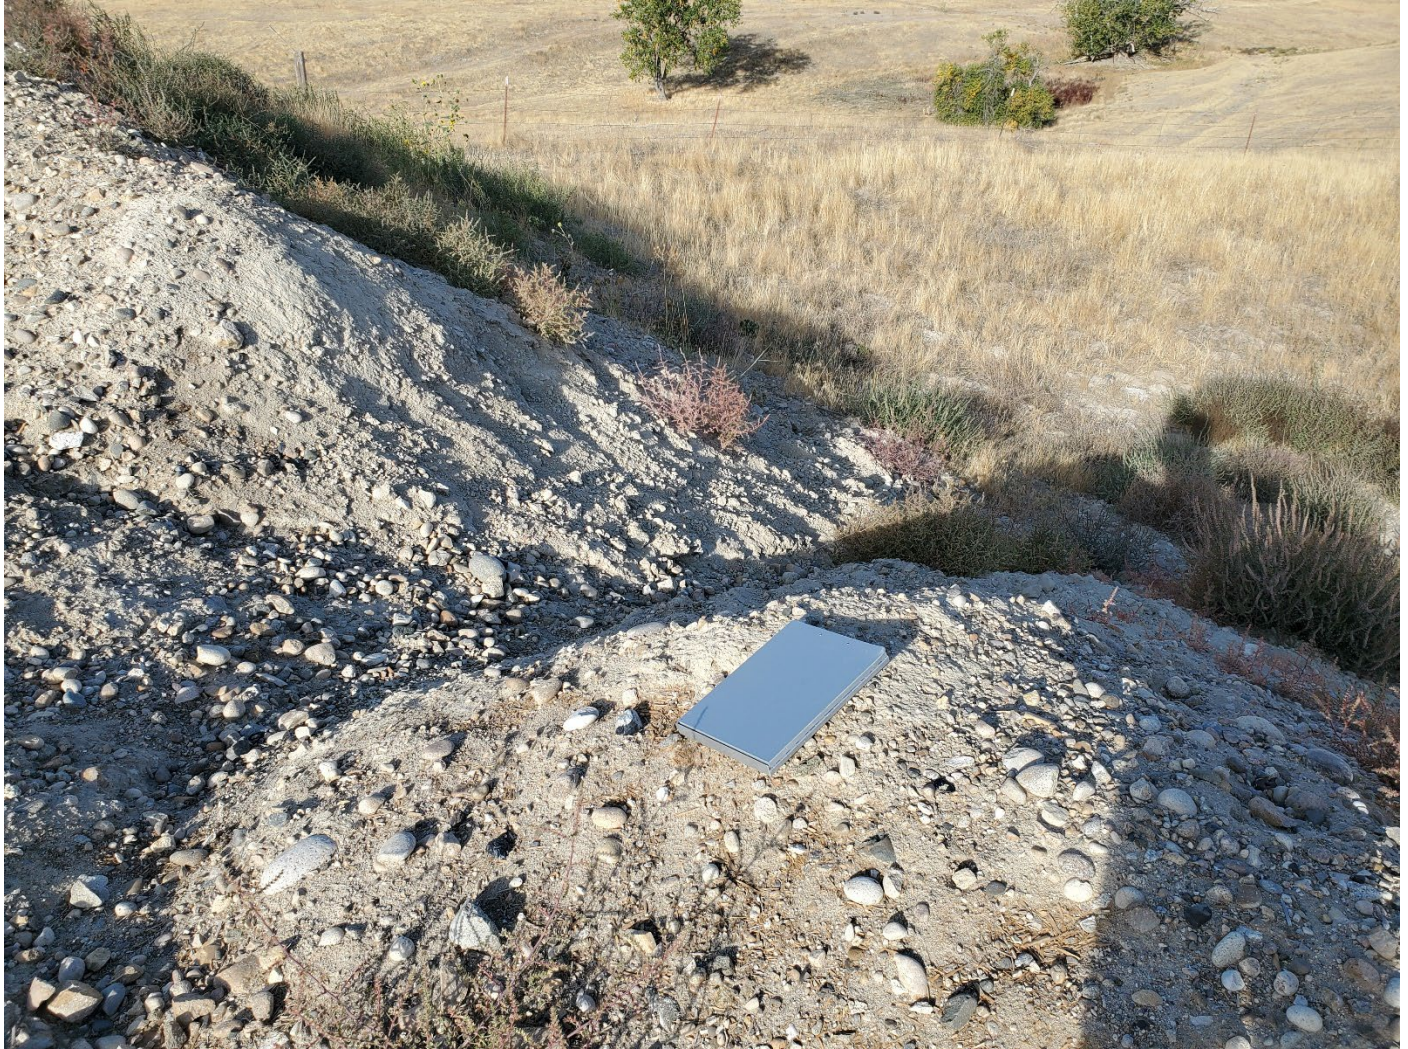
Minor pad erosion along northwest perimeter of pad. Erosion is not new, does not appear to be expanding.

Minor pad erosion on northwest perimeter of well pad. Erosion is not new and does not appear to be expanding.
